**Monthly Environmental Monitoring & Auditing report for**

**Contract No.DC/2009/22**

**Drainage Improvement in Shuen Wan, Tai Po – Contract 1**

**June 2014**

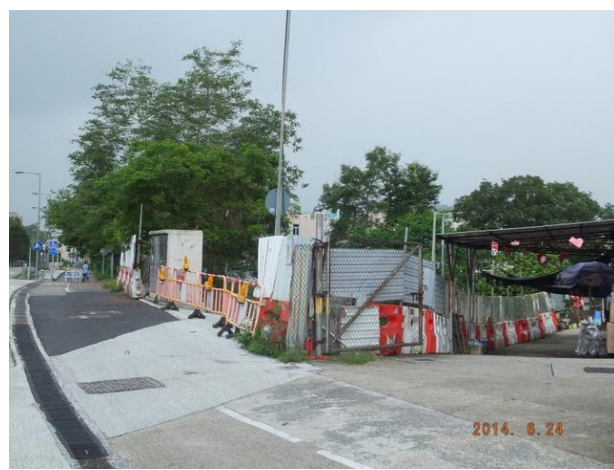
Temporary construction hoardings have been erected around Wai Ha River estuary since the building of an automatic mechanical penstock at the area (**Photo 1**). Since February 2014, the construction hoardings surrounding Area A (i.e. the proposed pump house station) have been replaced by the built boundary walls along the western and part of the northern sides of Area A (**Photo 2**), with chain-link fence erected along the rest of the boundary sides of Area A. As observed since May 2014, all the planting works and major

**Photo 1** – Temporary construction hoardings have been established around the works area at Wai Ha River estuary and the work was completed.

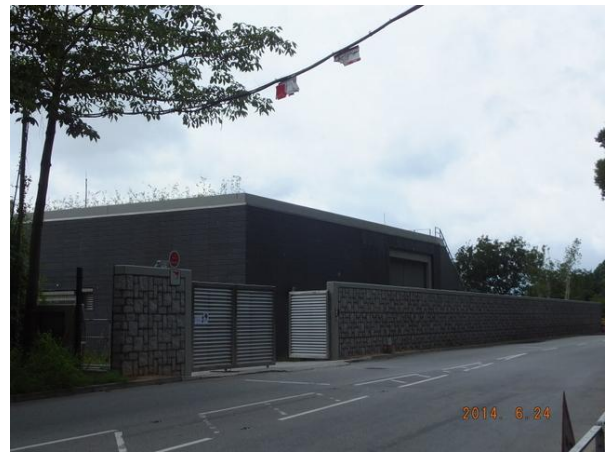
**Photo 2** – The proposed boundary wall along the western boundary of Area A.

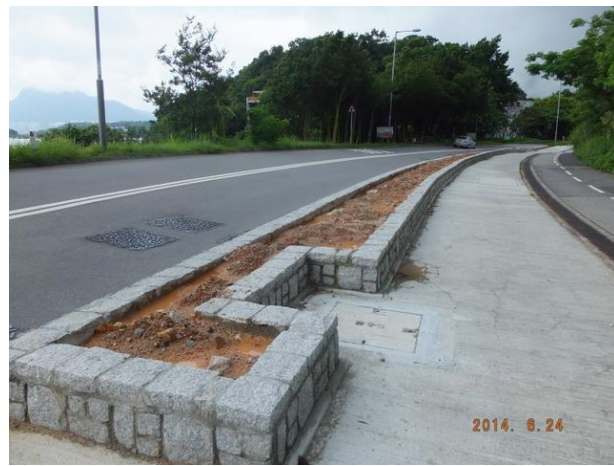
Construction of the proposed roadside planters along Ting Kok Road was commenced in March 2014. The temporary construction barriers erected around the built planters were removed as observed since late May 2014 and no planting was carried out as observed in June 2014 (**Photo 3**).

**Photo 3** – The roadside planters along Ting Kok Road were constructed but no shrub planting has been carried out.

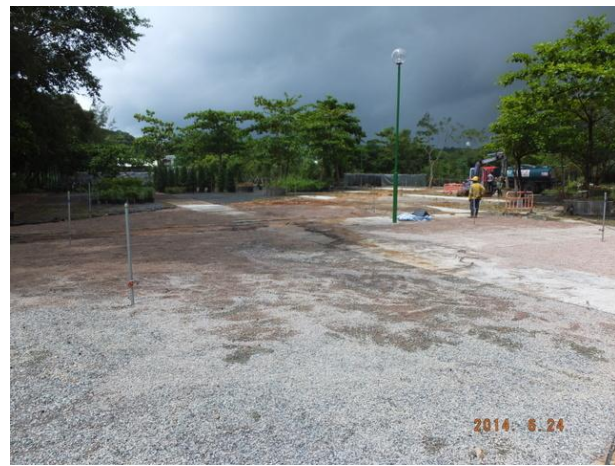
**Photo 4** – The reinstatement work of the nursery ground in Phase 2 of Area B was under progress.

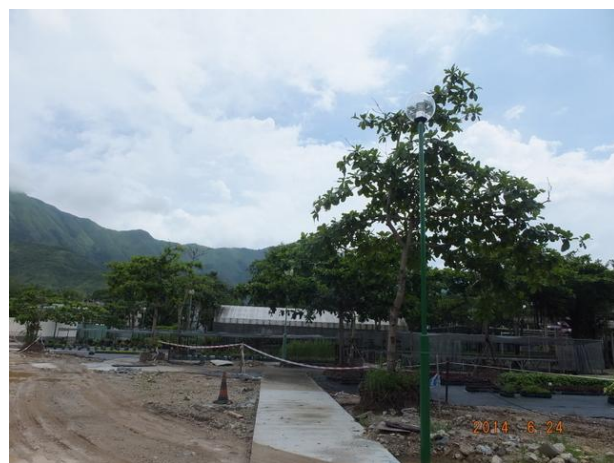
**Photo 5** – The boundary of Phase 1 of Area B was loosely demarcated with barrier tape.

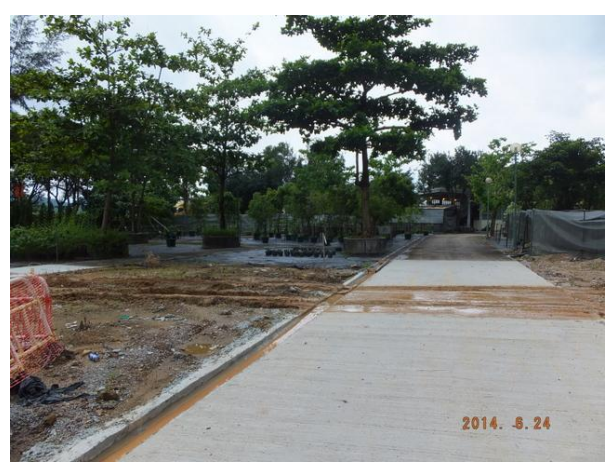
**Photo 6** – An open access path has been maintained during the current reinstatement work period.

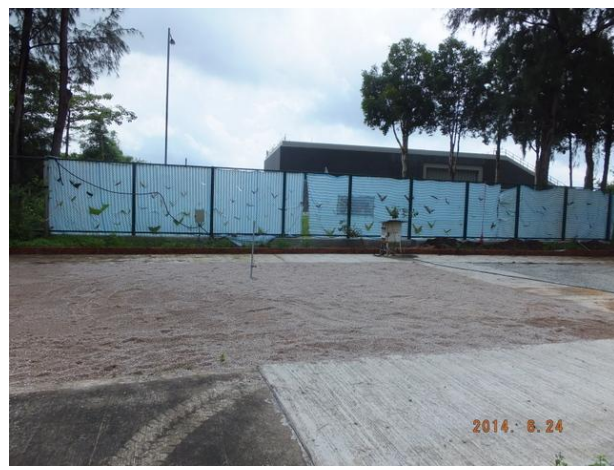
The temporary hoardings established for demarcating the construction site boundary of Phases 1 and 2 construction works area of Area B in Tung Tsz Nursery have been removed since January 2014. The reinstatement works in the nursery have been under progress (see **Photo 4** for the reinstatement work in Phase 2 construction works area as observed on 24<sup>th</sup> June 2014). However, both areas were demarcated with loosened barrier tapes (**Photo 5**). The open section and other reinstated access path connecting between Phases 1 and 2 works areas have been maintained during the current reinstatement work period, providing an access path for the daily operation of the nursery (**Photo 6**). Since November 2013, the hoarding along the eastern boundary of Phase 2 in Area B (i.e. the section next to Ting Kok Road) was permanently reinstated with the original chain-link fence. Canvas sheets were put on the reinstated fence to screen off the existing construction site from the pedestrian path (**Photo 7**).

**Photo 7** – Chain-link fence was reinstated at the eastern end of Phase 2 works area and covered by canvas sheets.

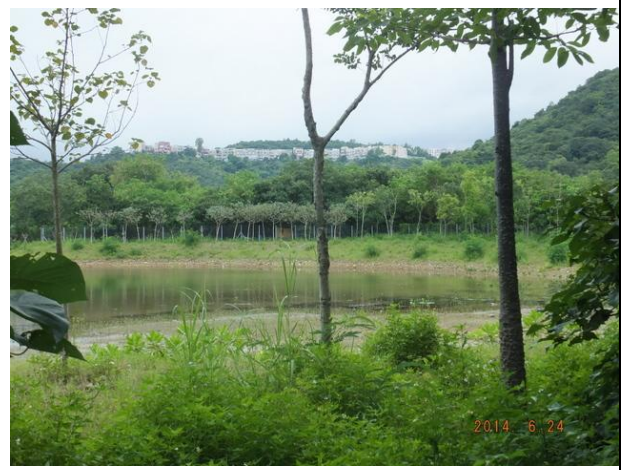
Area C was formally handed over to AFCD on 16<sup>th</sup> October 2012 for management and maintenance. The pond of the ECA has been connected to Wai Ha River directly as following the scheme design of Habitat Compensatory Plan. No direct discharge of turbid water into the adjacent Wai Ha River was observed through the fence of Tung Tsz Nursery (**Photo 8**).

**Photo 8** – No discharge of muddy water was observed in Area C.

The Contractor should regularly check the condition and locations of the drainage pipes and ensure that all used water should be appropriately filtered and discharged to the manholes/other discharge points agreed by the Engineer and EPD. This is to avoid any potential contamination to the vegetation in Shuen Wan marsh and other vegetated/marinated areas adjacent to the active works area.

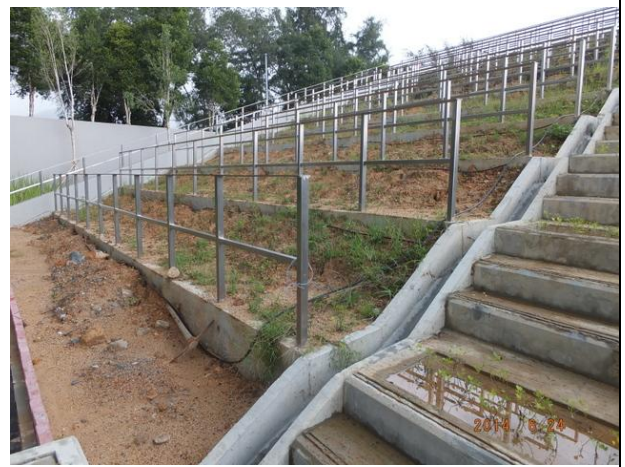
As observed in June 2014, the planted ground cover *Arachis duranensis* on the green roof was in fair condition (**Photo 9**) but the growth of those planted on the slanting component of the proposed green roof was generally slower (**Photo 10**). Other planted vegetation, including *Ficus pumila* and *Parthenocissus dalzielii* on the ground for vertical greening, ground cover *Iris tectorum*, shrubs *Ficus microcarpa* (Golden Leaf) and trees *Cinnamomum burmannii*, were also in fair condition (**Photos 11-12**).

**Photo 10** – The growth of the ground cover planted on the slanting component of the green roof was generally slower.

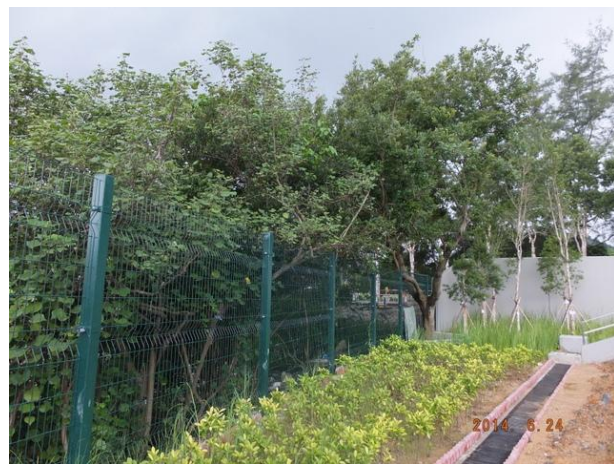
**Photo 11** – The planted shrubs *Ficus microcarpa* (Golden Leaf) were in fair condition.

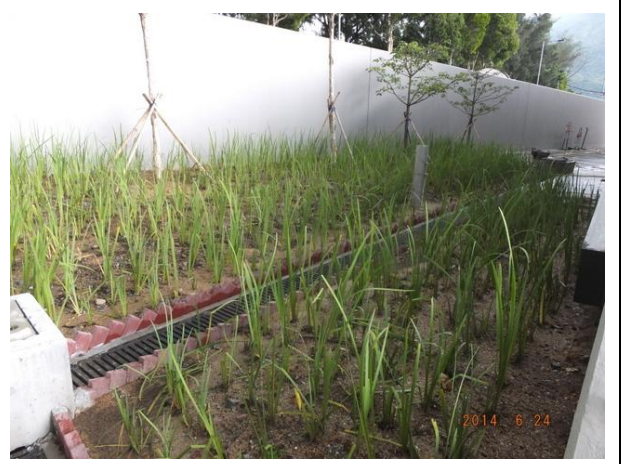
**Photo 12** – The planted ground cover *Iris tectorum* were in fair condition.

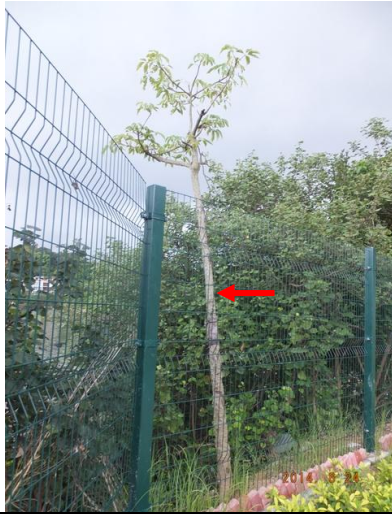
The tree to be transplanted E16 (*Bombax ceiba*) was relocated to the southern side of Area A next to the site hoarding in July 2012. The tree was in fair condition with regeneration of healthy leaves as observed in June 2014 (**Photo 13**). However, it was separated outside the proposed chain-link fence along the boundary sides of Area A. Soil grade change was observed around the trunk base and minor exposed roots were found in January 2014. The stability of the tree may be affected. Though this tree is fenced outside the chain-link fence, the condition and stability of this tree should be regularly monitored throughout the construction period.

**Photo 13** – The tree E16 (*Bombax ceiba*) was relocated to the southern side of Area A and now outside the boundary fence.

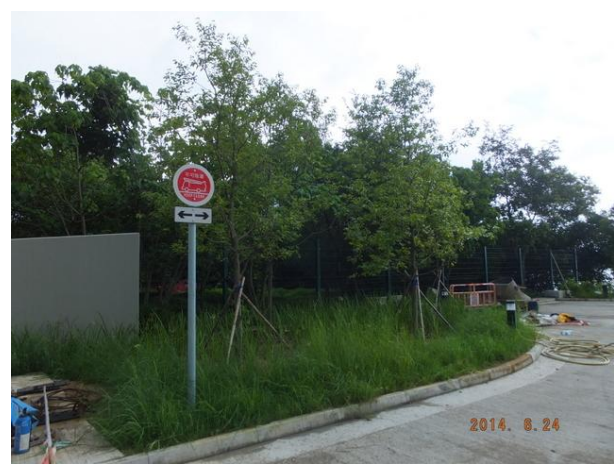
The relocated tree E38 (*Melaleuca cajuputi* subsp. *cumingiana*) was found dead after its relocation in August 2013, and it was removed by the Contractor in November 2013 (reported in *Monthly EM&A Report for November 2013*). A planter was built at the same location in accordance with the approved Landscape Plan. The four newly planted *Cinnamomum burmannii* and the ground cover *Iris tectorum* appeared in fair condition (**Photo 14**).

**Photo 14** – The planted trees *Cinnamomum burmannii* and ground cover *Iris tectorum* were in fair condition.

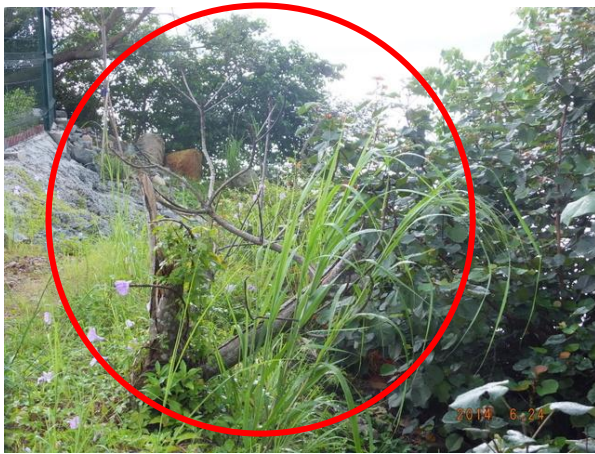
Damaged tree trunk on E55 (*Macaranga tanarius* var. *tomentosa*) has been reported in the submitted *Monthly EM&A Reports* since May 2013. The wound on the trunk of E55 has been burlapped since May 2013. The upper section of the tree trunk was broken in June 2013. The tree was suspected to be a dead specimen with no sign of vigor. It was separated outside the proposed chain-link fence along the boundary sides of Area A (**Photo 15**).

**Photo 15** – Tree E55 (*Macaranga tanarius* var. *tomentosa*) was suspected to be a dead specimen with no sign of vigor.

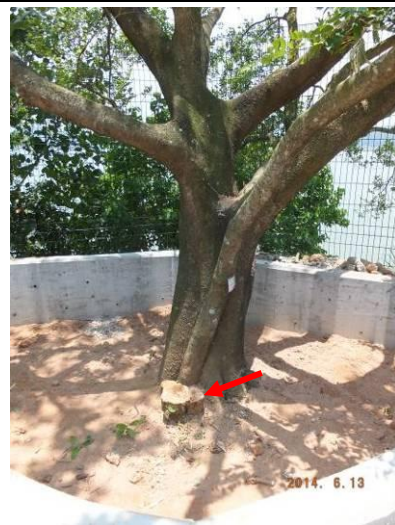
As reported in the previously *Monthly EM&A Reports*, a retained tree T253 (*Bridelia tomentosa*) was in poor condition, with dead scaffold limbs and dry, peeled bark. The whole tree was removed as observed on 13<sup>th</sup> June 2014 (**Photo 16**).

**Photo 16** – A retained tree T253 (*Bridelia tomentosa*) of poor condition was removed as observed on 13<sup>th</sup> June 2014.

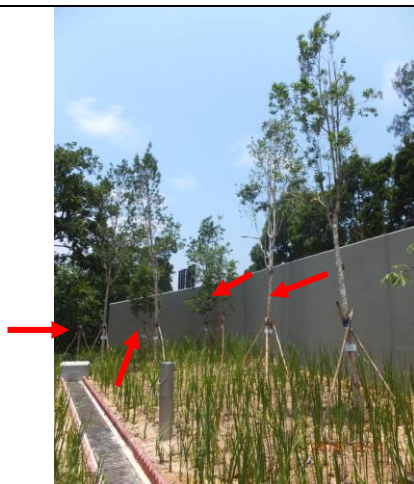
**Photo 17** – The four newly replaced trees *Melaleuca cajuputi* subsp. *cumingiana* at the southeastern corner were in fair condition.

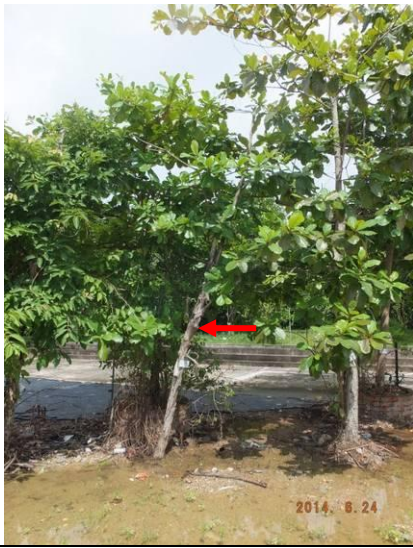
The relocated tree U37 was certified as a dead specimen (**Photo 19**). No significant stockpiling of excavated soil was observed close to the relocated trees along both sides of Phase 1 works area.

**Photo 19** – Dead tree U37.

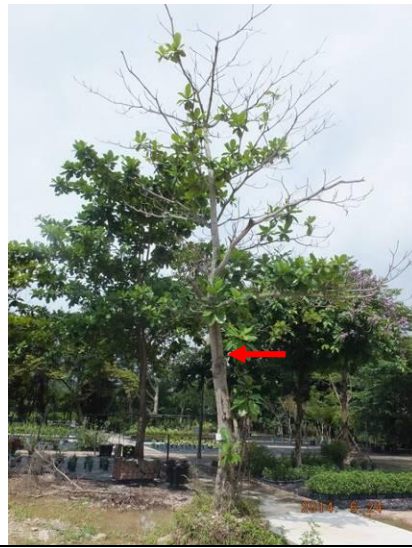
**Photo 20** – Half of the planter of U47 (*Terminalia catappa*) has been broken since August 2013.

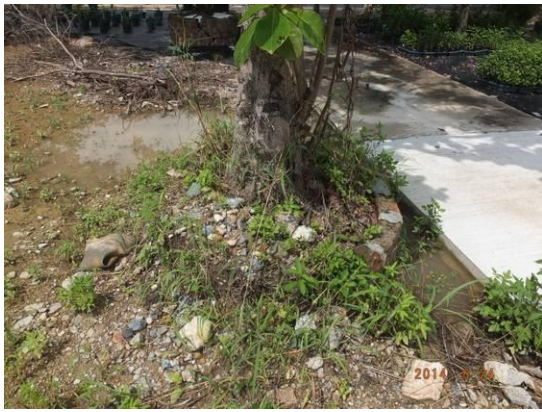
**Photo 21** – Close-up view of the broken planter of U47.

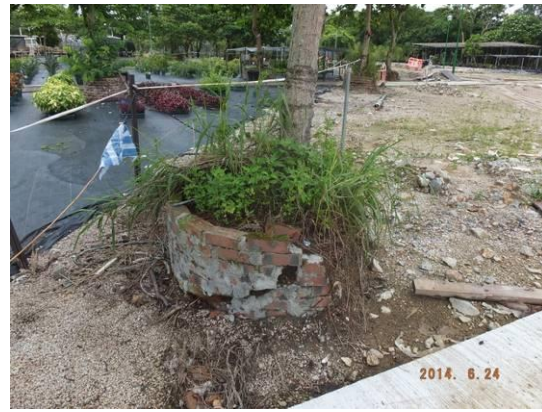
**Photo 22** – The planter of an untagged *Terminalia catappa* next to U54 was broken, with exposed roots and soil.

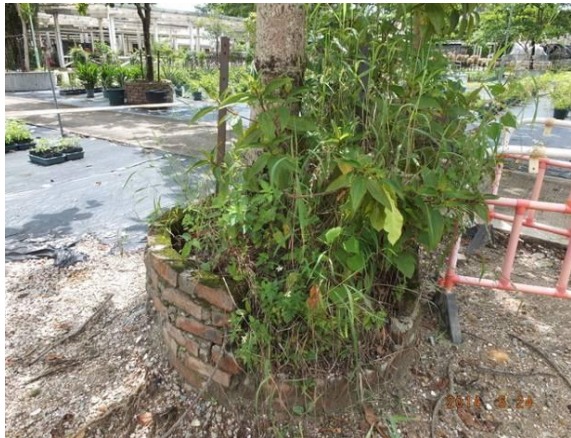
**Photo 23** – The planter of U54 (*Terminalia catappa*) was broken and the exposed roots and soil was observed.

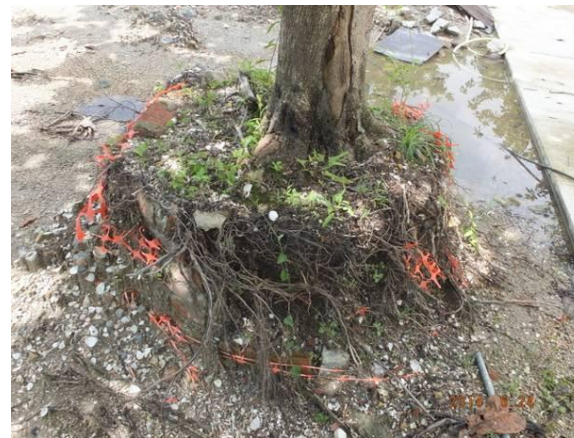
**Photo 24** – The planter of another untagged *Terminalia catappa* next to U54 was broken, with exposed roots and soil.

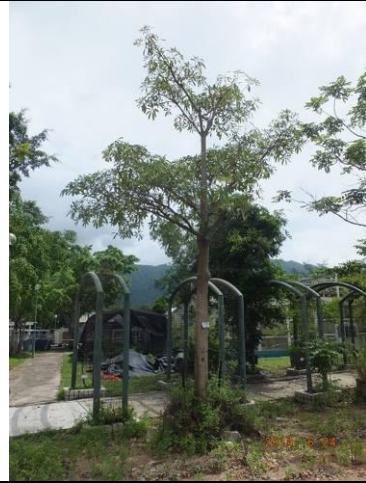
**Photo 25** – The planter of U69 (*Alstonia scholaris*) was broken and the exposed roots and soil were observed.

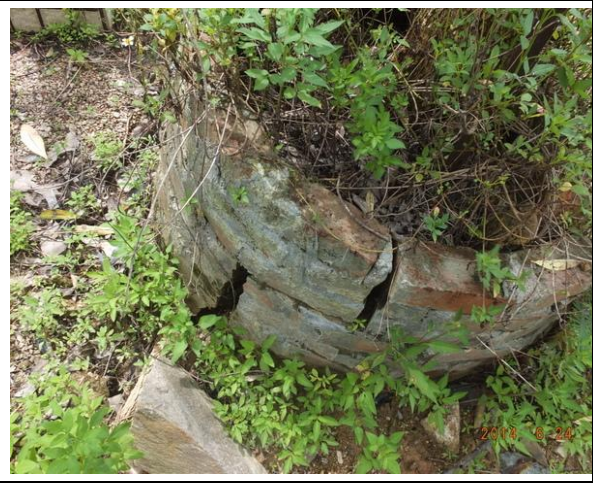
**Photo 26** – Close-up view of the broken planter of U69.

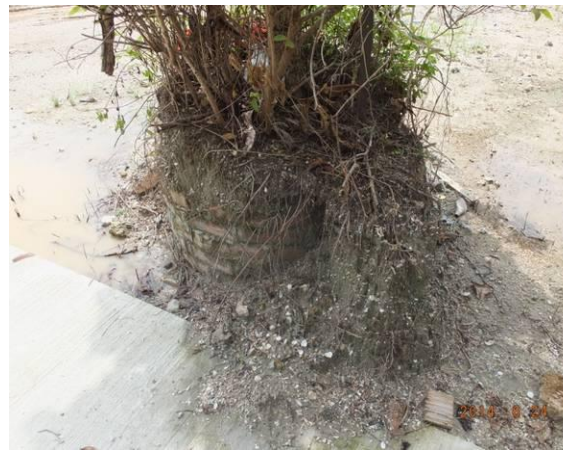
**Photo 27** – The piled soil around the planter and on the root flare of U51 (*Terminalia catappa*) was not yet removed.

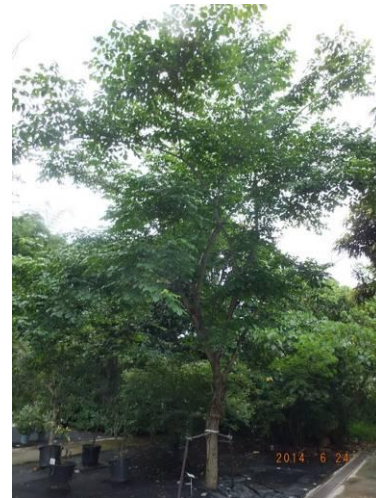
**Photo 28** – The relocated tree U55 (*Pterocarpus indicus*) was in fair condition.

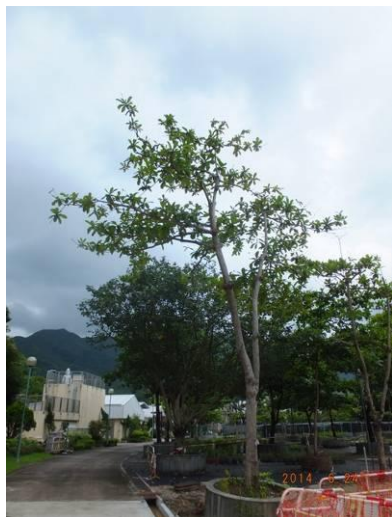
**Photo 29** – The condition of the retained tree A40 (*Terminalia catappa*) was in fair condition only, with the risk of leaning tree trunk.

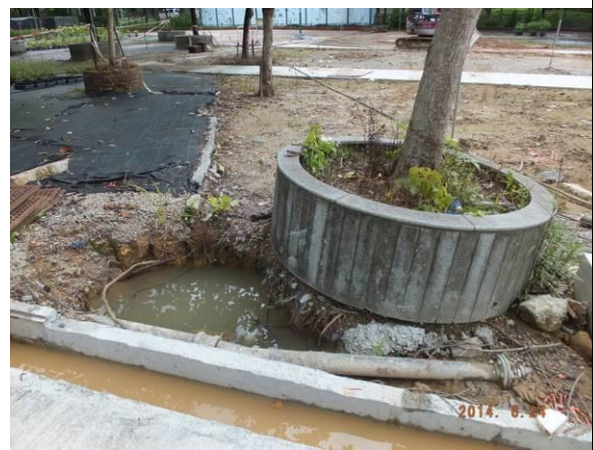
**Photo 30** – The northern excavated area close to the planter of the retained tree A40 was not yet refilled.

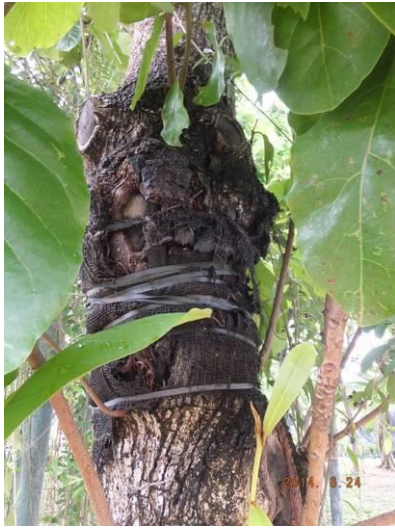
**Photo 31** – Close-up view of the hessian wrapping and tied string (as indicated) on the trunk of U53. The wrapping was not yet removed.

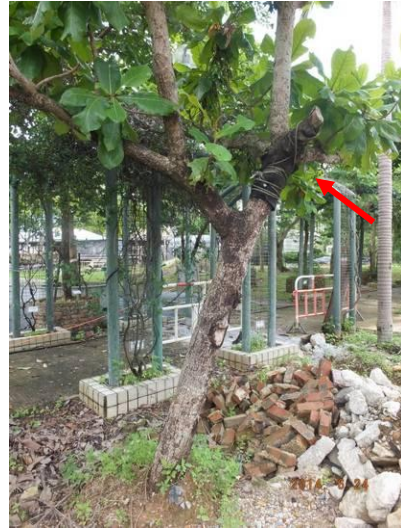
**Photo 32** – Hessian wrapping was found on the scaffold limb of the relocated tree A22.

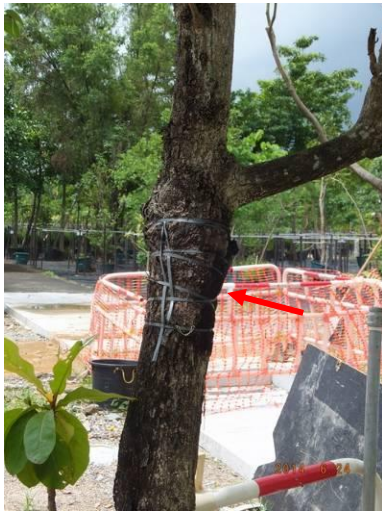
**Photo 33** – Close-up view of the tied string on the relocated tree.

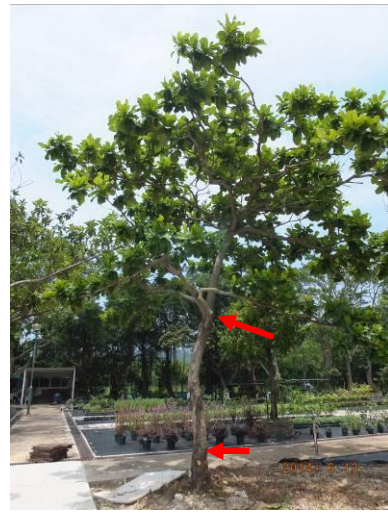
**Photo 34** – The watersprouts at the base and scaffold branches of U48 were pruned.

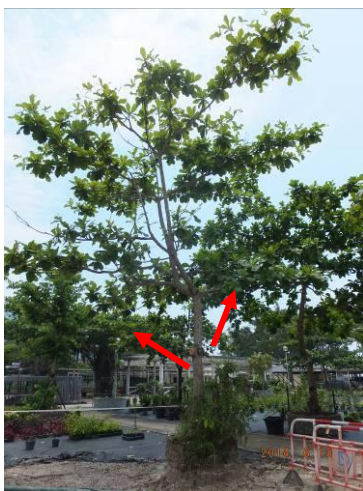
**Photo 35** – The scaffold limbs along the trunk of an untagged *Terminalia catappa* were pruned.

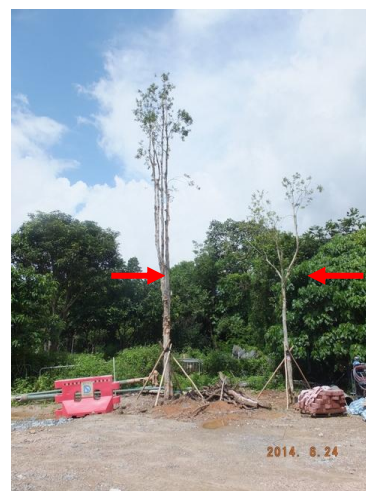
**Photo 36** – Two trees were newly transplanted next to the main gate of Phase 1 works area by other party.

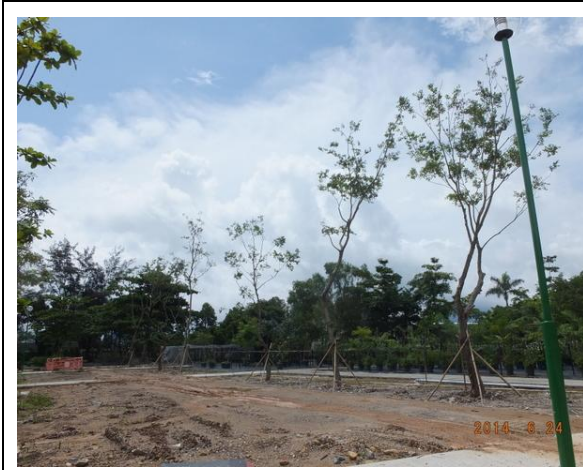
As observed on 13<sup>th</sup> June 2014, a total of eight mature trees (including *Celtis sinensis* and *Melaleuca cajuputi* subsp. *cumingiana*) of around 8-10m were transplanted to Phase 1 construction works area. Based on the information provided by the Main Contractor, these trees were transplanted from other LCSD-related project and Tung Tsz Nursery was selected as the receptor site for these trees

**Photo 37** – Six trees of *Celtis sinensis* were transplanted to Phase 1 works area by other party.

Any reinstatement work nearby the recently transplanted trees from LCSD-related project should be carefully programmed. The on-site workers and operator of any movable heavy machinery should avoid damaging these tree parts during the re-instatement work. If necessary, a buffer zone is recommended to separate the reinstatement work areas from these transplanted trees.

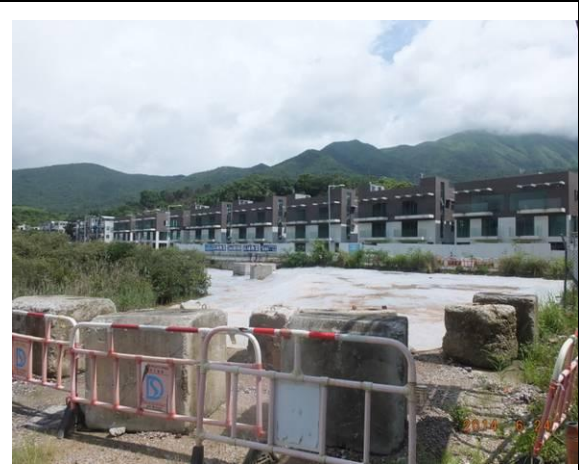
**Photo 38** – The soil ground to the northwest of Tung Tsz Nursery has been hydroseeded.

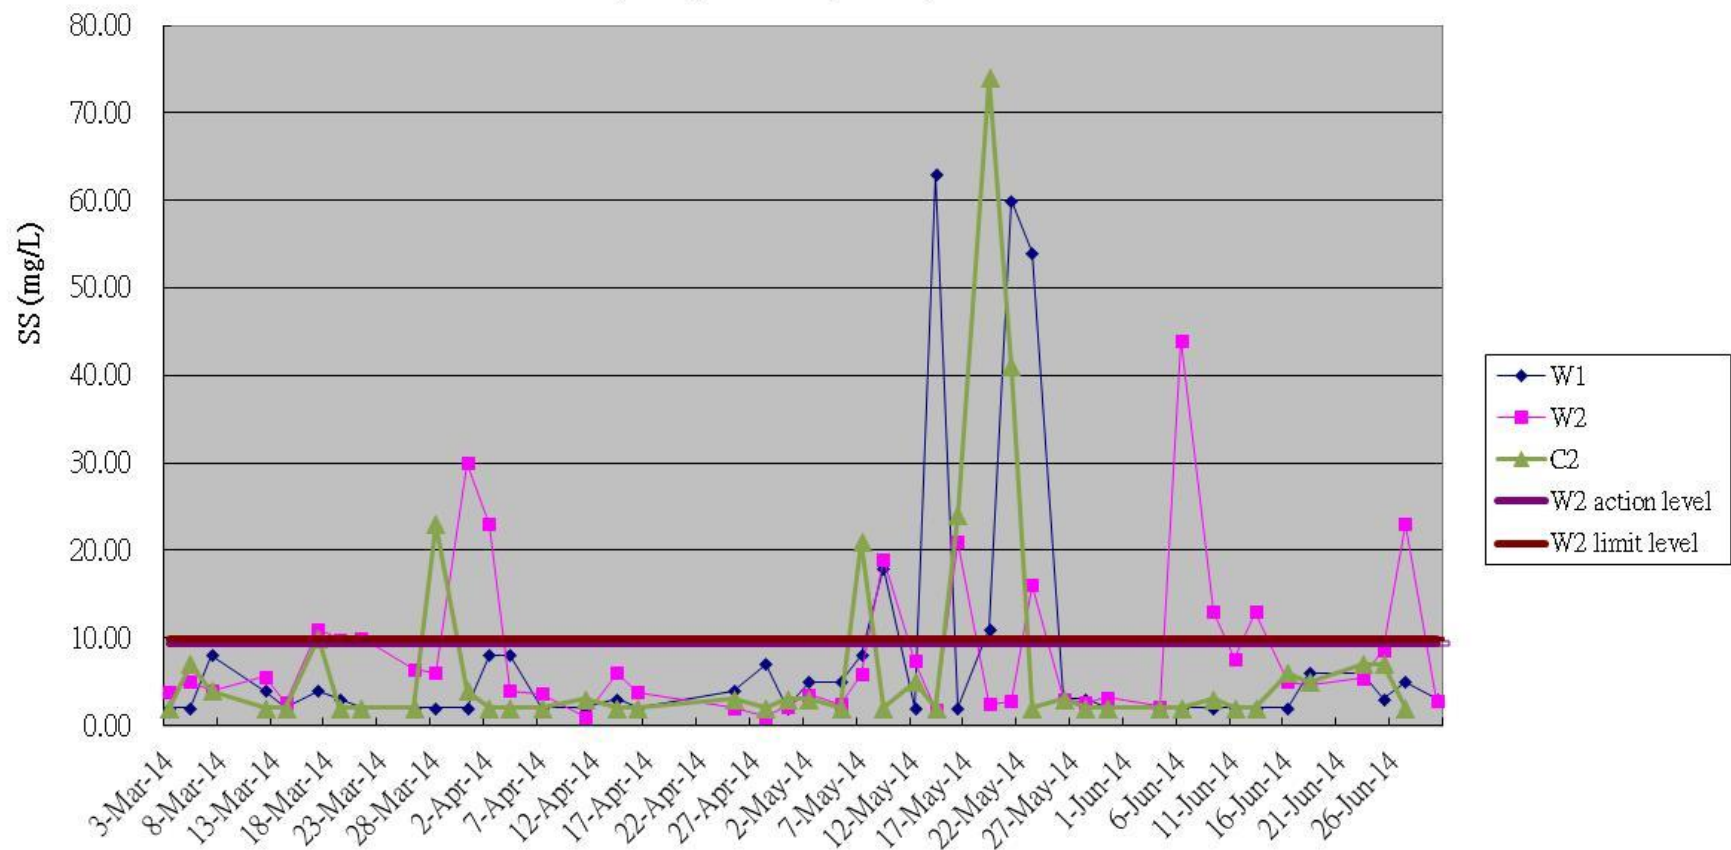
Graphical plots of SS (ebb tide) for W1&W2

Remarks: Action limit is 95% of baseline data or 120% of upstream control station's SS  
 Limit level is 99% of baseline data or 130% of upstream control station's SS
