Monthly Environmental Monitoring & Auditing report for

Contract No.DC/2009/22

Drainage Improvement in Shuen Wan, Tai Po – Contract 1

July 2014

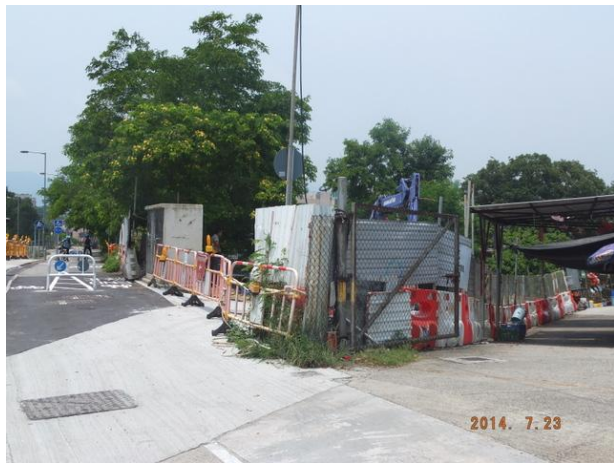
Temporary construction hoardings have been erected around Wai Ha River estuary since the building of an automatic mechanical penstock at the area (**Photo 1**). A rock breaker machine was under operation near the area of the built automatic mechanical penstock on 23rd July 2014, but caused no influenced on the built penstock. Since February 2014, the construction hoardings surrounding Area A (i.e. the proposed pump house station) have been replaced by the built boundary walls along the western and part of the northern sides

Photo 1 – Temporary construction hoardings have been established around the works area at Wai Ha River estuary. Minor rock breaking work was noted on 23rd July 2014.

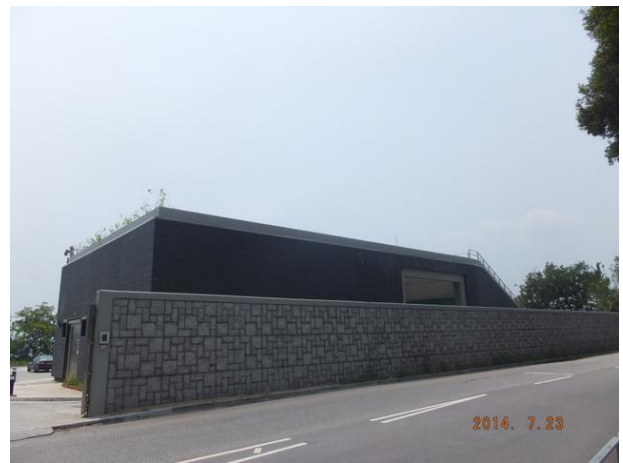
of Area A (**Photo 2**), with chain-link fence erected along the rest of the boundary sides of Area A. As observed since May 2014, all the planting works and major civil works were completed. The site office located at the northern part of Area A was also removed. As informed by the Main Contractor in June 2014, the pumping house area of Area A was handed over to DSD in early June 2014.

Photo 2 – The built boundary wall along the western boundary of Area A.

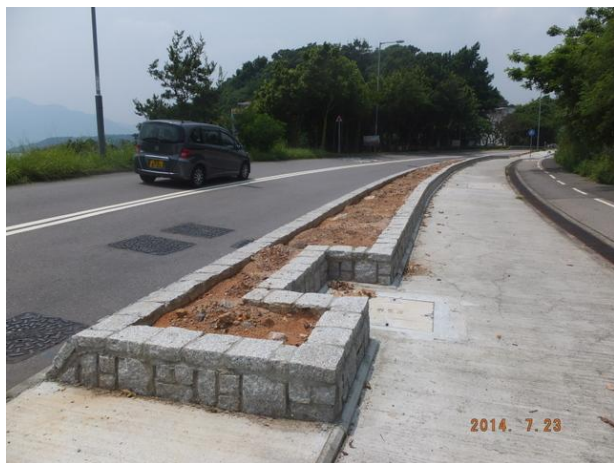
Construction of the proposed roadside planters along Ting Kok Road was completed in July 2014, but the proposed shrub planting has not yet commenced as observed in July 2014. As reported since May 2014, the temporary construction barriers erected around the built planters were removed (**Photo 3**).

Photo 3 – The roadside planters along Ting Kok Road were constructed but no shrub planting has been carried out.

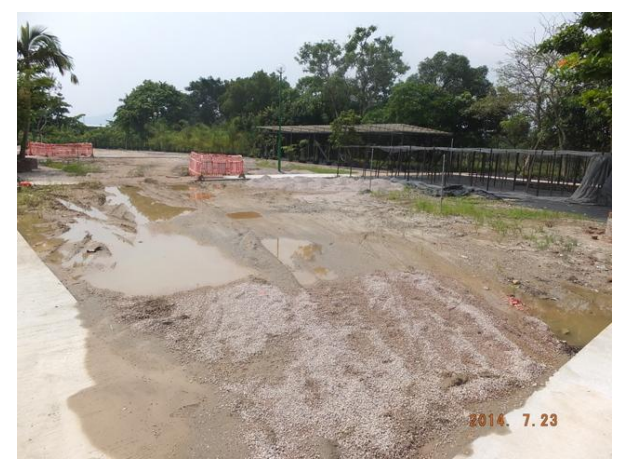
Photo 4 – The reinstatement work of the nursery ground in Phase 1 of Area B was under progress.

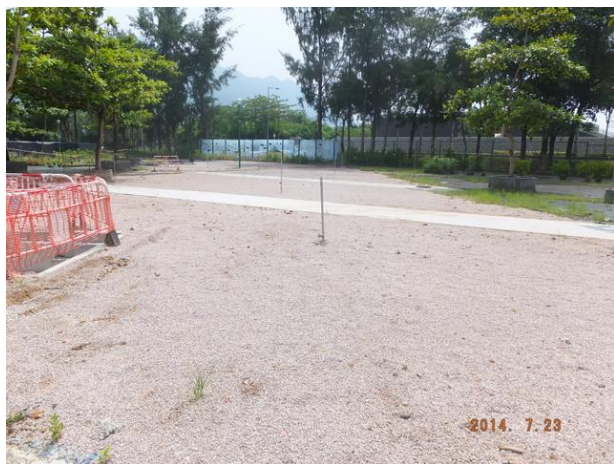
Photo 5 – The reinstatement work of the nursery in Phase 2 of Area B was almost completed.

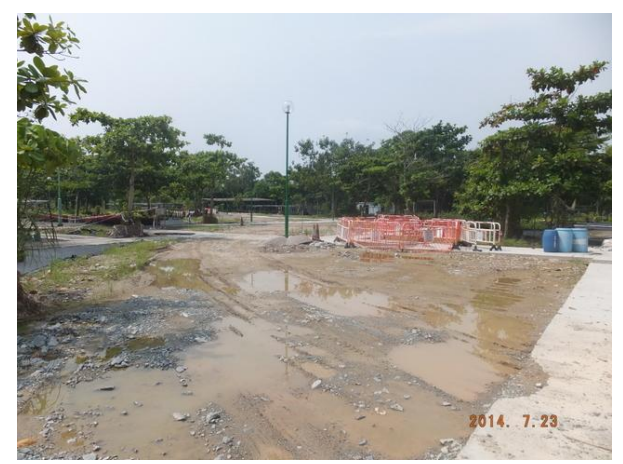
Photo 6 – Phase 1 works area was still demarcated with loosed barrier tapes.

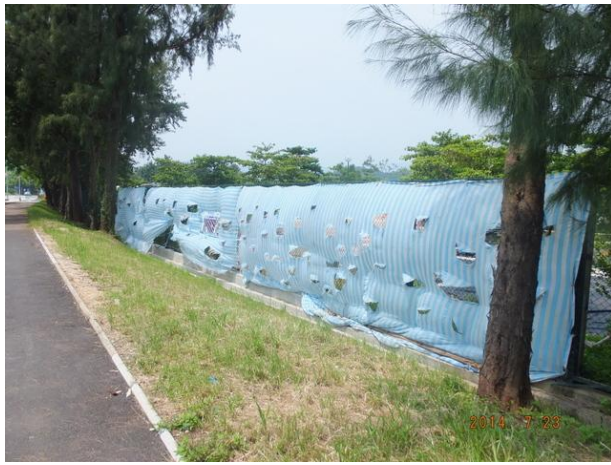
The temporary hoardings established for demarcating the construction site boundary of Phases 1 and 2 construction works area of Area B in Tung Tsz Nursery have been removed since January 2014. The reinstatement works in the nursery have been under progress (**Photo 4**), in particular, the reinstatement work in Phase 2 works area was almost finished (**Photo 5**). Both areas were demarcated with loosened barrier tapes (**Photo 6**). The open section and other reinstated access path connecting between Phases 1 and 2 works areas have been maintained during the current reinstatement work period, providing an access path for the daily operation of the nursery. Since November 2013, the hoarding along the eastern boundary of Phase 2 in Area B (i.e. the section next to Ting Kok Road) was permanently reinstated with the original chain-link fence. Canvas sheets were put on the reinstated fence to screen off the existing construction site from the pedestrian path (**Photo 7**).

Photo 7 – Chain-link fence was reinstated at the eastern end of Phase 2 works area and covered by canvas sheets.

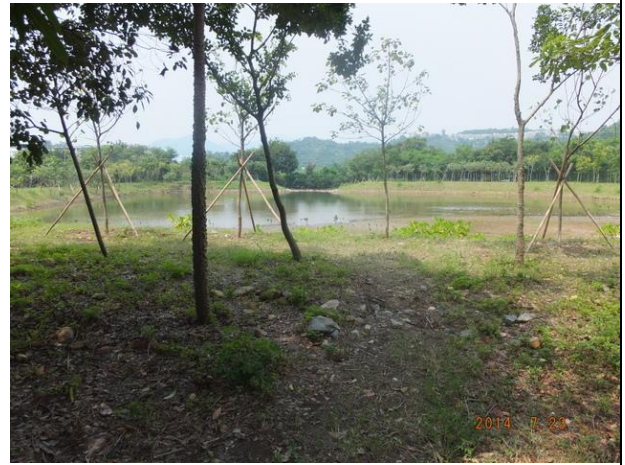
maintenance. The pond of the ECA has been connected to Wai Ha River directly as following the scheme design of Habitat Compensatory Plan. No direct discharge of turbid water into the adjacent Wai Ha River was observed through the fence of Tung Tsz Nursery (**Photo 8**).

Photo 8 – No discharge of muddy water was observed in Area C.

The Contractor should regularly check the condition and locations of the drainage pipes and ensure that all used water should be appropriately filtered and discharged to the manholes/other discharge points agreed by the Engineer and EPD. This is to avoid any potential contamination to the vegetation in Shuen Wan marsh and other vegetated/marinated areas adjacent to the active works area.

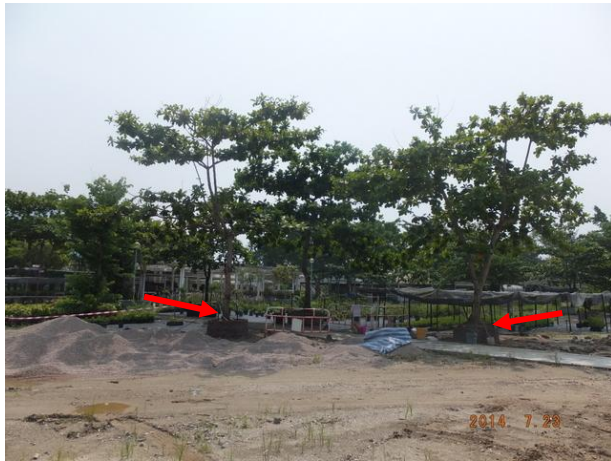
Major excavation works have been completed in Phases 1 and 2. The reinstatement works for the original access paths, ground of the nursery beds and basic nursery utility (such as irrigation pipes and lamp posts) were almost finished in Phase 2 area, but still in progress in Phase 1 area. As observed in July 2014, the old and damaged planters surrounding the relocated trees (such as U54 and two untagged trees nearby U54, A22, A36, A43, U69) were already repaired or under repaired (e.g. **Photos 9-11**). Some of these planters were backfilled with soil or aggregates.

Photo 9 – Example of the repaired planters for U54 and its nearby untagged tree *Terminalia catappa*.

Since the Contractor is under the process of replacing the broken planters or building new planters for those relocated trees, it is recommended to backfill appropriate amount of planting soil into the repaired planter. For those planters with backfilled soil or aggregate covering the trunk flare, the Contractor should remove surplus soil or aggregate to prevent suffocation of the trunk flare. In addition, for those trees that were planted directly on ground but surrounded by the newly built planters, the Contractor is recommended to design suitable drainage holes at the planter bases so as to prevent waterlogged within the planters after irrigation or rain.

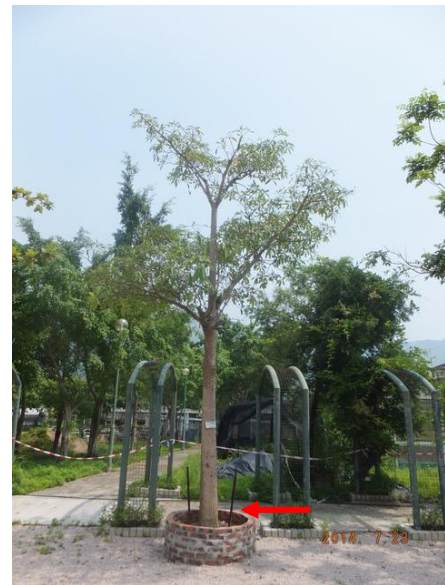
Photo 10 – The broken planter of U69 was repaired.

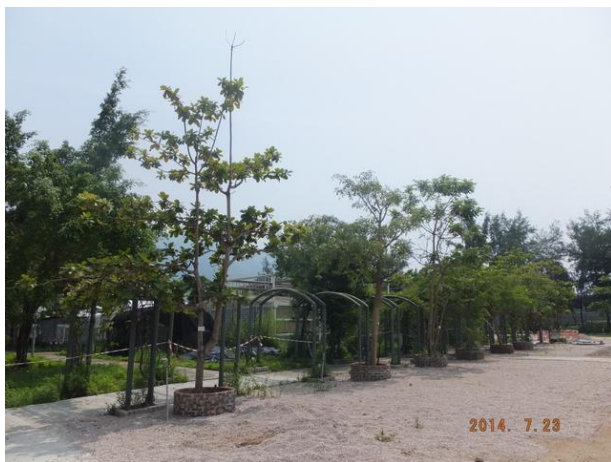
Photo 11 – Examples of other repaired planters of the relocated trees in Phase 1 works area.

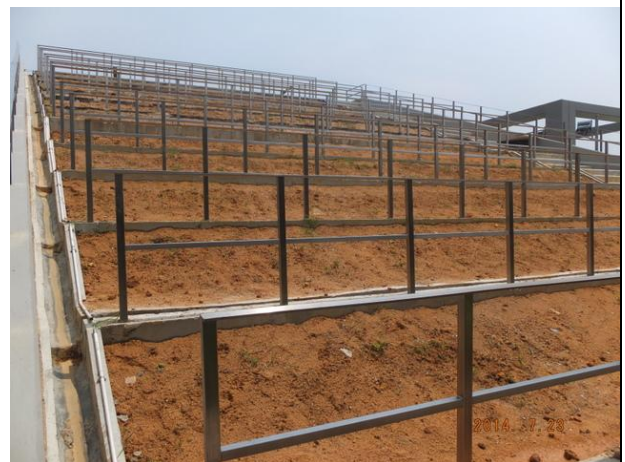
Photo 12 – The planted ground cover *Arachis duranensis* on the sloping green roof was removed.

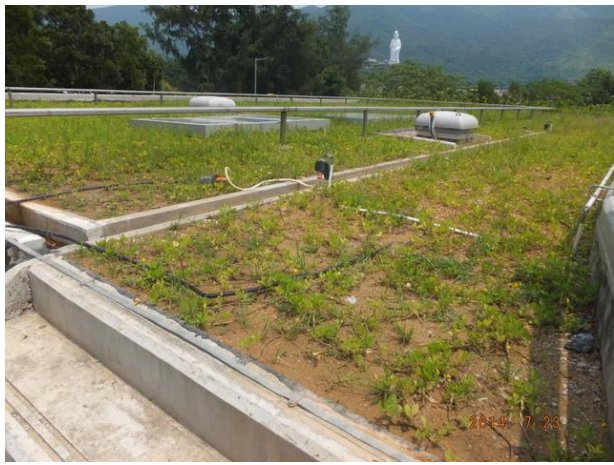
As observed in July 2014, the planted ground cover *Arachis duranensis* on the green roof was in fair condition (**Photo 13**). Other planted vegetation, including *Ficus pumila* and *Parthenocissus dalzielii* on the ground for vertical greening, ground cover *Iris tectorum*, shrubs *Ficus microcarpa* (Golden Leaf) and trees *Cinnamomum burmannii*, were also in fair condition (**Photos 14-15**).

Photo 13 – The ground cover *Arachis duranensis* planted on the green roof was in fair condition.

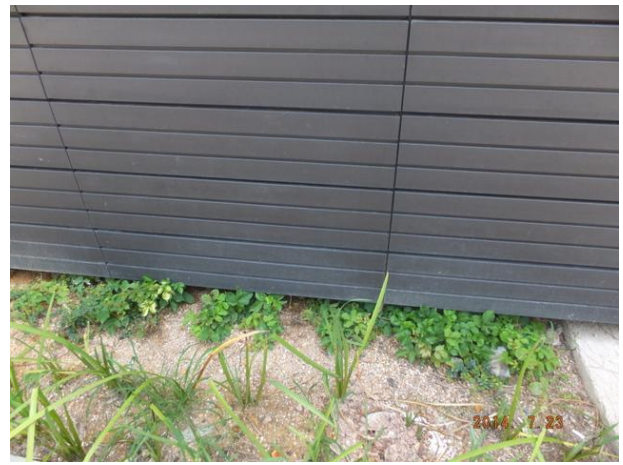
Photo 14 – Close-up view of the planted climber *Parthenocissus dalzielii* on the ground for vertical greening on the pump house.

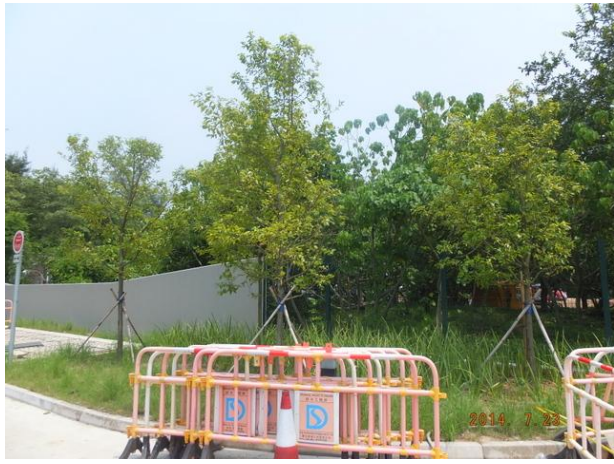
(reported in *Monthly EM&A Report for November 2013*). A planter was built at the same location in accordance with the approved Landscape Plan. The four newly planted *Cinnamomum burmannii* and the ground cover *Iris tectorum* appeared in fair condition (**Photo 15**).

Photo 15 – Four planted trees *Cinnamomum burmannii* and ground cover *Iris tectorum* were in fair condition.

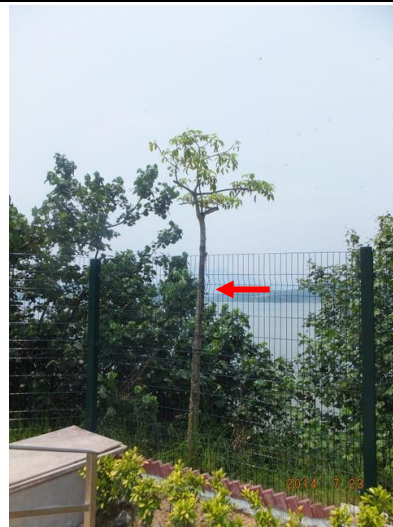
The tree to be transplanted E16 (*Bombax ceiba*) was relocated to the southern side of Area A next to the site hoarding in July 2012. The tree was in fair condition with regeneration of healthy leaves as observed after the onset of the wet season (**Photo 16**). However, it was separated outside the proposed chain-link fence along the boundary sides of Area A. Soil grade change was observed around the trunk base and minor exposed roots were found in January 2014. The stability of the tree may be affected. Though this tree is fenced outside the chain-link fence, the condition and stability of this tree should be regularly monitored throughout the construction period.

Photo 16 – The tree E16 (*Bombax ceiba*) was relocated to the southern side of Area A and now outside the boundary fence.

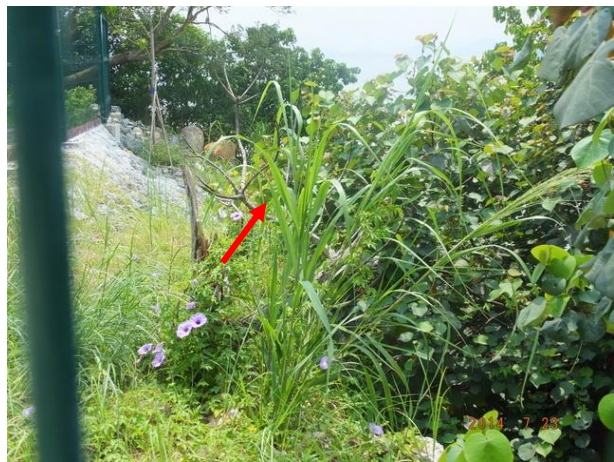
Damaged tree trunk on E55 (*Macaranga tanarius* var. *tomentosa*) has been reported in the submitted *Monthly EM&A Reports* since May 2013. The wound on the trunk of E55 has been burlapped since May 2013. The upper section of the tree trunk was broken in June 2013. The tree was suspected to be a dead specimen with no sign of vigor. It was separated outside the proposed chain-link fence along the boundary sides of Area A (**Photo 17**).

Photo 17 – Tree E55 (*Macaranga tanarius* var. *tomentosa*) was suspected to be a dead specimen with no sign of vigor.

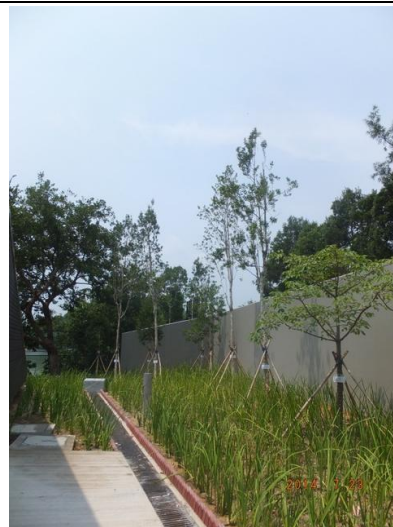
Photo 18 – All original planted and newly replaced trees *Melaleuca cajuputi* subsp. *cumingiana* at the southeastern corner were in fair condition.

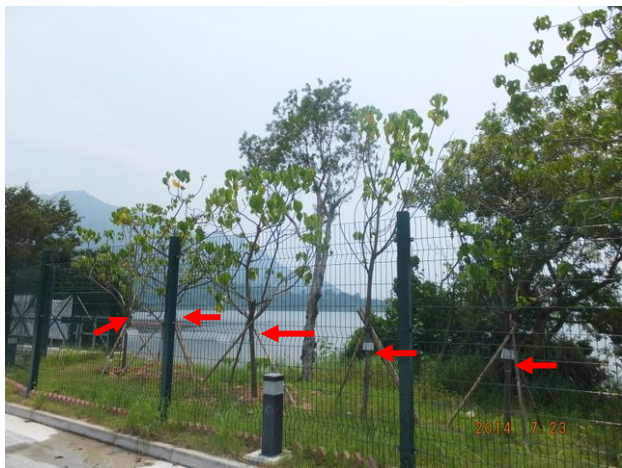
Photo 19 – Some new *Macaranga tanarius* var. *tomentosa* were planted at the eastern side of Area A to replace the specimens with poor performance.

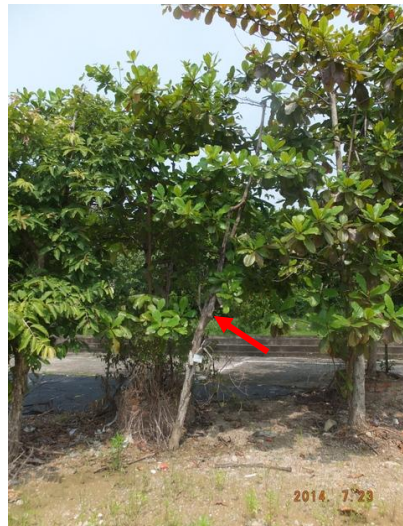
Photo 20 – Dead tree U37.

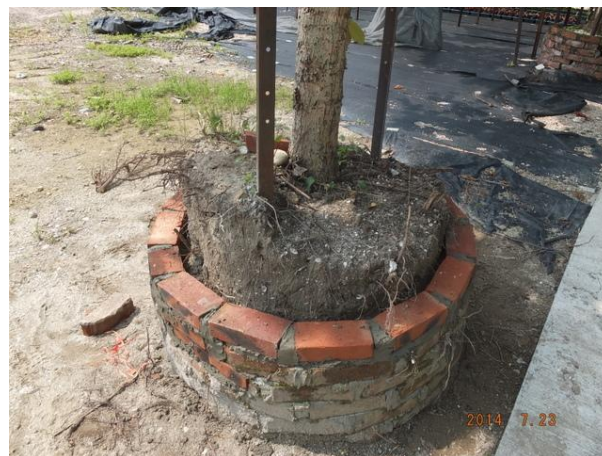
Photo 22 – The planter of U51 was repaired, but it was lower than the soil surface of the tree.

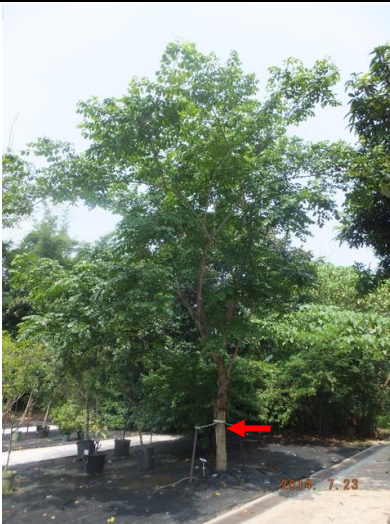
Photo 23 – The relocated tree U55 (*Pterocarpus indicus*) was in fair condition.

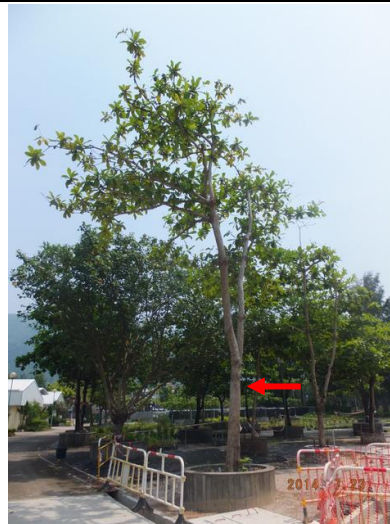
Photo 24 – The leaning tree of A40 at the entrance of Phase 2 was replanted upright with its planter.

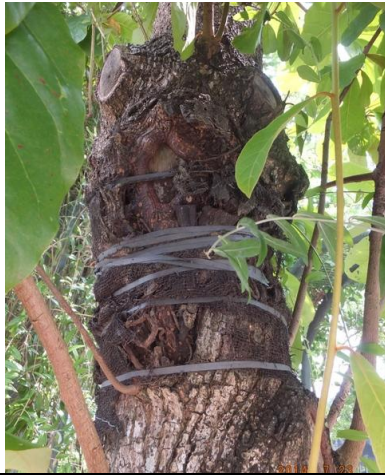
Photo 25 – The trunk of the transplanted tree U53 was still tied tightly by strings and hessian wrapping.

Maintenance of the existing trees within the works areas generally follows the recommendations as stated in *Monthly EM&A Report for June 2014*, except that the surplus soil and tied strings on the trees have not yet removed and the broken planters have not yet repaired. The observations recorded in July 2014 are highlighted in the following sections.

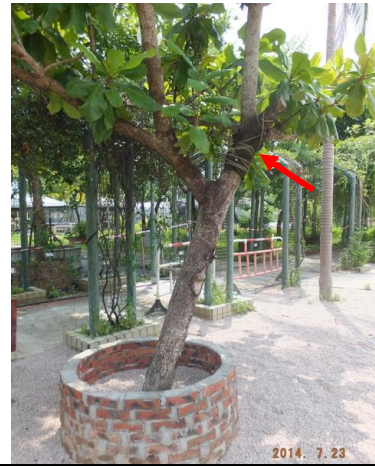
Photo 26 – Hessian wrapping and tied strings were found on the scaffold branch of the relocated tree A22, with its newly built planter.

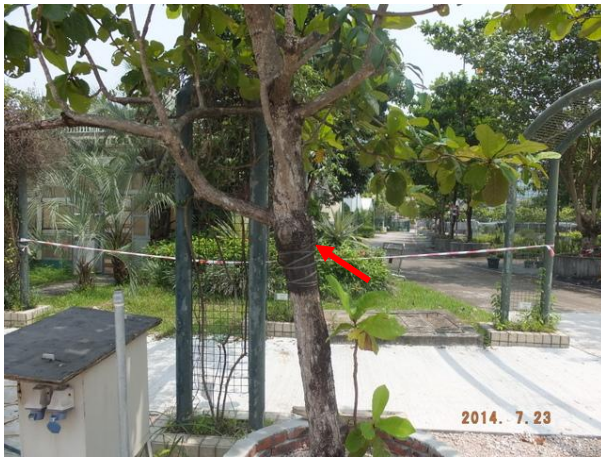
Photo 27 – Hessian wrapping and tied strings were found on the trunk of the relocated tree A42.

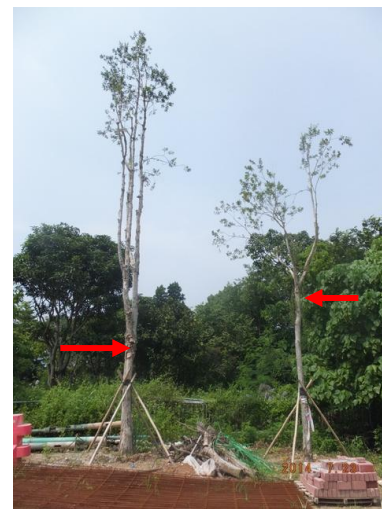
Photo 28 – Two trees were newly transplanted next to the main gate of Phase 1 works area by other party in June 2014.

Any reinstatement work nearby the recently transplanted trees from LCSD-related project should be carefully programmed. The on-site workers and operator of any movable heavy machinery should avoid damaging these tree parts during the re-instatement work. If necessary, a buffer zone is recommended to separate the reinstatement work areas from these transplanted trees

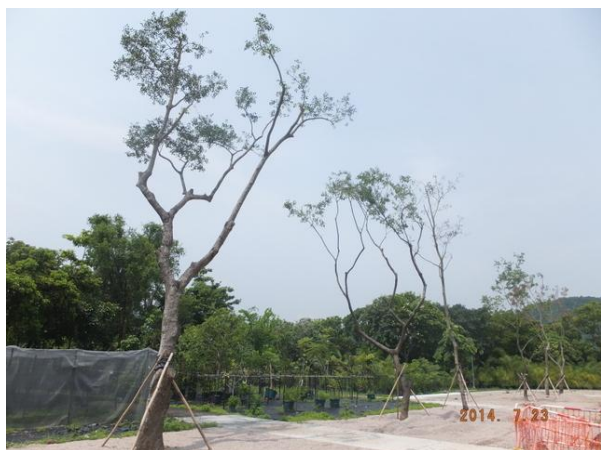
Photo 29 – Six trees of *Celtis sinensis* were transplanted to Phase 1 works area by other party in June 2014.

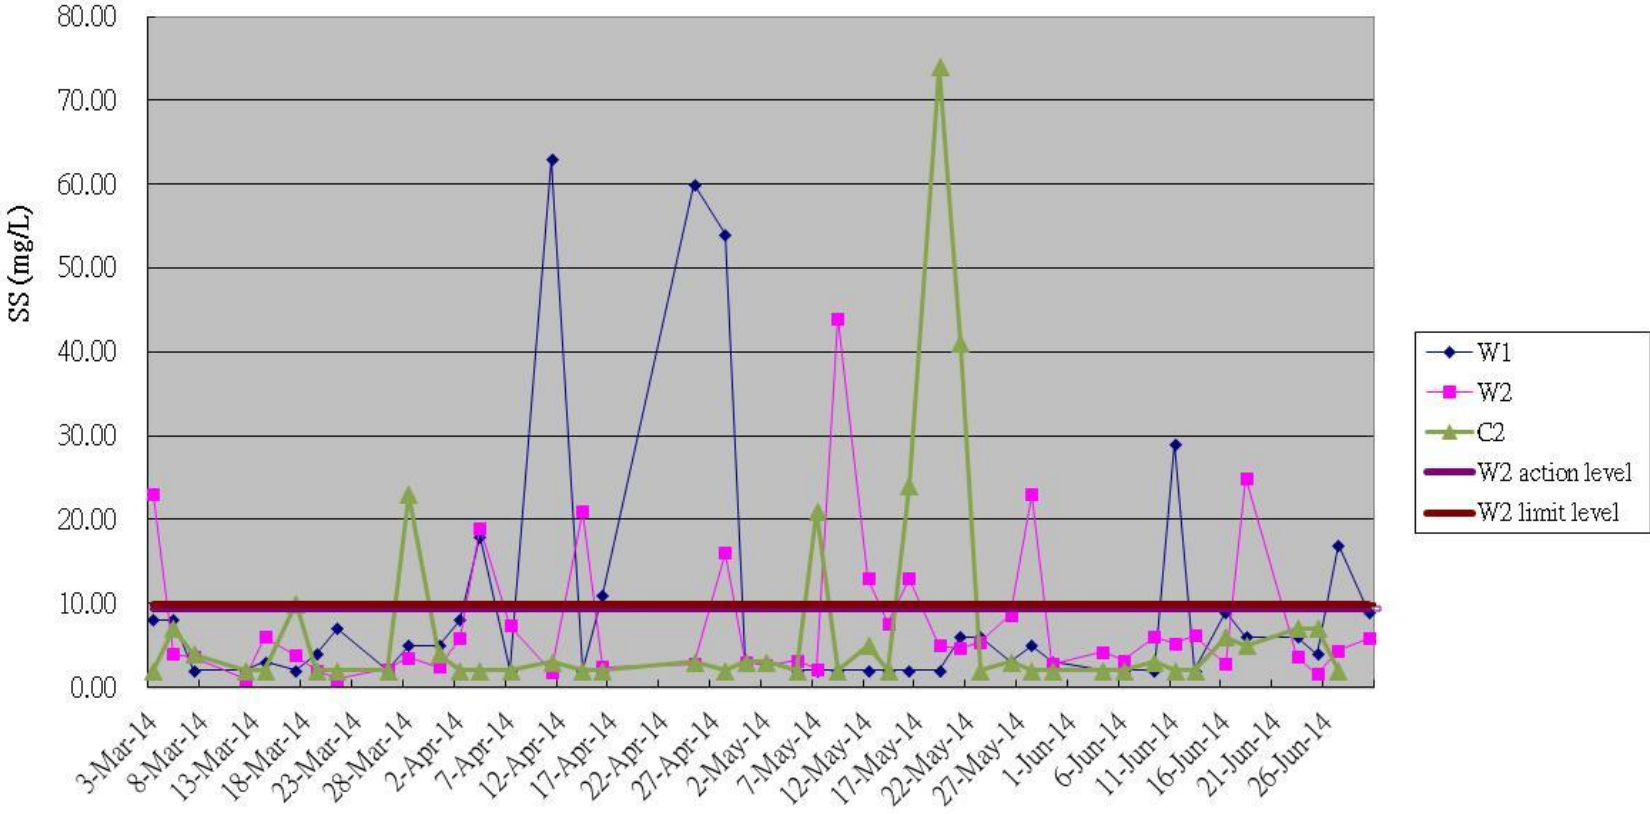
Graphical plots of SS (ebb tide) for W1&W2

Remarks: Action limit is 95% of baseline data or 120% of upsteam control station's SS
 Limit level is 99% of baseline data or 130% of upsteam control station's SS

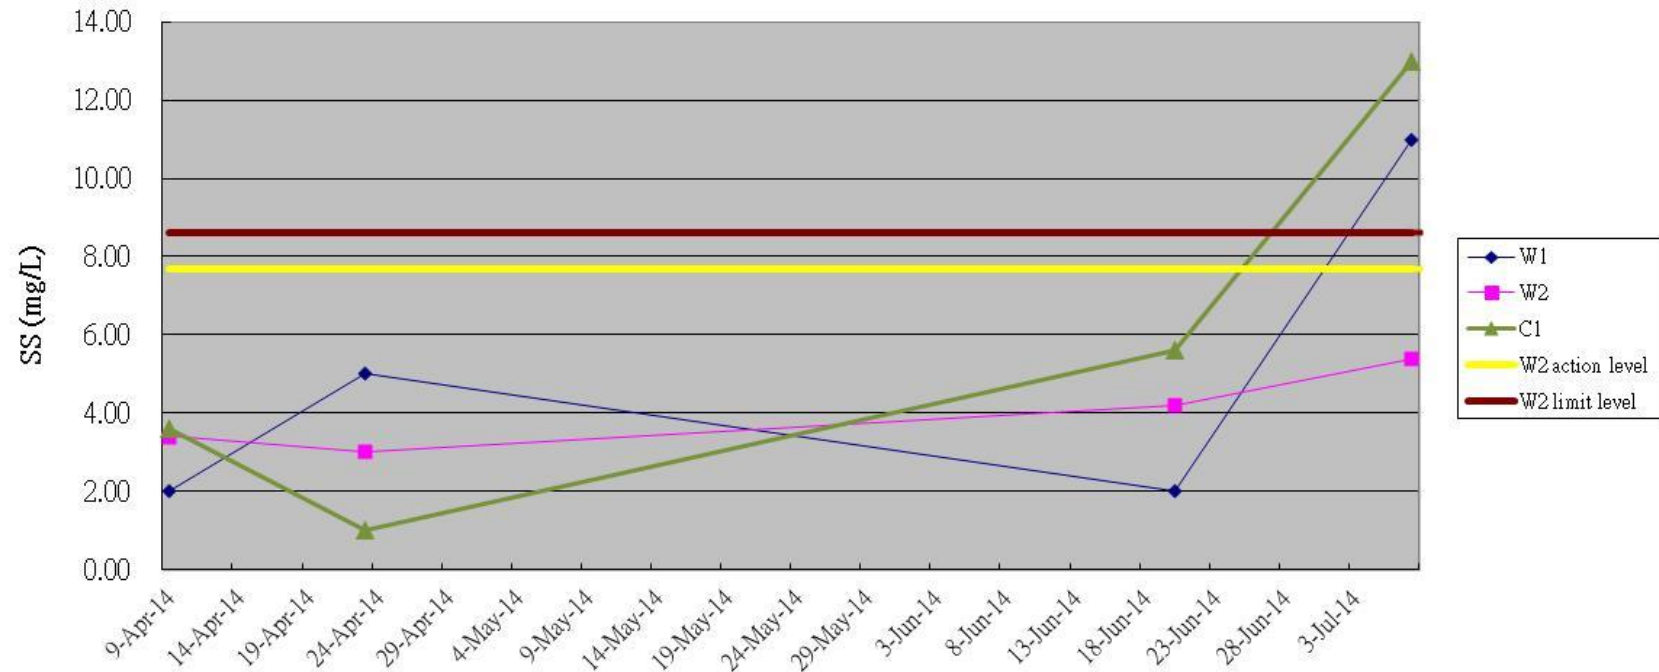
Graphical plots of SS (flood tide) for W1&W2

Remarks: Action limit is 95% of baseline data or 120% of upstream control station's SS
Limit level is 99% of baseline data or 130% of upstream control station's SS

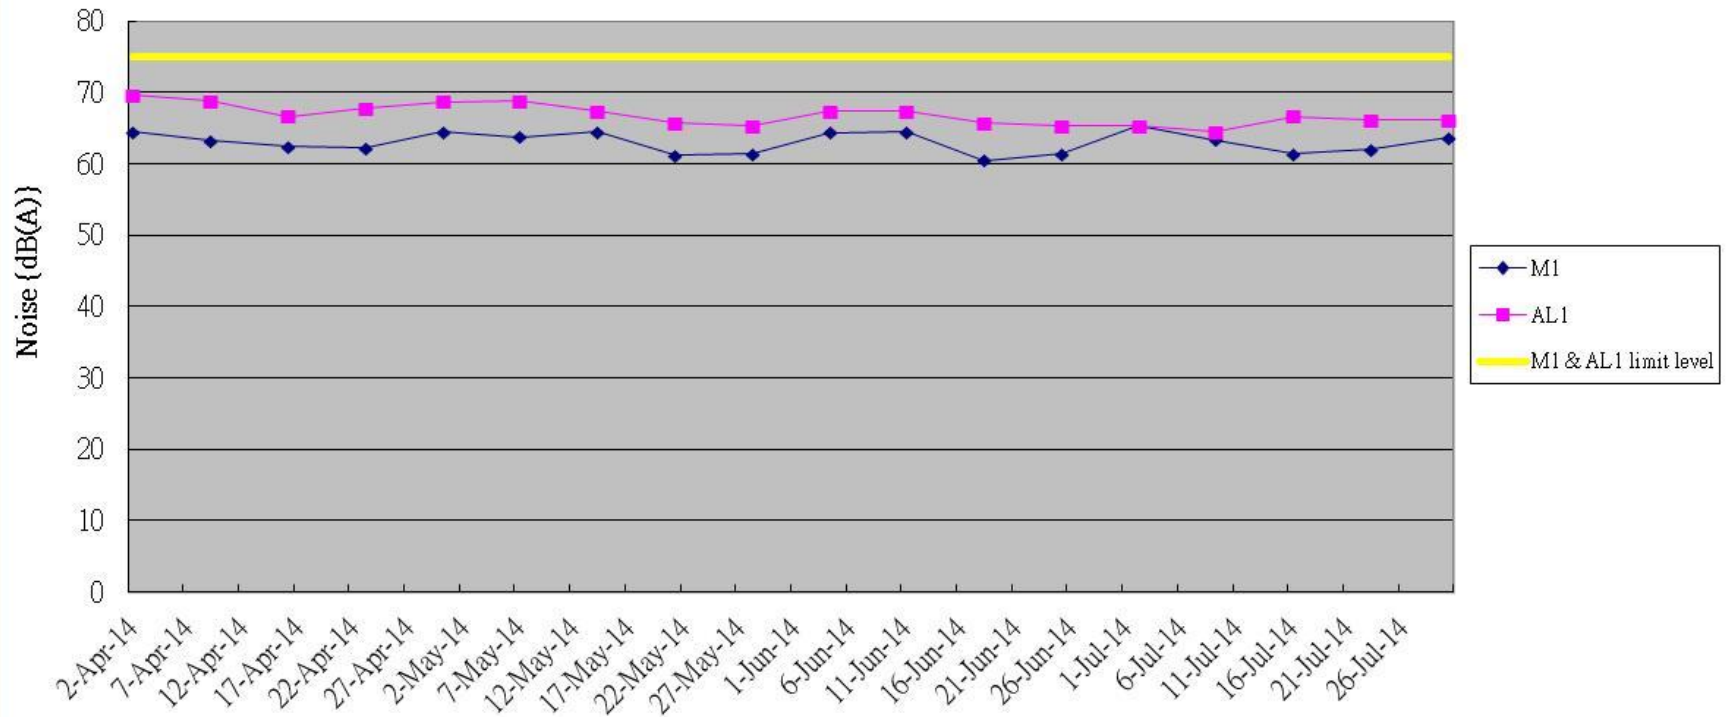
Graphical plots of Noise for M1 & AL1

Relevant details of the noise monitoring results are presented in Table 3.4.1. The results of M1 ranged between 61.5dB (A) and 65.3dB (A), and AL1 ranged between 64.5dB (A) and 66.7dB (A), were within the limit levels and therefore, no exceedance was found.

Remarks: Action limit is when one documented complaint is received

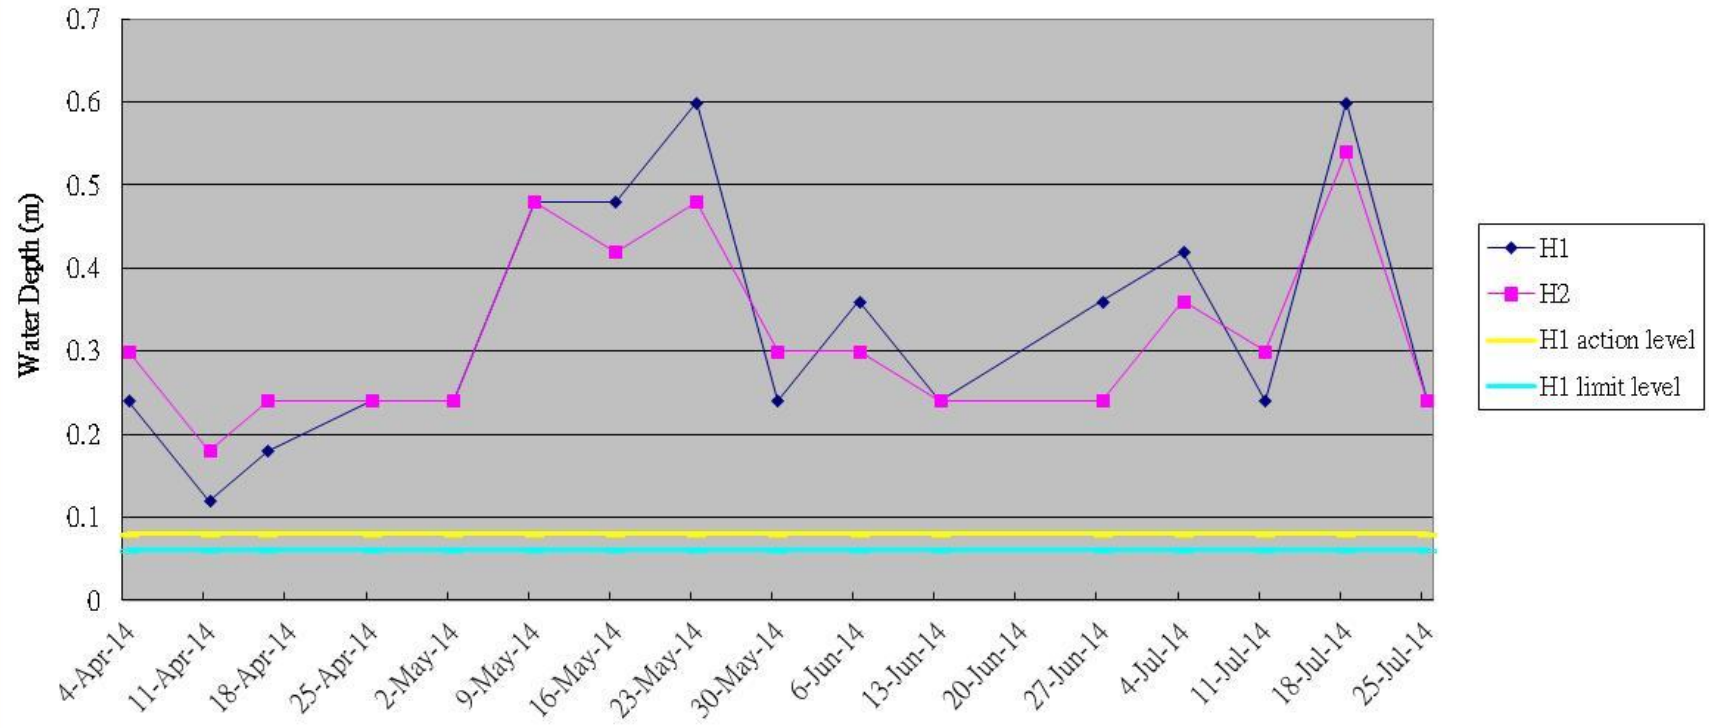
Graphical plots of Hydrological Monitoring(water depth at ebb tide) for H1 & H2

Remarks: Action level: 80% of baseline water depth.
Limit level: 60% of baseline water depth.

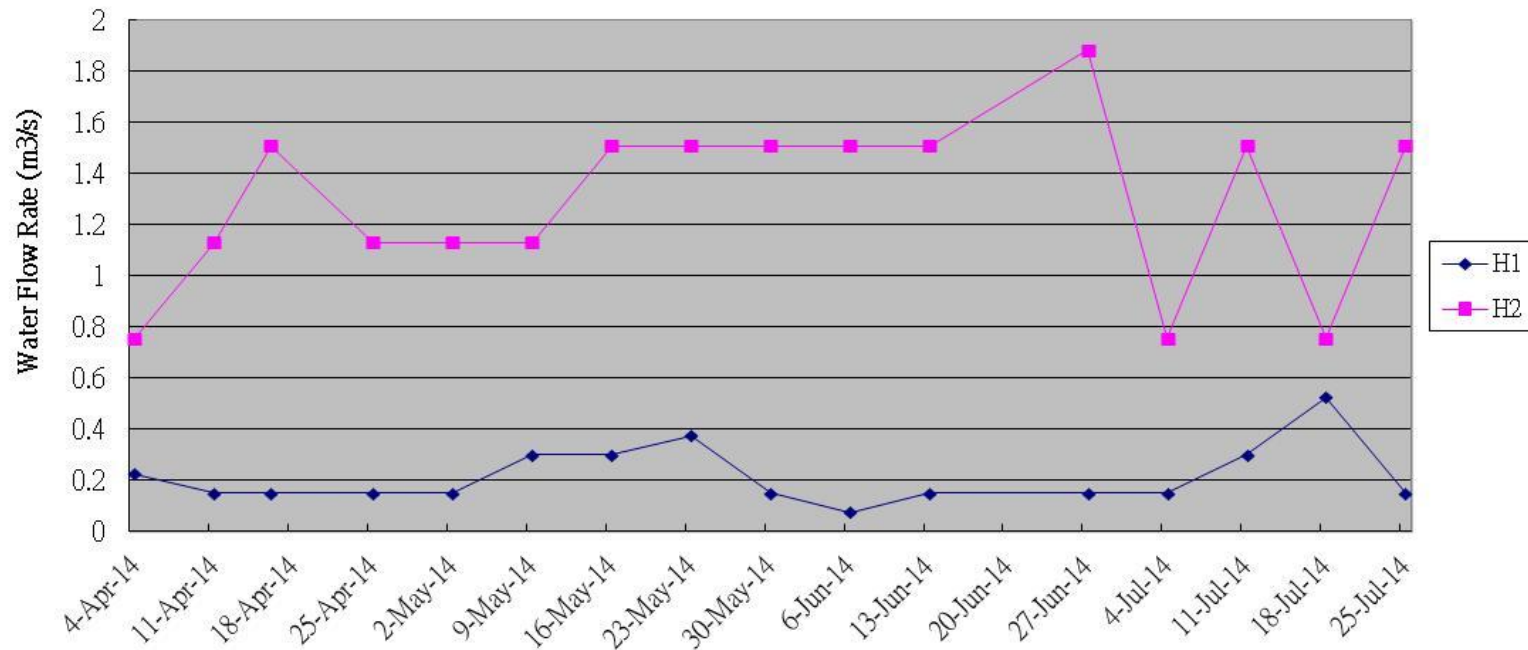
Graphical plots of Hydrological Monitoring(water flow rate at ebb tide) for H1 & H2

Remarks: Action level: 120% of control station's water flow rate on the same day of measurement.
Limit level: 140% of control station's water flow rate on the same day of measurement.

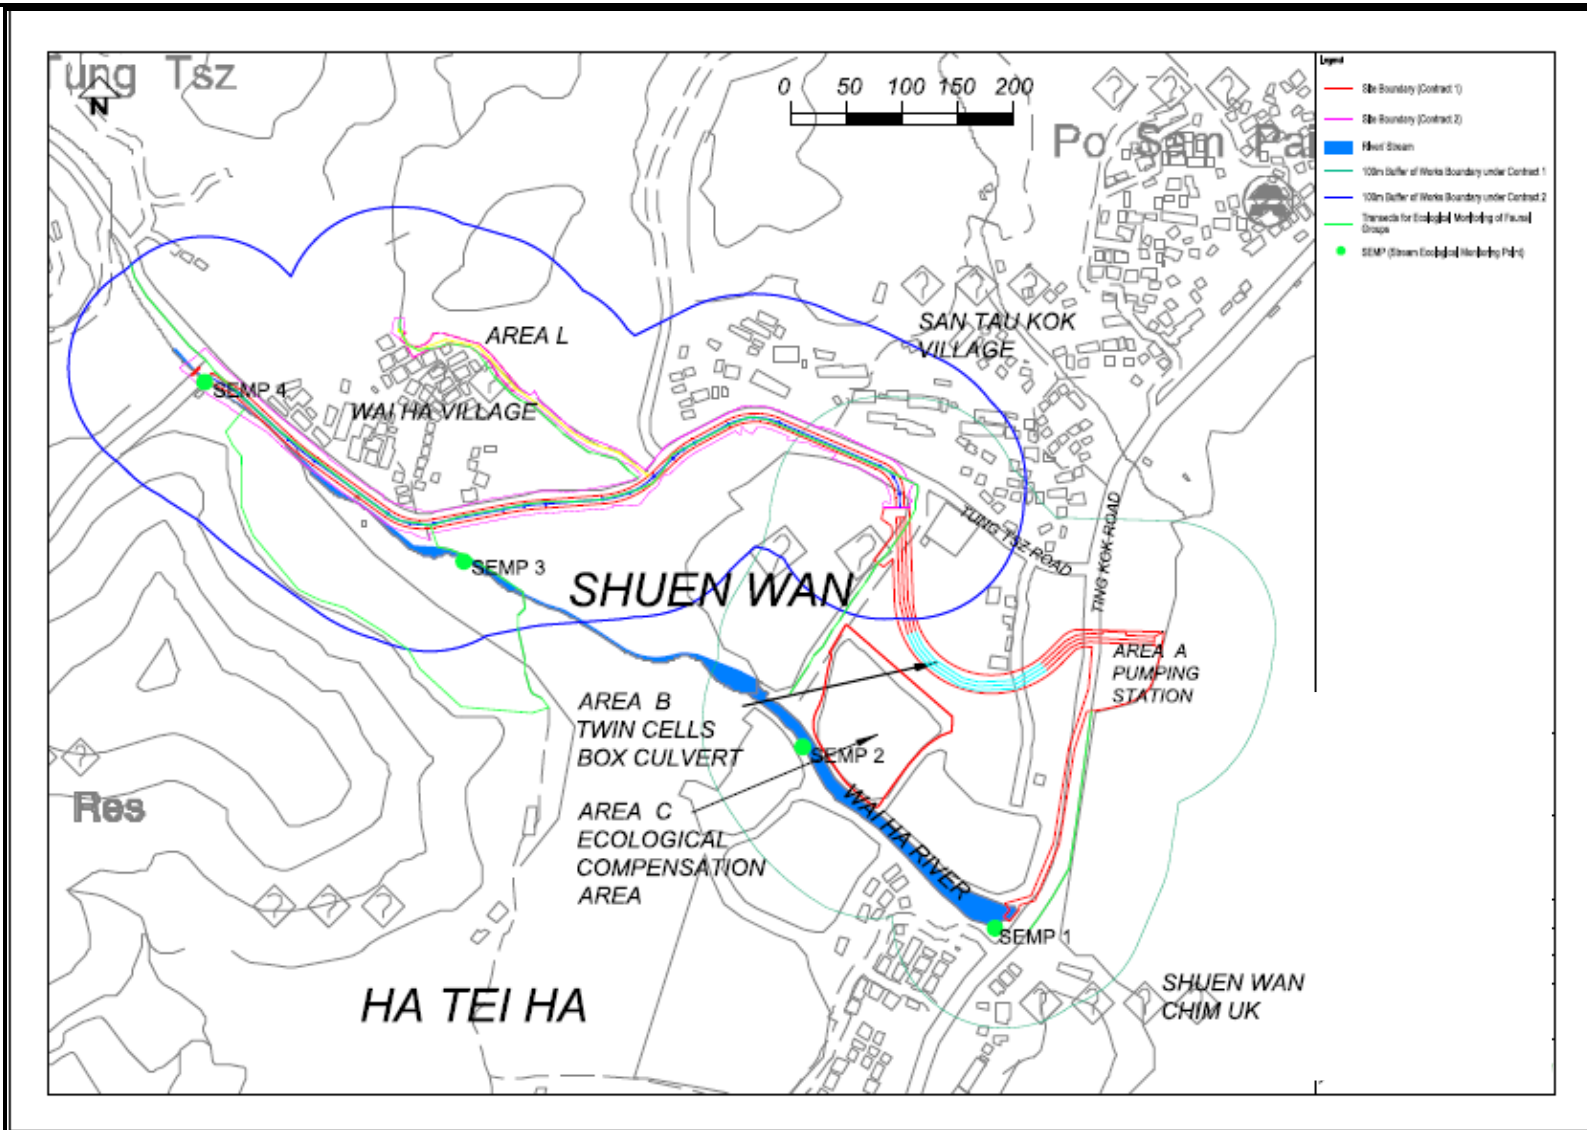
Figure: 1

Title: Map showing the ecological monitoring transect and the boundary of assessment area.

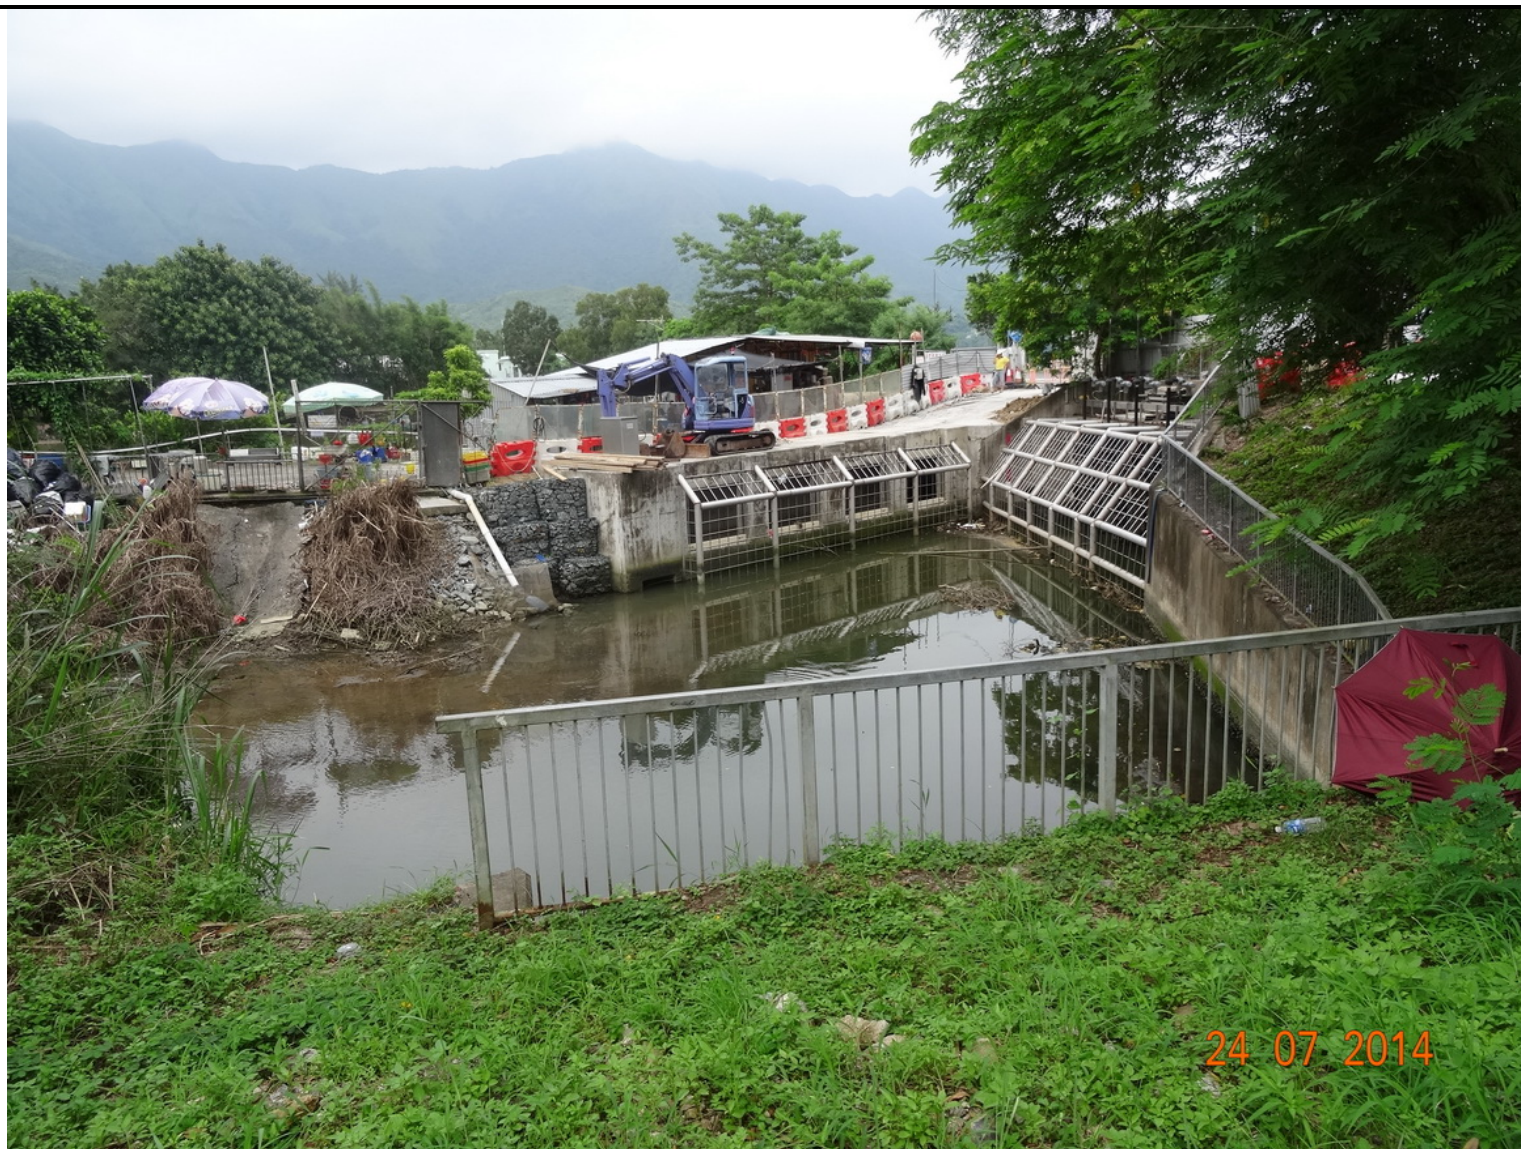
Figure: 2

Title: SEMP 1, the first sampling point of Wai Ha River under Contract 1.
