PROJECT NO.: TCS/00553/11

**CONTRACT NO. DC/2010/02 –
DRAINAGE IMPROVEMENT IN SHUEN WAN AND
SHEK WU WAI**

**MONTHLY ENVIRONMENTAL MONITORING AND
AUDIT REPORT (NO.37) – JULY 2014**

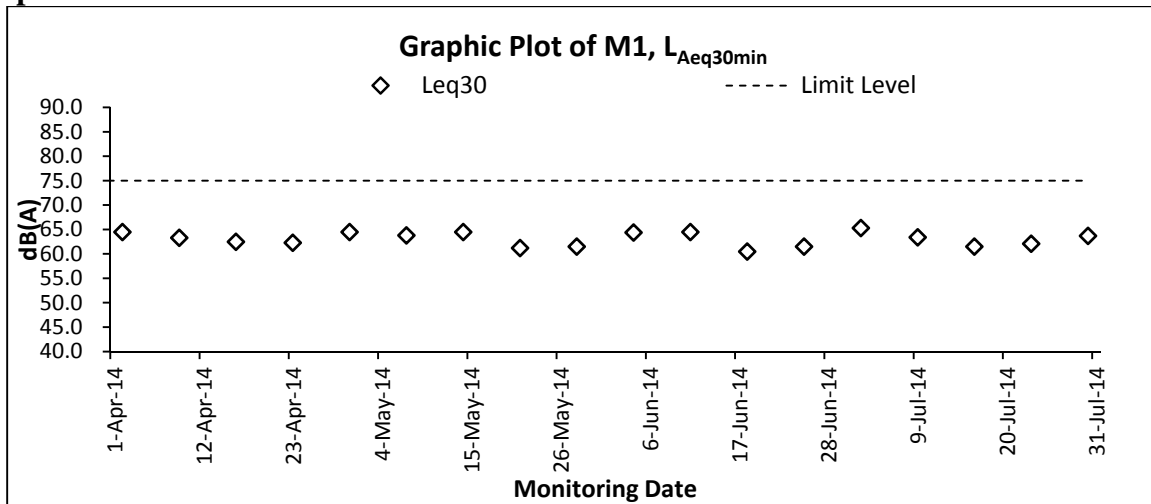
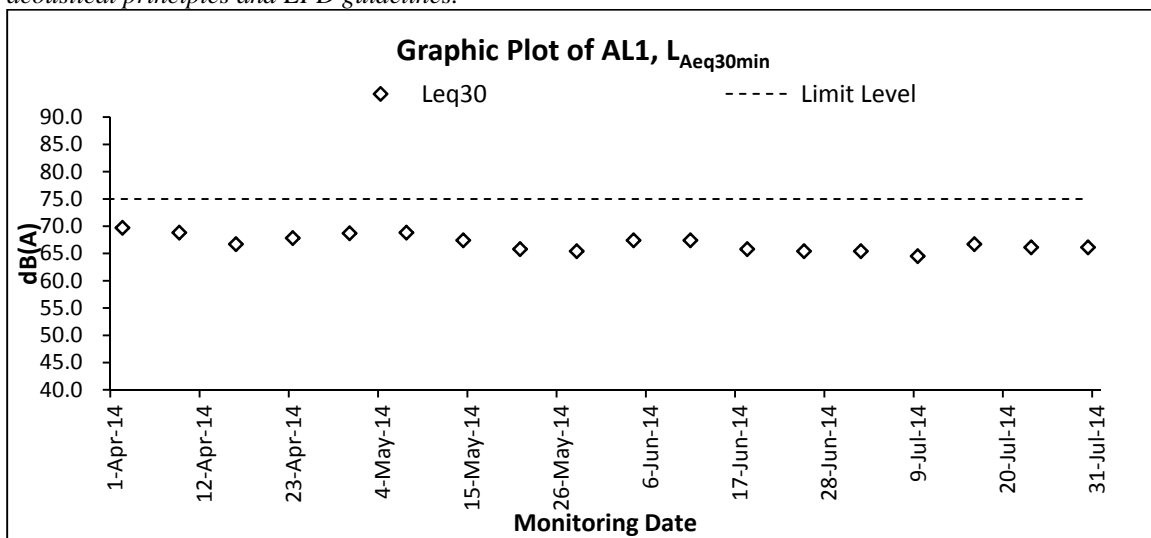
Graphic Plot – Construction Noise

Remark: The monitoring is undertaken under façade situation. No façade correction is added according to acoustical principles and EPD guidelines.

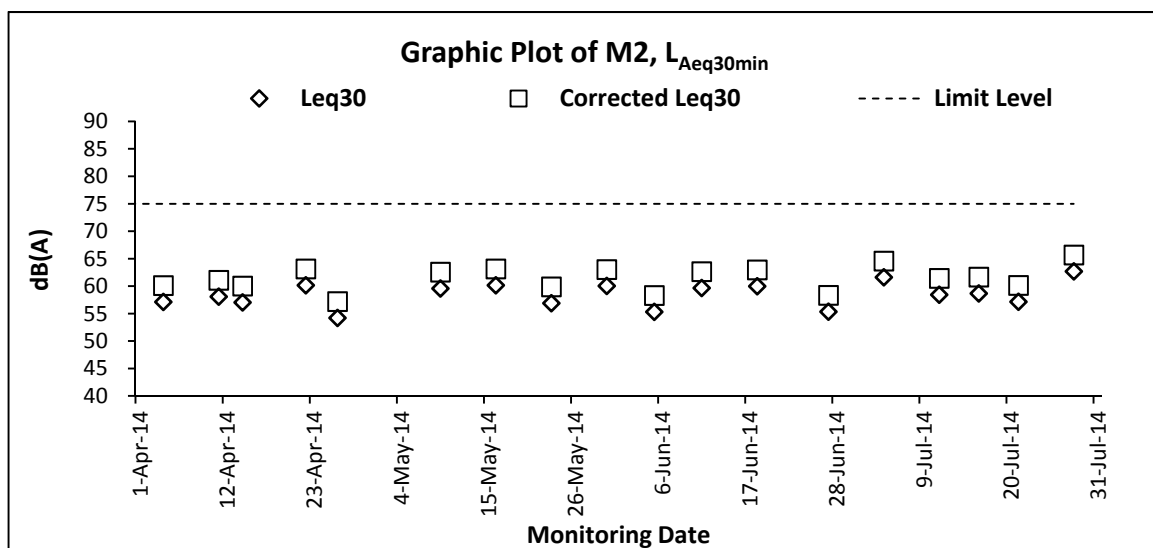
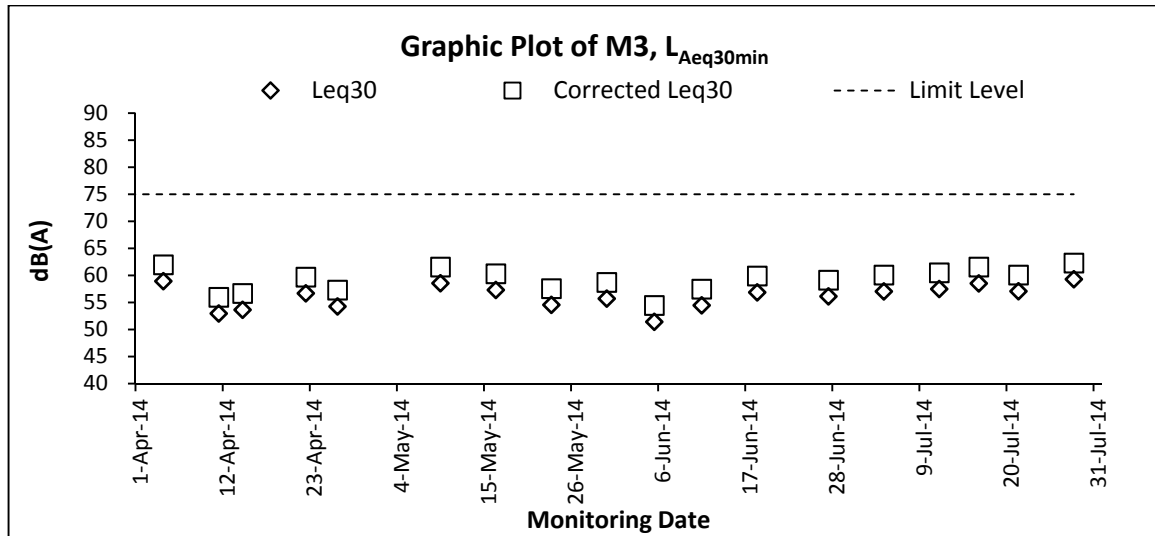
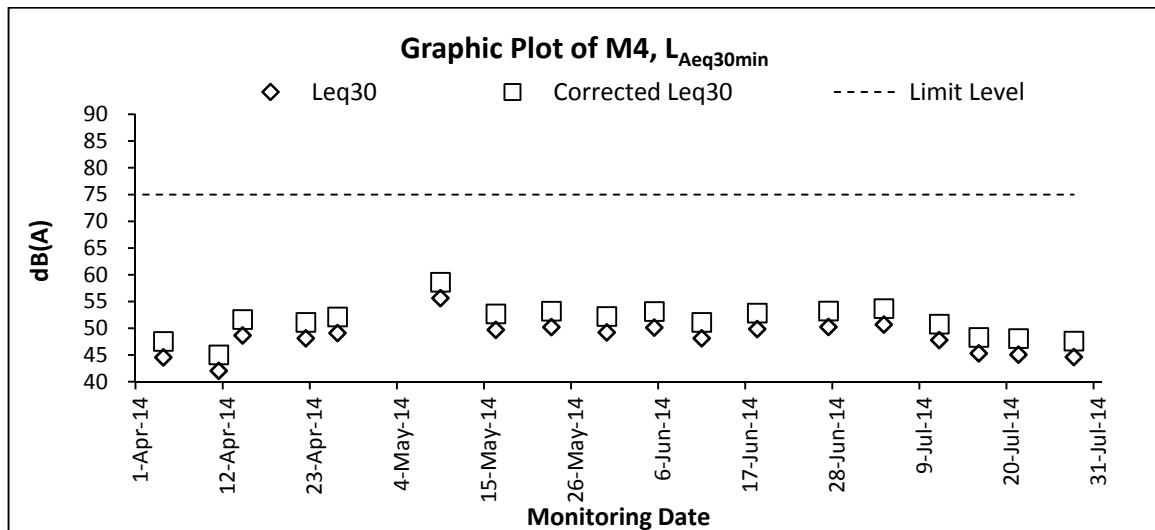
Remark: The monitoring is undertaken under free field situation. A façade correction of +3 dB(A) has been added according to acoustical principles and EPD guidelines.

Remark: The monitoring is undertaken under free field situation. A façade correction of +3 dB(A) has been added according to acoustical principles and EPD guidelines

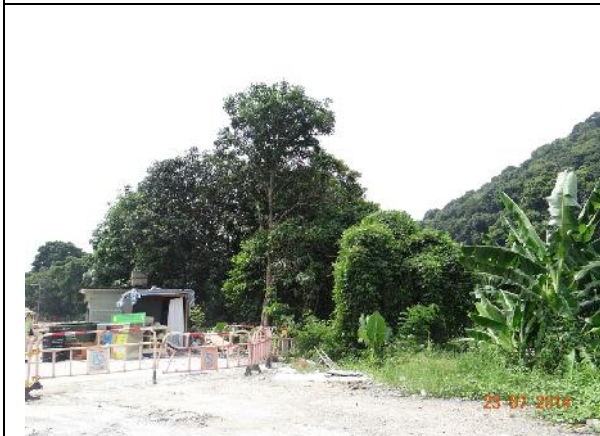
Photo 3 – Construction works for building the box culverts along Tung Tsz Road opposite to Wai Ha outside the public toilet have been stopped.

3.2.3 Major construction works for building the box culverts in the works area along Tung Tsz Road opposite to Wai Ha and next to Wai Ha River have almost been completed. No major construction work was observed during the inspections on 11th and 23rd July 2014 (**Photos 3-4**).

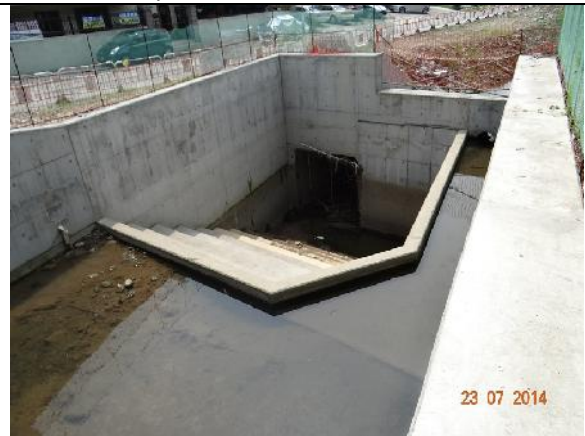
Photo 4 – Construction works have been stopped next to Wai Ha River.

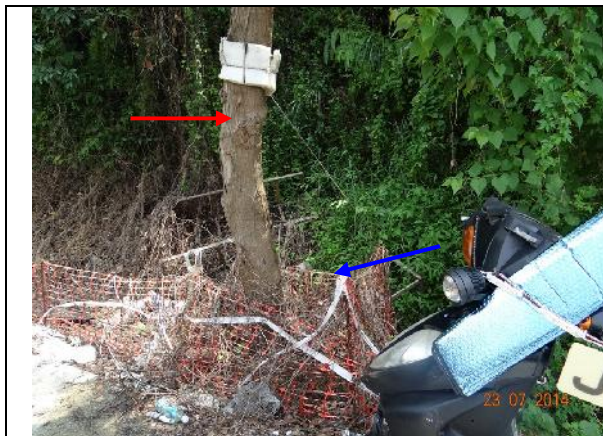
Photo 7 – The untagged tree (Red arrow) was guyed at the edge of the parking area within a Tree Protection Zone demarcated by orange construction nets (Blue arrow).

- 3.2.11 No specific recommendation is required. However, with regard to the previous dumping incident by other parties on the Taro field near the Treasure Spot Garden, the Contractor is recommended to check the site condition regularly to avoid any extent of dumping or paving of area within the project boundary.
- 3.2.12 The Contractor should also make sure there are no piled rocks, construction materials or programmed construction works influencing the existing trees within the Project Area or the wetland rehabilitation area. Otherwise, the Contractor should request the on-site workers to remove those piled rocks or construction materials. As a reminder, the Contractor should keep all construction works within the Project Boundary.
- 3.2.13 The Contractor could establish a warning sign to remind the driver to beware of the presence of the tree(s) close to the temporary parking area.

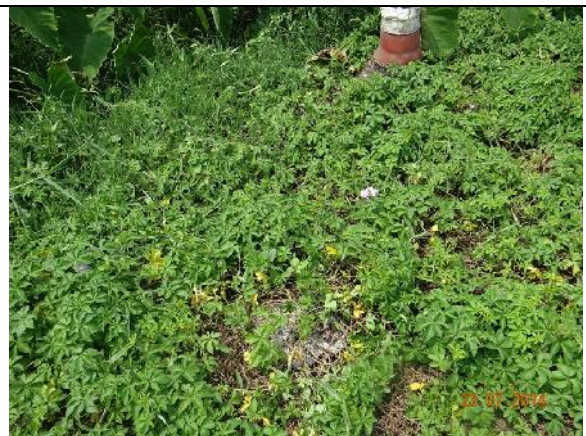
Photo 8 – Cement mortar was discharged to the Taro field next to the access road from Tung Tsz Road to Treasure Spot Garden II. This area was covered by ground vegetation as observed in July 2014.

- 3.2.6 As reported in the previous *Monthly EM&A Reports*, dumping on the Taro field located along the path towards the Treasure Spot Garden was observed and a paved area created for parking next to the retained tree groups (T088 – T091) has been found since November 2012. In October 2013, the path to Treasure Spot Garden II was expanded towards the Taro field due to the reprovision of vehicular access road to the villagers during the works at the entrance of the Treasure Spot Garden. Cement mortar discharged to the Taro field was observed in March 2014 and such area was covered by ground vegetation (**Photo 8**).

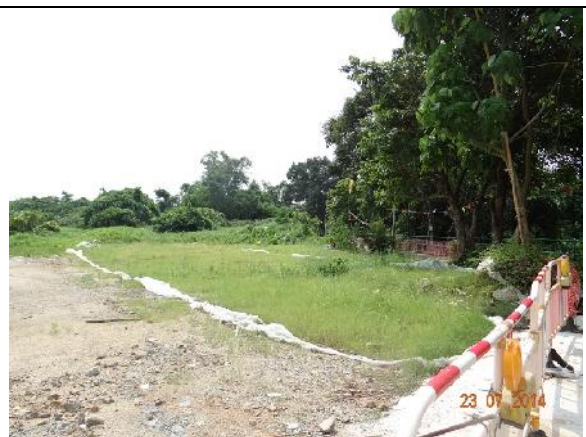
Photo 10 –The construction materials stored on the works area near the location of the previously removed tree T190 (*Ficus hispida*) were removed. This area has been covered by a mat in May 2014 and hydroseeding was applied in June 2014.

- 3.2.8 The works area near the previous collapsed tree T190 (*Ficus hispida*) was found to be expanded to the grassland on the south in January 2014. Most of the construction materials stored in this area were removed in April 2014. This area has been covered by a mat since May 2014 and hydroseeding was applied in June 2014 (**Photo 10**).

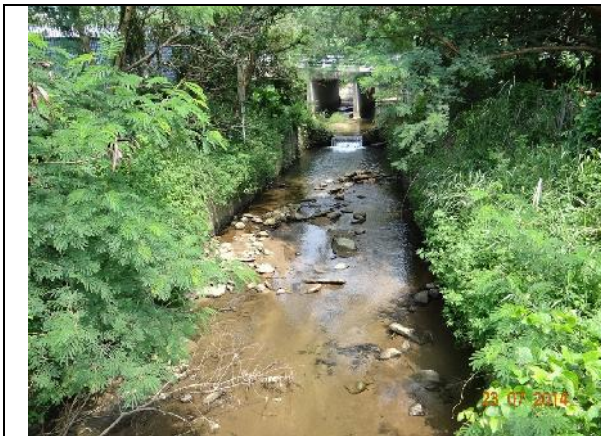
Photo 13 - The river water was clear in the upper stream near the tree group T107-117.

3.3.3 As observed during the inspections on 11th and 23rd July 2014, most of the construction works in Contract 2 works area were stopped. No more muddy water has been released from the works area. The river water was generally clear (**Photos 13-16**).

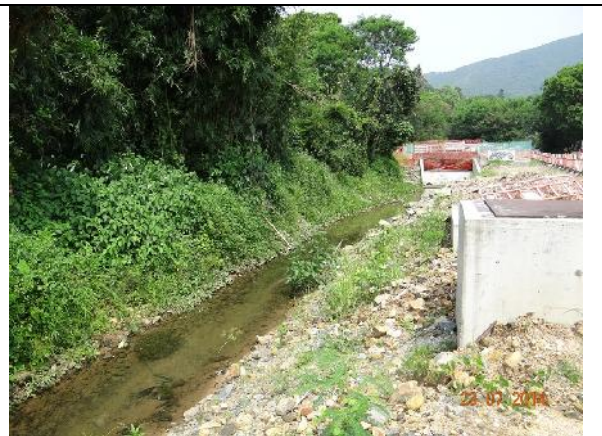
Photo 14 – The river water was clear near the tree group T119-122.

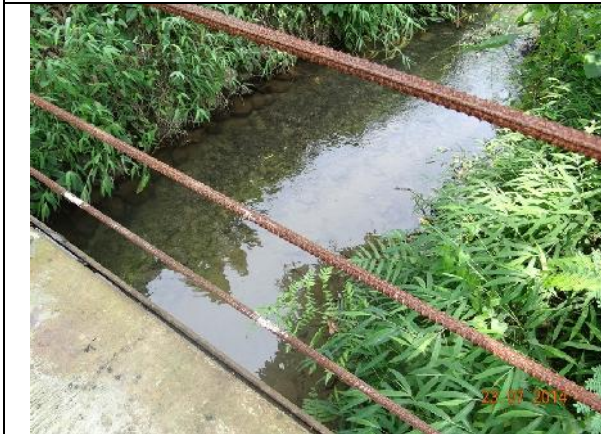
Photo 15 – Down the stream near the public toilet, the water was clear.

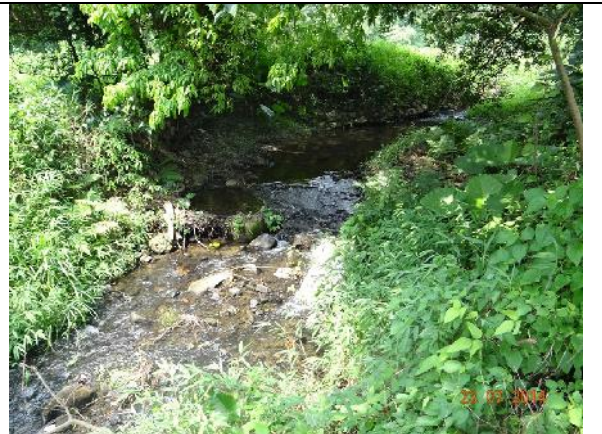
Photo 16 – The water was still clear at the lower stream.

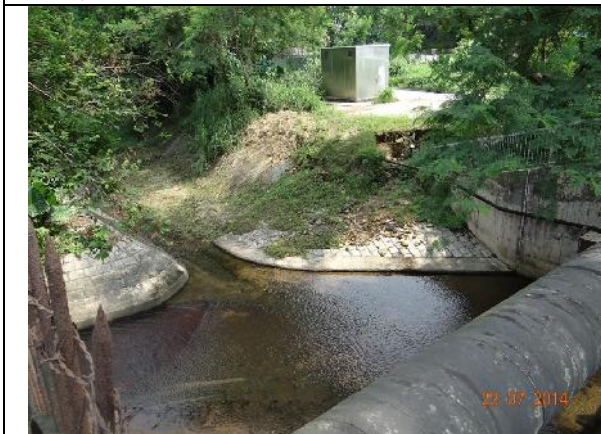
Photo 17 – No direct water discharge into the upper stream of Wai Ha River was observed as the construction works have been concentrated at the lower end of the river.

3.3.5 Regular monitoring should be conducted to ensure no direct discharge or leakage of contaminants or any polluted fluid into the adjacent Wai Ha River and the nearby Shuen Wan marsh. The Contractor should maintain regular check (e.g. daily) on the sedimentation and filtration facilities and appropriate sedimentation beds and/or tanks throughout the construction phase (e.g. check the function of the sedimentation beds and remove surplus sand and gravels deposited along the beds or within the tanks) to make sure all discharged water was filtered appropriately prior to any discharge.

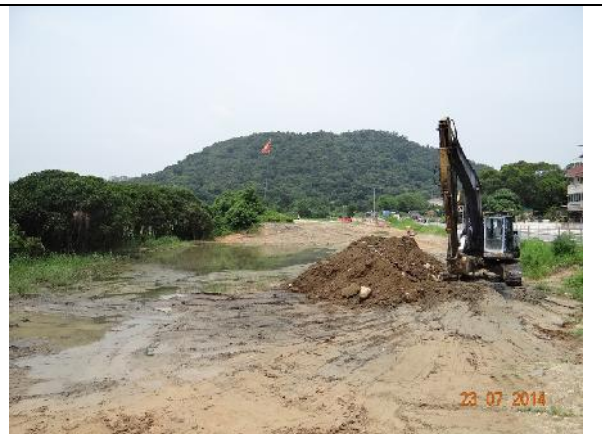
Photo 18 – Excavation works were carried out next to the wetland opposite to Jade View Villa during the site inspection on 23rd July 2014. The area was waterlogged and unclear water overflowed into the nearby marsh area.

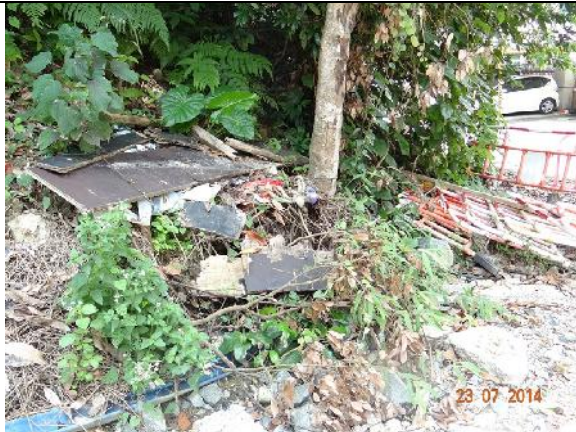
Photo 25 – Excavated soil and rocks, and construction materials were noted piling close to the trunk base of the retained tree T103.

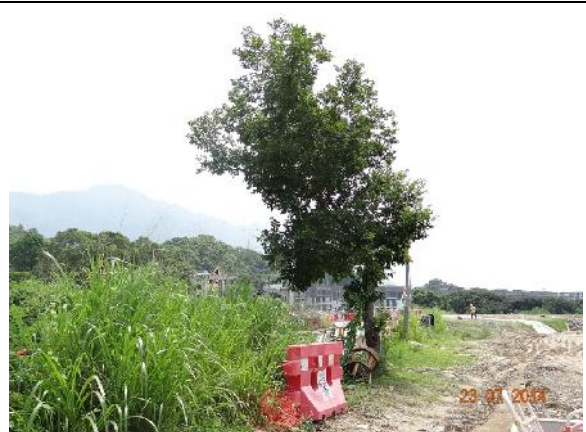
Photo 26 – The retained tree T025 was temporarily guyed to provide additional support to this tree.

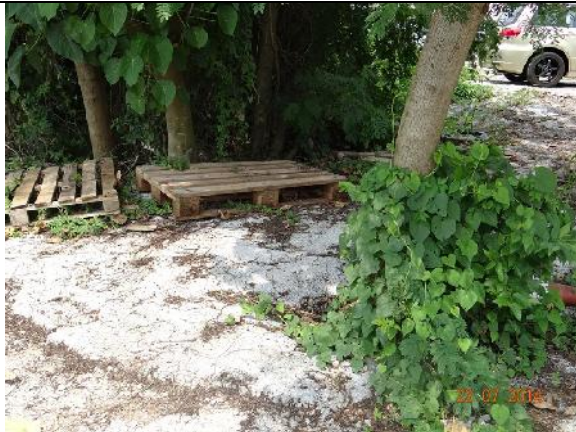
Photo 27 – Concrete pavement and wooden plates were observed close to the root flares of the tree group T089-091.

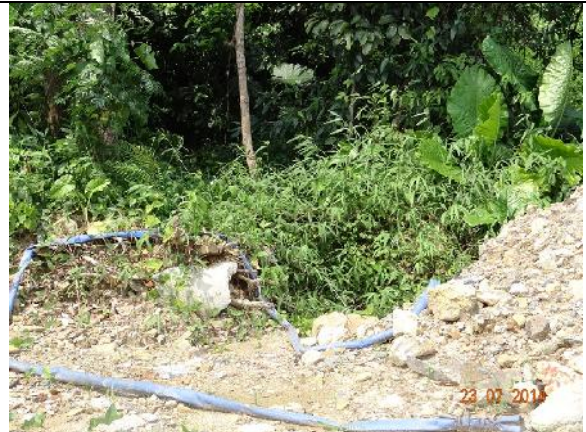
Photo 28 – Excavation work was noted between T153 and T155, and severe exposed roots were noted on these two trees.

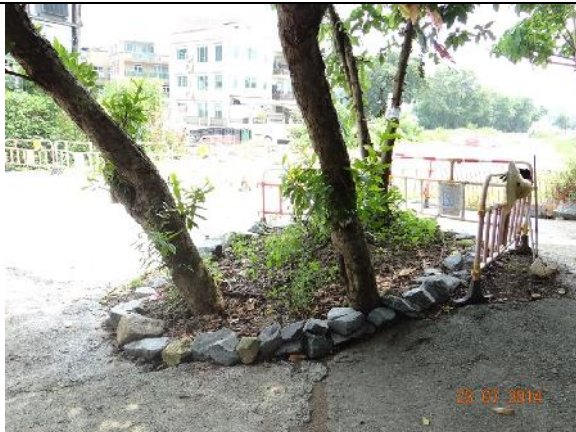
Photo 29 – Excavation work was noted very close to the tree group T181-T183. Excavated soil was noted piling around their trunk flares and the orange construction nets covering on the three trees were removed. These trees have been surrounded by some stones.

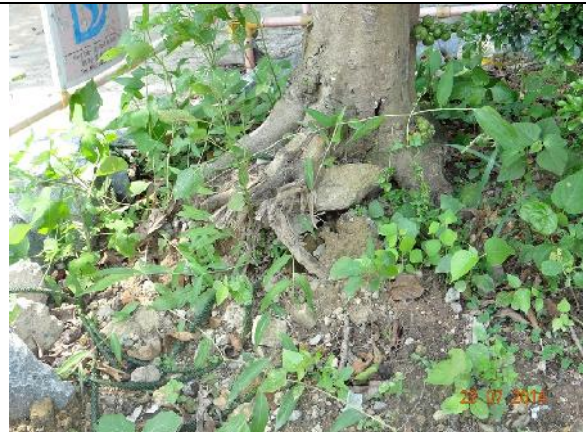
Photo 30 – Exposed and pruned roots were noted on T183.

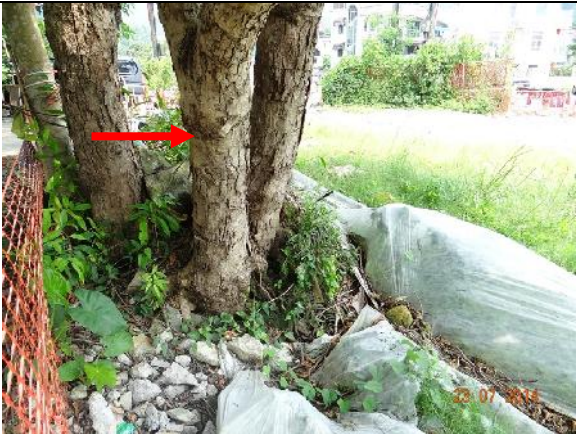
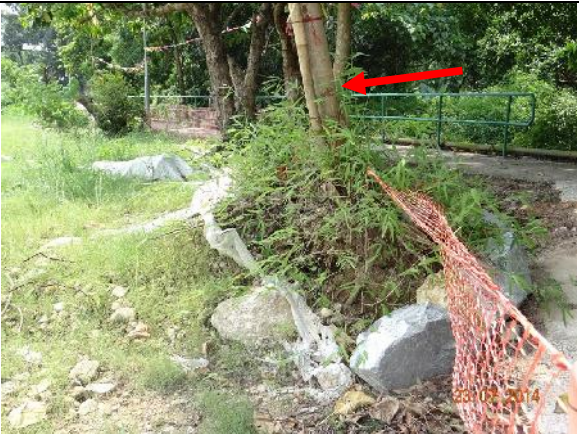
<p>Photo 31 – Excavation work was noted next to an untagged tree (<i>Cleistocalyx nervosum</i>) (Red arrow). Severe exposed roots were noted on this tree.</p>	<p>Photo 32 – Excavation work was noted next to another untagged tree (<i>Macaranga tanarius</i> var. <i>tomentosa</i>) (Red arrow). Severe exposed roots were noted on this tree.</p>
