**CONTRACT NO. DC/2010/02 –
DRAINAGE IMPROVEMENT IN SHUEN WAN AND
SHEK WU WAI**

**MONTHLY ENVIRONMENTAL MONITORING AND
AUDIT REPORT (NO.38) – AUGUST 2014**

PREPARED FOR
KWAN LEE-KULY JOINT VENTURE

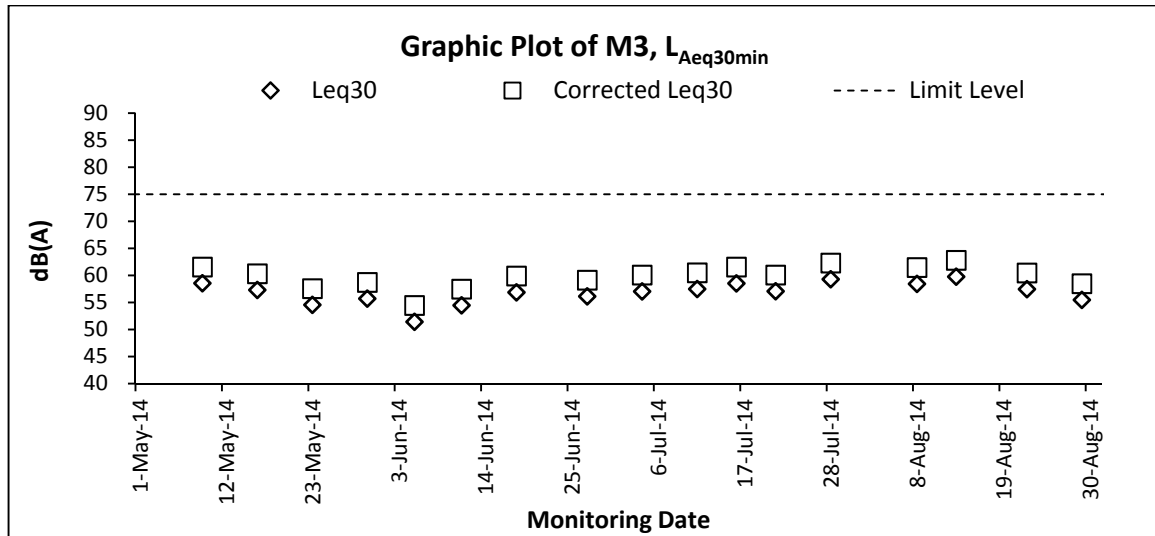
Remark: The monitoring is undertaken under free field situation. A façade correction of +3 dB(A) has been added according to acoustical principles and EPD guidelines

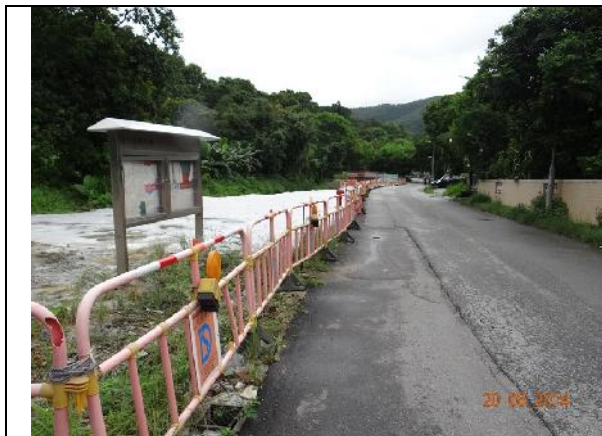
Photo 1 – Temporary hoardings have been erected along Tung Tsz Road opposite to Wai Ha.

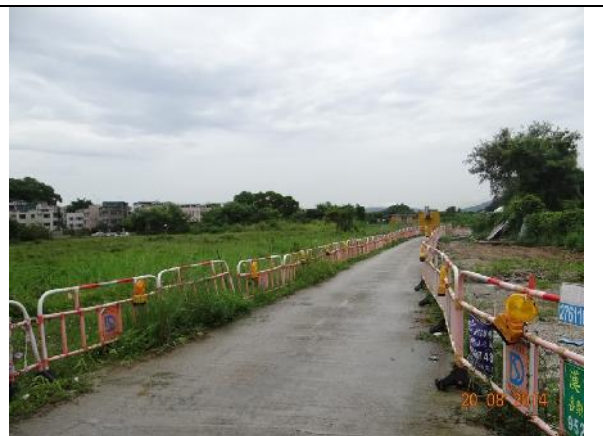
Photo 2 – Temporary hoardings have been erected along the access road from Tung Tsz Road to Treasure Spot Garden II.

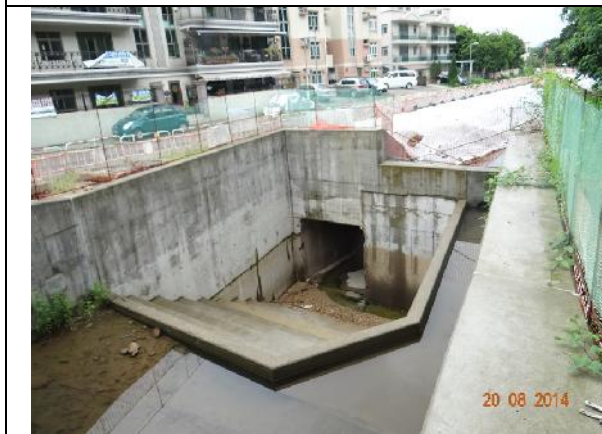
Photo 3 – Construction works have been stopped next to Wai Ha River.

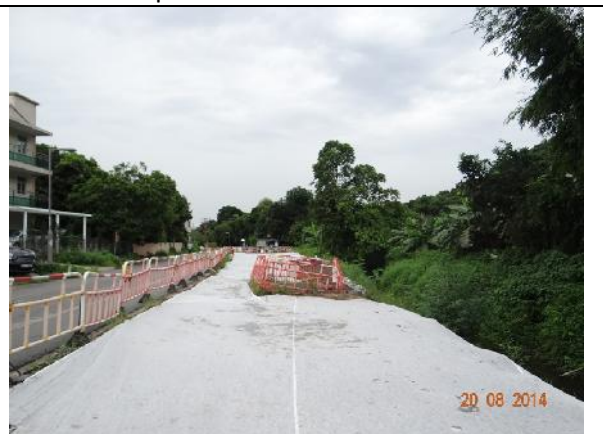
Photo 4 – Construction works for building the box culverts along Tung Tsz Road opposite to Wai Ha outside the public toilet have been stopped. The site was covered by a mat.

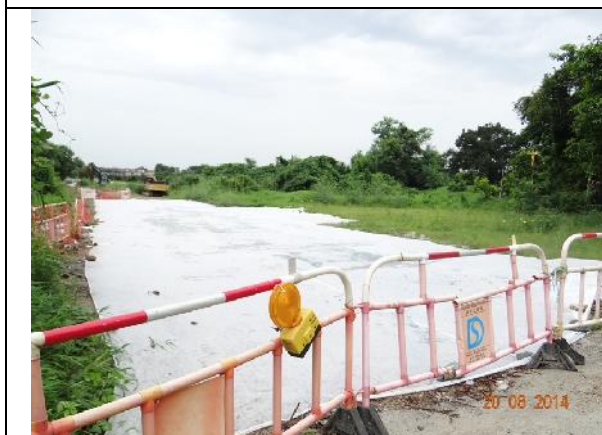
Photo 5 - Construction works next to the wetland near the location of the previously removed tree T190 have been stopped. The site was covered by a mat.

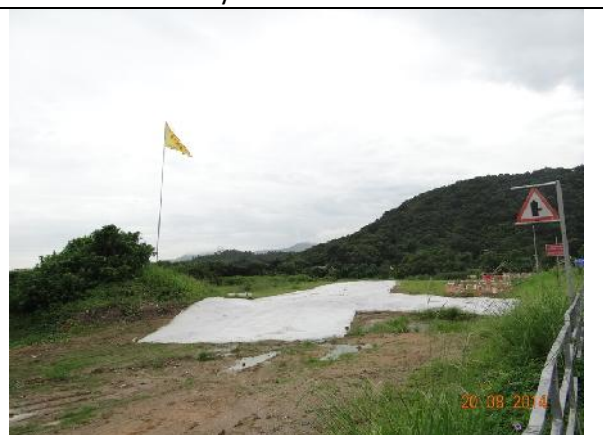
Photo 6 – Construction works next to the wetland opposite to Jade View Villa have been stopped. The site was covered by a mat.

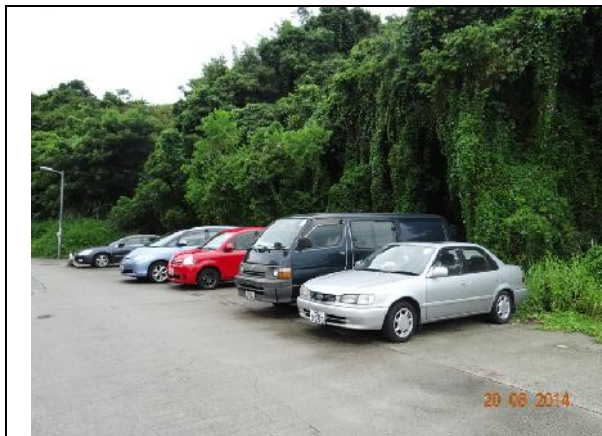
- 3.2.4 The temporary parking area was still maintained at the end of the access path to Treasure Spot Garden Phase II (**Photo 7**). The untagged leaning tree was still guyed at the edge of the area within a Tree Protection Zone (TPZ), which was demarcated by orange construction nets. Villagers' vehicles were sometimes noted being parked next to the TPZ (**Photo 8**).

Photo 7 – Temporary parking area has still been maintained at the end of the access path to Treasure Spot Garden Phase II.

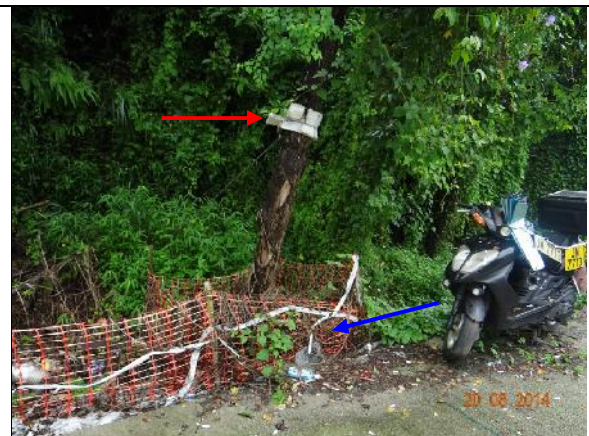
Photo 8 – The untagged tree (Red arrow) was guyed at the edge of the parking area within a Tree Protection Zone demarcated by orange construction nets (Blue arrow).

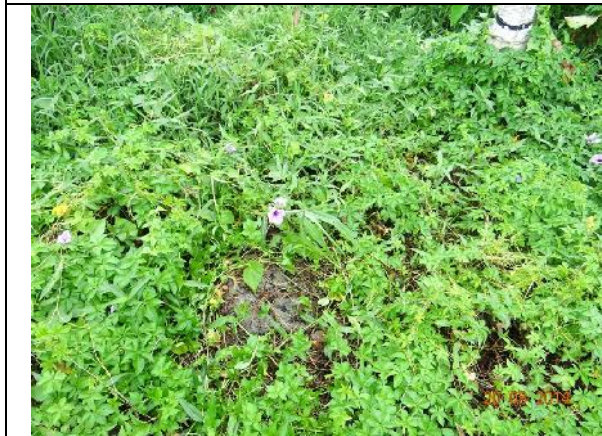
- 3.2.5 As reported in the previous *Monthly EM&A Reports*, dumping on the Taro field located along the path towards the Treasure Spot Garden was observed and a paved area created for parking next to the retained tree groups (T088 – T091) has been found since November 2012. In October 2013, the path to Treasure Spot Garden II was expanded towards the Taro field due to the re-provision of vehicular access road as requested by the villagers during the works at the entrance of the Treasure Spot Garden. Cement mortar discharged to the Taro field was observed in March 2014 and such area was progressively covered by ground vegetation (**Photo 9**).

Photo 9 – Cement mortar was previously discharged to the Taro field next to the access road from Tung Tsz Road to Treasure Spot Garden II. This area was covered by ground vegetation as observed in August 2014.

- 3.2.9 No specific recommendation is required in regard to the observations made in August 2014. However, with regard to the previous dumping incident by other parties on the Taro field near the Treasure Spot Garden, the Contractor is recommended to check the site condition regularly to avoid any extent of dumping or paving of area within the project boundary throughout the construction phase.
- 3.2.10 For good site practices, the Contractor should also make sure there are no piled rocks, construction materials or programmed construction works influencing the existing trees within the Project Area or the wetland rehabilitation area throughout the construction phase. Otherwise, the Contractor should request the on-site workers to remove those piled rocks or construction materials. As a reminder, the Contractor should keep all construction works within the Project Boundary.

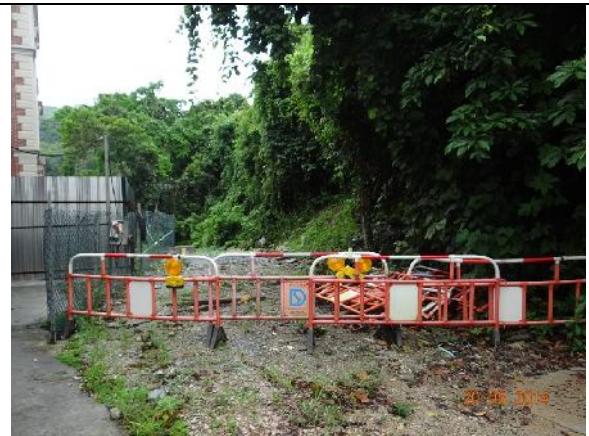
Photo 10 – Construction works have been stopped at the end of the Treasure Spot Garden II near the retained tree T103 and the works area was surrounded by temporary construction barriers and chain-link fence.

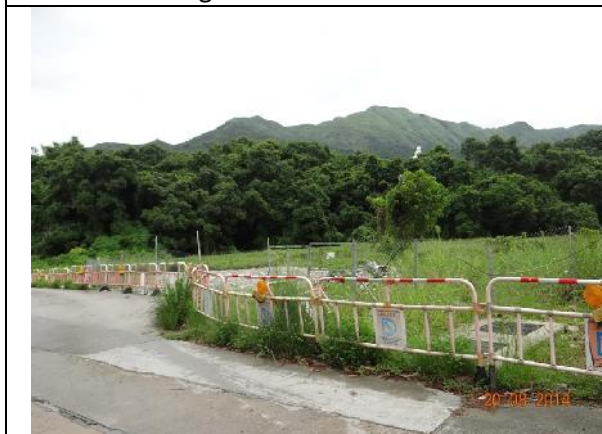
Photo 11 – A fenced area was seen on the field next to the construction site along the access to Treasure Spot Garden in March 2014. The area was still surrounded by chain-link fence by an unknown party.

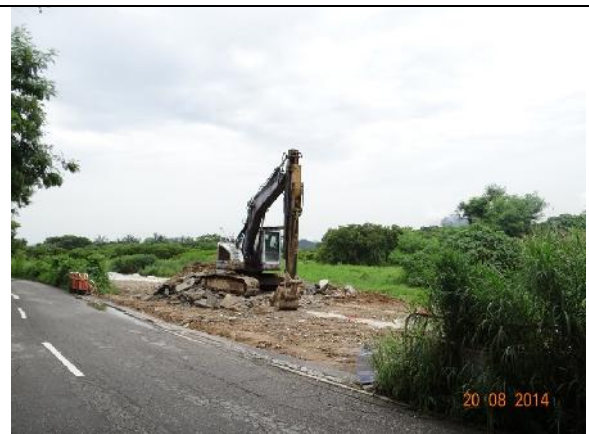
- 3.3.2 Cement mortar was previously noted near the exit point of Contract 2 works area opposite to the tree group T021-029 (*Leucaena leucocephala*) in February. The cement mortar was removed as observed during the site inspection on 20th August 2014 (**Photo 12**).
- 3.3.3 As observed during the inspections in August 2014, most of the construction works in Contract 2 works area were stopped. No more muddy water has been released from the works area. The river water was generally clear (**Photos 13-16**).
- 3.3.4 In August 2014, no water from the nearby box culvert and the works area opposite to Wai Ha was released to the area near the expanded works area next to the previous collapsed tree T190 (*Ficus hispida*).

Photo 12 – An excavator was removing the cement mortar next to the exit point opposite to the tree group T021-029 (*Leucaena leucocephala*) as observed on 20th August 2014.

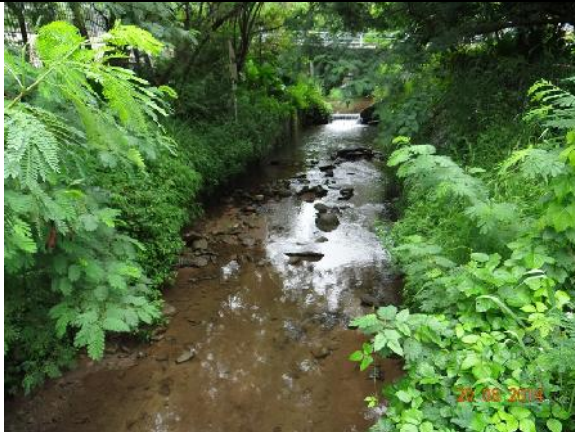
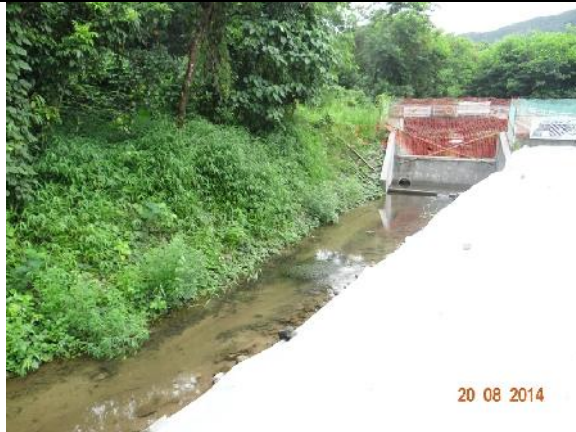
<p>Photo 13 - The river water was clear in the upper stream near the tree group T107-117.</p>	<p>Photo 14 – The river water was clear near the tree group T119-122.</p>

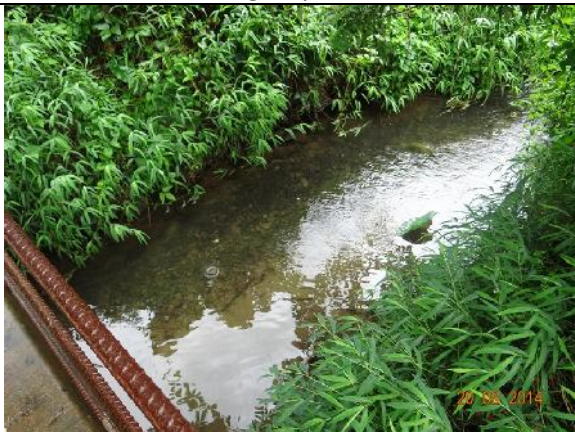
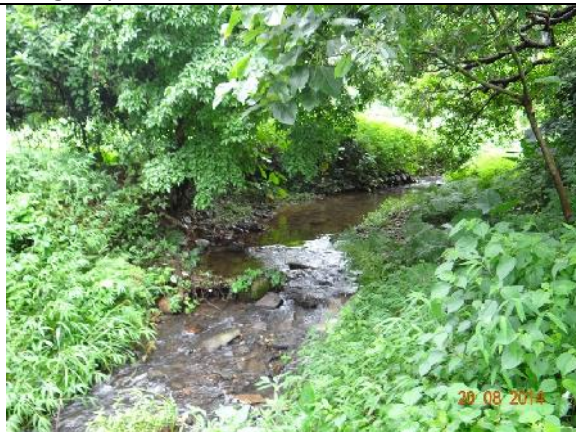
<p>Photo 15 – Down the stream near the public toilet, the water was clear.</p>	<p>Photo 16 – The water was clear at the lower stream.</p>

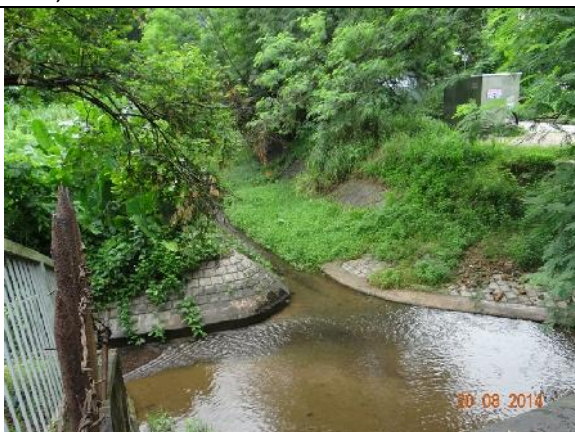
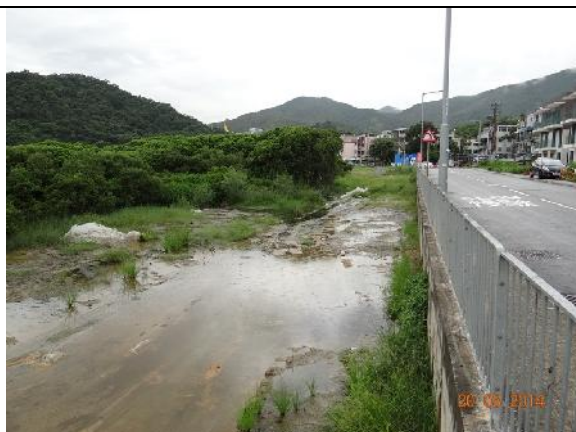
<p>Photo 17 – No direct water discharge into the upper stream of Wai Ha River was observed as the construction works have been concentrated at the lower end of the river.</p>	<p>Photo 18 – The area opposite to Jade View Villa to the exit point near Shuen Wan Tung Tsz Children's Playground was covered by a mat. The area was waterlogged and unclear water overflowed into the nearby marsh area.</p>

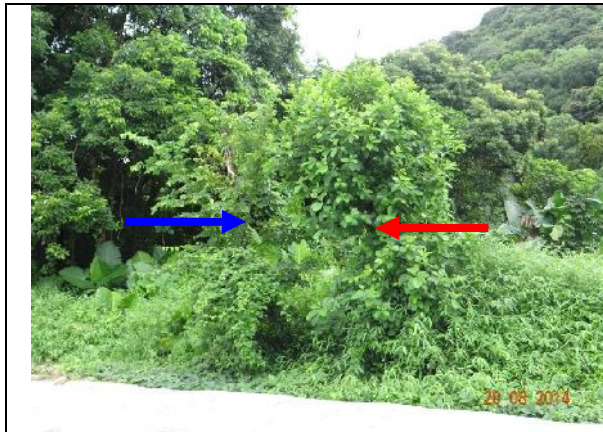
Photo 19 – Topped trees T167 (Red arrow) and T168 (Blue arrow) were in poor health condition with vigorous development of epicormics. Excavated soil was noted piling around the trunk flare.

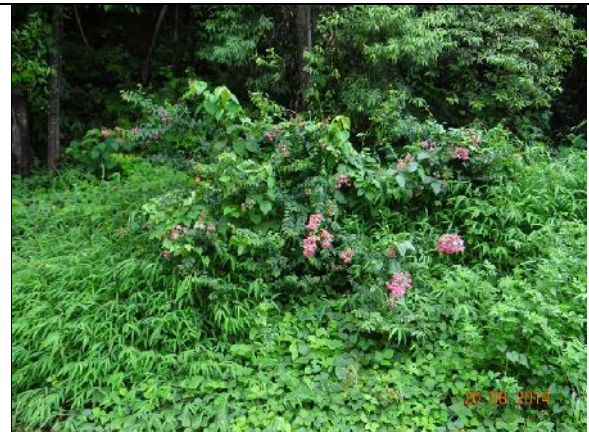
Photo 20 – Storage of construction materials and sand piling close to the trunk flare of T093 was removed. However, cement mortar has been noted on the soil surface close to T093. This area was covered by ground vegetation as observed in August 2014.

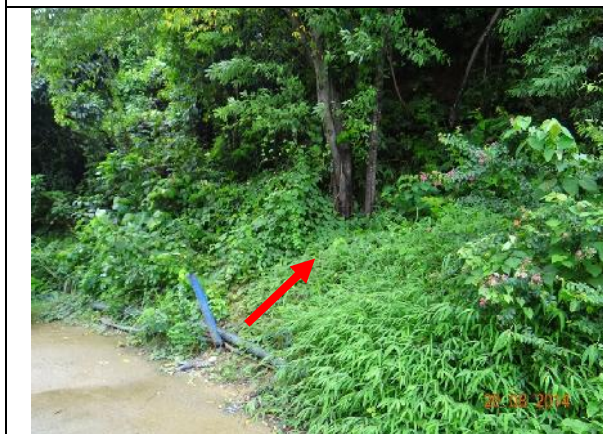
Photo 21 – Storage of construction materials and sand piling close to the trunk flare of T094 was removed. However, cement mortar has been noted on the soil surface close to T094. This area was covered by ground vegetation as observed in August 2014 (indicated by Red arrow).

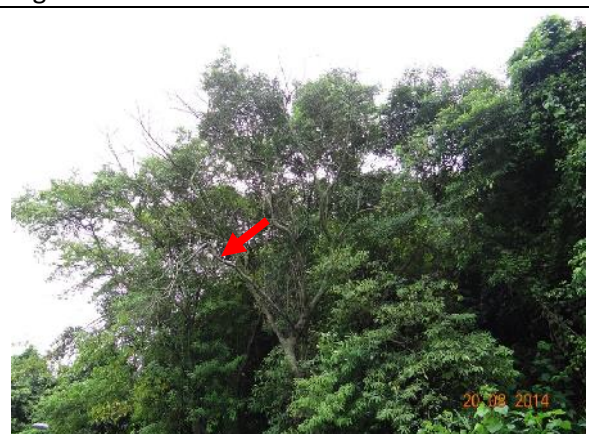
Photo 22 – Significant defoliation was noted on the tree crown of T093 and a hanger was found above the access road (Red arrow).

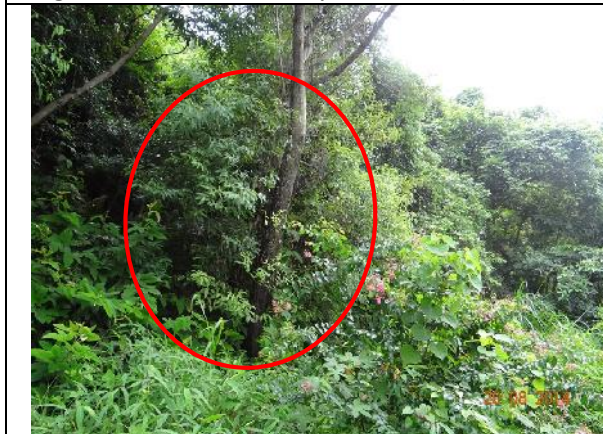
Photo 23 – Epicormics have developed along the lower tree trunk of T093 (Red circle).

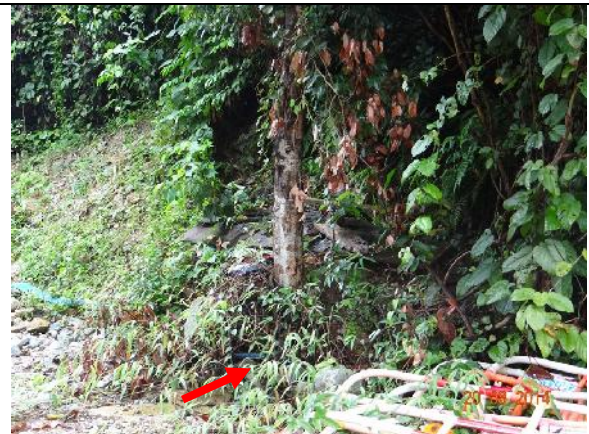
Photo 24 – Excavated soil and rocks, and construction materials were still noted piling close to the trunk base of the retained tree T103.

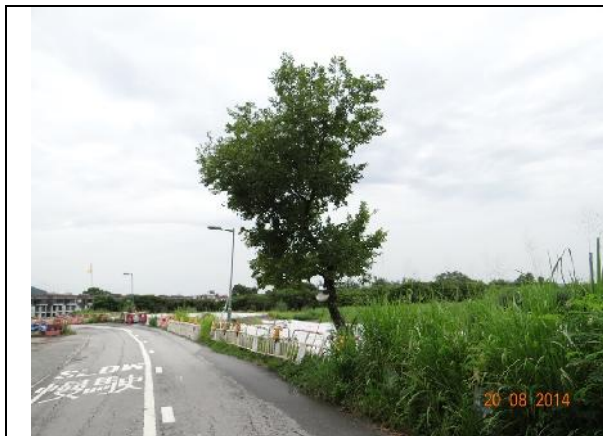
Photo 25 – The retained tree T025 was temporarily guyed to provide additional support to this tree.

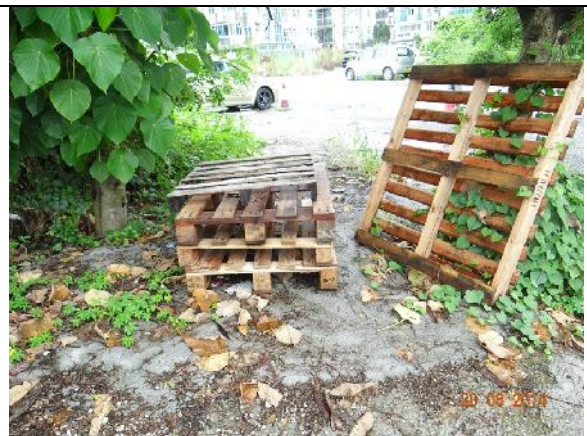
Photo 26 – Concrete pavement and wooden plates were observed close to the root flares of the tree group T089-091.

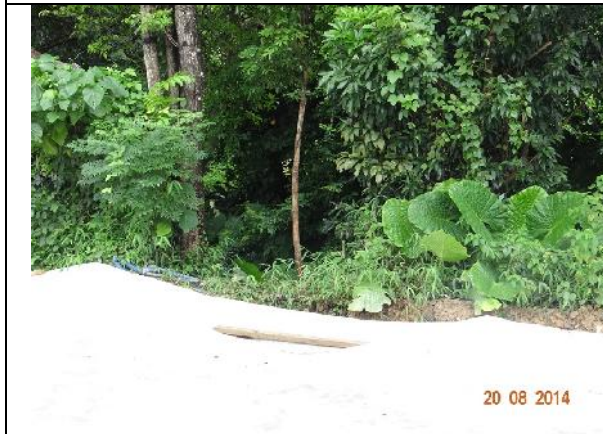
Photo 27 – Excavation work was noted between T153 and T155, and severe exposed roots were noted on these two trees.

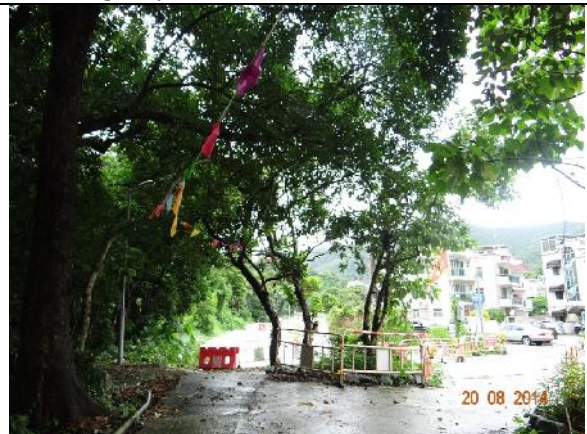
Photo 28 – Excavation work was noted very close to the tree group T181-T183 in May 2014. Excavated soil was noted piling around their trunk flares and the orange construction nets covering on the three trees were removed. These trees have been surrounded by some stones to demarcate the tree group area.

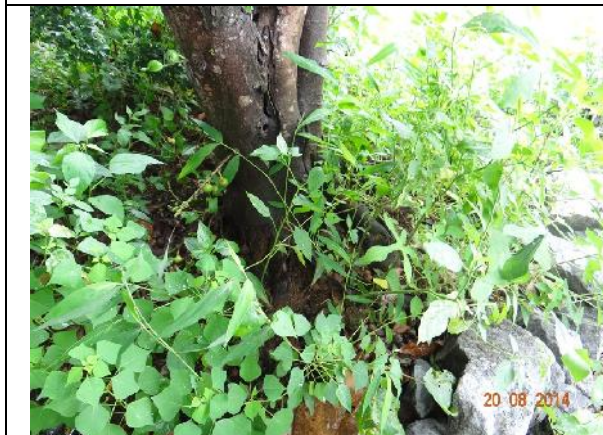
Photo 29 – Exposed and pruned roots were noted on T183, the pruning work was carried out by the third party to extend the access path immediately adjacent to T183.

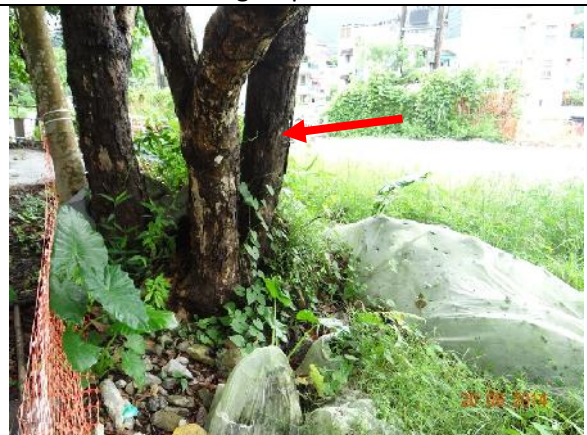
Photo 30 – Excavation work was noted next to an untagged tree (*Cleistocalyx nervosum*) (Red arrow). Severe exposed roots were noted on this tree.

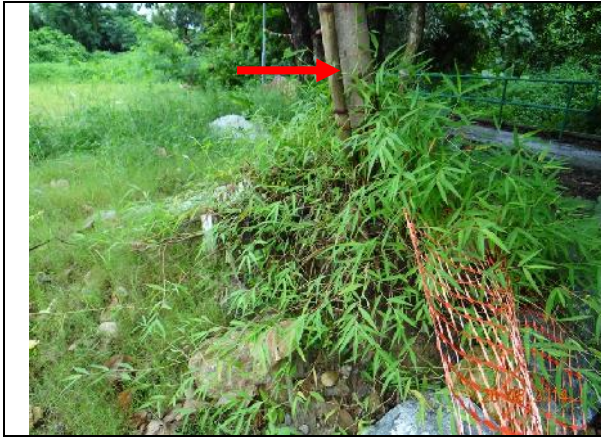
Photo 31 – Excavation work was noted next to another untagged tree (*Macaranga tanarius* var. *tomentosa*) (Red arrow). Severe exposed roots were noted on this tree.

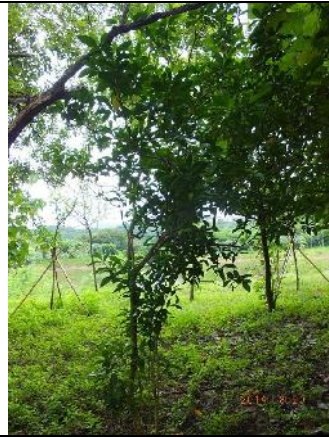
Photo 32 – The transplanted shrub of *Pavetta hongkongensis* (PH01) in Area C under Contract 1 has remained in satisfactory condition
