PROJECT NO.: TCS/00553/11

**CONTRACT NO. DC/2010/02 –
DRAINAGE IMPROVEMENT IN SHUEN WAN AND
SHEK WU WAI**

**MONTHLY ENVIRONMENTAL MONITORING AND
AUDIT REPORT (NO.39) – SEPTEMBER 2014**

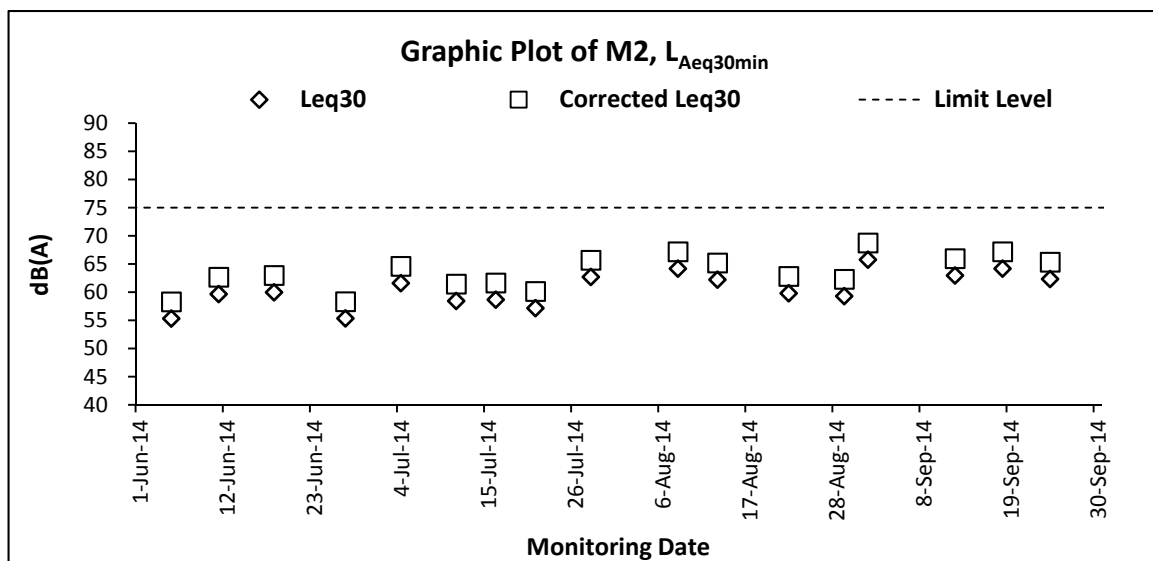
Remark: The monitoring is undertaken under free field situation. A façade correction of +3 dB(A) has been added according to acoustical principles and EPD guidelines.

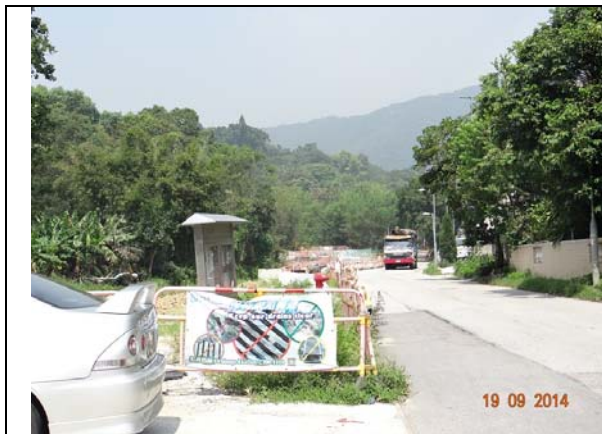
Photo 1 – Temporary hoardings have been erected along Tung Tsz Road opposite to Wai Ha.

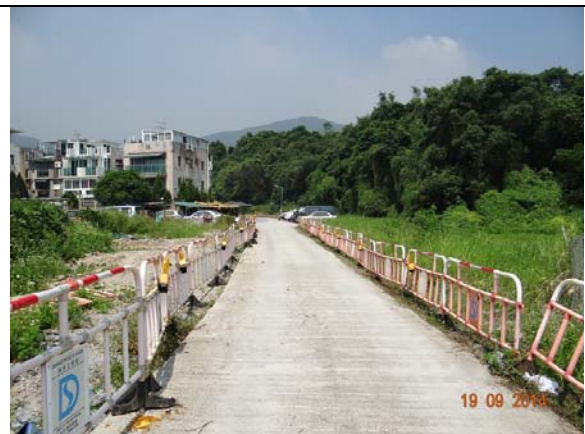
Photo 2 – Temporary hoardings have been erected along the access road from Tung Tsz Road to Treasure Spot Garden II.

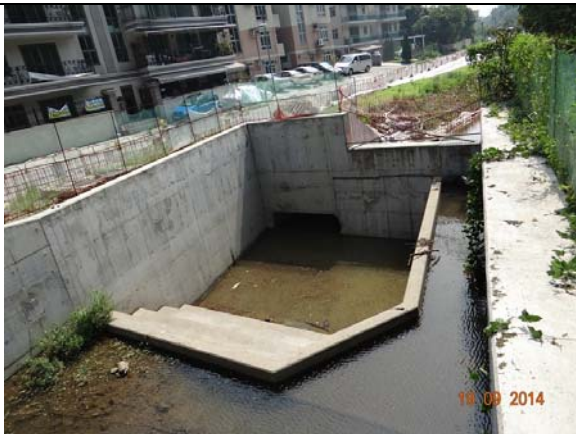
completed. Hydroseeding was applied and planting of compensatory trees was in progress along these areas as observed on 19th September 2014 (**Photos 3-8**).

Photo 3 – Construction works have been stopped next to Wai Ha River.

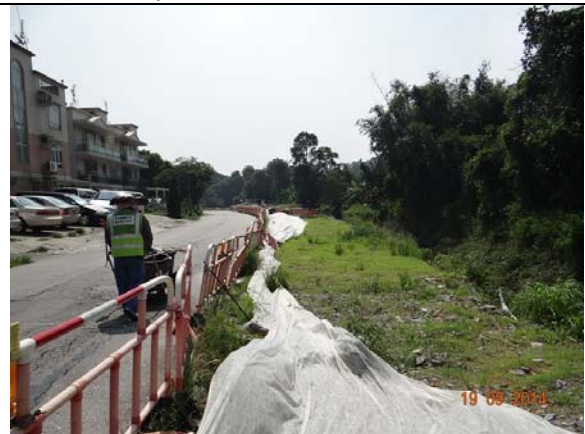
Photo 4 – Construction works for building the box culverts along Tung Tsz Road opposite to Wai Ha outside the public toilet have been stopped. Hydroseeding was applied on the site.

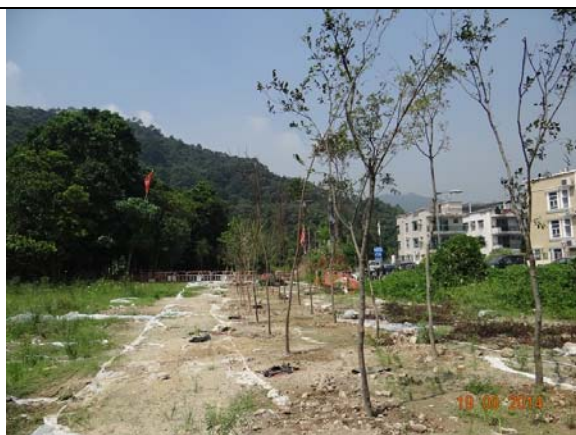
Photo 5 - Construction works next to the wetland near the location of the previously removed tree T190 have been stopped. Planting of the compensatory trees was in progress on 19th September 2014.

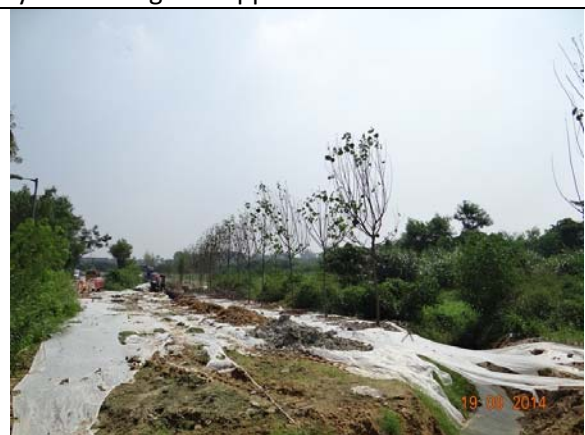
Photo 6 - Planting of the compensatory trees was in progress on 19th September 2014 opposite to the tree groups T030-033 and T035-036.

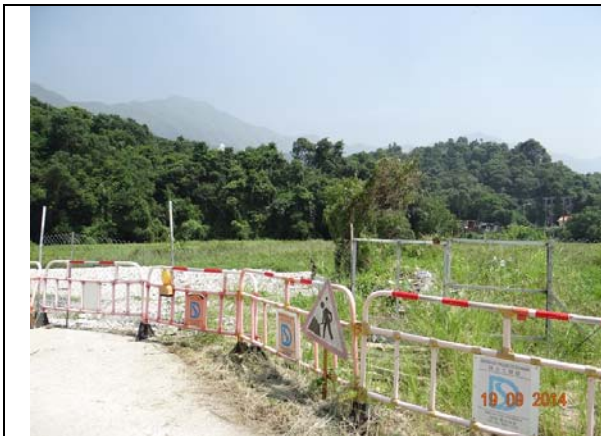
Photo 13 – A fenced area was seen on the field next to the construction site along the access to Treasure Spot Garden in March 2014. The area was still surrounded by chain-link fence by an unknown party.

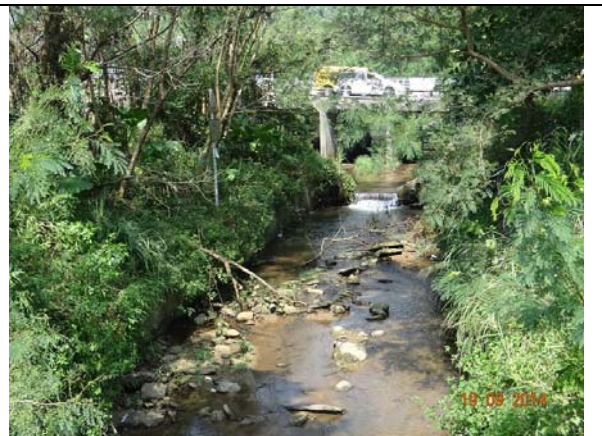
3.3.2 As observed during the inspections in September 2014, most of the construction works in Contract 2 works area were stopped. No more muddy water has been released from the works area. The river water was generally clear (**Photos 14-17**).

Photo 14 - The river water was clear in the upper stream near the tree group T107-117.

3.3.4 For good site practices, the Contractor is suggested to conduct regular checking to ensure no direct discharge or leakage of contaminants or any polluted fluid into the adjacent Wai Ha River and the nearby Shuen Wan marsh. The Contractor should maintain regular check (e.g. daily) on the sedimentation and filtration facilities and appropriate sedimentation beds and/or tanks throughout the construction phase (e.g. check the function of the sedimentation beds and remove surplus sand and gravels deposited along the beds or within the tanks) to make sure all discharged water was filtered appropriately prior to any discharge.

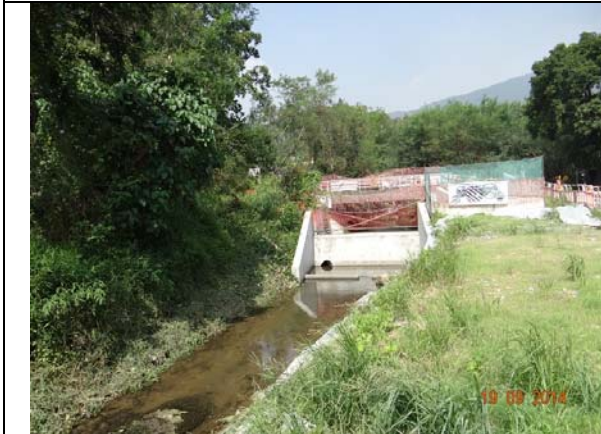
Photo 15 – The river water was clear near the tree group T119-122.

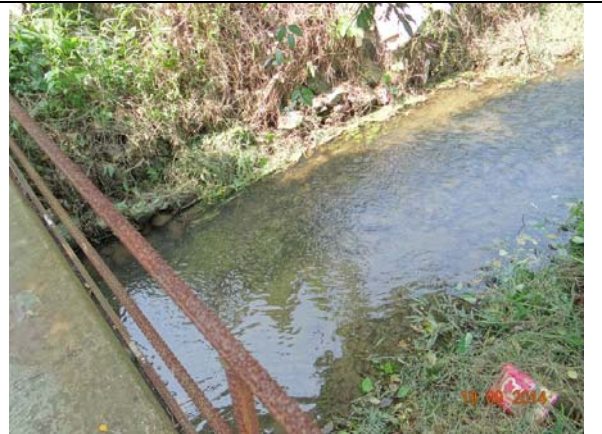
Photo 16 – Down the stream near the public toilet, the water was clear.

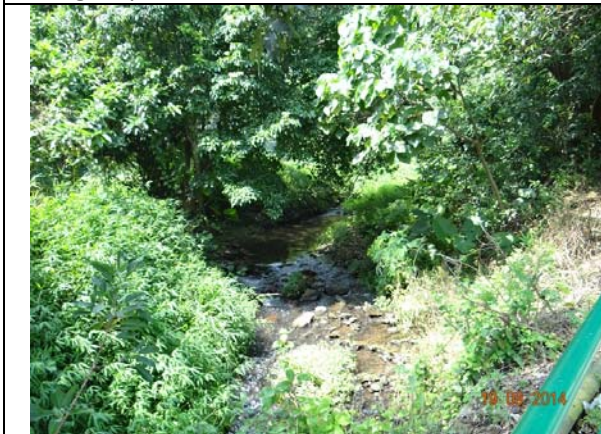
Photo 17 – The water was clear at the lower stream.

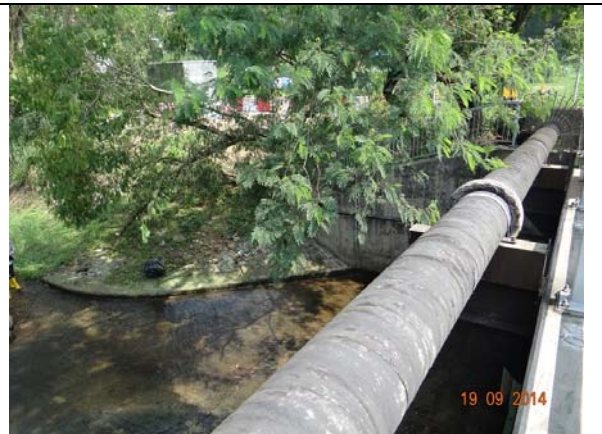
Photo 18 – No direct water discharge into the upper stream of Wai Ha River was observed as the construction works have been concentrated at the lower end of the river.

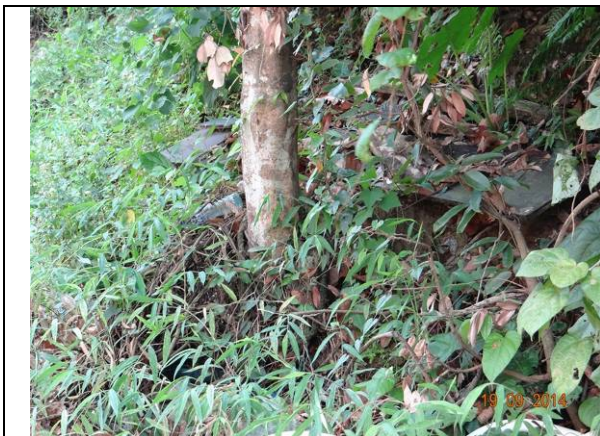
Photo 25 – Excavated soil and rocks, and construction materials were still noted piling close to the trunk base of the retained tree T103.

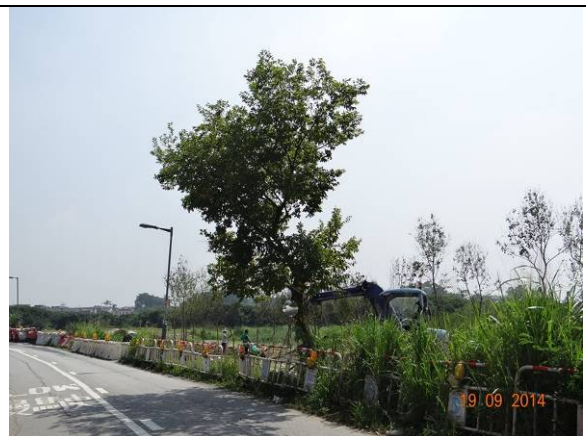
Photo 26 – The retained tree T025 was temporarily guyed to provide additional support to this tree.

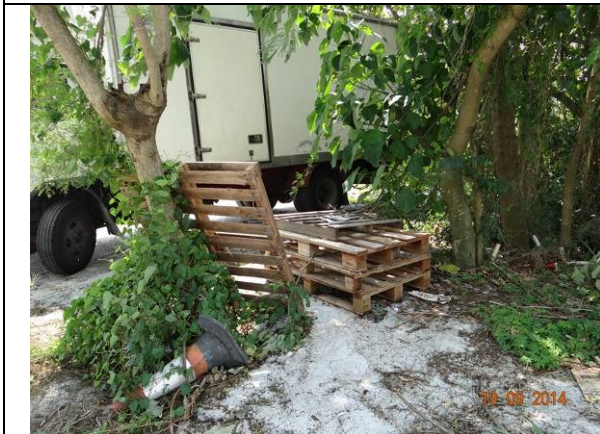
Photo 27 – Concrete pavement and wooden plates were observed close to the root flares of the tree group T089-091. The wooden plates were owned by the villagers.

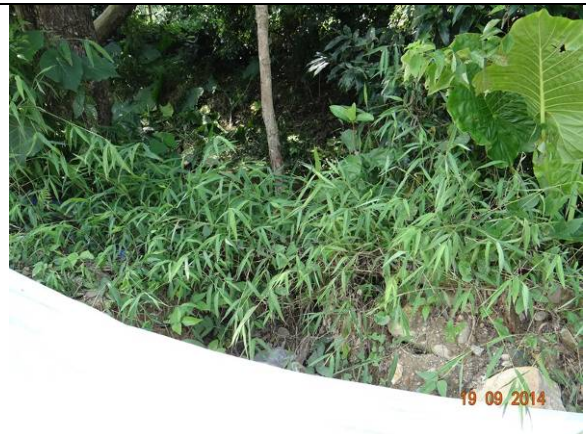
Photo 28 – Excavation work was noted previously between T153 and T155 in April 2014, and exposed roots were noted on these two trees. Surrounding ground was covered by vegetation.

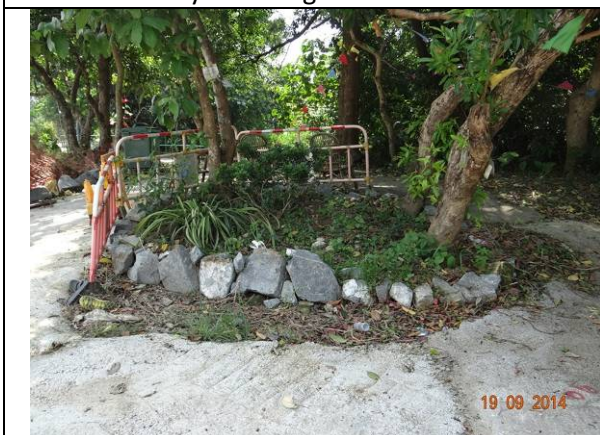
Photo 29 – Excavation work was noted very close to the tree group T181-T183 in May 2014. Excavated soil was noted piling around their trunk flares and the orange construction nets covering on the three trees were removed. These trees have been surrounded by some stones to demarcate the tree group area by the villagers.

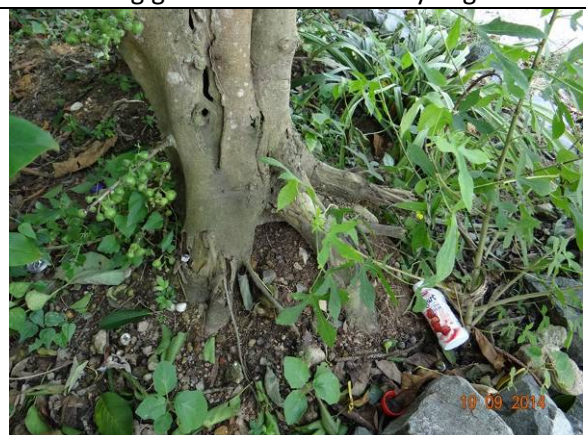
Photo 30 – Exposed and pruned roots were noted on T183, the pruning work was carried out by the third party to extend the access path immediately adjacent to T183.

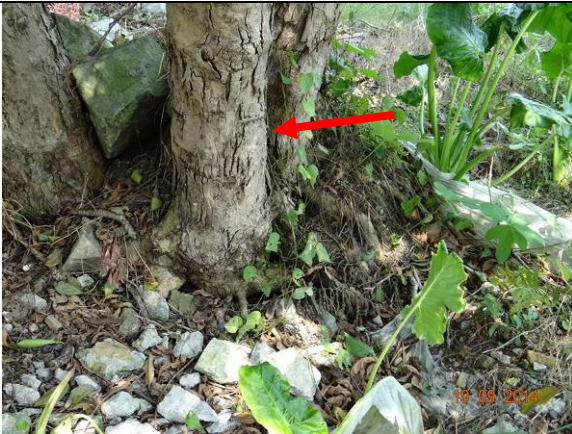
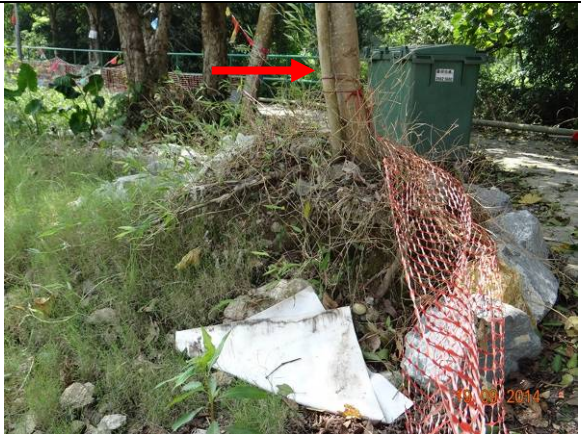
<p>Photo 31 – Previous excavation work was noted next to an untagged tree (<i>Cleistocalyx nervosum</i>) (indicated by Red arrow). Severe exposed roots were noted on this tree.</p>	<p>Photo 32 – Previous excavation work was noted next to another untagged tree (<i>Macaranga tanarius</i> var. <i>tomentosa</i>) (indicated by Red arrow). Severe exposed roots were noted on this tree.</p>

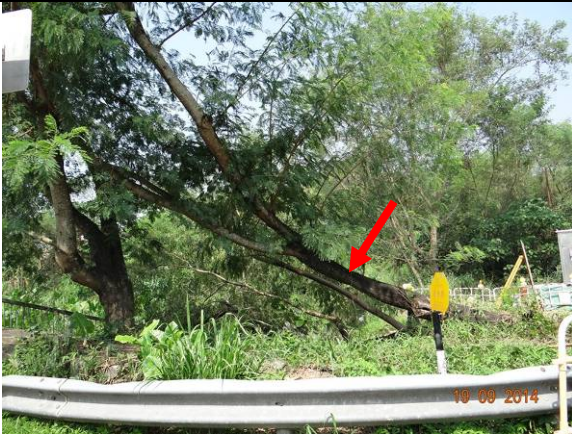
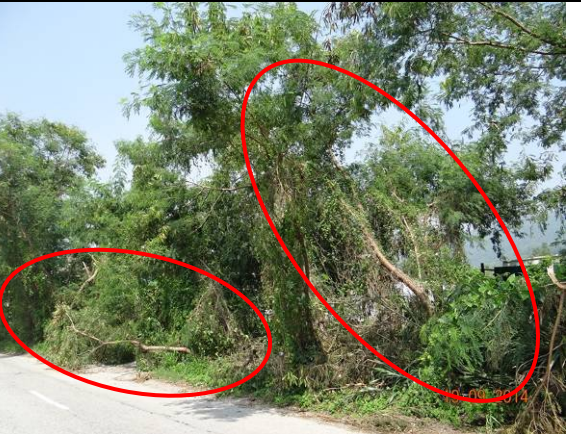
<p>Photo 33 – A tree (<i>Leucaena leucocephala</i>) within the tree group T086-087 and T104 was collapsed possibly due to the typhoon Kalmaegi in September 2014 (indicated by Red arrow).</p>	<p>Photo 34 – Several trees (<i>Leucaena leucocephala</i>) within the tree groups T021-023; T026-027 and T029 were collapsed possibly due to the typhoon Kalmaegi in September 2014 (indicated by Red circles).</p>

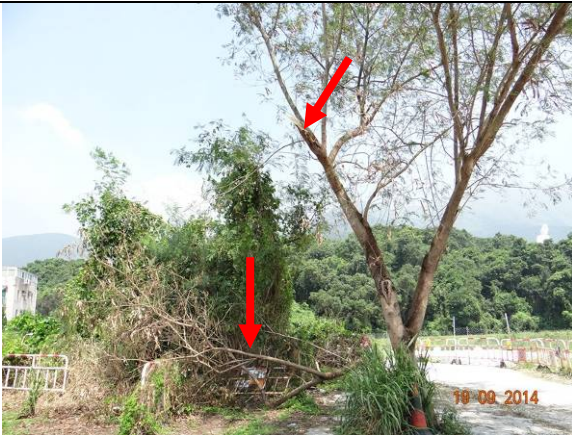
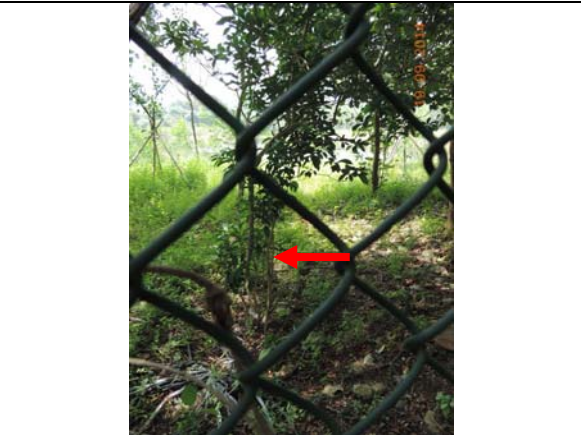
<p>Photo 35 - A main branch of T092 was broken possibly due to the typhoon Kalmaegi in September 2014 (indicated by Red arrows).</p>	<p>Photo 36 – The transplanted shrub of <i>Pavetta hongkongensis</i> (PH01) in Area C under Contract 1 has remained in satisfactory condition</p>

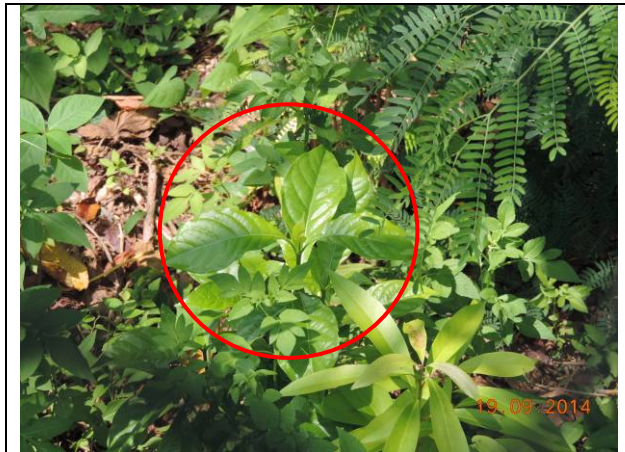
Photo 37 – The previously cut shrub *Pavetta hongkongensis* (PH-03) regenerated as inspected in September 2014.

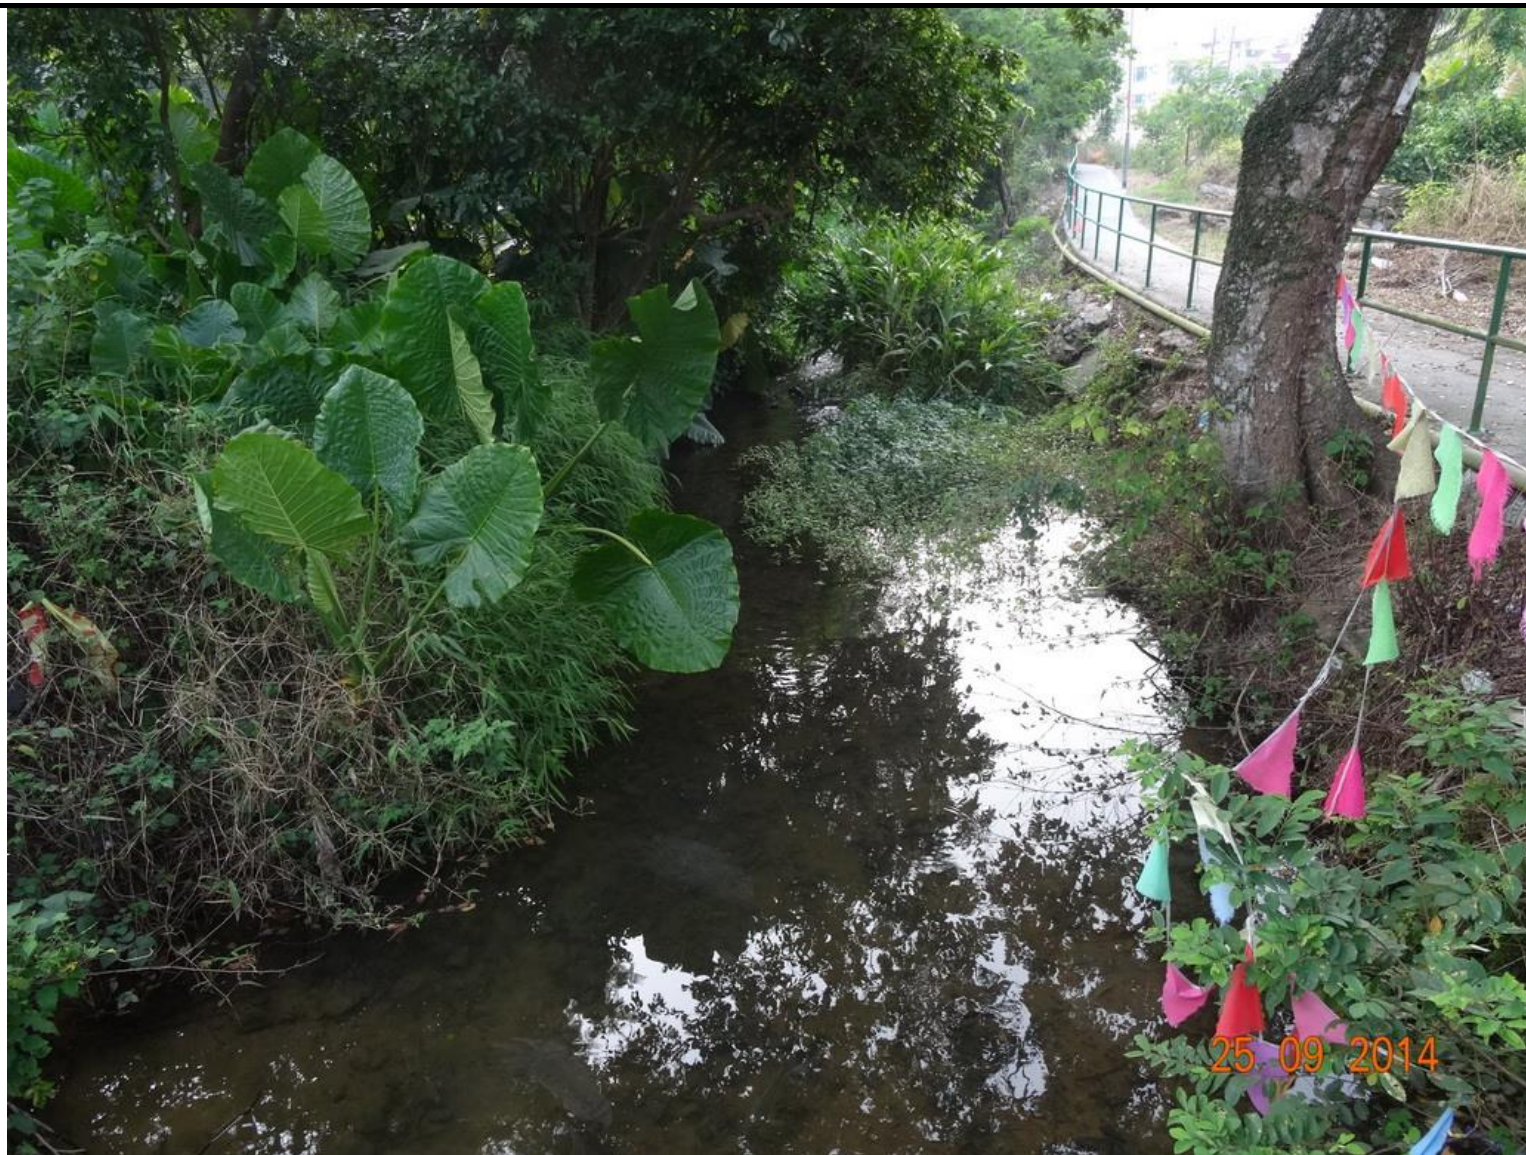
Figure: 2

Title: SEMP 3, the third sampling point of Wai Ha River under Contract 2.

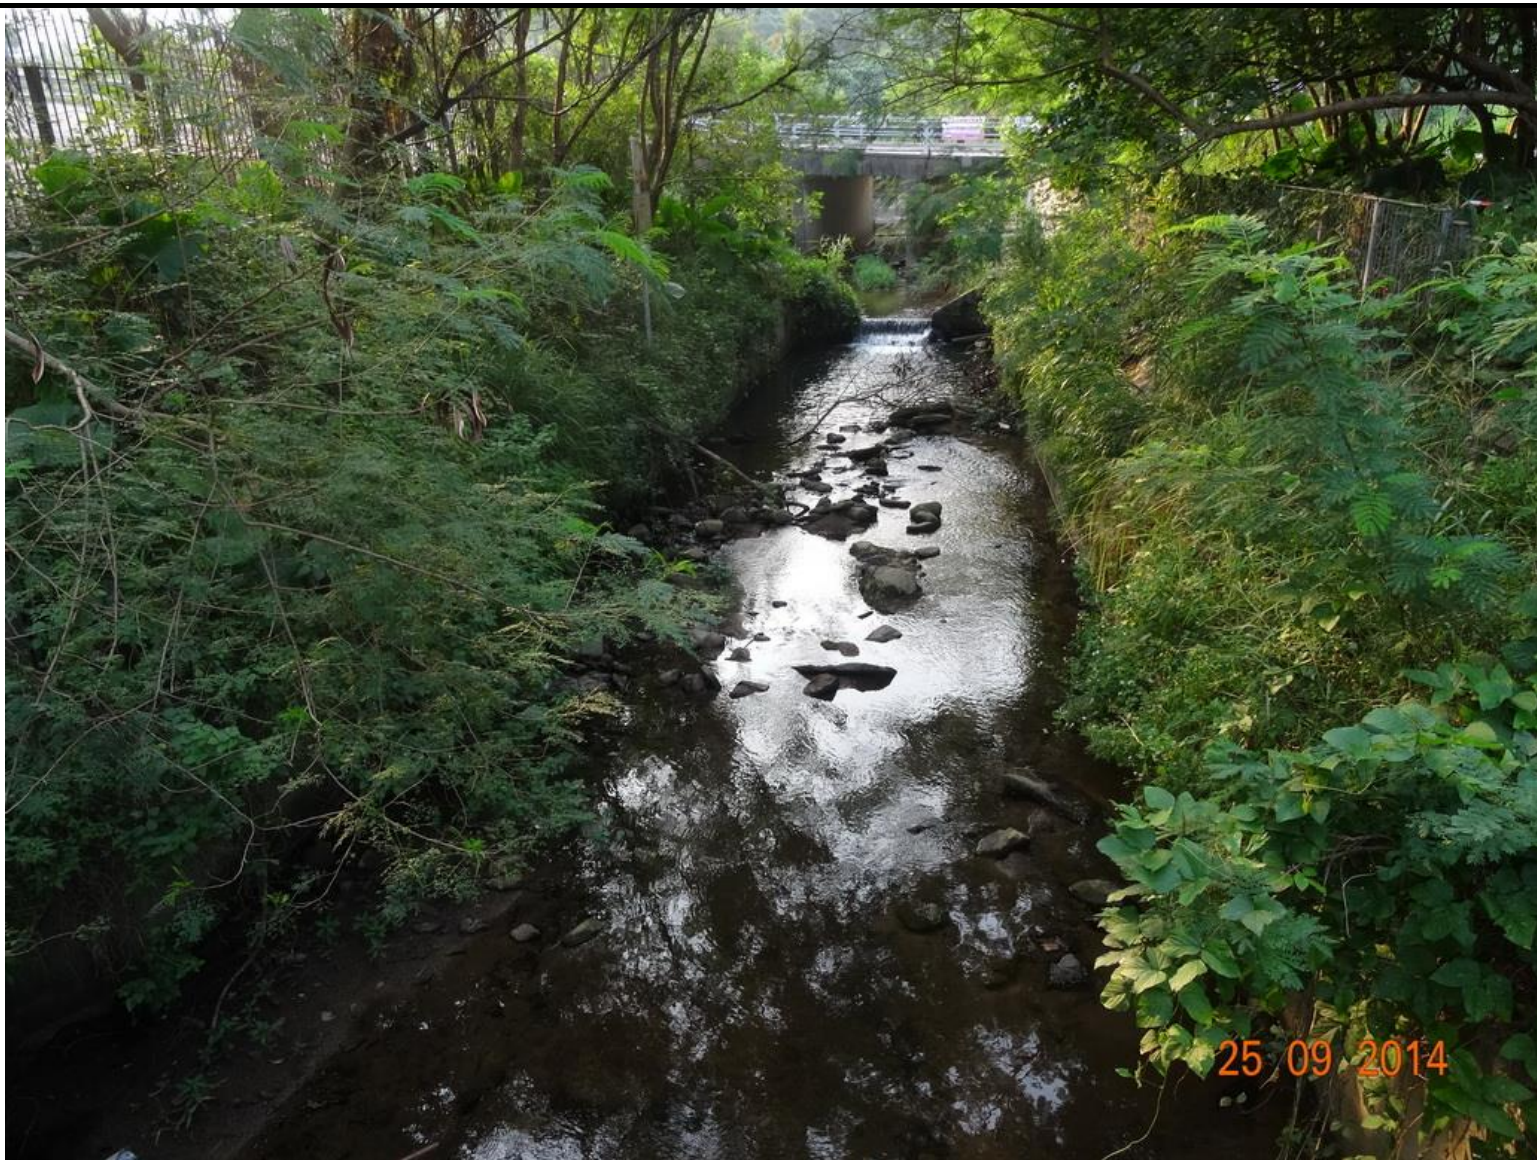
Figure: 3

Title: SEMP 4, the second sampling point along Wai Ha River under Contract 2.
