**CONTRACT NO. DC/2010/02 –
DRAINAGE IMPROVEMENT IN SHUEN WAN AND
SHEK WU WAI**

**MONTHLY ENVIRONMENTAL MONITORING AND
AUDIT REPORT (NO.40) – OCTOBER 2014**

PREPARED FOR
KWAN LEE-KULY JOINT VENTURE

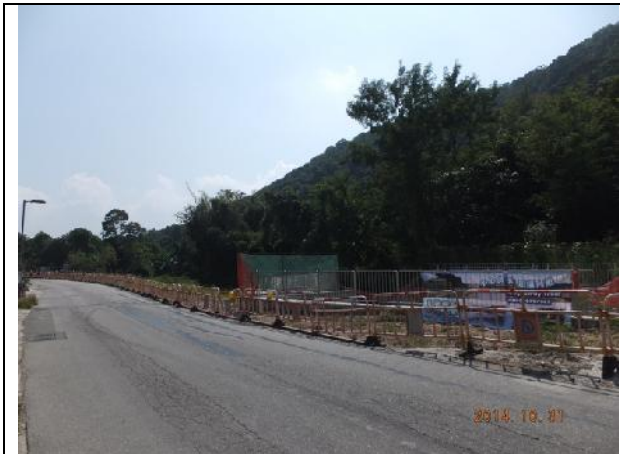
Photo 1 – Temporary hoardings have been erected along Tung Tsz Road opposite to Wai Ha.

3.2.2 Temporary hoardings, in the form of construction barriers, have been erected from west to east parts along Tung Tsz Road from the opposite side of Wai Ha to the opposite side of San Tau Kwok. The construction site along the access road from Tung Tsz Road towards Treasure Spot Garden II has also been demarcated with temporary construction barriers. Another section of temporary hoardings previously erected next to the path outside Treasure Spot Garden II was removed with the completion of the drainage work as observed on 31st October 2014. **Photos 1-2** show the views of the erected hoardings along the works area under Contract 2.

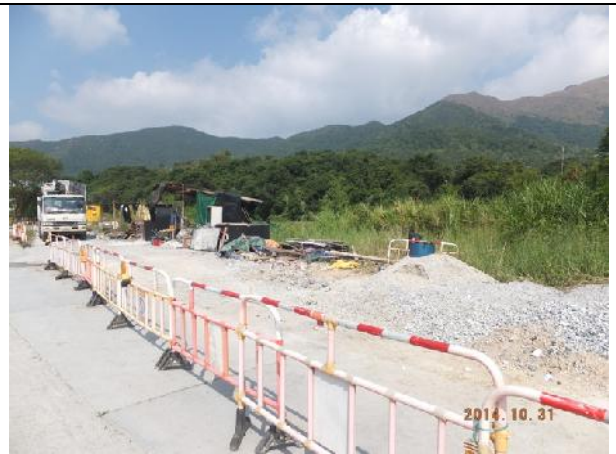
Photo 2 – Temporary hoardings have been erected along the access road from Tung Tsz Road to Treasure Spot Garden II.

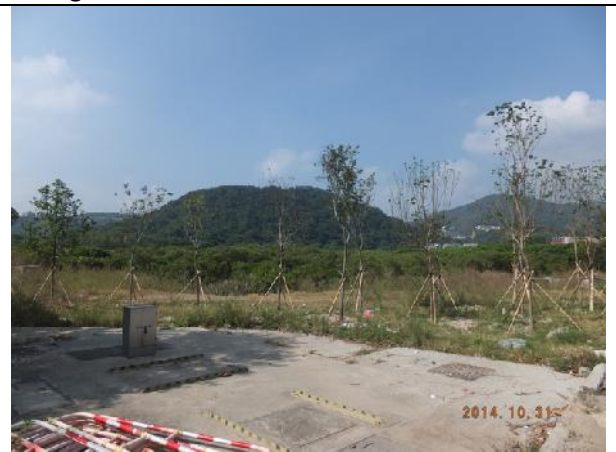
Photo 6 – Compensatory trees were planted in an area opposite to San Tau Kok.

- 3.2.3 Almost all construction works for building the box culverts in the works area along Tung Tsz Road opposite to Wai Ha, next to Wai Ha River and next to the rehabilitation wetland have been completed, leaving comparatively minor civil work continued along the path leading from Tung Tsz Road to Treasure Spot Garden II (**Photos 3-5**). Hydroseeding was applied in the works area along Tung Tsz Road, and planting of compensatory trees was continued in October 2014 and all trees were planted as observed on 31st October 2014 (**Photos 6-8**).

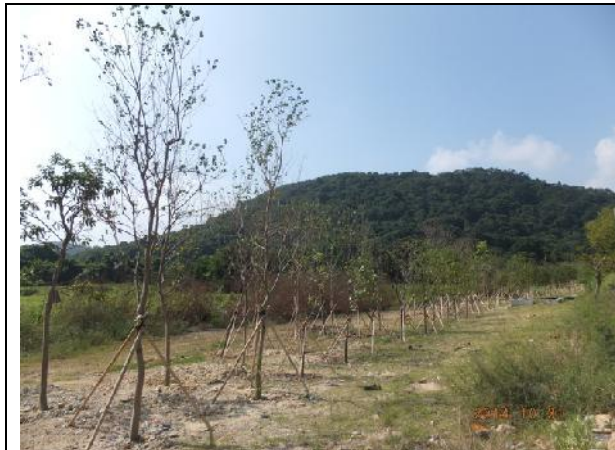
Photo 7 – Compensatory trees were planted opposite to the entrance of Treasure Spot Garden II.

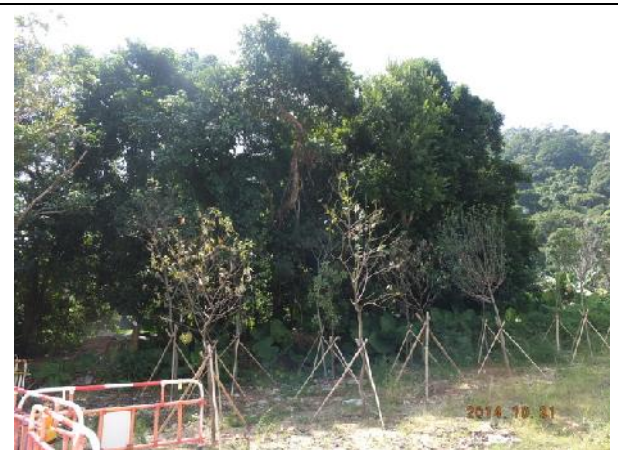
Photo 8 – Compensatory trees were planted in area opposite to Wai Ha.

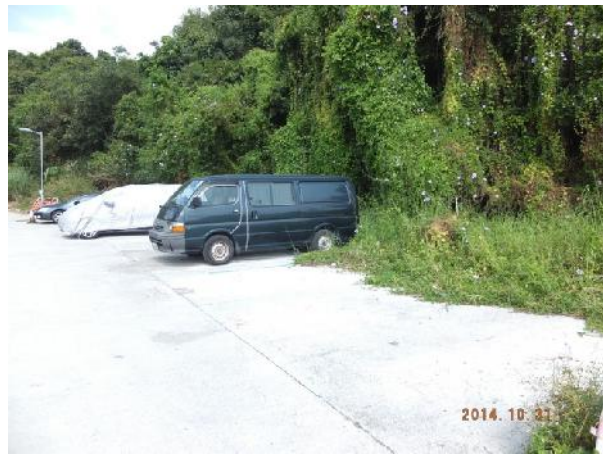
Photo 9 – Temporary parking area has still been maintained at the end of the access path to Treasure Spot Garden Phase II.

- 3.2.5 As reported in the previous *Monthly EM&A Reports*, dumping on the Taro field located along the path towards the Treasure Spot Garden was observed and a paved area created for parking next to the retained tree groups (T088 – T091) has been found since November 2012. In October 2013, the path to Treasure Spot Garden II was expanded towards the Taro field due to the reprovision of vehicular access road as requested by the villagers during the works at the entrance of the Treasure Spot Garden.

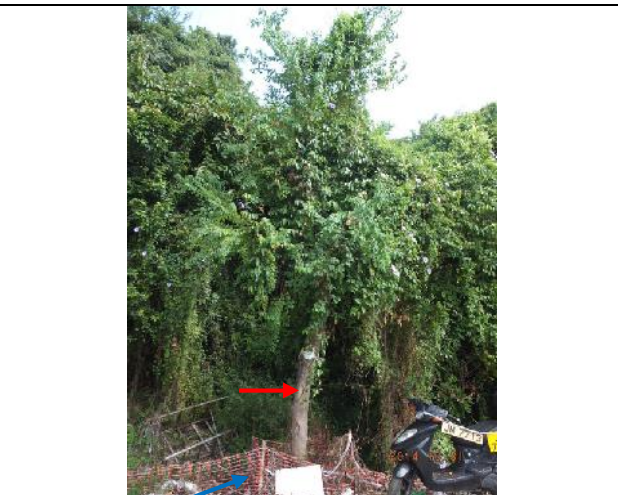
Photo 10 – The untagged tree (indicated by Red arrow) was guyed at the edge of the parking area within a Tree Protection Zone demarcated by orange construction nets (indicated by Blue arrow).

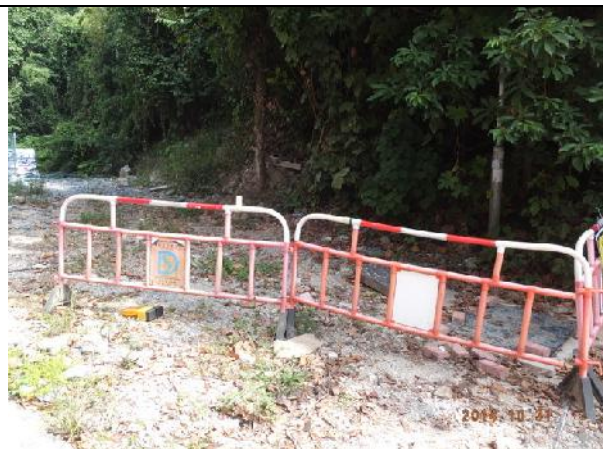
Photo 11 – Construction works have been stopped at the end of the Treasure Spot Garden II near the retained tree T103 and it was surrounded by temporary construction barriers.

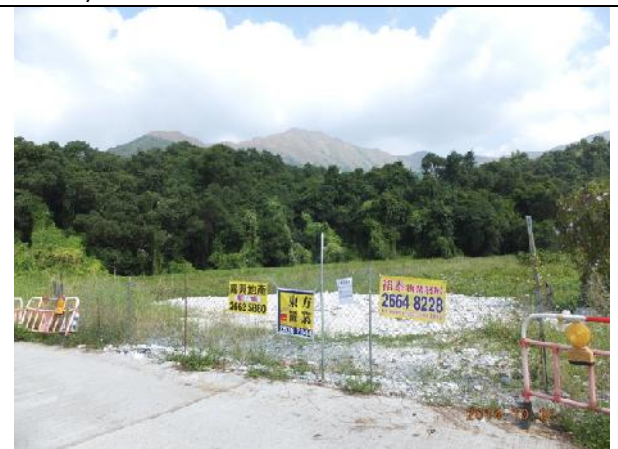
Photo 12 – A fenced area has been seen on the field next to the construction site along the access to Treasure Spot Garden II since March 2014.

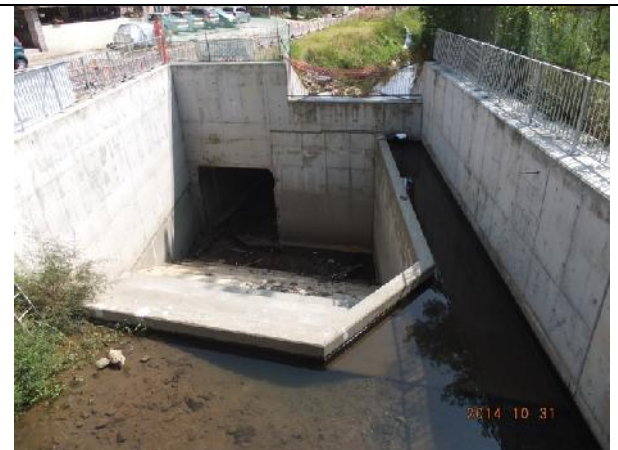
3.4.2 Major construction works in Contract 2 works area were completed as observed in October 2014, leaving comparatively minor civil works conducted in area near Treasure Spot Garden II and some next to Wai Ha. No more muddy water has been released from the works area. The river water was generally clear (**Photos 13-15**).

Photo 14 - The river water was clear in the upper stream near the tree group T119-T122.

3.4.4 For good site practice, the Contractor should prevent any contaminant and sediment from entering the sensitive water-based habitats (i.e. Shuen Wan marsh and Wai Ha River) and implement pollution control measures to minimize any adverse environmental impacts to the water body throughout the construction phase. The Contractor should maintain appropriate sedimentation beds and/or tanks throughout the construction phase. The Contractor should adopt a good site practice in maintaining appropriate sedimentation beds and filtration tanks as recommended in the above Section for Contaminant/ Sediment Control. Muddy water pumped from the works area should be filtered appropriately through sedimentation beds or other filtration system prior to the discharge.

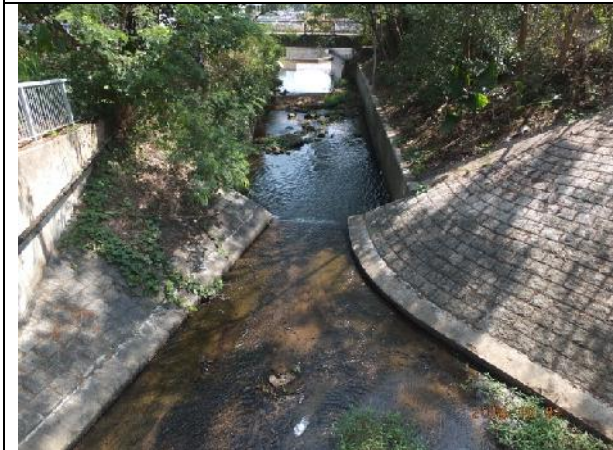
Photo 15 – The river water in the upper stream was clear near the tree group T107-T117.

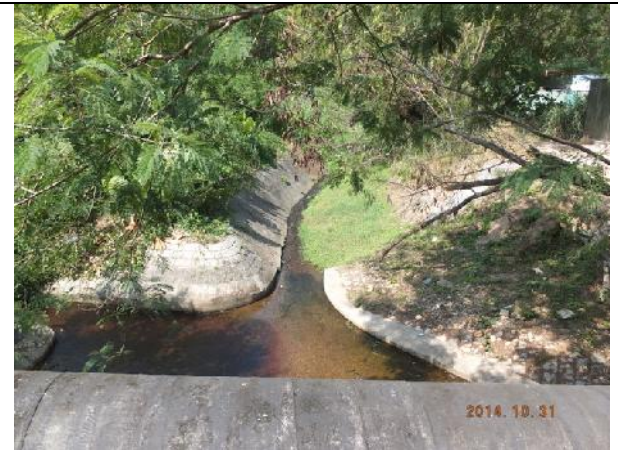
3.4.3 No direct water discharge into the upper stream of Wai Ha River was observed as all major construction works in Contract 2 works area have been completed (**Photo 16**).

Photo 16 – No direct water discharge into the upper stream of Wai Ha River was observed as all major construction works were completed.

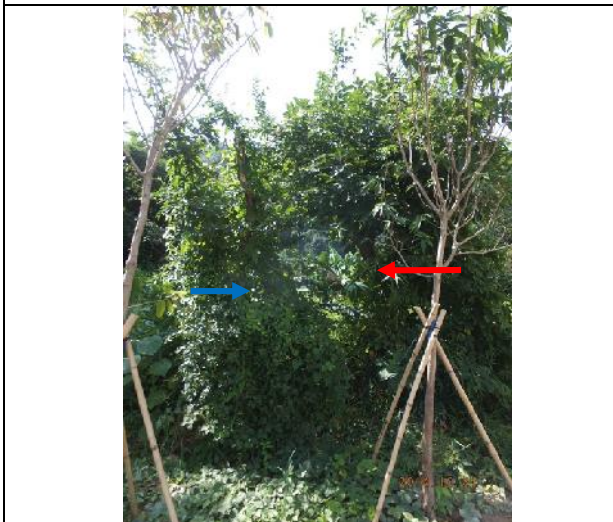
Photo 17 – Topped trees T167 (indicated by Red arrow) and T168 (indicated by Blue arrow) were in poor health condition with vigorous development of epicormics.

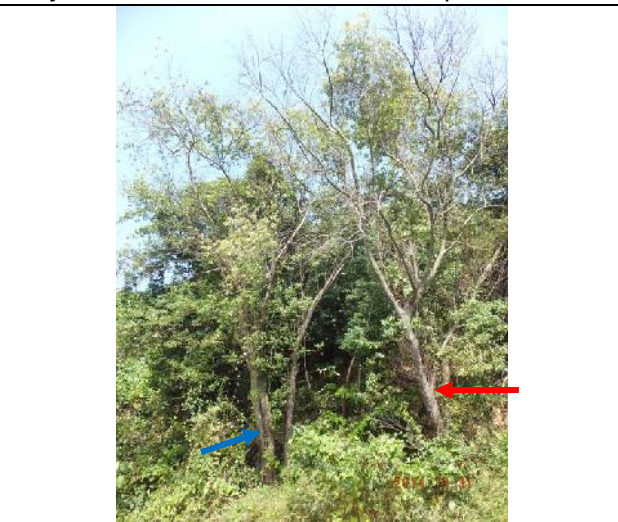
Photo 18 – T093 (Red arrow) and T094 (Blue arrow) on the slope. T093 shows significant defoliation and poor health condition.

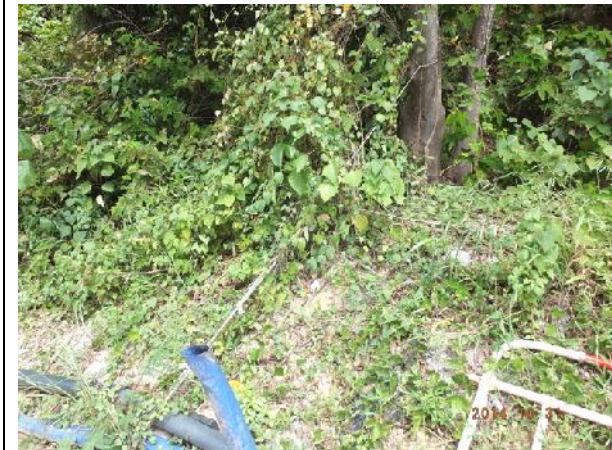
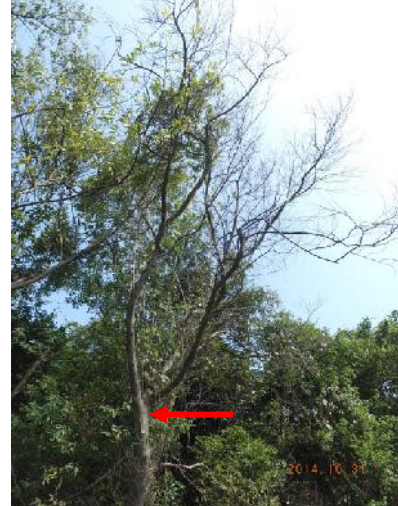
<p>Photo 19 – The previously discharged cement mortar on the soil has been covered by ground vegetation.</p>	<p>Photo 20 – Close view of the tree canopy of T093, with significant defoliation.</p>

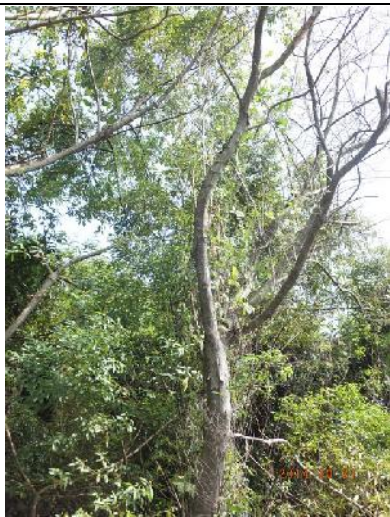
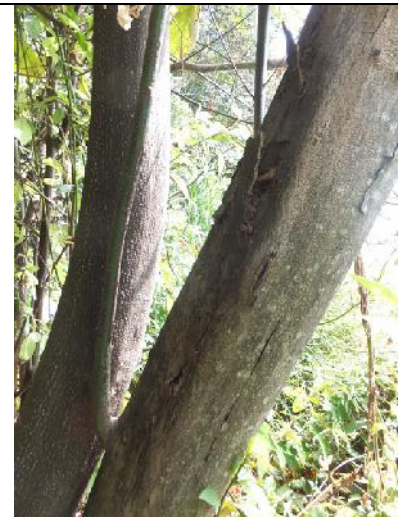
<p>Photo 21 – Close up view of the tree trunk of T093.</p>	<p>Photo 22 – Close up view of the cracked tree bark and termite infestation along the lower tree trunk of T093.</p>

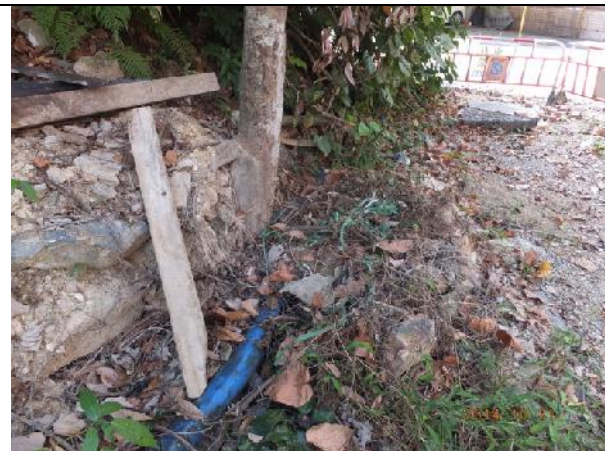
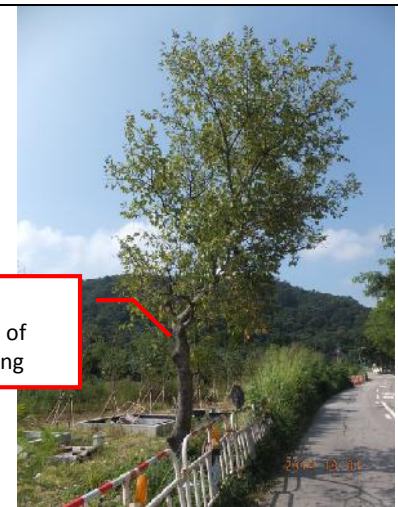
<p>Photo 23 – Some previously piled excavated soil and rocks were removed from the trunk flare of T103, but minor wooden plates were still found.</p>	<p>Photo 24 – The guying on the retained tree T025 was removed after mid-October 2014.</p>

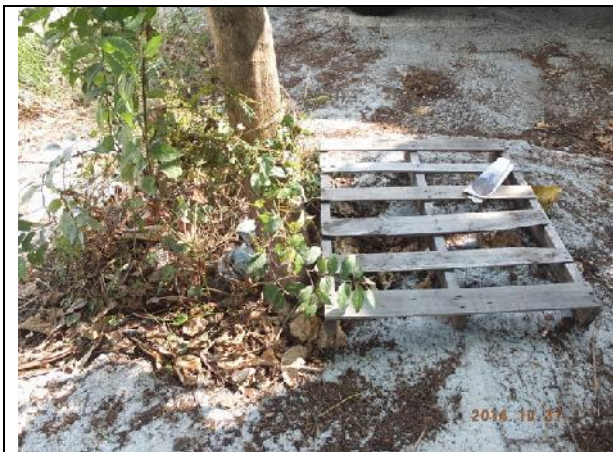
Photo 25 – A wooden pallet was still stored by the local villager next to the tree group T089-T091.

- 3.2.9 No specific recommendation is required in regard to the observations made in August 2014. However, with regard to the previous dumping incident by other parties on the Taro field near the Treasure Spot Garden, the Contractor is recommended to check the site condition regularly to avoid any extent of dumping or paving of area within the project boundary throughout the construction phase.
- 3.2.10 For good site practices, the Contractor should also make sure there are no piled rocks, construction materials or programmed construction works influencing the existing trees within the Project Area or the wetland rehabilitation area throughout the construction phase. Otherwise, the Contractor should request the on-site workers to remove those piled rocks or construction materials. As a reminder, the Contractor should keep all construction works within the Project Boundary.

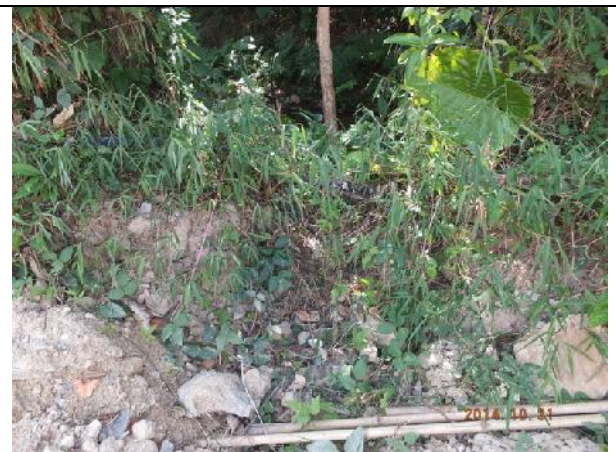
Photo 26 – Excavation work was noted previously between T153 and T155 in April 2014, and exposed roots were noted on these two trees. Surrounding ground was covered by vegetation.

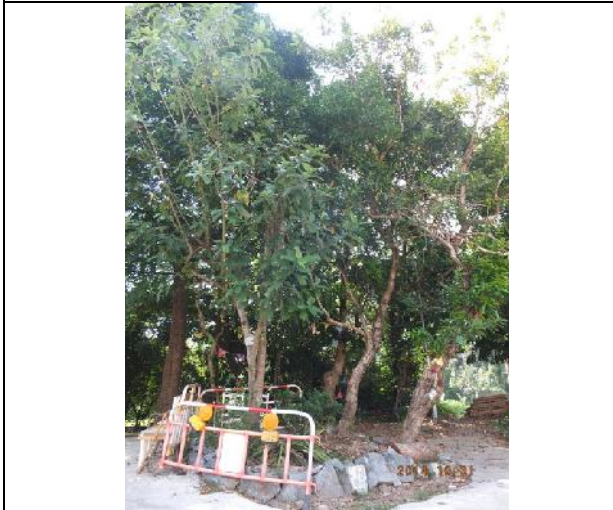
Photo 27 – Excavation work was noted very close to the tree group T181-T183 in May 2014. These trees have been surrounded by some stones to demarcate the tree group area by the villagers.

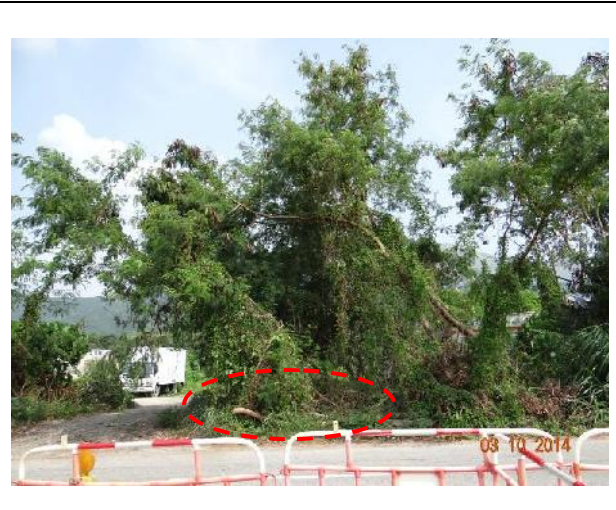
Photo 28 – Some broken branches of individual trees in the tree group “T021-023; T026-027 and T029” were removed by the Contractor as observed on 3rd October 2014.

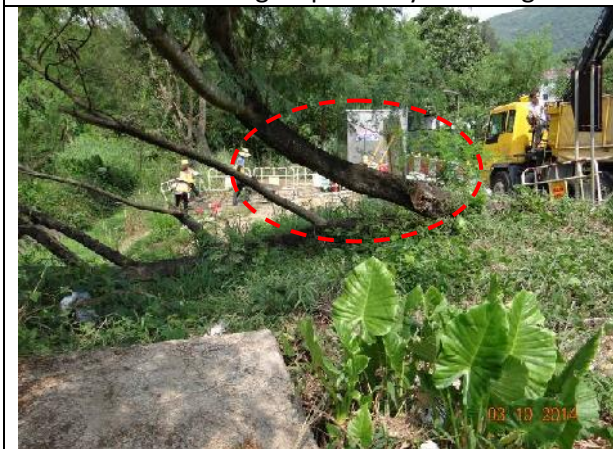
Photo 29 – Some broken branches of individual trees in the tree group “T086-087 and T104” were removed by the Contractor as observed on 3rd October 2014.

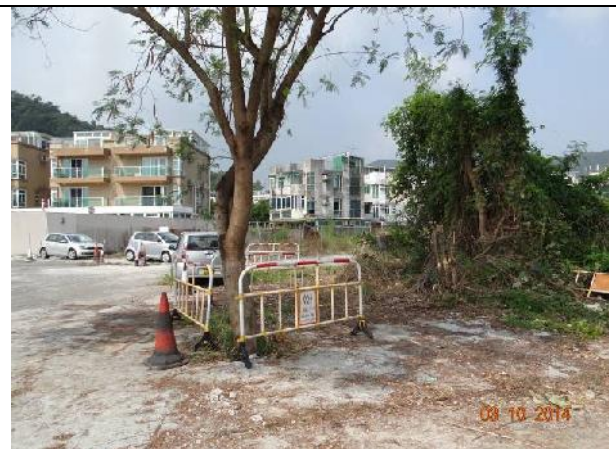
Photo 30 – The fallen main branch and twigs from T092 were removed as observed on 3rd October 2014.

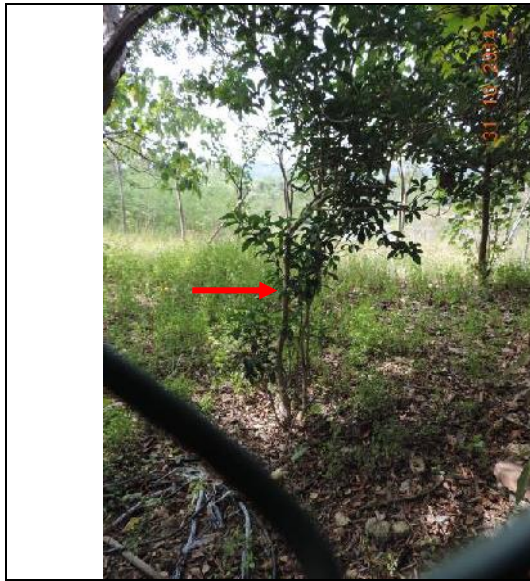
Photo 31 – The transplanted shrub of *Pavetta hongkongensis* (PH01) in Area C under Contract 1 has remained in satisfactory condition.

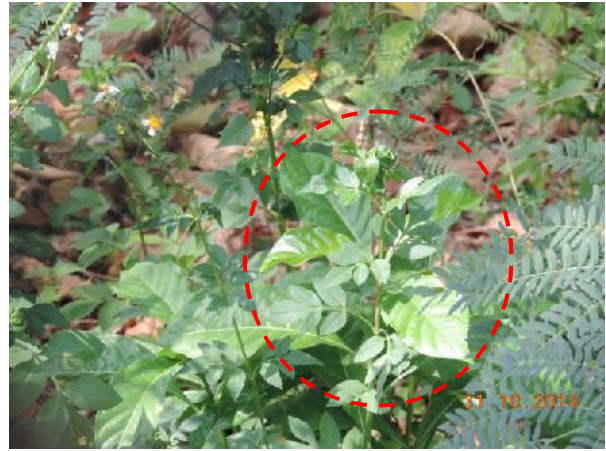
Photo 32 – The previously cut shrub *Pavetta hongkongensis* (PH-03) regenerated.
