CONTRACT NO. DC/2009/22
DRAINAGE IMPROVEMENT WORKS IN SHUEN WAN

CONTRACT NO. DC/2010/02
DRAINAGE IMPROVEMENT WORKS IN SHUEN WAN
AND SHEK WU WAI

MONTHLY ENVIRONMENTAL MONITORING AND
AUDIT REPORT (NO.41) – NOVEMBER 2014

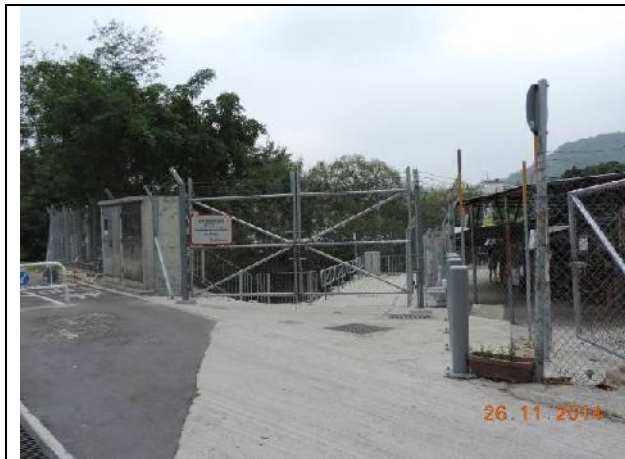
Photo 1 – Temporary construction hoardings have been removed around the works area at Wai Ha River estuary and a new gate and chain-link fence were erected to demarcate the area.

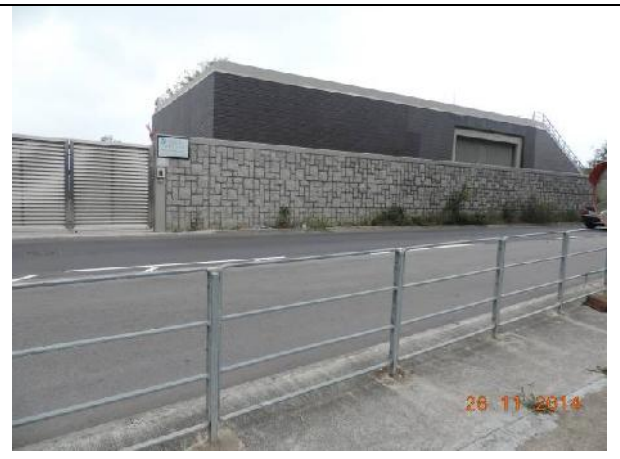
Photo 2 – The built boundary wall along the western boundary of Area A.

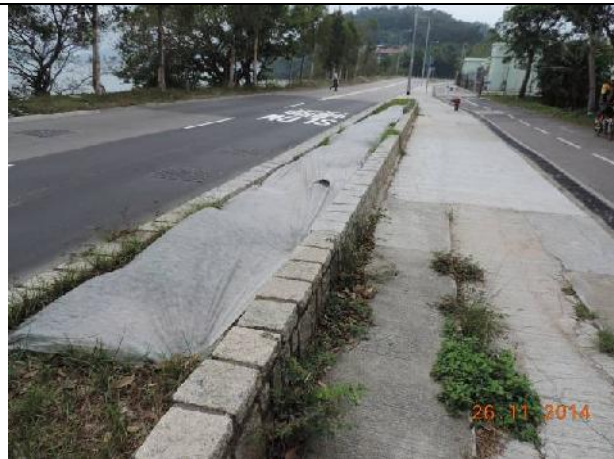
Photo 3 – The roadside planters along Ting Kok Road were hydroseeded and shrubs were planted in the planters.

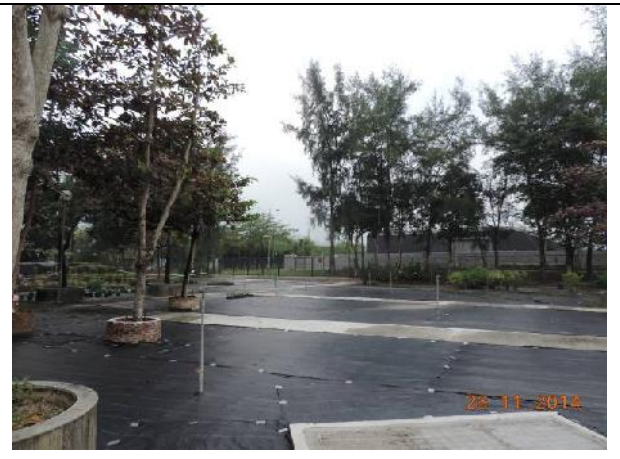
Photo 4 – The reinstatement work of the nursery ground in Phase 2 of Area B was completed.

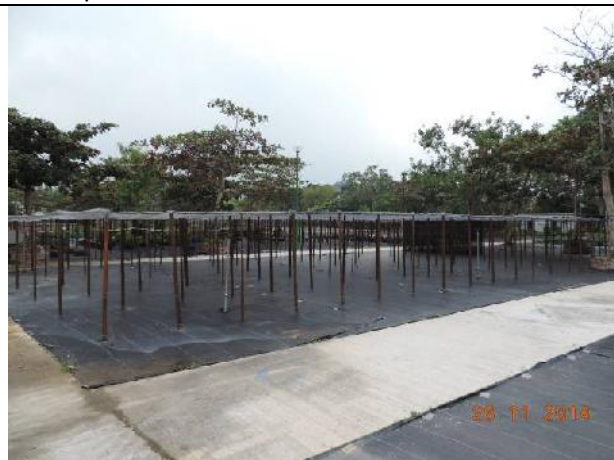
Photo 5 – The reinstatement work of the nursery in Phase 1 of Area B was under progress and almost completed.

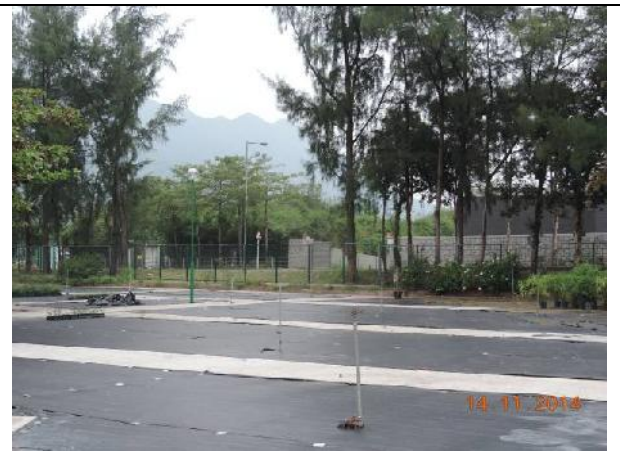
Photo 6 – Chain-link fence was reinstated at the eastern end of Phase 2 works area and the canvas sheet previously found on the fence was removed.

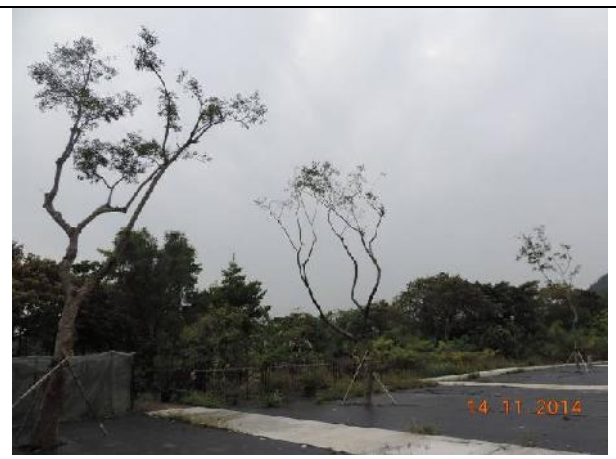
Photo 10 – Three of the trees *Celtis sinensis* transplanted from other LCSD-related project were removed by the nursery workers, leaving only three *Celtis sinensis* still at the receptor site in Phase 1 works area.

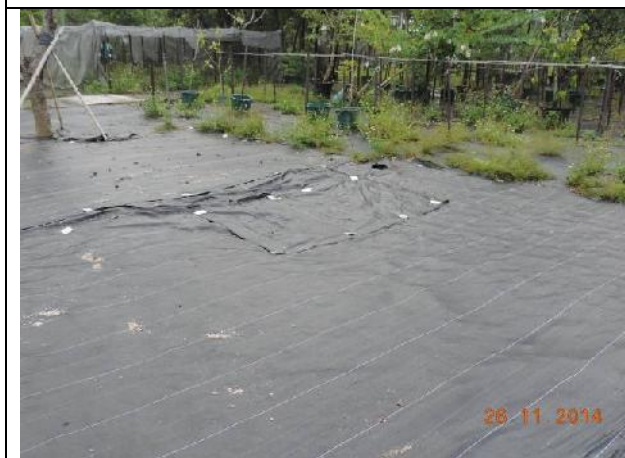
Photo 11 –The stumps of all three removed *Celtis sinensis* was removed from ground as inspected on 14th November 2014, and the ground was covered by shade net.

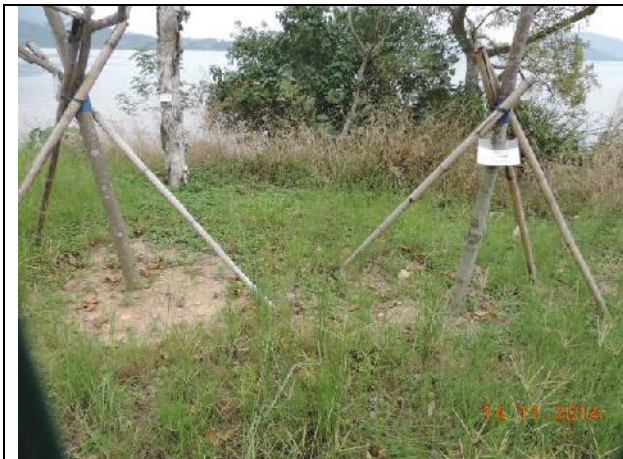
Photo 19 – Replacement tree of *Bridelia tomentosa* has not yet been planted back to the eastern boundary of Area A

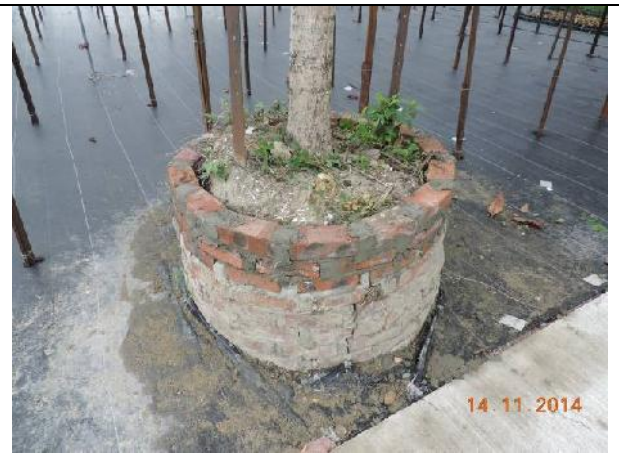
Photo 20 – The planter of U51 was repaired and built up to the soil surface of the tree.

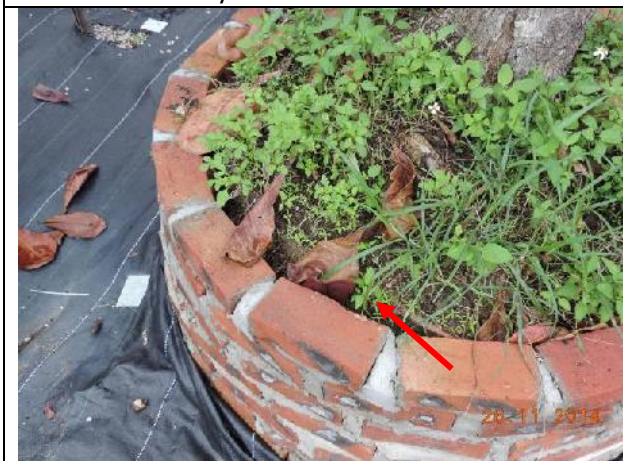
Photo 21 – Example of gap between the root ball and the inner surface of the new planter.

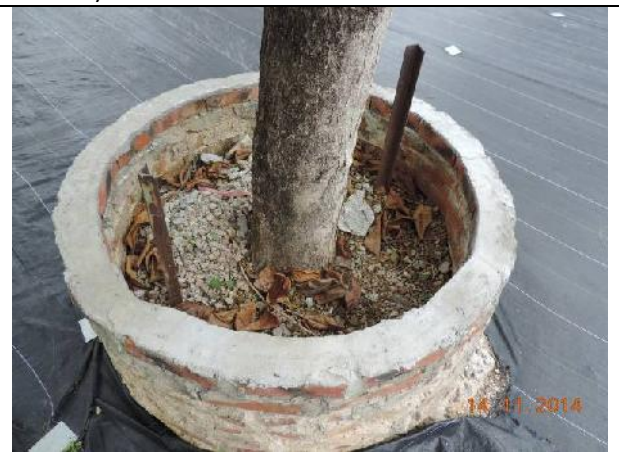
Photo 24 – Fungi fruiting bodies and the canvas sheet found in the soil within the planter of A38 were removed.

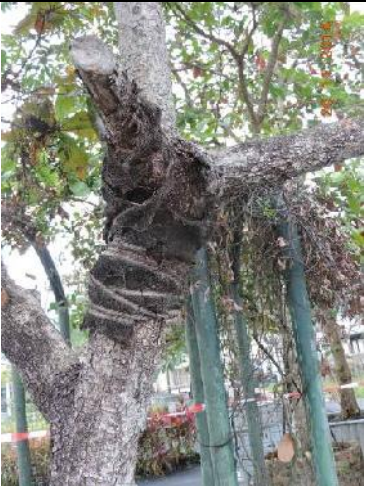
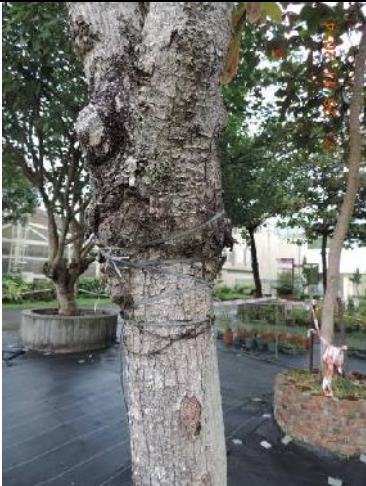
<p>Photo 25 –The trunk of the transplanted tree A36 was still tied tightly by nylon cable ties and hessian wrapping.</p>	<p>Photo 26 – The trunk of the transplanted tree A41 was still tied tightly by nylon cable ties.</p>

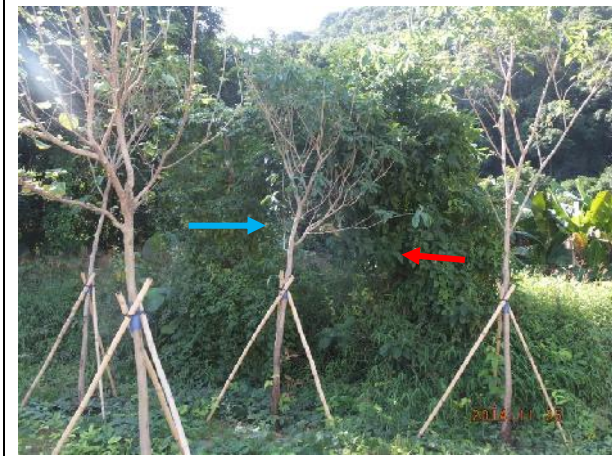
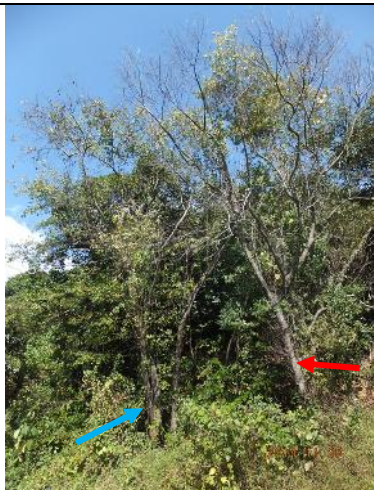
<p>Photo 19 – Topped trees T167 (indicated by Red arrow) and T168 (indicated by Blue arrow) were in poor health condition with vigorous development of epicormics.</p>	<p>Photo 20 – T093 (Red arrow) and T094 (Blue arrow) on the slope. One of the co-dominant trunks of T093 showed significant defoliation and poor health condition.</p>

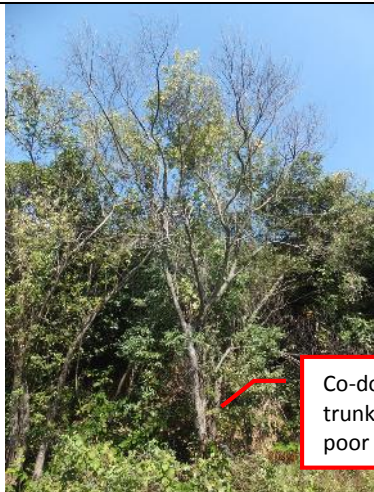
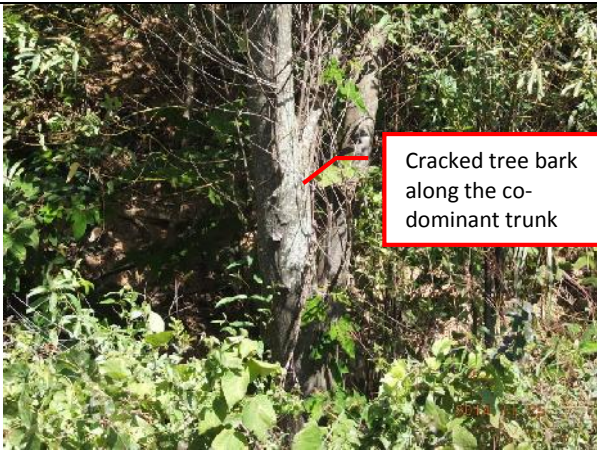
<div data-bbox="603 1232 790 1344" style="border: 1px solid red; padding: 2px;"> <p>Co-dominant trunk with poor</p> </div>

<div data-bbox="1204 1008 1428 1120" style="border: 1px solid red; padding: 2px;"> <p>Cracked tree bark along the co-dominant trunk</p> </div>
<p>Photo 21 – Close up view of the co-dominant tree trunk of T093 with poor condition.</p>	<p>Photo 22 – Close up view of the cracked tree bark along the lower tree trunk of T093.</p>

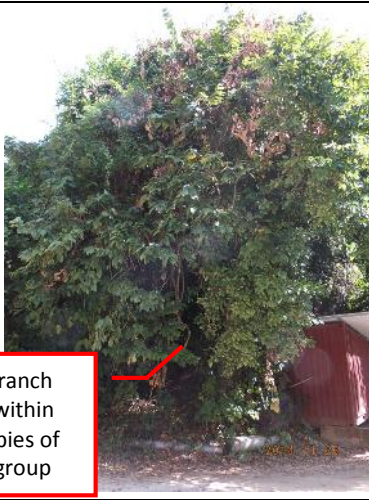
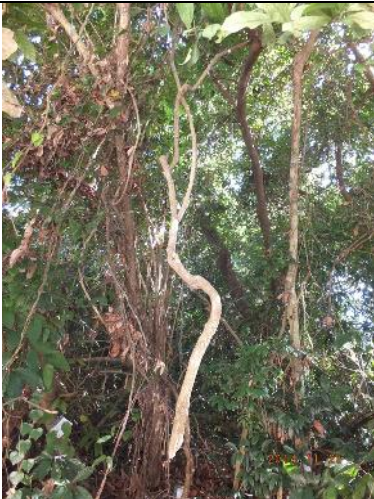
<p>Broken branch hanging within the canopies of the tree group</p>
<p>Photo 25 – Concrete pavement maintained for parking area for the villagers was still observed around the tree group T089-T091.</p>	<p>Photo 26 – One broken branch was noted hanging within the tree canopies of tree group T099-T102.</p>

<p>Photo 27 – Close-up view of the broken branch hanging within the canopies of the tree group T099-T102.</p>	<p>Photo 28 – Excavation work was noted previously between T153 and T155. The surrounding ground was covered by vegetation.</p>
