**CONTRACT NO. DC/2009/22**  
**DRAINAGE IMPROVEMENT WORKS IN SHUEN WAN**

**CONTRACT NO. DC/2010/02**  
**DRAINAGE IMPROVEMENT WORKS IN SHUEN WAN**  
**AND SHEK WU WAI**

**MONTHLY ENVIRONMENTAL MONITORING AND**  
**AUDIT REPORT (NO.42) – DECEMBER 2014**

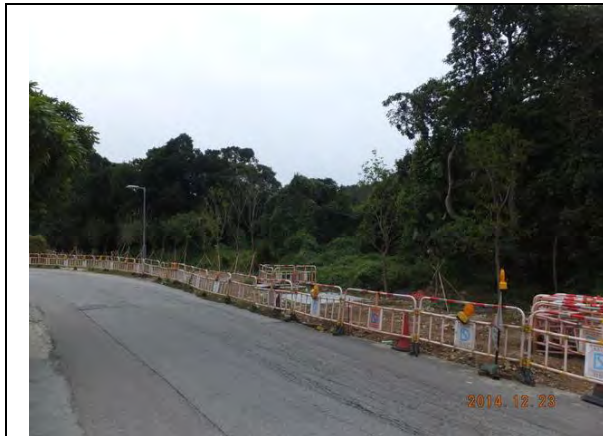
**Photo 1** – Temporary hoardings have been erected along Tung Tsz Road opposite to Wai Ha.

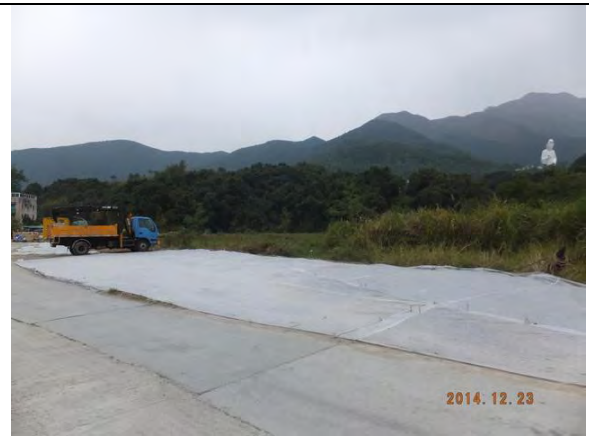
**Photo 2** – Temporary hoardings along the access road from Tung Tsz Road to Treasure Spot Garden II were removed in December 2014.

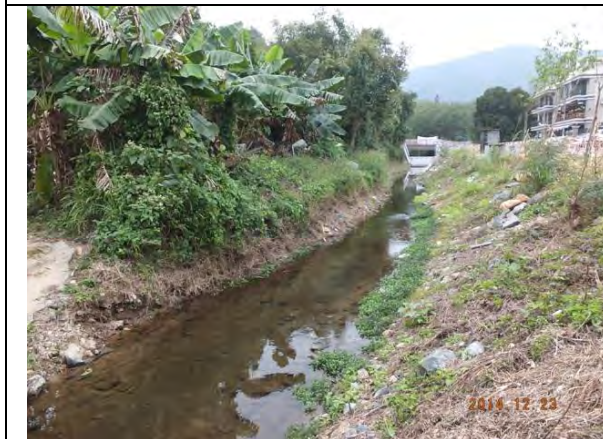
**Photo 3** – All construction works along Wai Ha River were completed.

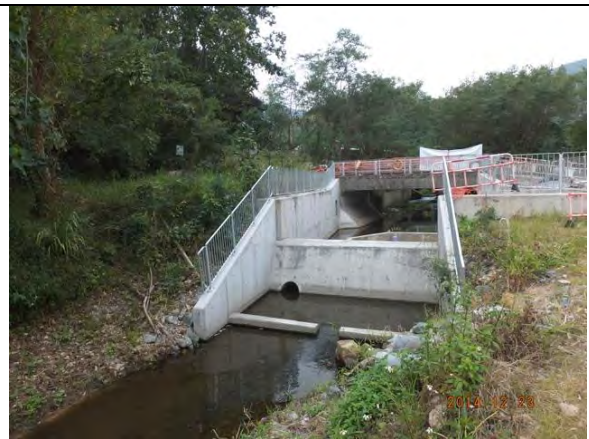
**Photo 4** – Close-up view of the built drainage structure opposite to Wai Ha.

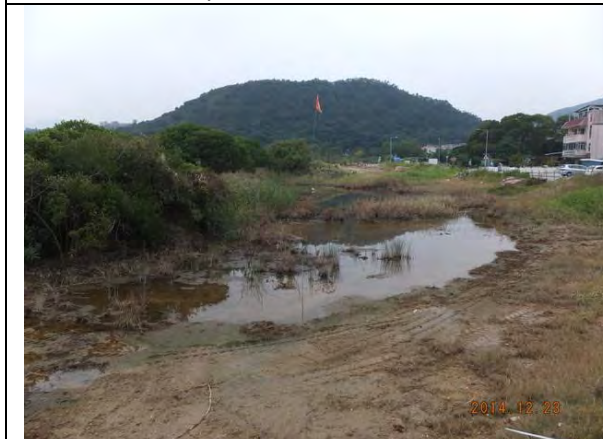
**Photo 5** – No construction work was conducted in an extensive area opposite to Treasure Spot Garden II, and the area was naturally vegetated with grass and a tidal pond was maintained.

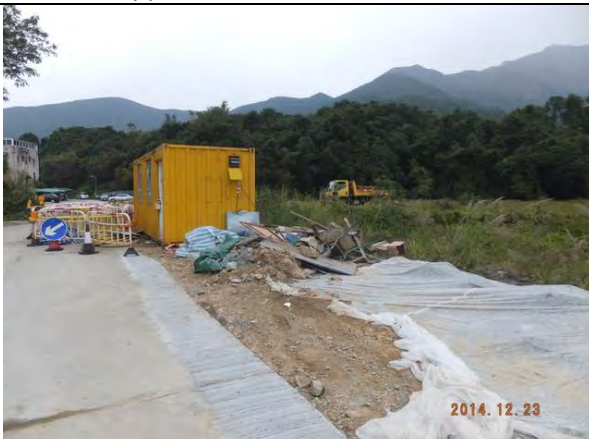
**Photo 6** – Minor civil work was continued along the access path leading from Tung Tsz Road to Treasure Spot Garden II.

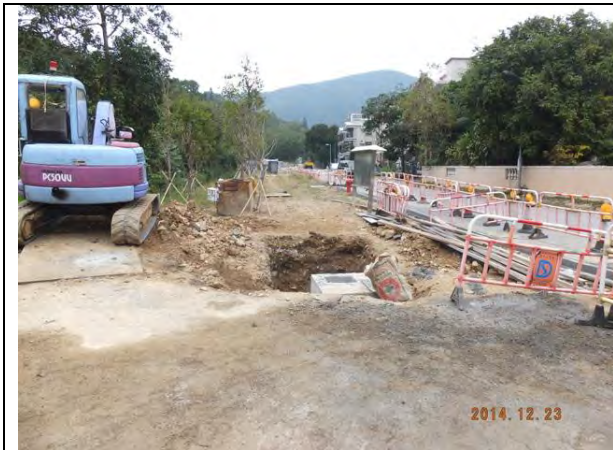
**Photo 7** – Minor civil work was conducted for building a refuse collection point opposite to Wai Ha area.

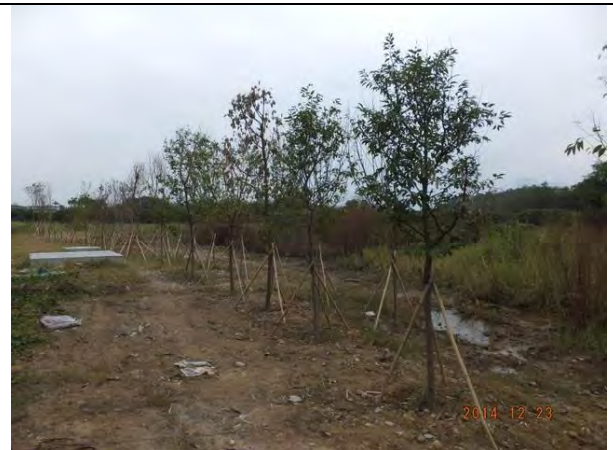
**Photo 8** – Compensatory trees were planted in area opposite to Treasure Spot Garden II.

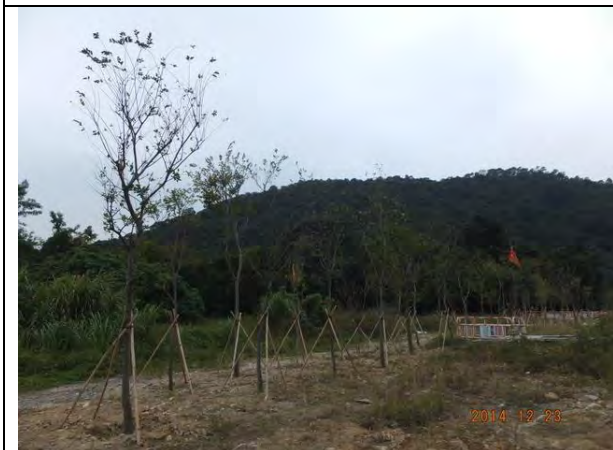
**Photo 9** – Compensatory trees were planted in area opposite to Wai Ha.

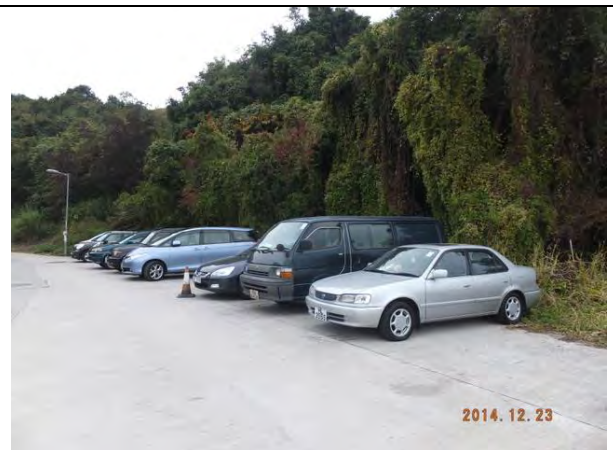
**Photo 10** – Temporary parking area has still been maintained at the end of the access path to Treasure Spot Garden Phase II.

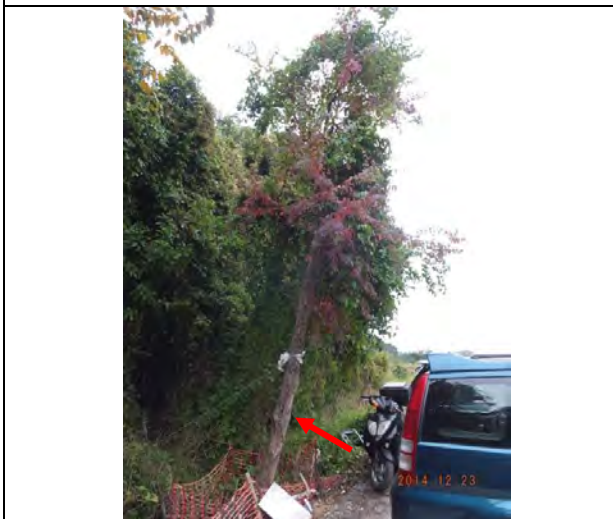
**Photo 11** – The untagged tree (indicated by Red arrow) was guyed at the edge of the parking area within a Tree Protection Zone.

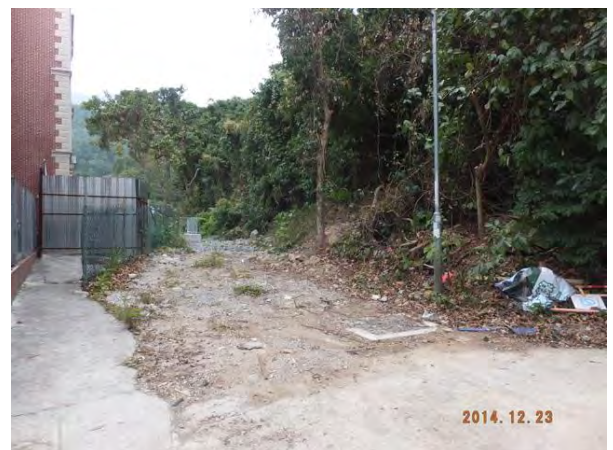
**Photo 12** – The temporary construction barriers and chain-link fence next to T103 were removed in December 2014.

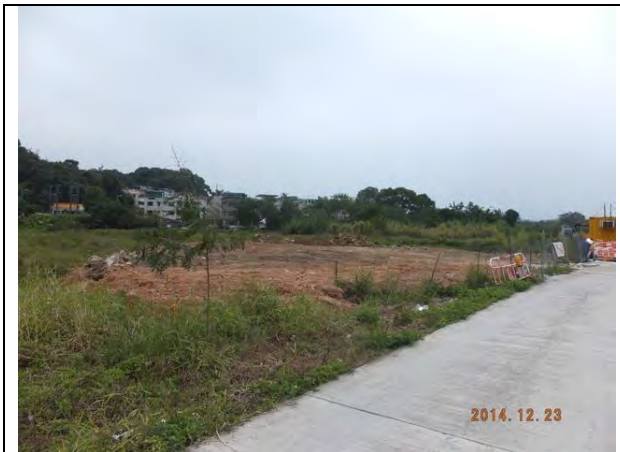
**Photo 13** – A fenced area has been seen on the field next to the construction site along the access to Treasure Spot Garden II since March 2014.

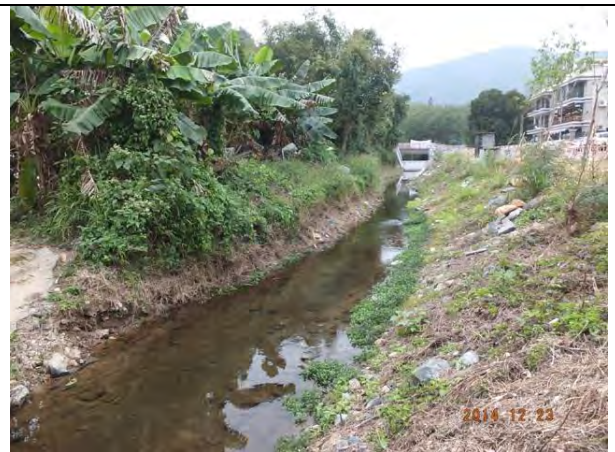
**Photo 14** - The river water was clear in the upper stream section of Wai Ha River.

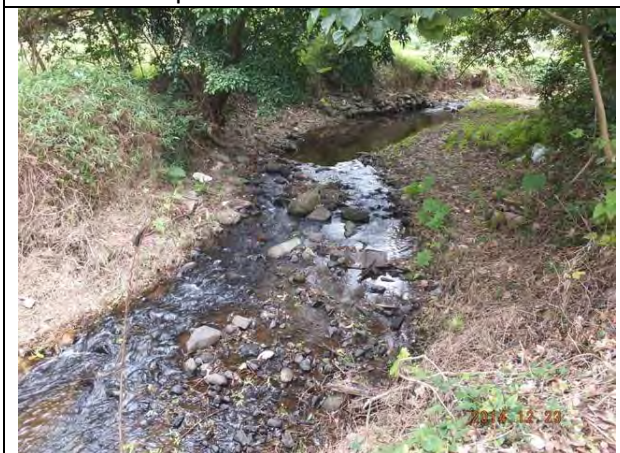
**Photo 15** – The river water along the middle section of Wai Ha River was clear.

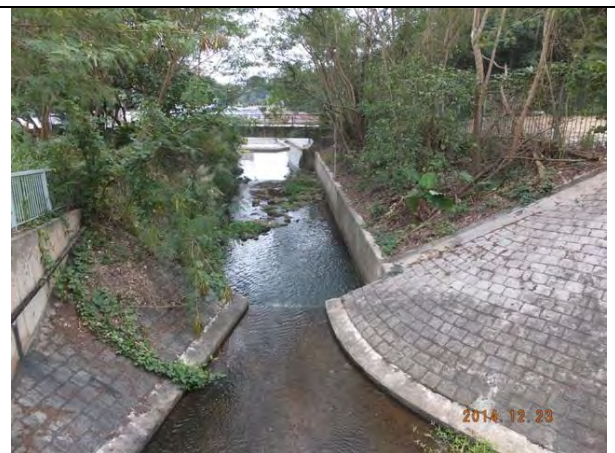
- 3.5.2 Major construction works in Contract 2 works area were completed, leaving minor civil works conducted in area near Treasure Spot Garden II and some next to Wai Ha. No used water has been released from the works area nearby Wai Ha River. The river water was clear (**Photos 14-15**). No direct water discharge into the upper stream of Wai Ha River was observed as all major construction works in Contract 2 works area have been completed (**Photo 16**).

**Photo 16** – No direct water discharge into the upper stream of Wai Ha River was observed.

- 3.5.3 For good site practice, the Contractor should prevent any contaminant and sediment from entering the sensitive water-based habitats (i.e. Shuen Wan marsh and Wai Ha River) and implement pollution control measures to minimize any adverse environmental impacts to the water body throughout the construction phase. The Contractor should maintain appropriate sedimentation beds and/or tanks throughout the construction phase. The Contractor should adopt a good site practice in maintaining appropriate sedimentation beds and filtration tanks as recommended in the above Section for Contaminant/ Sediment Control. Muddy water pumped from the works area should be filtered appropriately through sedimentation beds, or other filtration system prior to the discharge.

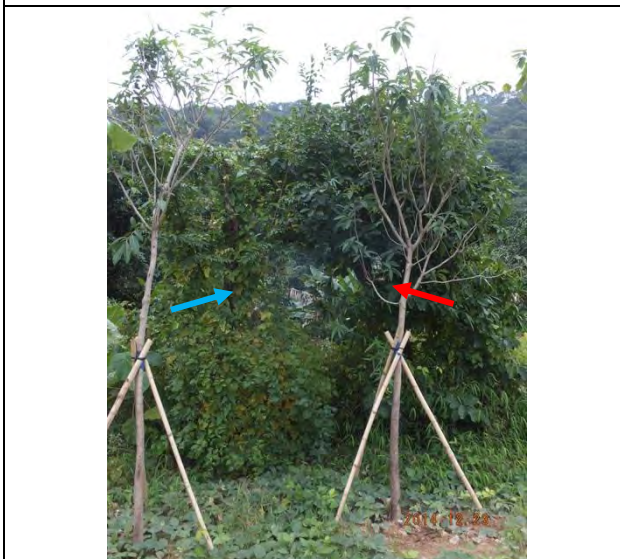
- 3.7.4 As reported in the submitted Reports, the retained trees T167 (*Litsea monopetala*) and T168 (*Celtis sinensis*) were topped after the vegetation clearance in the surrounding works area in November 2013. Both of them have been monitored since the topping incident, and both were in fairly poor health condition with vigorous development of epicormics along trunks or branches (**Photo 17**), forming the tree canopies.

**Photo 17** – Topped trees T167 (indicated by Red arrow) and T168 (indicated by Blue arrow) were in poor health condition with vigorous development of epicormics to form canopies.

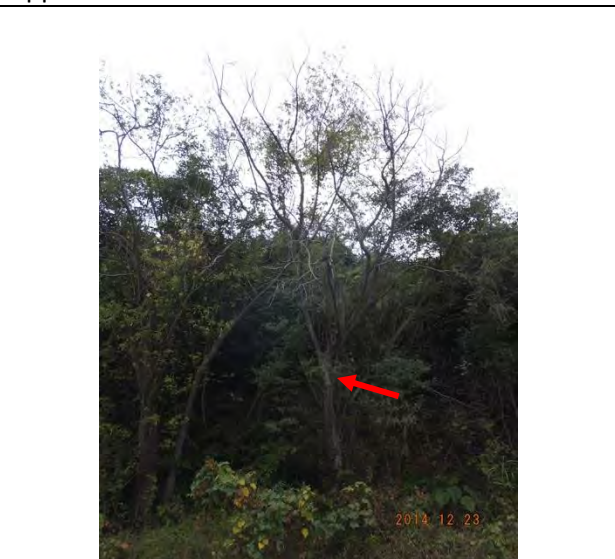
- 3.7.5 Temporary storage of construction materials close to the trunk flares of T093 and T094 (both *Litsea cubeba*) was removed in June 2014 in accordance with the recommendation listed in the submitted *Monthly EM&A Reports*. The previously discharged cement mortar on the soil has been covered by ground vegetation. The tree health of T093 has been declining since June 2014. No foliage has been observed on the main tree canopy since October 2014, and the previously developed watersprouts found on the tree trunk were dead. Cracked tree bark was noted along the tree trunk and branches of one co-dominant trunk of T093, with sign of termite infestation noted along the lower tree trunk of this co-dominant trunk (**Photos 18-19**). The Contractor has not yet removed one of the hazardous tree trunk and its canopy in December 2014. The relatively healthy co-dominant trunk of T093 pointing towards the forested area was still remained. The Contractor is advised to remove the hazardous tree trunk in January 2015.

**Photo 18** – Co-dominant trunk of T093 (indicated by Red arrow) was in poor condition, with cracked tree bark and sign of termite infestation.

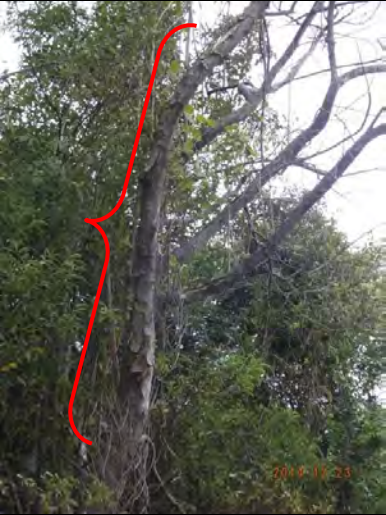
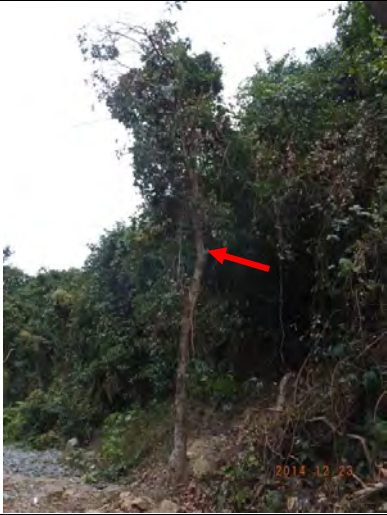
<p><b>Photo 19</b> – Close up view of the co-dominant tree trunk of T093 with cracked tree park.</p>	<p><b>Photo 20</b> – Branches (indicated by Red arrow) on the retained T103 were pruned by a third party.</p>

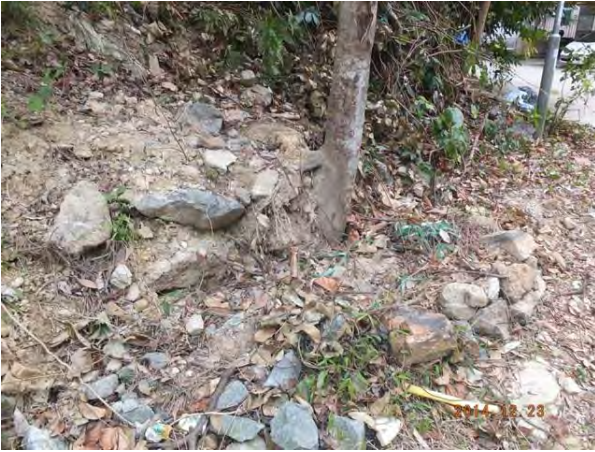
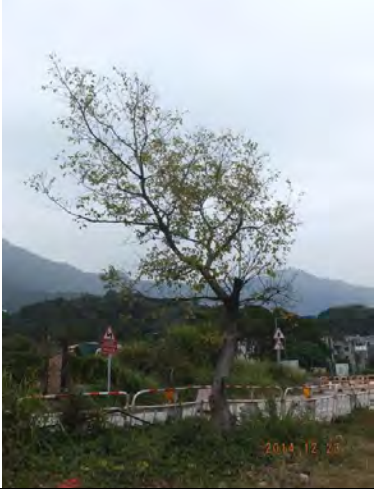
- 3.7.7 Sheet piling works were conducted within the tree root zone of a retained tree T025 (*Celtis sinensis*) in June 2013. Due to the close proximity of the erected sheet piles to the tree, root damage by previous sheet piling works was anticipated. The tree was also over-pruned in June 2013. It had been temporarily guyed by strings so as to provide additional support to the tree until September 2014. The tree was quite stable at its location and it was in fair health condition as observed in December 2014 (**Photo 22**).

<p><b>Photo 21</b> – Rocks were lined around the remaining root ball of T103.</p>	<p><b>Photo 22</b> – The guying on the retained tree T025 was removed after mid-October 2014, and the tree was in fair condition.</p>

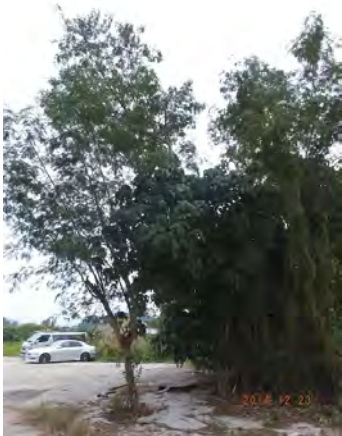
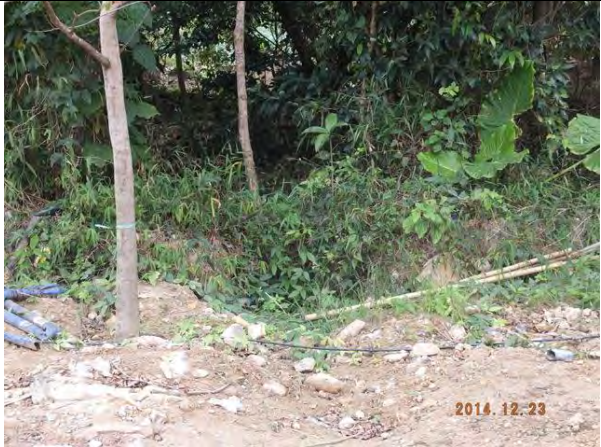
- 3.7.8 Concrete pavement, which was applied for additional parking area for the villagers, was still observed close to the root flare of the tree group T089-091, and the trees were in fair condition (**Photo 23**).

<p><b>Photo 23</b> – Concrete pavement maintained for parking area for the villagers was still observed around the tree group T089-T091.</p>	<p><b>Photo 24</b> – The soil ground surrounding T153 and T155 has been subsequently covered by herbaceous vegetation.</p>

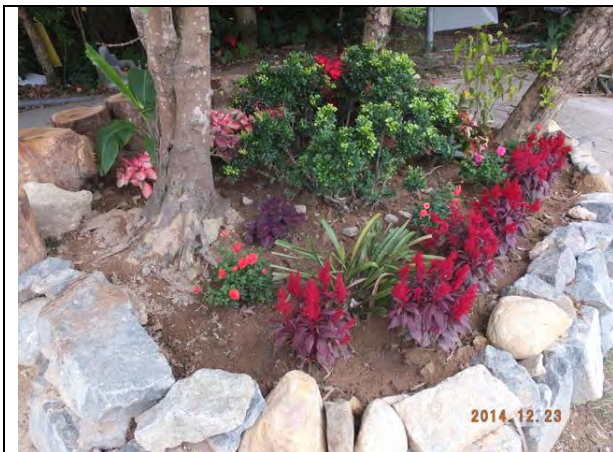
**Photo 25** – Planting of ornamental plants was noted on the raised soil ground within the tree group of T181-T183 by a third party.

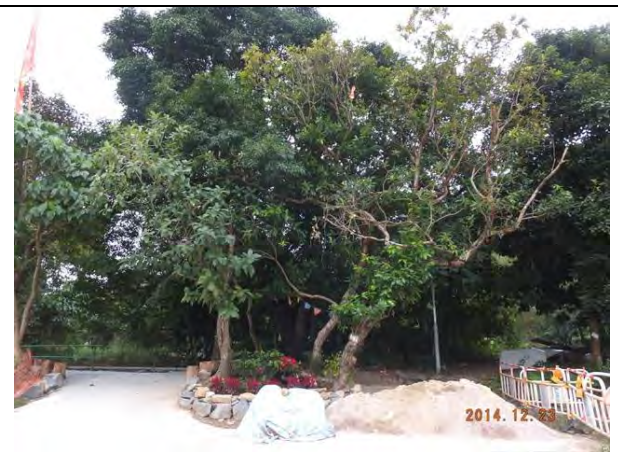
**Photo 26** – Excavation work was noted very close to the tree group T181-T183 in May 2014. These trees have been surrounded by some stones to demarcate the tree group area by the villagers.

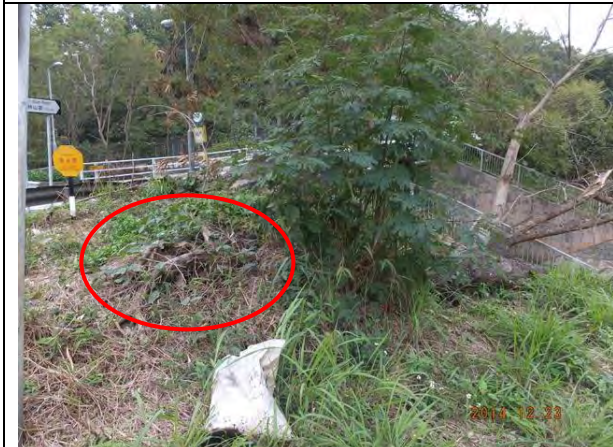
**Photo 27** – An uprooted tree trunk was noted in the tree group of T085-T087.

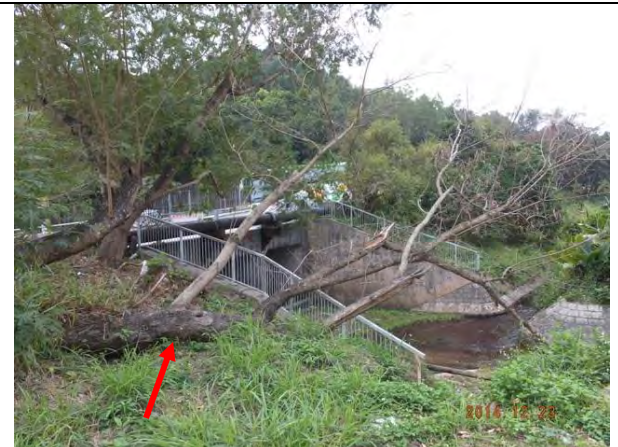
**Photo 28** – The uprooted tree trunk leaned severely towards Wai Ha River.

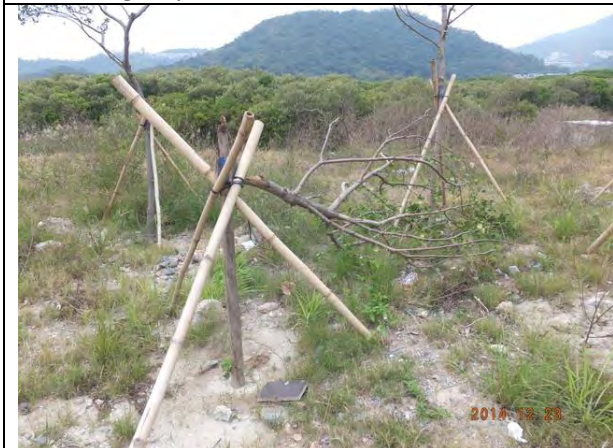
**Photo 29** – A compensatory tree with broken tree trunk was noted.

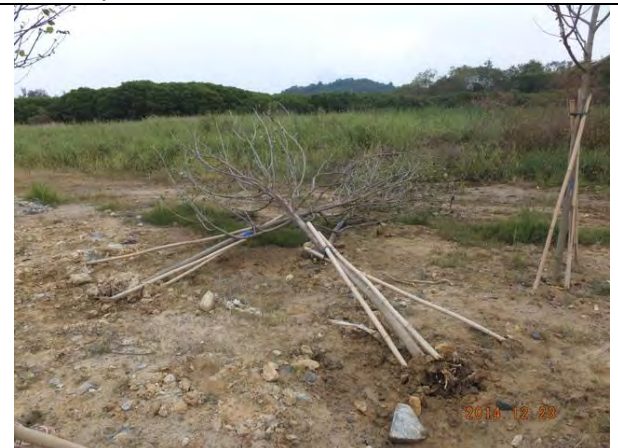
**Photo 30** – Some compensatory trees were uprooted and collapsed in an area opposite to Treasure Spot Garden II.

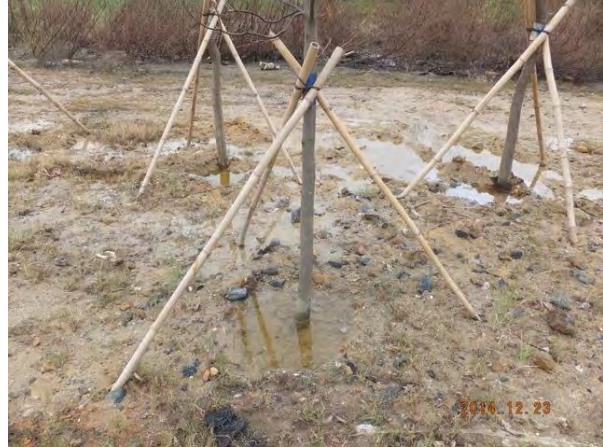
**Photo 31** – Some compensatory trees were inundated with tidal water.

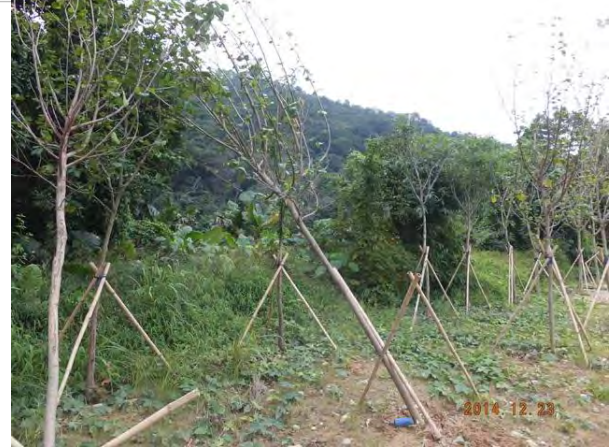
**Photo 32** – Bamboo stakes used to support the compensatory trees were not stable or noted tied appropriately.

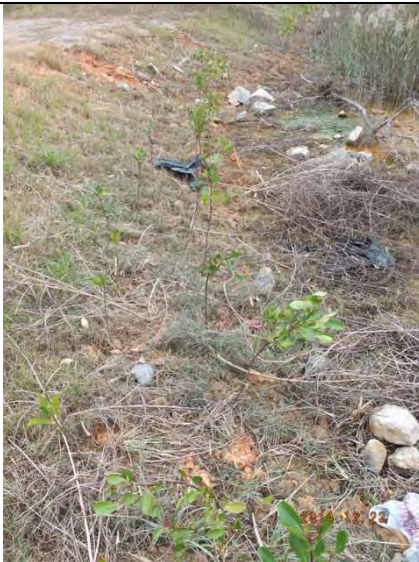
**Photo 33** – Mangroves were planted along the sloping area facing Shuen Wan Marsh.

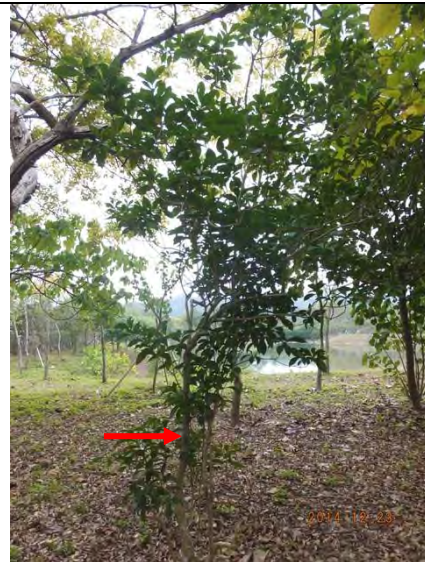
**Photo 34** – The transplanted shrub of *Pavetta hongkongensis* (PH01) in Area C under Contract 1 has remained in satisfactory condition.

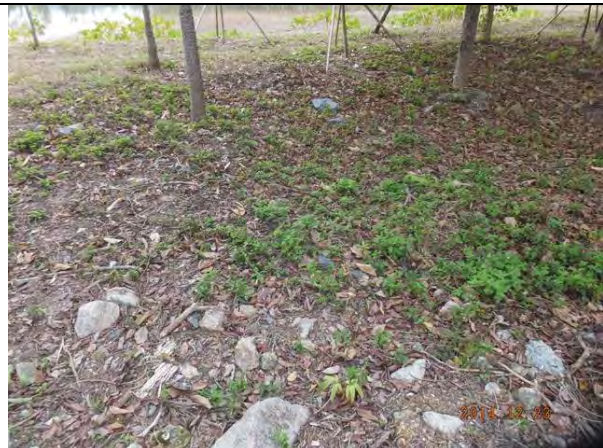
**Photo 35** – The transplanted shrub of *Pavetta hongkongensis* (PH03) was cut by the third party during the recent grass cutting work within Area C. No resprout on the cut specimen was noted.
