CONTRACT NO. DC/2009/22
DRAINAGE IMPROVEMENT WORKS IN SHUEN WAN
(OPERATION PHASE)

CONTRACT NO. DC/2010/02
DRAINAGE IMPROVEMENT WORKS IN SHUEN WAN
AND SHEK WU WAI

MONTHLY ENVIRONMENTAL MONITORING AND
AUDIT REPORT (NO.43) – JANUARY 2015

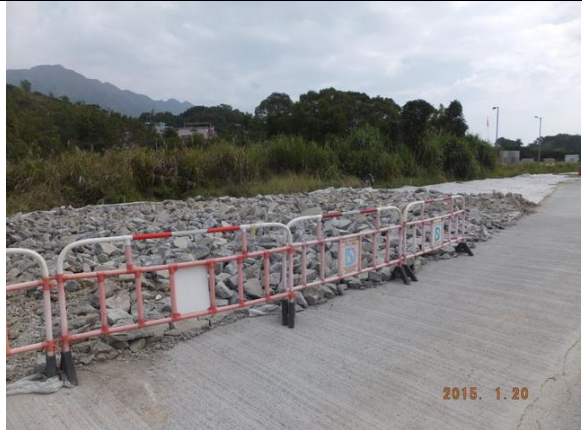
| <p>Photo 1 – Temporary hoardings were erected again along part of the access path towards Treasure Spot Garden II.</p> | <p>Photo 2 – Temporary hoardings and works areas along the access road from Tung Tsz Road to Treasure Spot Garden II.</p> |

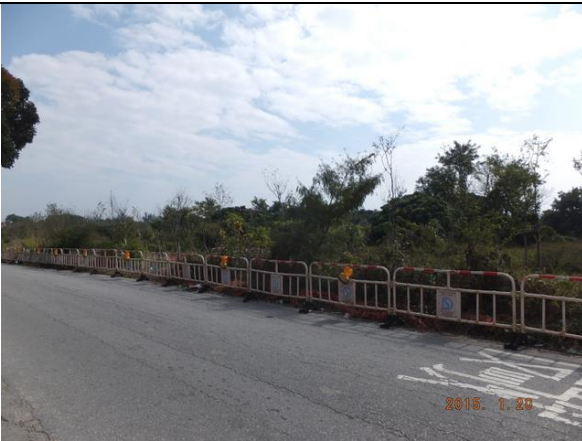
| <p>Photo 3 – Construction works areas along Tung Tsz Road opposite to Wai Ha and Treasure Spot Garden II.</p> | <p>Photo 4 – Construction works opposite to Wai Ha were already completed, leaving very minor civil work along the edge of Tung Tsz Road.</p> |

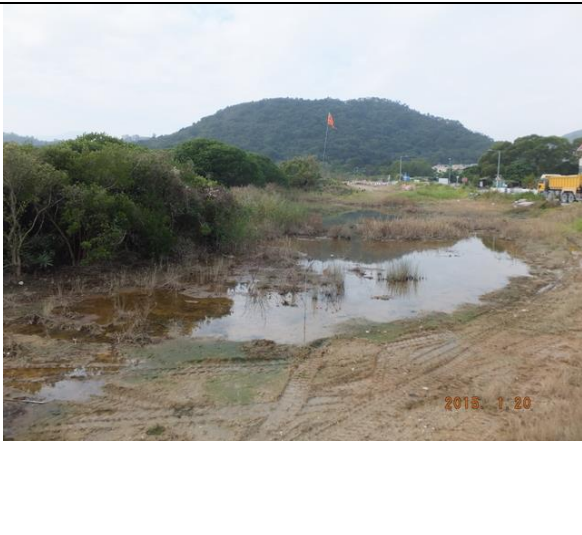
| <p>Photo 5 – No construction work was conducted in an extensive area opposite to Treasure Spot Garden II, and the area was naturally vegetated with grass and a tidal pond was maintained.</p> | <p>Photo 6 – The box culvert and the associated drainage work were completed at the upper part of Wai Ha River.</p> |

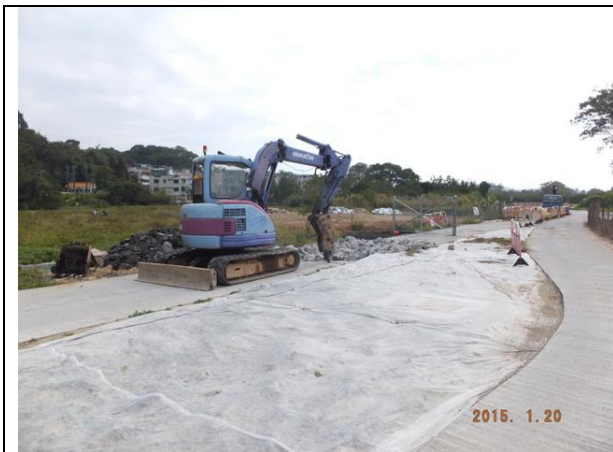
Photo 7 – Minor civil work was conducted on the temporary access road in Treasure Spot Garden II.

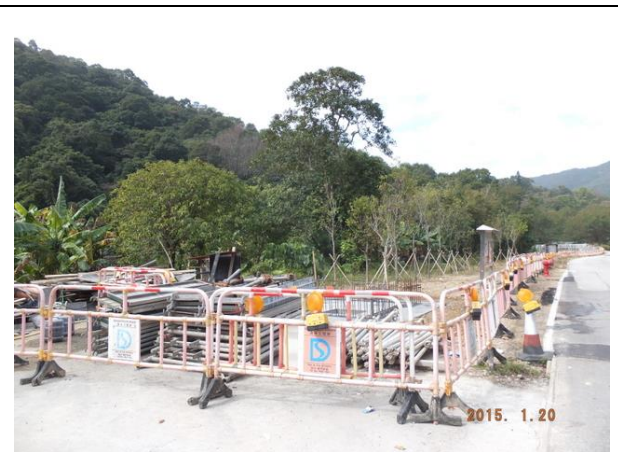
Photo 8 – Minor civil work was still carried out in the works area opposite to Wai Ha.

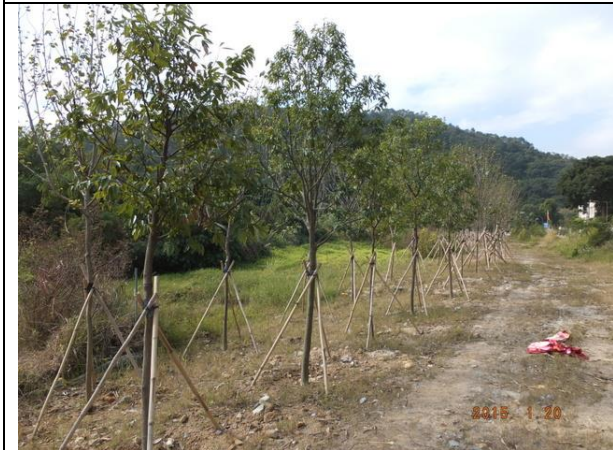
Photo 9 – Compensatory trees were planted in area opposite to Wai Ha.

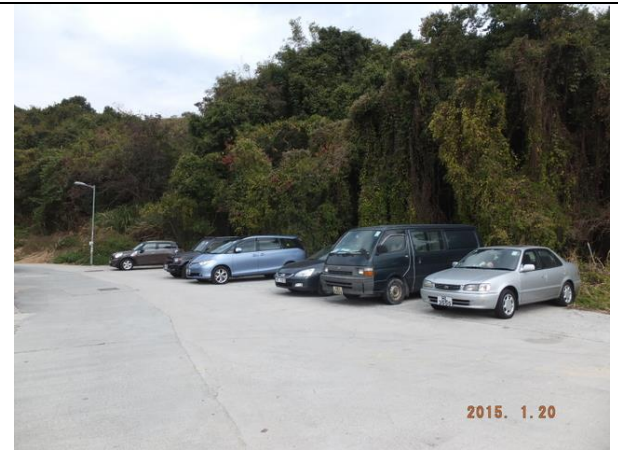
Photo 10 – Temporary parking area has still been maintained at the end of the access path to Treasure Spot Garden Phase II.

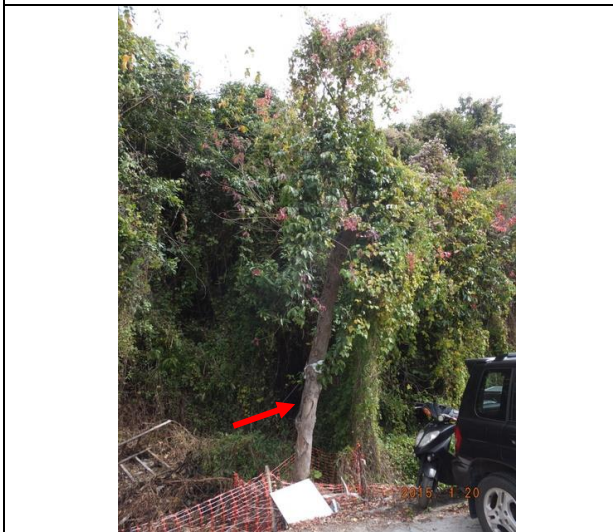
- 3.7.3 As stated in Section 3.3, a TPZ was set up with orange construction nets to protect the untagged leaning tree from the newly formed temporary parking area at Treasure Spot Garden Phase II (**Photo 11**). Rubbish disposed by the villagers was found next to this tree.

Photo 11 – The untagged tree (indicated by Red arrow) was guyed at the edge of the parking area within a Tree Protection Zone.

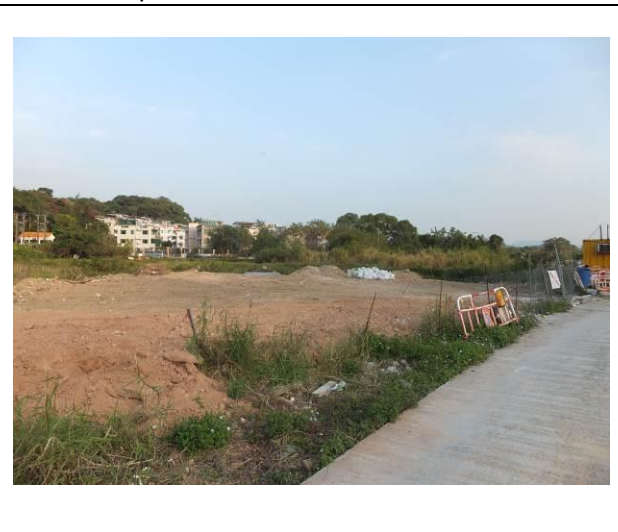
March 2014 (**Photo 12**). The area was still surrounded by chain-link fence, which was not fenced by the construction works related to the current project as reported by the Contractor.

Photo 12 – A fenced area has been seen on the field next to the construction site along the access to Treasure Spot Garden II since March 2014. This is maintained by an unknown party.

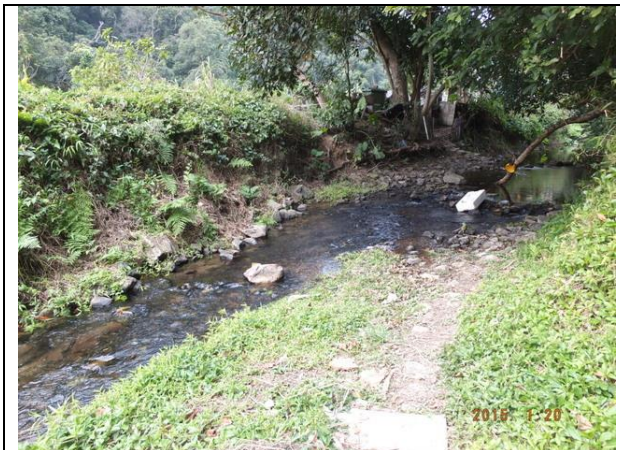
| <p>Photo 13 – The river water was clear along the middle section of Wai Ha River.</p> | <p>Photo 14 - The river water was clear in the upper stream section of Wai Ha River.</p> |

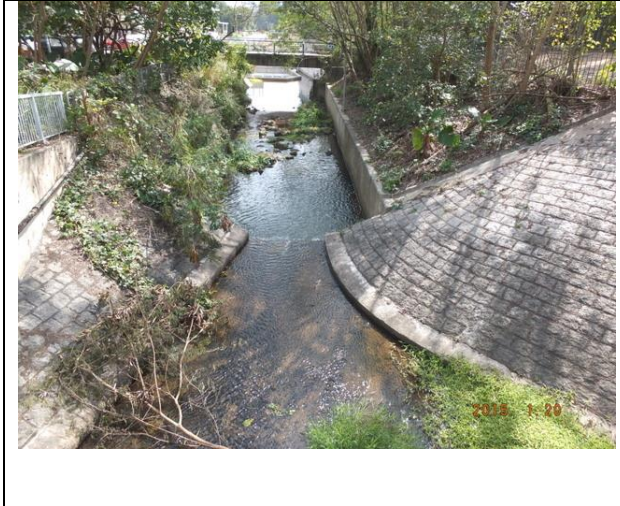
- 3.5.2 Major construction works in Contract 2 works area were completed, leaving minor civil works conducted in area near Treasure Spot Garden II and some next to Wai Ha. No used water has been released from the works area nearby Wai Ha River. The river water was clear (**Photos 13-14**). No direct water discharge into the upper stream of Wai Ha River was observed as all major construction works in Contract 2 works area have been completed (**Photo 15**).

| <p>Photo 15 – No direct water discharge into the upper stream of Wai Ha River was observed.</p> | <p>Photo 16 – Topped trees T167 (indicated by Red arrow) and T168 (indicated by Blue arrow) were in poor health condition with vigorous development of epicormics to form canopies.</p> |

- 3.5.3 For good site practice, the Contractor should prevent any contaminant and sediment from entering the sensitive water-based habitats (i.e. Shuen Wan marsh and Wai Ha River) and implement pollution control measures to minimize any adverse environmental impacts to the water body throughout the construction phase. The Contractor should maintain appropriate sedimentation beds and/or tanks throughout the construction phase. The Contractor should adopt a good site practice in maintaining appropriate sedimentation beds and filtration tanks as recommended in the above Section for Contaminant/ Sediment Control. Muddy water pumped from the works area should be filtered appropriately through sedimentation beds, or other filtration system prior to the discharge.

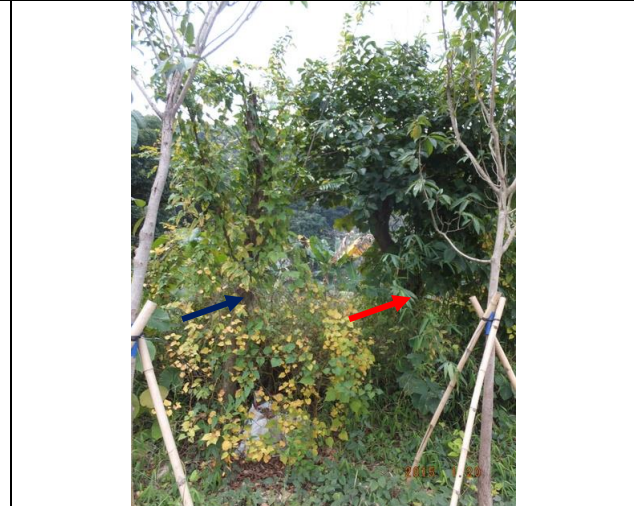
- 3.7.4 As reported in the submitted Reports, the retained trees T167 (*Litsea monopetala*) and T168 (*Celtis sinensis*) were topped after the vegetation clearance in the surrounding works area in November 2013. These trees have been monitored since the topping incident, and both were in fairly poor health condition with vigorous development of epicormics along trunks or branches (**Photo 16**) to form the tree canopies.

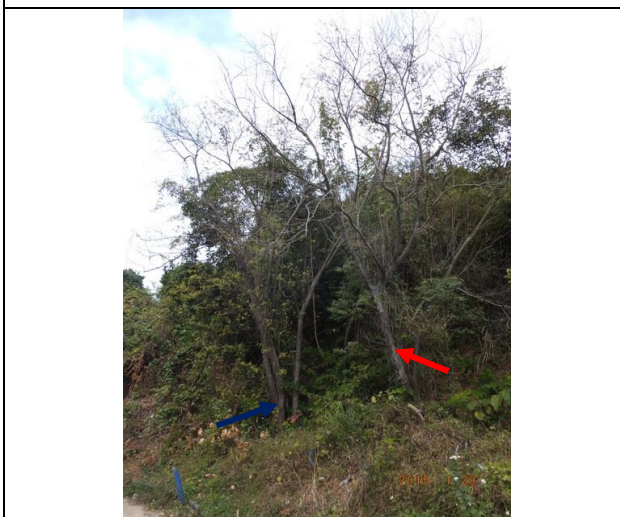
- 3.7.5 The civil works next to the two trees T093 and T094, which are located next to the access path in Treasure Spot Garden II, were completed and the construction materials were removed in the past few months (**Photo 17**). As reported before, the tree health of T093 has been declining since June 2014. No foliage has been observed on the main tree canopy since October 2014. Cracked tree bark was noted along the tree trunk and branches of one co-dominant trunk of T093, with sign of termite infestation noted along the tree trunk of this co-dominant trunk (**Photos 18-19**). The Contractor has still not yet removed one of the hazardous tree trunk and its canopy in January 2015. The relatively healthy co-dominant trunk of T093 pointing towards the forested area was still remained.

| <p>Photo 17 – The civil works next to the trees T093 (indicated by red arrow) and T094 (indicated by blue arrow) were completed in the past few months.</p> | <p>Photo 18 – Co-dominant trunk of T093 (indicated by Red arrow) was in poor condition, with cracked tree bark and sign of termite infestation.</p> |

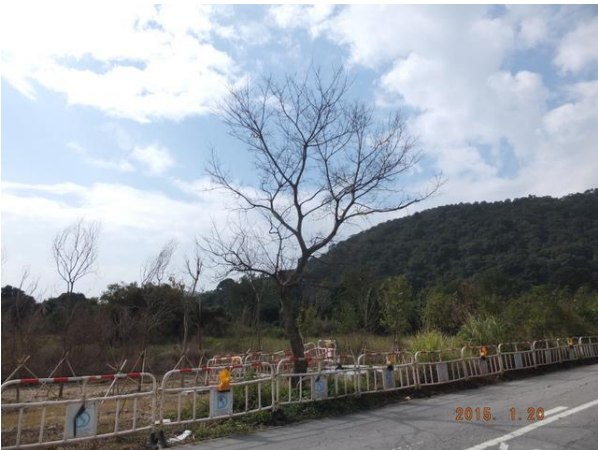
- 3.7.7 Sheet piling works were conducted within the tree root zone of a retained tree T025 (*Celtis sinensis*) in June 2013. Due to the close proximity of the erected sheet piles to the tree, root damage by previous sheet piling works was anticipated. The tree was also over-pruned in June 2013. It had been temporarily guyed by strings so as to provide additional support to the tree until September 2014. The tree was quite stable at its location and it was in fair health condition (shed in dry season since it is a deciduous tree) as observed in January 2015 (**Photo 23**).

| <p>Photo 23 – The retained tree T025 was in fair condition. It shed in the dry season as it is a deciduous tree.</p> | <p>Photo 24 – Concrete pavement maintained for parking area for the villagers was still observed around the tree group T089-T091.</p> |

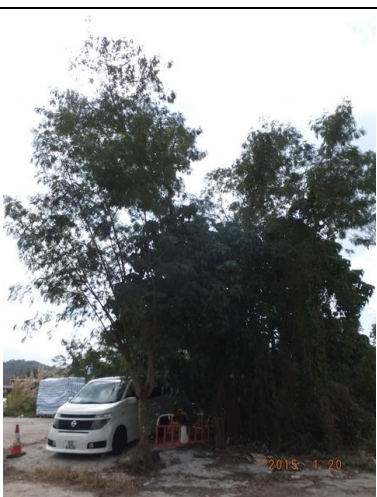
- 3.7.8 Concrete pavement, which was applied for additional parking area for the villagers, was still observed close to the root flare of the tree group T089-091, and the trees were in fair condition (**Photo 24**).

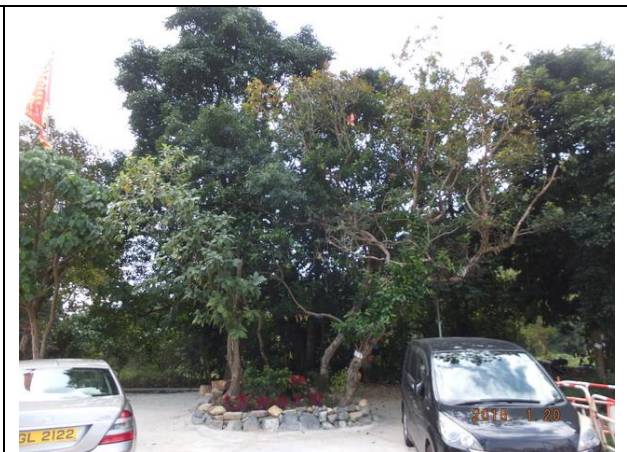
Photo 26 – Retained trees T181-T183 have been surrounded by some stones to demarcate the tree group area by the villagers.

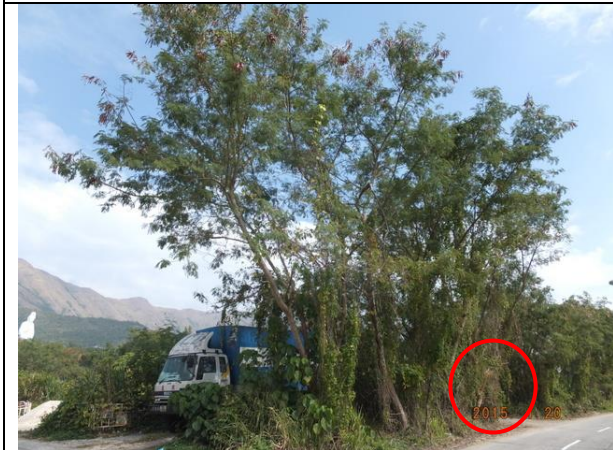
Photo 27 – Branches and trunks of a group of *Leucaena leucocephala* (indicated) along Tung Tsz Road were unskillfully pruned and cut by an unknown party.

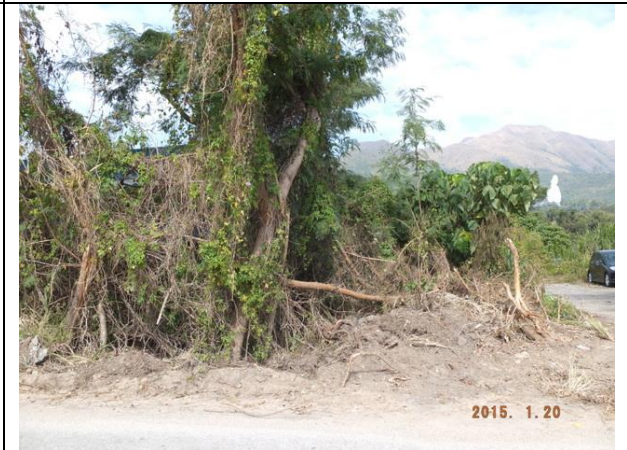
Photo 28 – Close-up view of the pruned and cut trees of the *Leucaena leucocephala* group.

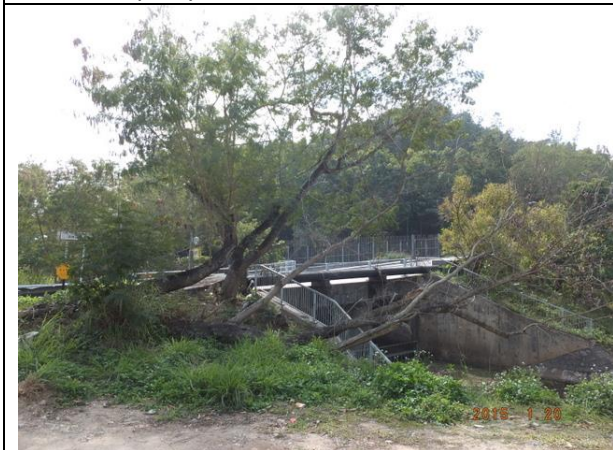
Photo 29 – The tree trunk from the tree group of T085-T087 at the junction of Tung Tsz Road and Tung Tsz Shan Road was partly uprooted and significantly leaned towards Wai Ha River.

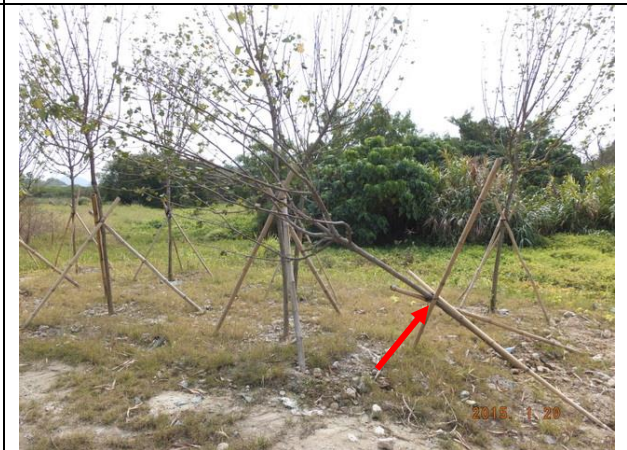
Photo 30 – A compensatory tree was uprooted.

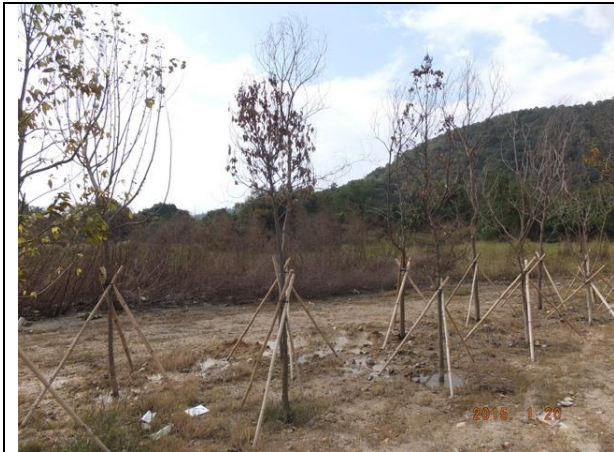
Photo 31 – Some compensatory trees were inundated with tidal water.

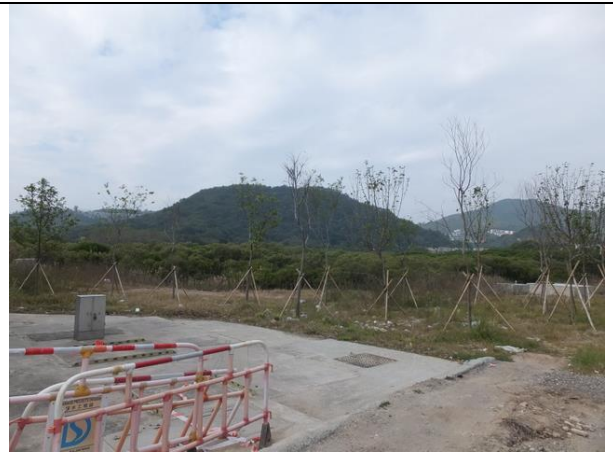
- 3.7.14 As reported in December 2014, at least 10 compensatory trees (including *Sapium sebiferum*, *Hibiscus tiliaceus* and *Cinnamomum burmannii*) were inundated with tidal water in which their root balls were still wet and muddy as inspected in January 2015 (**Photo 31**). The underground roots and overall tree health condition would be affected if the trees are inundated periodically during their establishment period. Other planted compensatory trees were in fair condition (**Photos 32-33**).

Photo 32 – General view of the compensatory trees planted opposite to San Tau Kok.

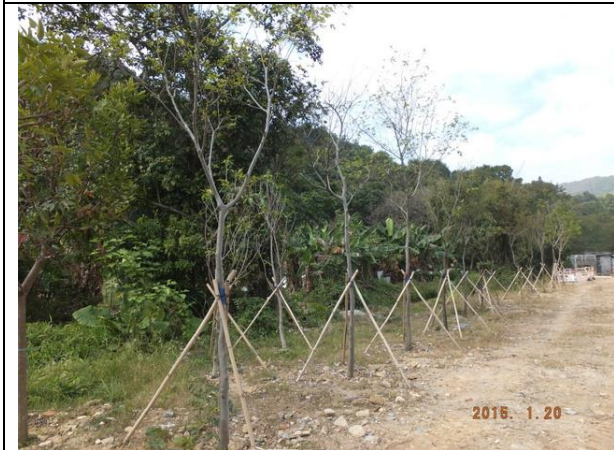
Photo 33 – Compensatory trees were planted opposite to Wai Ha area.

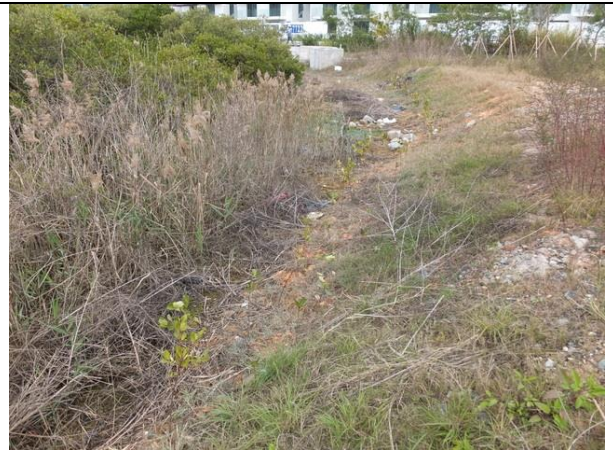
- 3.7.15 The planted mangrove seedlings of *Kandelia obovata* and *Aegiceras corniculatum* along the sloping area facing Shuen Wan Marsh were in fair condition (**Photo 34**).

Photo 34 – Mangrove seedlings were planted along the sloping area facing Shuen Wan Marsh.

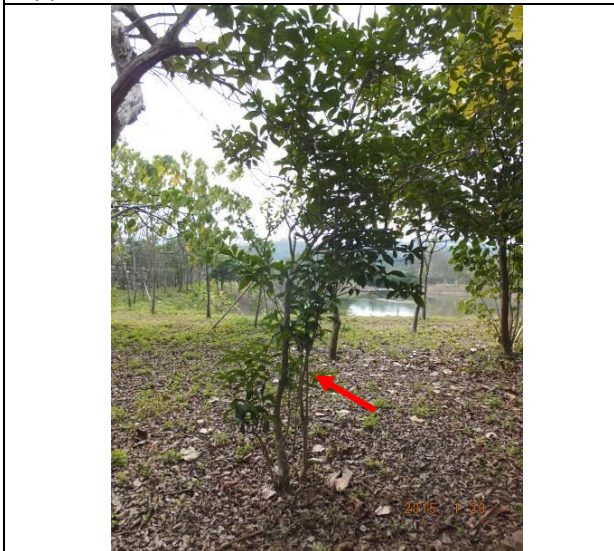
- 3.7.17 As Area C under Contract 1 of the Project has been formally handed over to AFCD for management and maintenance since October 2012, no access into the ECA is allowed. Two transplanted shrubs of *Pavetta hongkongensis* (PH-01 and PH-03) were inspected through the fence of Tung Tsz Nursery. PH01 has remained in satisfactory condition (**Photo 35**). The previously cut PH03 (cut during grass cutting by a third party who maintain the ECA) was cut again in November 2014 and no resprout was noted in January 2015 (**Photo 36**).

Photo 35 – The transplanted shrub of *Pavetta hongkongensis* (PH01) in Area C under Contract 1 has remained in satisfactory condition.

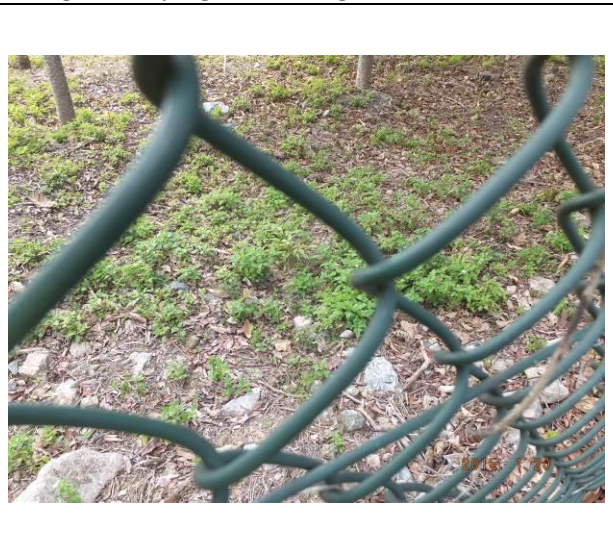
Photo 36 – The transplanted shrub of *Pavetta hongkongensis* (PH03) was cut by the third party during the recent grass cutting work within Area C. No resprout on the cut specimen was noted.

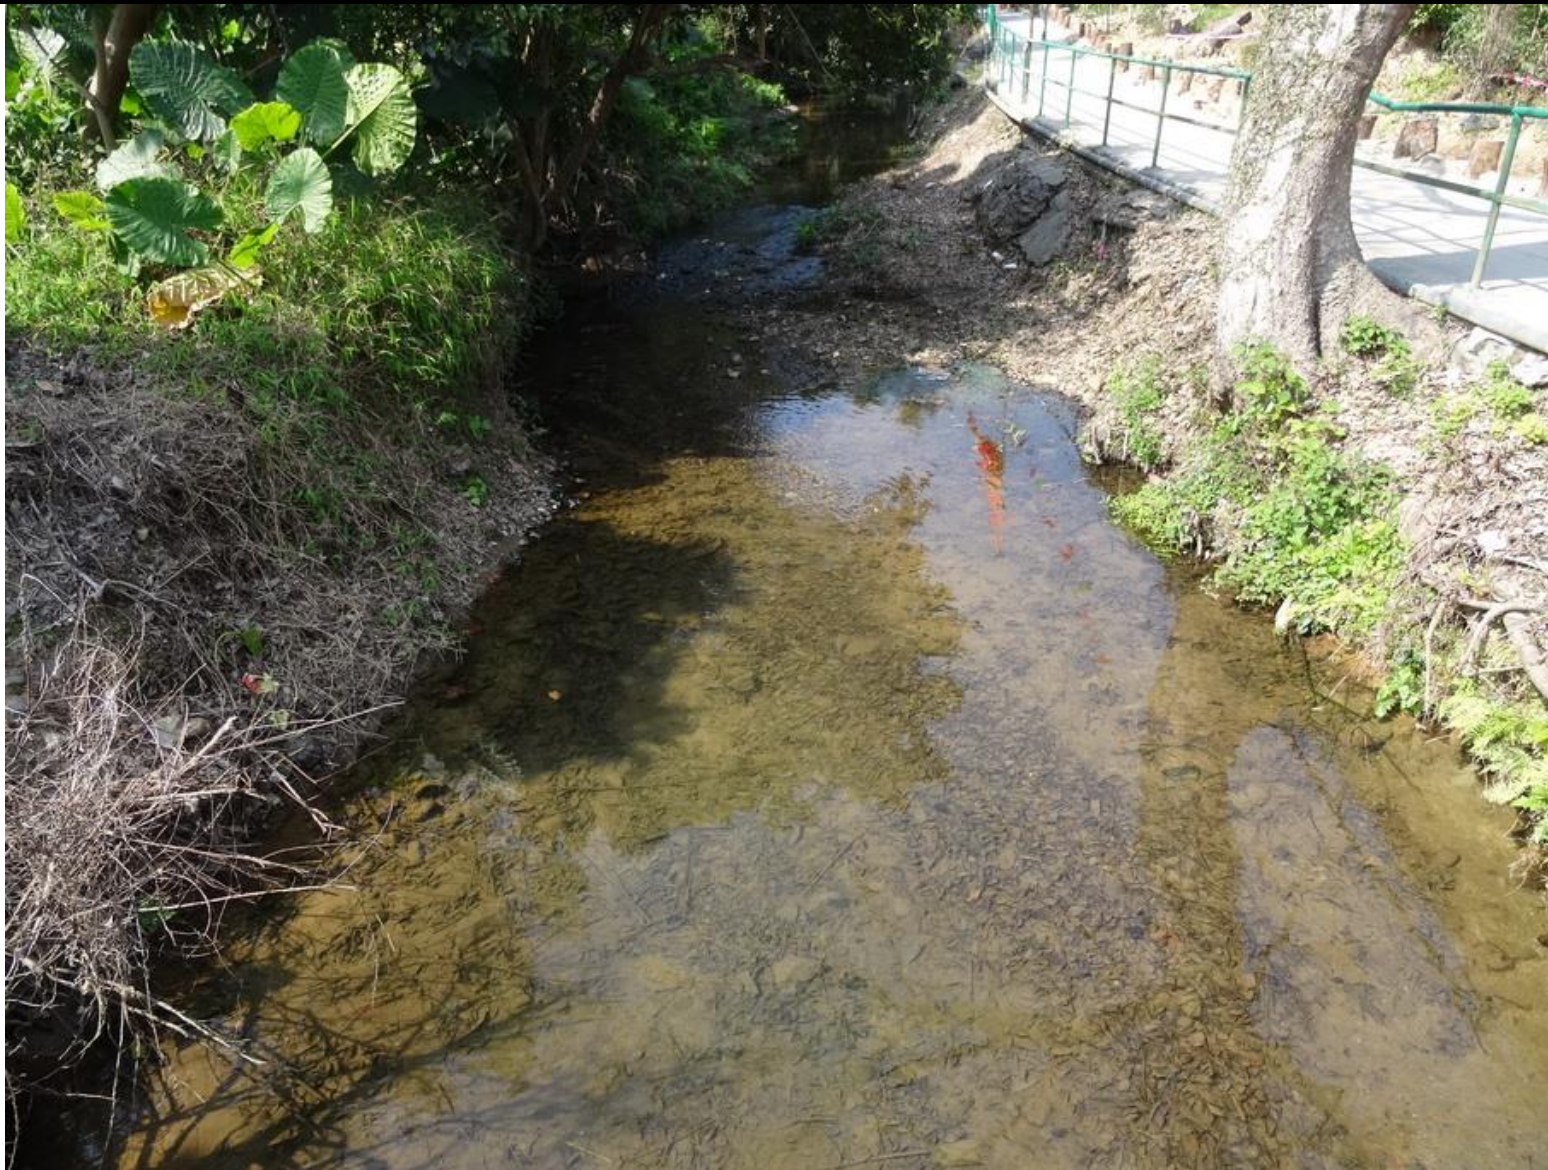
Figure: 2

Title: SEMP 3, the third sampling point of Wai Ha River under Contract 2.

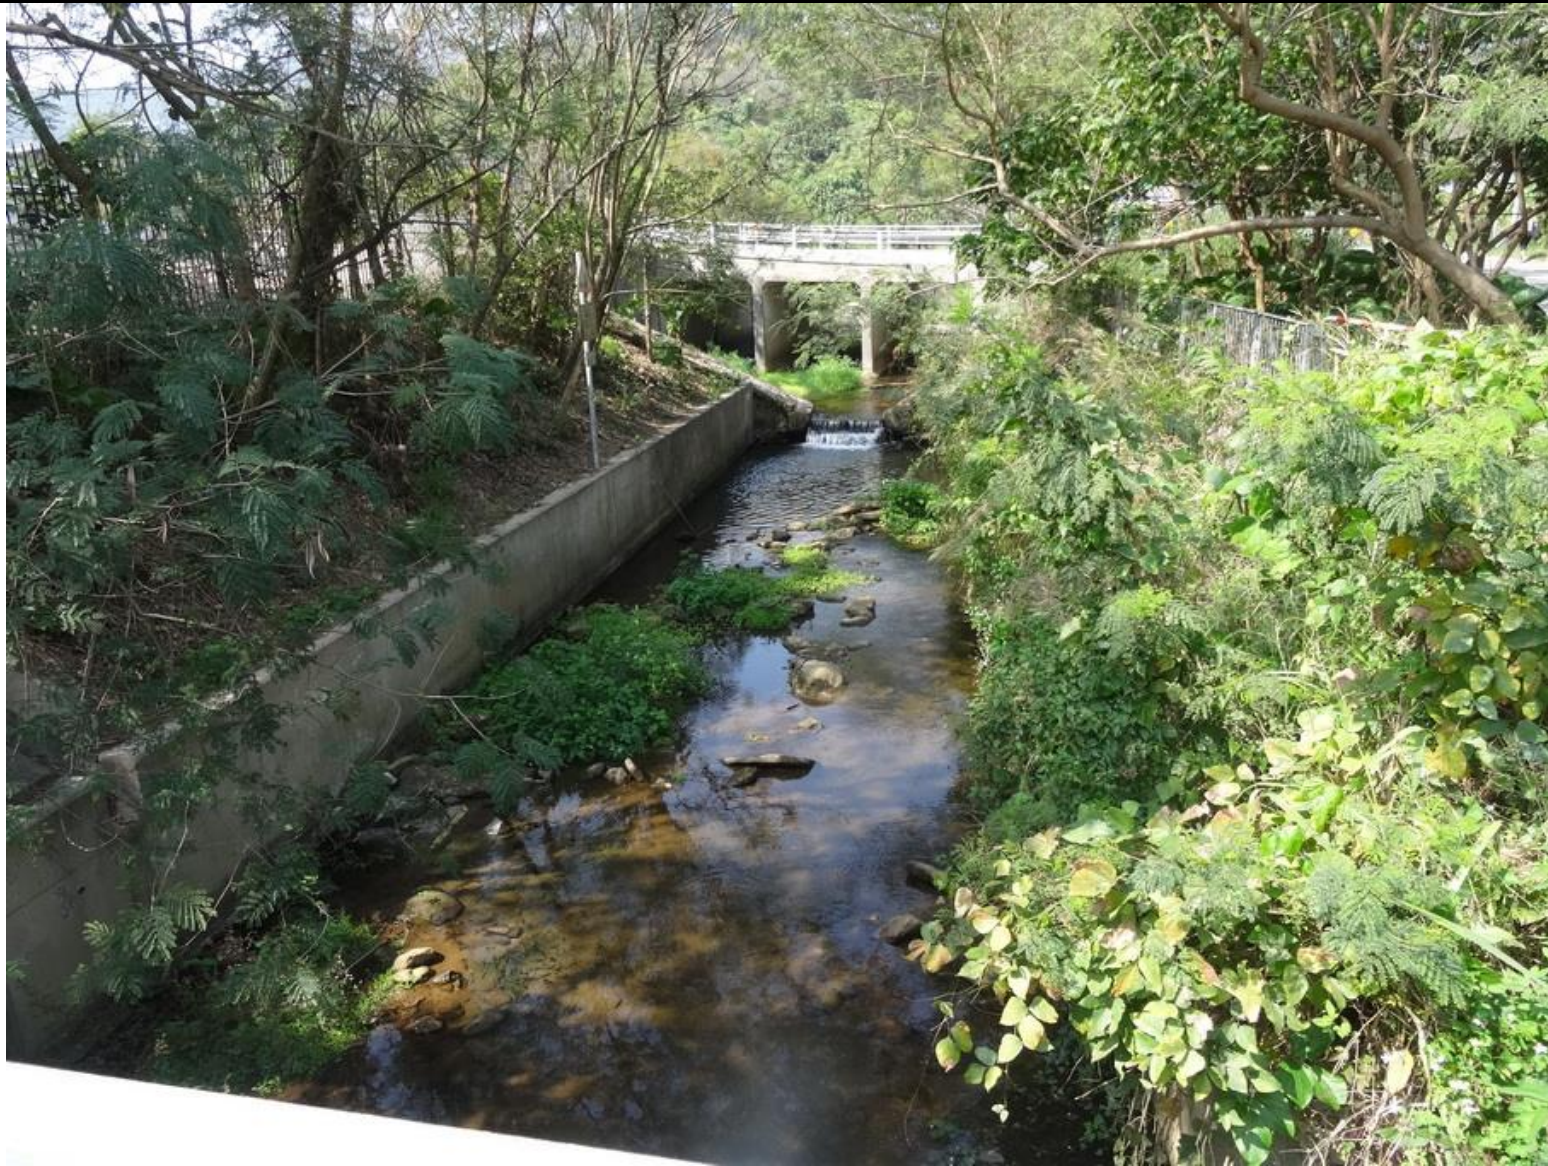
Figure: 3

Title: SEMP 4, the fourth sampling point along Wai Ha River under Contract 2.

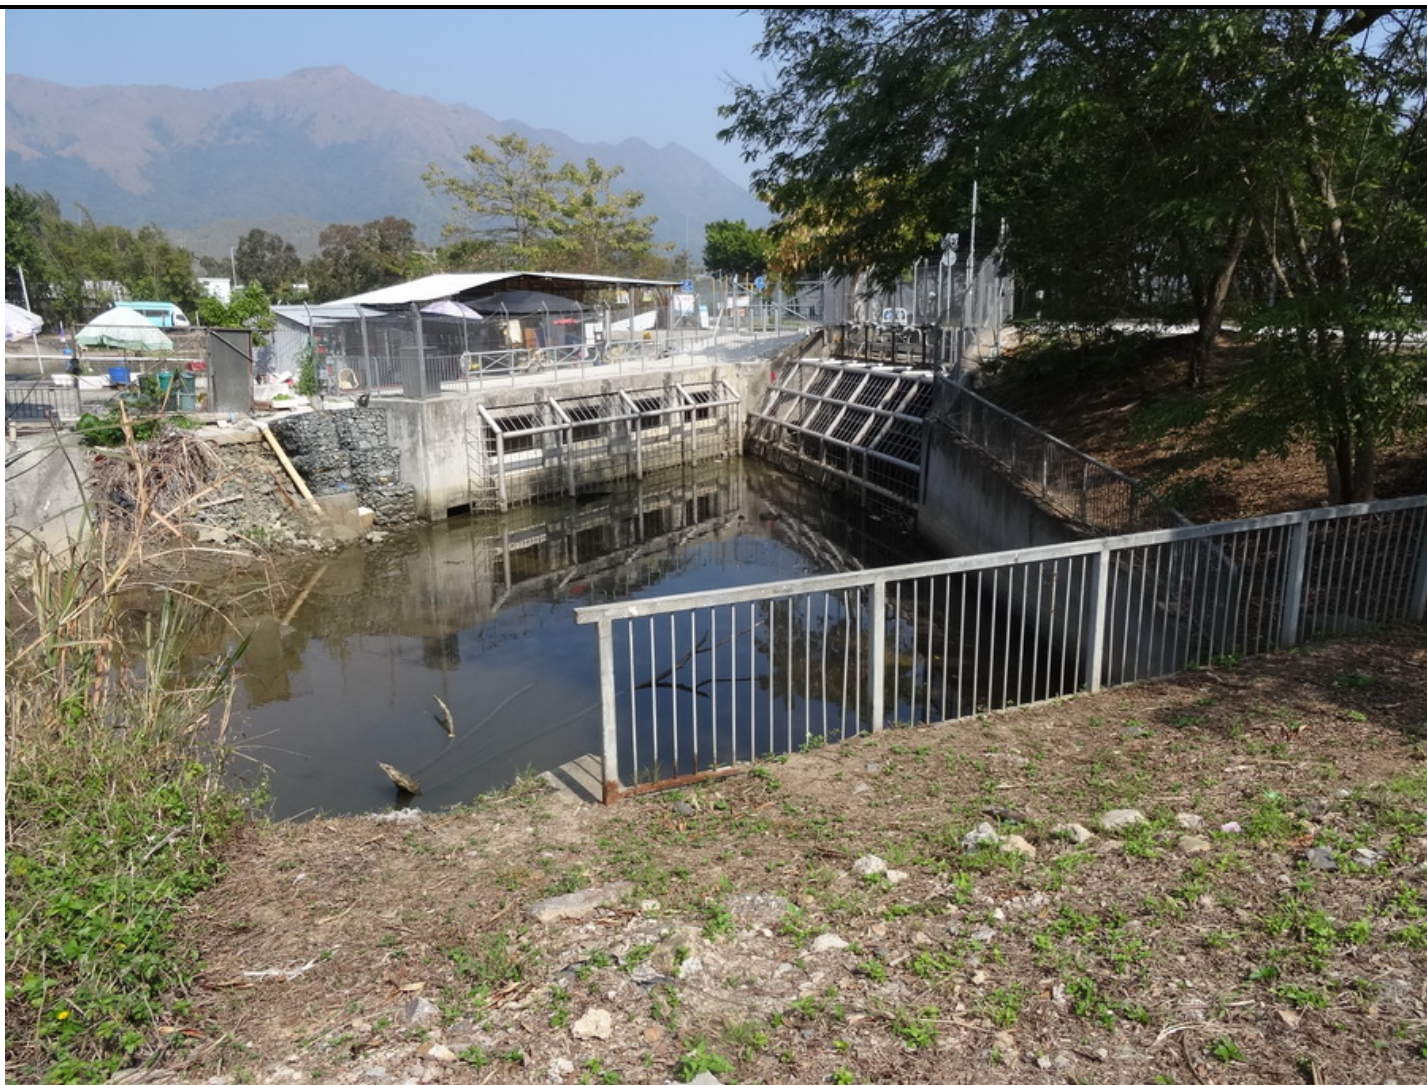
Figure: 2

Under Contract 1 (i.e. SEMP 1), a total of 8 fish species, 1 bivalve, 1 snail and 2 crustacean were recorded and most of them were residing in brackish environments (Table 4). River works in SEMP 1 was finished as showed in Figure 2. Overall, no protected or rare species were recorded.

Title: SEMP 1, the first sampling point of Wai Ha River under Contract 1.
