CONTRACT NO. DC/2009/22
DRAINAGE IMPROVEMENT WORKS IN SHUEN WAN
(OPERATION PHASE)

CONTRACT NO. DC/2010/02
DRAINAGE IMPROVEMENT WORKS IN SHUEN WAN
AND SHEK WU WAI

MONTHLY ENVIRONMENTAL MONITORING AND
AUDIT REPORT (NO.45) – MARCH 2015

PREPARED FOR
KWAN LEE-KULY JOINT VENTURE

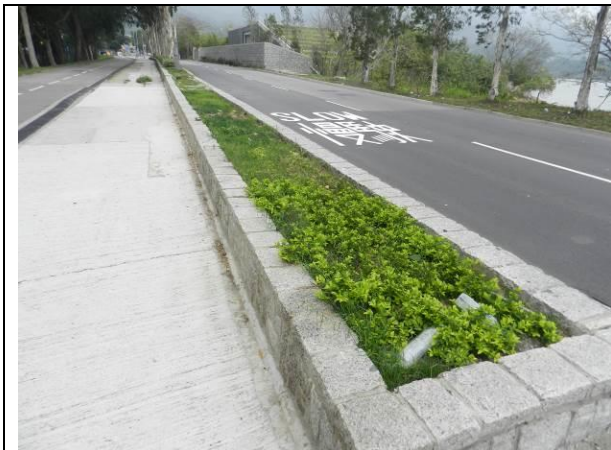
- 4.1.1 The roadside planters in Ting Kok Road were hydroseeded and planted with shrubs *Duranta erecta* which were in fair condition as observed in March 2015 (**Photo A1**).
- 4.1.2 According to EIA Report of the Project, planters with shrubs and grasses, and putting a few benches were suggested as Landscape & Visual Mitigation Measure (i.e. OM-01) along Ting Kok Road. However, with reference to the approved Landscape Plan of this Project, provision of benches along Ting Kok Road was not included in accordance with the engineering design. Thus only the record of reinstated planters and the monitoring of shrubs and grass along Ting Kok Road were adopted under this mitigation measure.

Photo A1 – Planters at Ting Kok Road were hydroseeded and planted with shrubs.

- 4.1.3 The roadside planters in Ting Kok Road were handed over to Highway Department and under maintenance by the corresponding party. No further recommendation on the growth performance of these planters is given from the current observation.

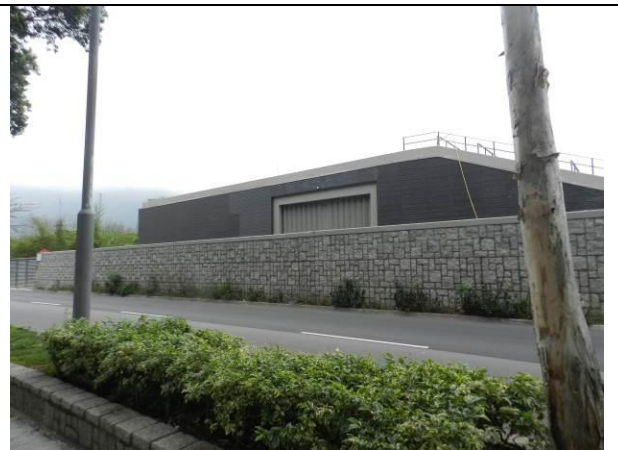
Photo A2 – General appearance of the pump house in Area A.

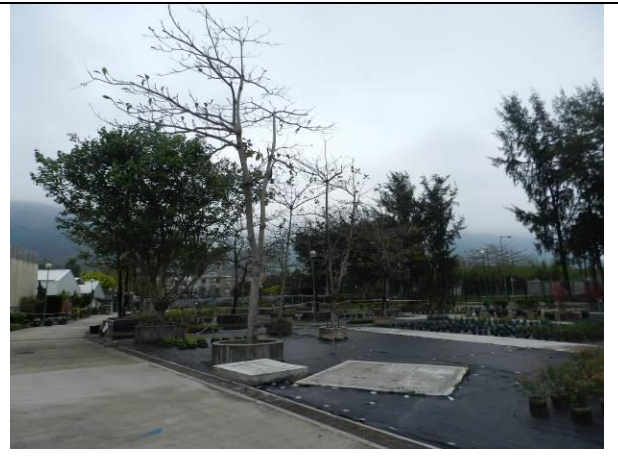
4.5.1 Transplantation of trees was finished during the early construction phase of Contract 1 (**Photo A4**). The health performance of these transplanted trees had been regularly monitored and reported during the construction phase. Any trees of poor performance were reported to the Contractor and replaced accordingly. Area B was handed over to Tung Tze Nursery after the construction phase, and the transplanted trees were under the maintenance of the Nursery Operator.

4.5.2 Some of the locations of the transplanted trees were different from those proposed in the approved Landscape Plan. Moreover, as reported during the construction phase, gap was observed between the root balls of some transplanted trees and the inner surface of their newly built planters. However, these trees were accepted by the Nursery Operator.

Photo A4 – Example of transplanted trees in Area B.

4.5.6 Area B was handed over to Tung Tze Nursery which will provide routine maintenance of these transplanted trees. No further recommendation is given under this mitigation measures.

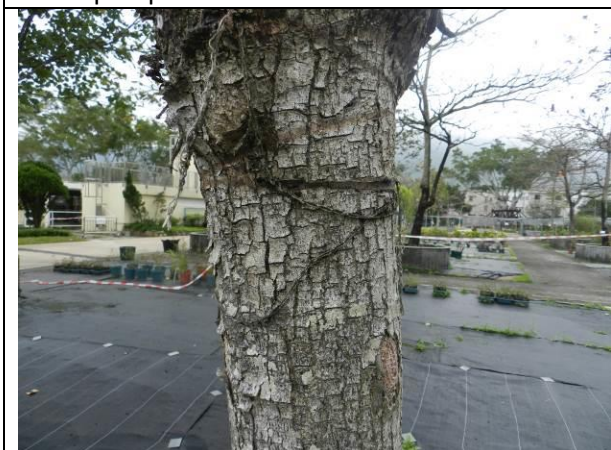
4.5.3 The nylon cables or hessian wrapping tied on tree trunks were removed as observed in March 2015 (**Photo A5**).

Photo A5 – The nylon cables or hessian wrapping previously tied on tree trunks were removed.

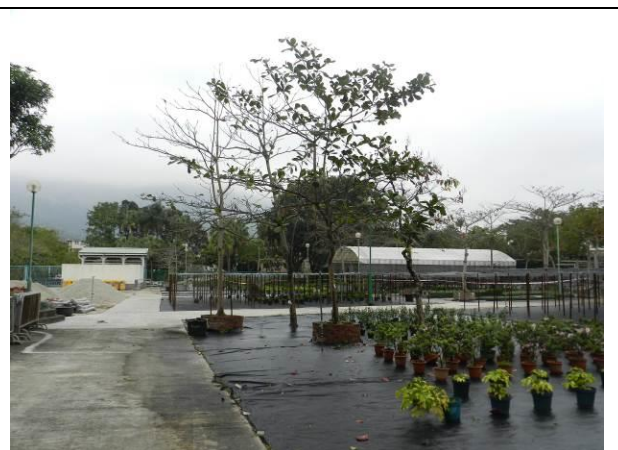
- 4.7.1 The reinstatement works for the original access paths, ground of the nursery beds, basic nursery utility (such as irrigation pipes and lamp posts), shelters for potted plants, planters for transplanting trees, and wire mesh fences within the nursery were finished in Area B as observed in March 2015 (**Photo A6**). The planters along Ting Kok Road were also reinstated (**Photo A1**).

Photo A6 – Example of the completed reinstatement works within the nursery (such as lamp posts, shelters for potted plants and new planters for the transplanted tree).

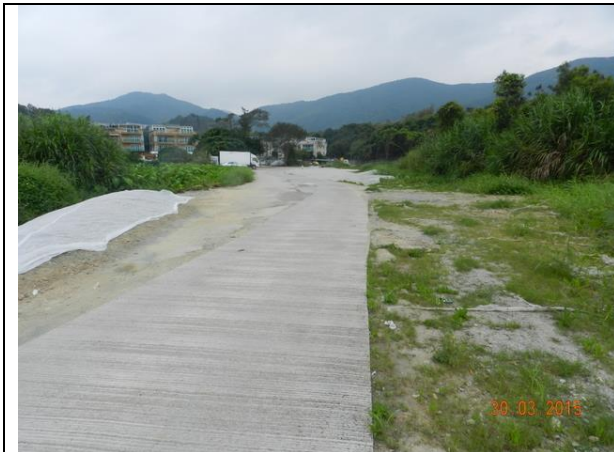
Photo B1 – Temporary hoardings along the access path towards Treasure Spot Garden II were removed.

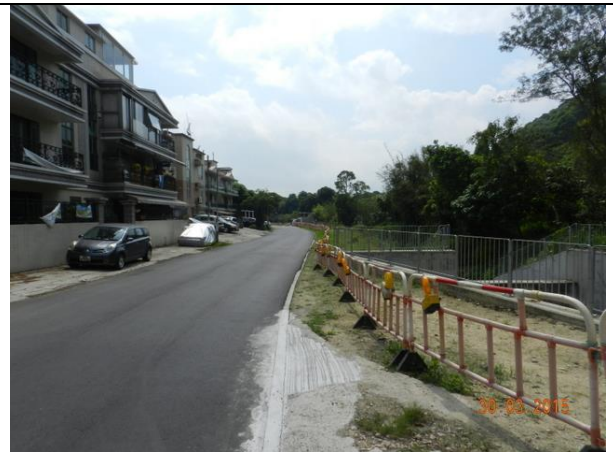
Photo B2 – Temporary hoardings erected along Tung Tsz Road and opposite to Wai Ha.

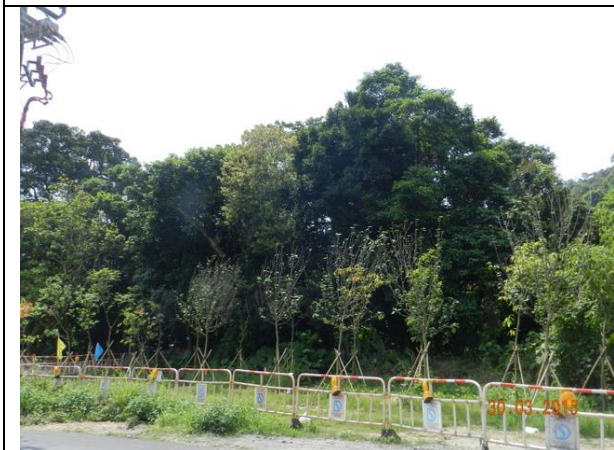
Photo B3 – Temporary hoardings erected opposite to Wai Ha.

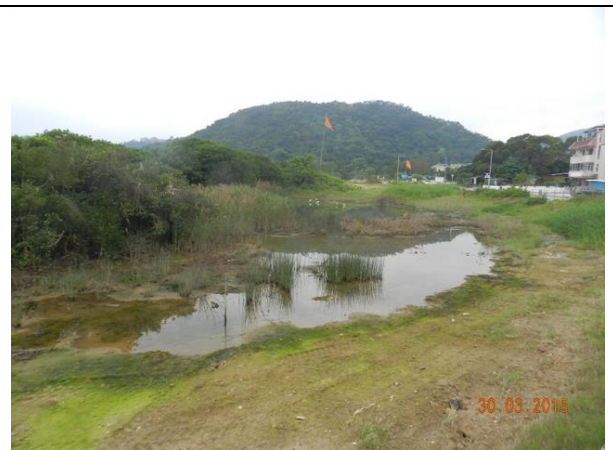
- 5.1.3 All construction works for building the box culverts in the works areas along Tung Tsz Road opposite to Wai Ha and San Tau Kok, and next to Wai Ha River were completed in March 2015 (**Photos B4-B6**). The civil works noted along the path leading from Tung Tsz Road to Treasure Spot Garden II, as well as those opposite to Wai Ha area were completed as observed on 30th March 2015 (**Photos B7-B8**). Compensatory trees were planted in October 2014 and have been maintained by the landscape contractor (**Photos B9-B10**).

Photo B4 – Construction works opposite to San Tau Kok was already completed and fully vegetated.

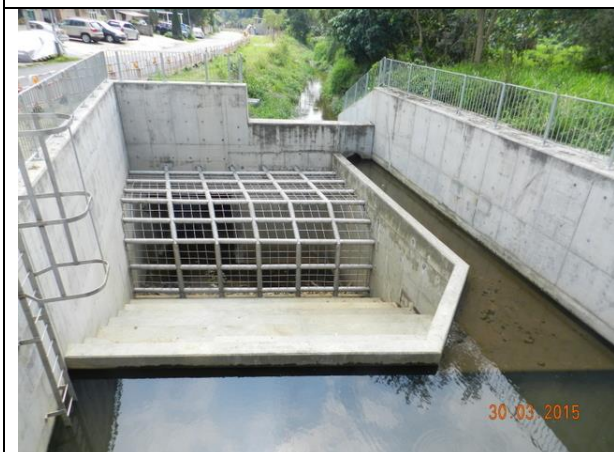
Photo B5 –The box culvert and the associated drainage work were completed at the upper part of Wai Ha River.

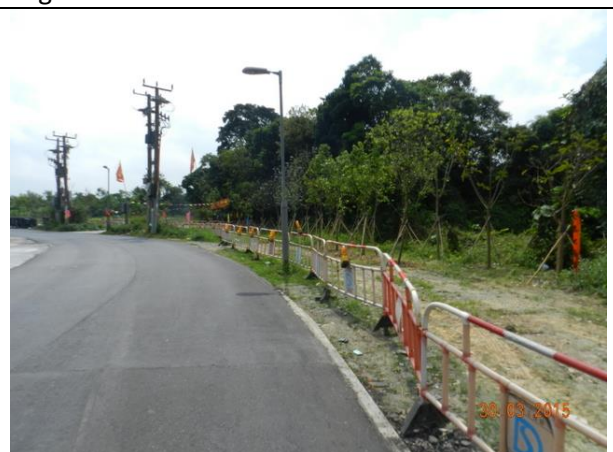
Photo B6 – Construction work opposite to Wai Ha area was already completed.

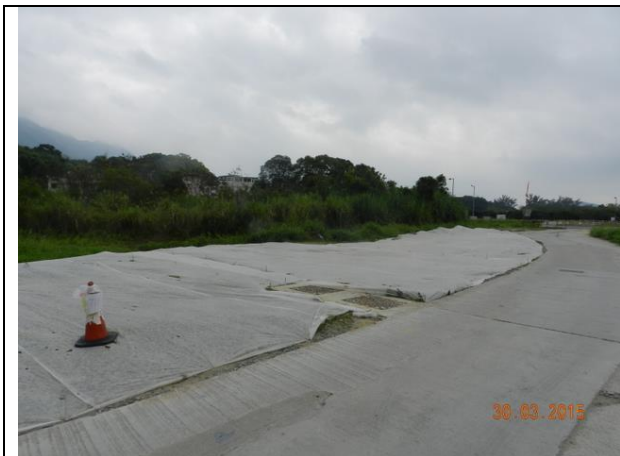
Photo B7 – The work along the access road in Treasure Spot Garden II was completed and the area was hydroseeded.

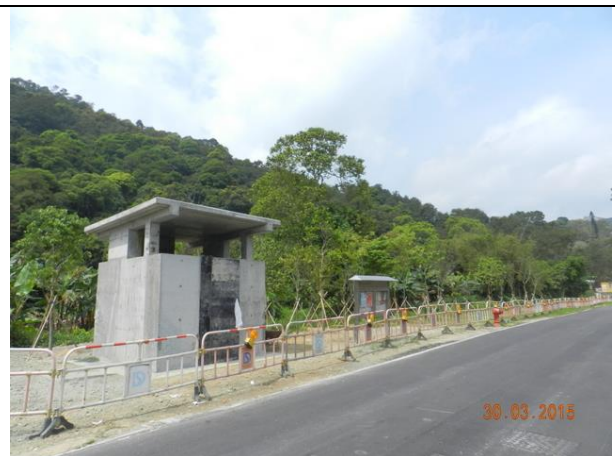
Photo B8 – The minor civil work opposite to Wai Ha area was completed by end of March 2015.

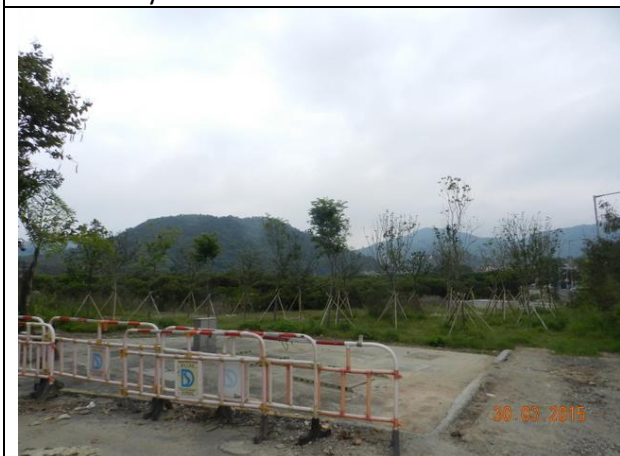
Photo B9 – Compensatory trees were planted in area opposite to San Tau Kok.

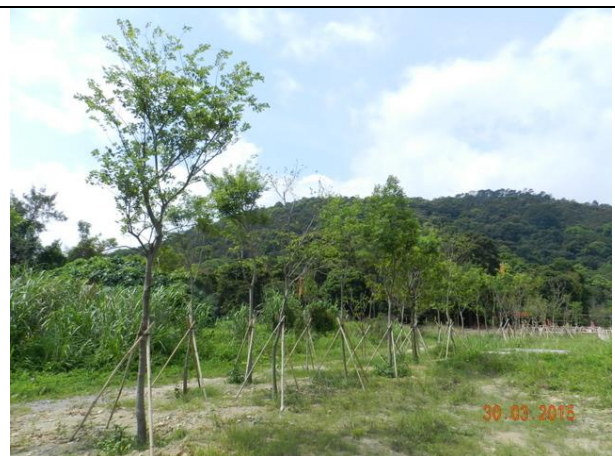
Photo B10 – Compensatory trees were planted opposite to Wai Ha area.

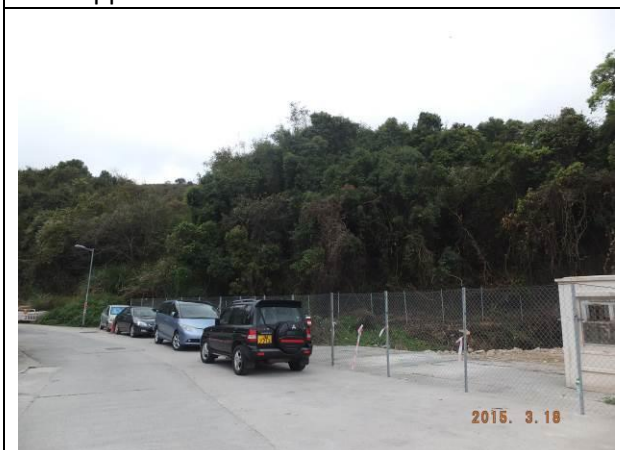
- 5.1.4 The temporary parking area which had been maintained at the end of the access path to Treasure Spot Garden Phase II was abandoned by the villagers since part of the parking area was demarcated with wire mesh fences by the villagers (**Photo B11**). The untagged leaning tree, which was located just outside the Project Site, was found being removed by an unknown party within the fenced area (**Photo B12**).

Photo B11 – The parking area in Treasure Spot Garden II was abandoned by the villagers and demarcated with wire mesh fence by the villagers.

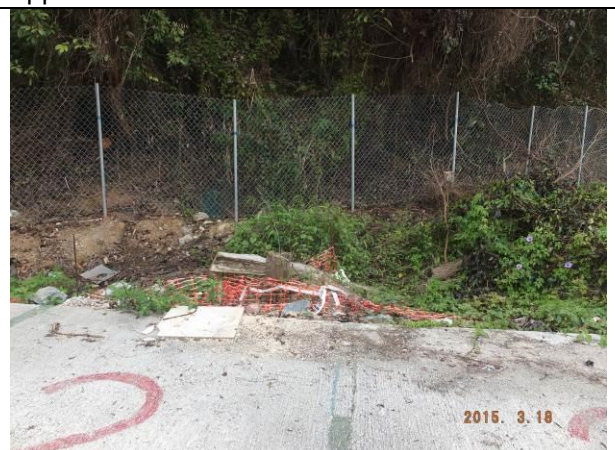
Photo B12 – The untagged tree isolated within the fenced area was found being removed by an unknown party on 18th March 2015.

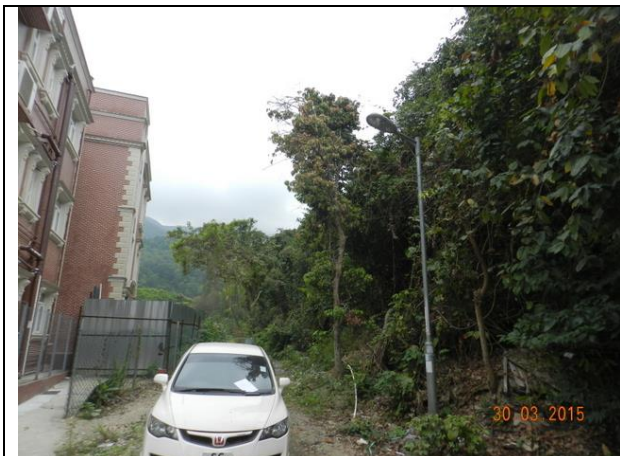
Photo B13 – Construction work at the end of the access path in Treasure Spot Garden II was finished. The works area was parked with villagers’ cars.

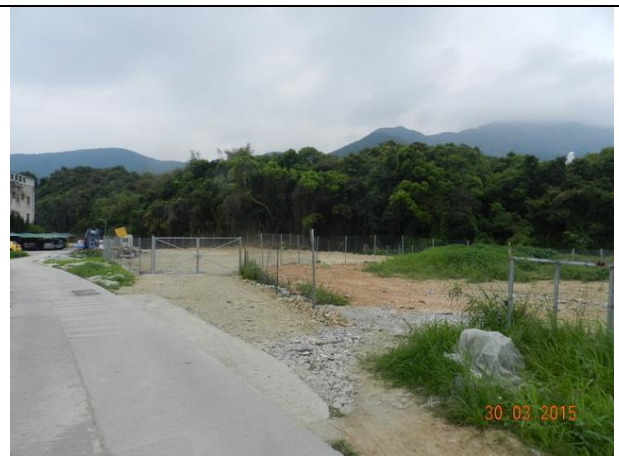
Photo B14 - A fenced area, which was erected by the villagers, has been recorded next to the works area of this Project.

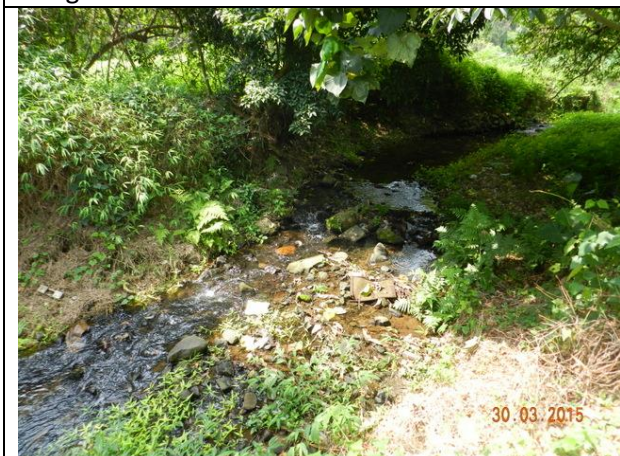
- 5.2.2 As observed on 30th March 2015, all construction works in Contract 2 works area were completed. No used water was released from the works area next to Wai Ha River was observed in March 2015. The river water was clear (**Photos B15-B16**).

Photo B15 – No used water was released from the works area to Wai Ha River and the lower section of Wai Ha River was clear.

- 5.2.3 For good site practice, the Contractor is suggested to conduct regular checking to ensure no direct discharge or leakage of contaminants or any polluted fluid into the adjacent Wai Ha River and the nearby Shuen Wan marsh. The Contractor should maintain regular check (e.g. daily) on the sedimentation and filtration facilities and appropriate sedimentation beds and/or tanks (e.g. check the function of the sedimentation beds and remove surplus sand and gravels deposited along the beds or within the tanks) to make sure all discharged water was filtered appropriately prior to any discharge.

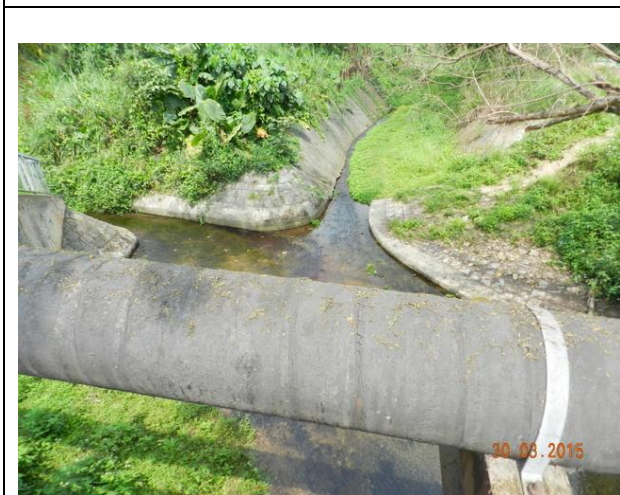
- 5.3.2 As observed on 30th March 2015, all construction works in Contract 2 works area were completed. No used water has been released from the works area nearby Wai Ha River. The river water was clear (**Photos B15-B16**). No direct water discharge into the upper stream of Wai Ha River was observed as all construction works in Contract 2 works area have been completed (**Photo B17**).

Photo B17 – The river water was clear at the upper section of Wai Ha River.

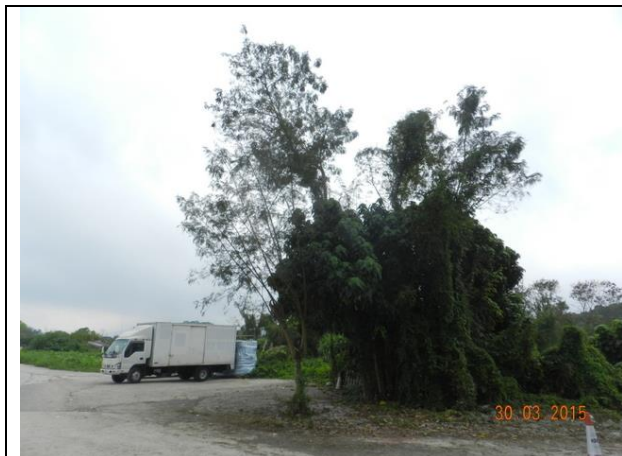
Photo B25 – Concrete pavement maintained for parking area for the villagers was still observed around the tree group T089-T091.

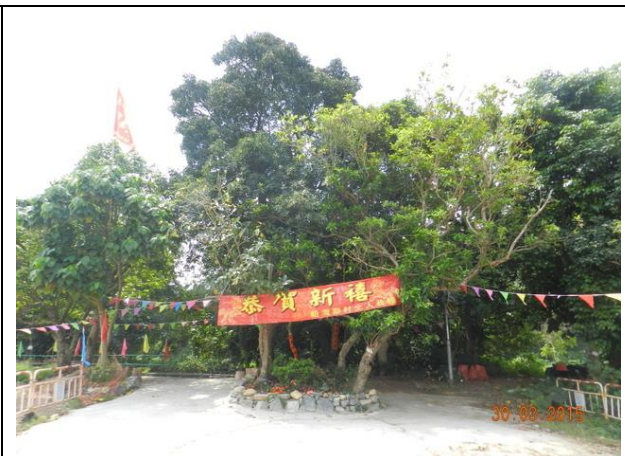
Photo B26 – Retained trees T181-T183 have been surrounded by some stones to demarcate the tree group area by the villagers.

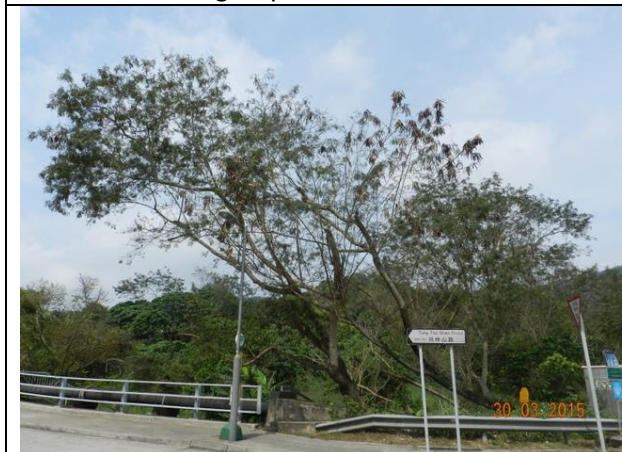
Photo B27 – The tree trunk from the tree group of T085-T087 at the junction of Tung Tsz Road and Tung Tsz Shan Road was partly uprooted and significantly leaned towards Wai Ha River.

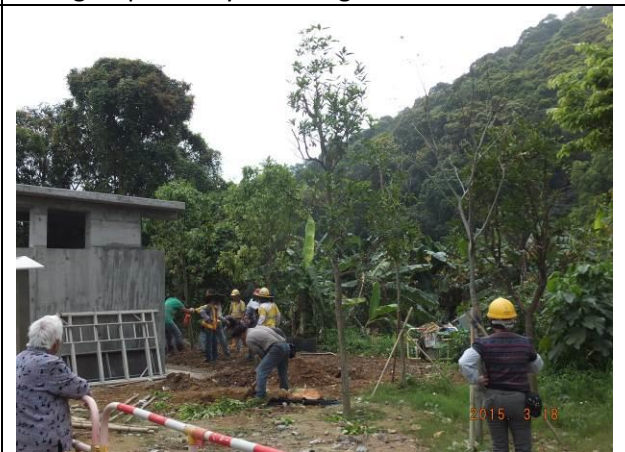
Photo B28 – Replacement planting of compensatory trees was observed on 18th March 2015.

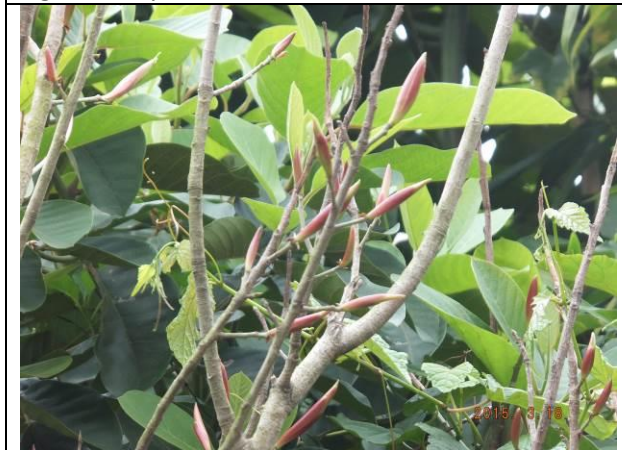
Photo B29 – Development of new buds and leaves of a compensatory tree of *Ficus virens*.

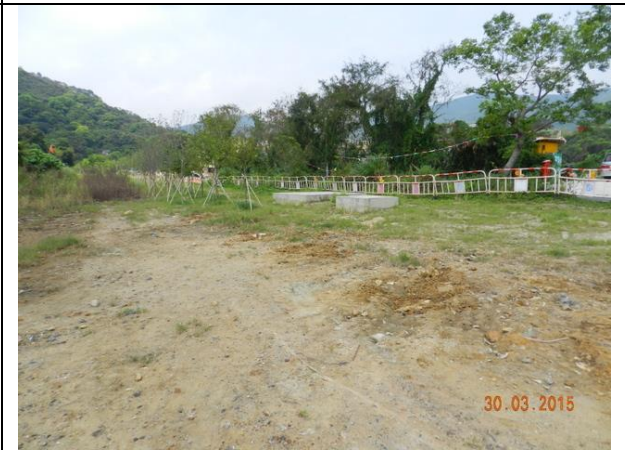
Photo B30 – The dead trees and trees of poor performance in the planting area that was influenced of tidal water were removed in March 2015.

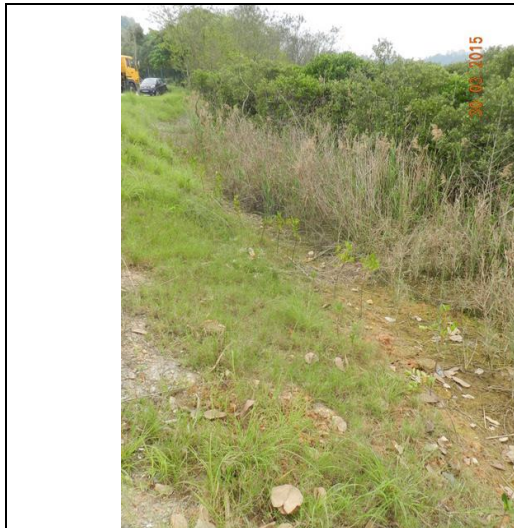
Photo B31 – Mangrove seedlings were planted along the sloping area facing Shuen Wan Marsh.

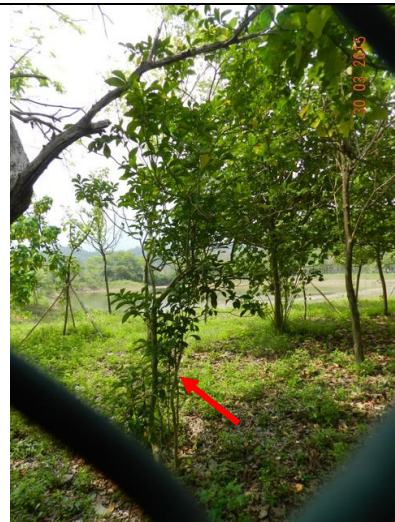
Photo B32 – The transplanted shrub of *Pavetta hongkongensis* (PH01) in Area C under Contract 1 has remained in satisfactory condition.

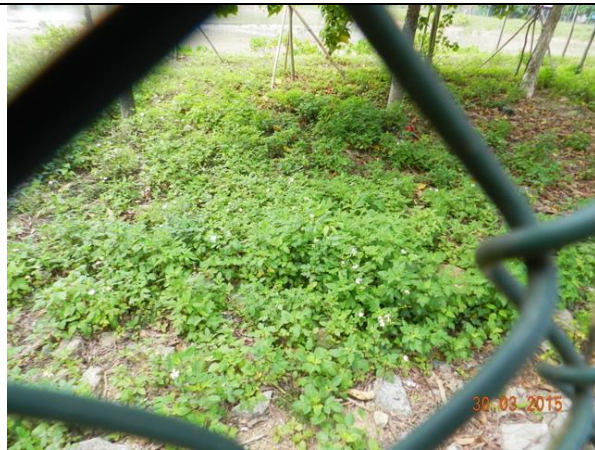
Photo B33 – The transplanted shrub of *Pavetta hongkongensis* (PH03) was cut by the third party during the grass cutting work within Area C. No resprout on the cut specimen was noted.
