**CONTRACT NO. DC/2009/22**  
**DRAINAGE IMPROVEMENT WORKS IN SHUEN WAN**

**CONTRACT NO. DC/2010/02**  
**DRAINAGE IMPROVEMENT WORKS IN SHUEN WAN**  
**AND SHEK WU WAI**

**MONTHLY ENVIRONMENTAL MONITORING AND**  
**AUDIT REPORT FOR OPERATION PHASE-**  
**JULY 2015**

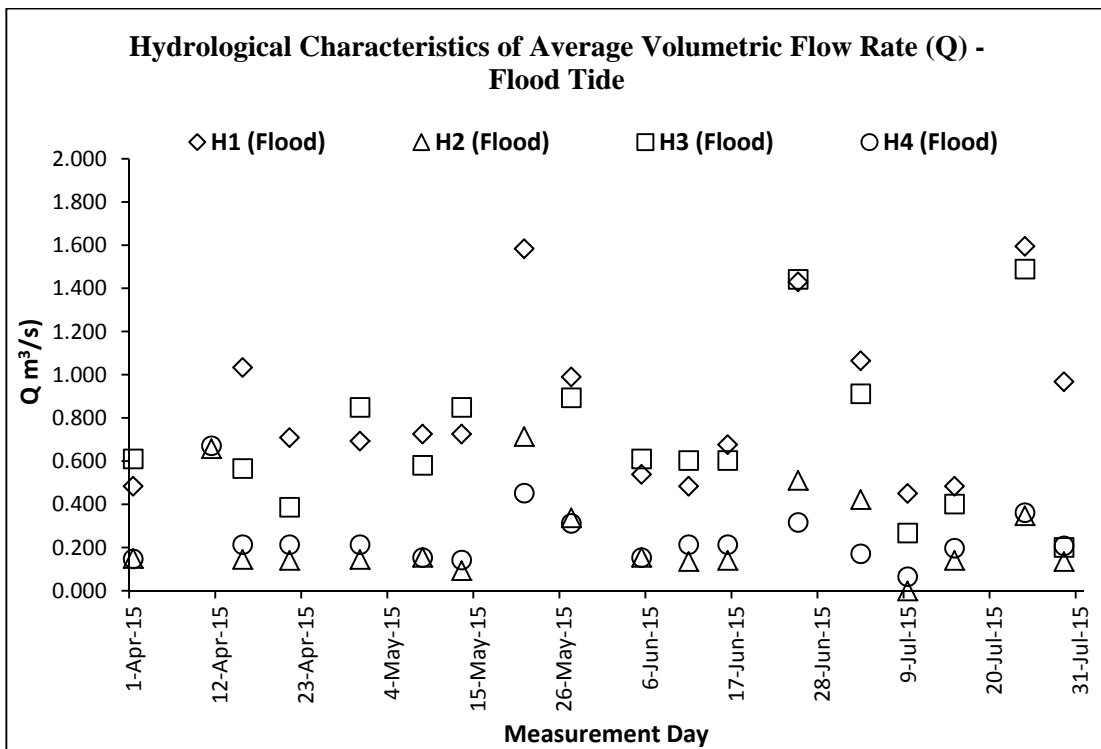
### **Graphical Plots of Hydrological Characteristics**

4.02 In this Reporting Period, hydrological characteristics measurements were carried out on **3, 9, 15, 24** and **29 July 2015**. The detailed measurement results in this Reporting Period are presented in *Tables 4-1* and the graphical plot area shown in *Appendix E*.

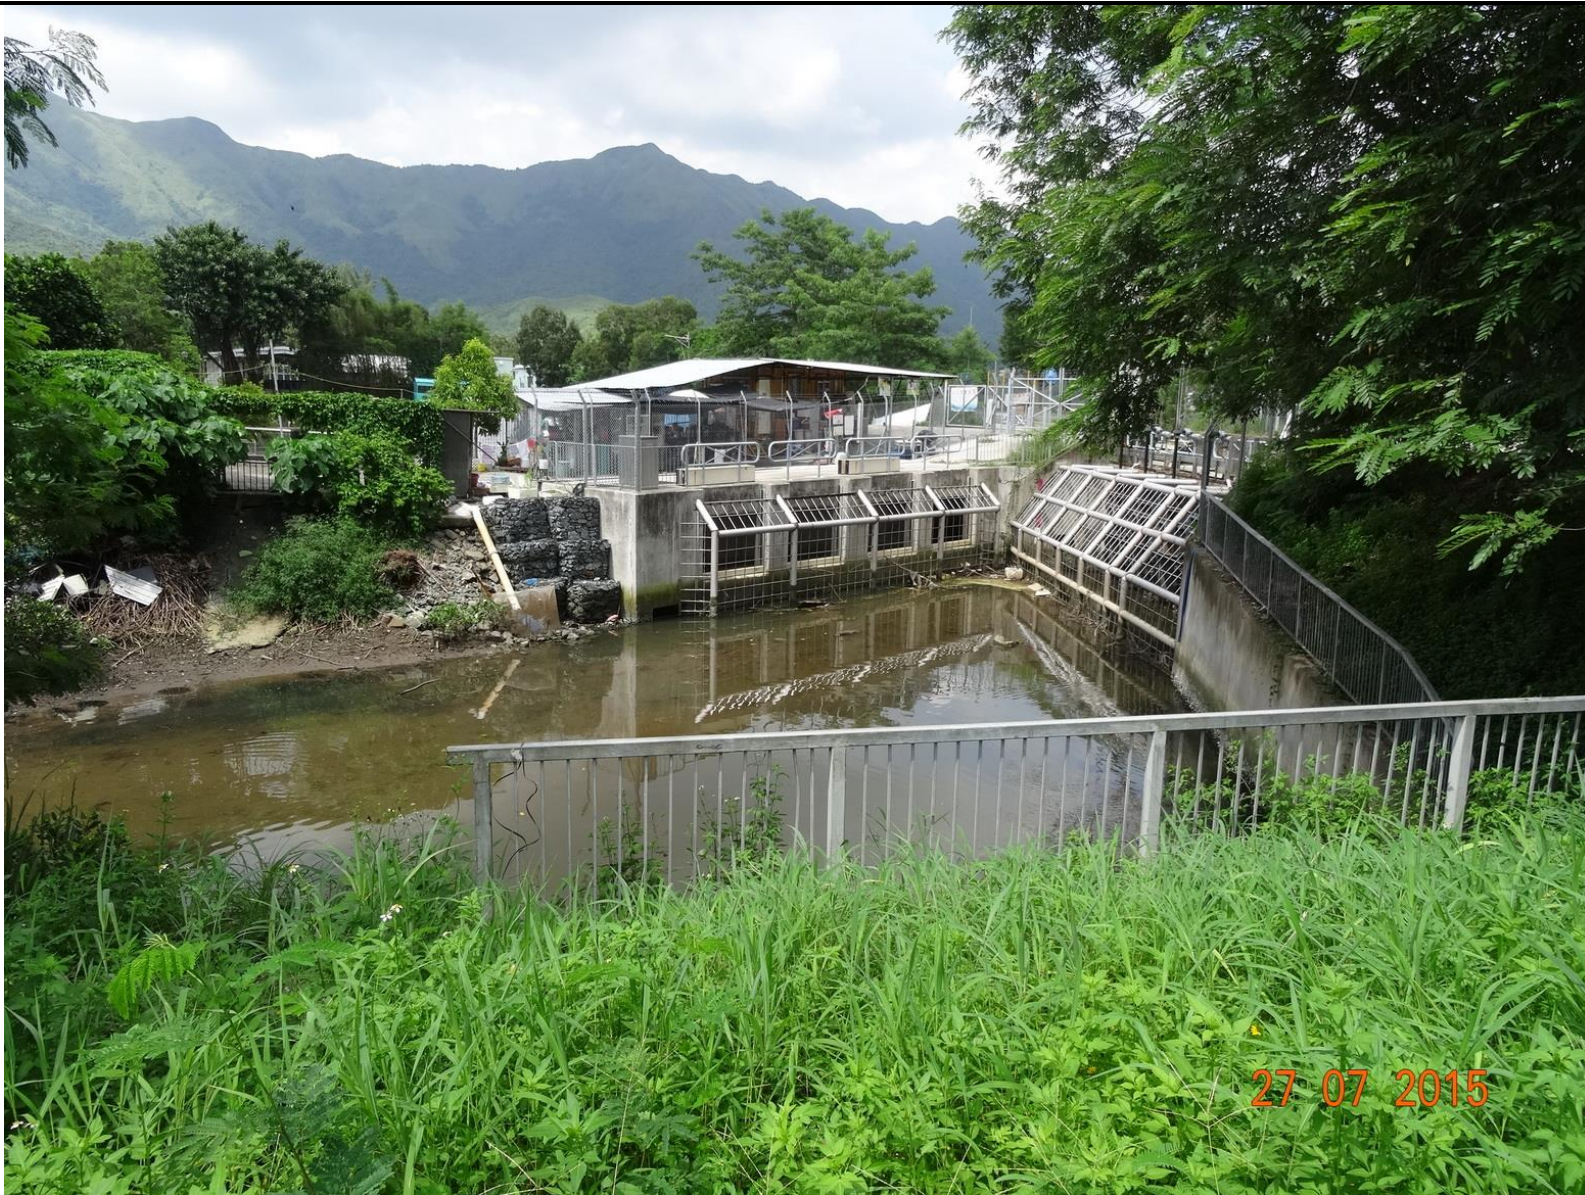
**Figure:** 2

**Title:** SEMP 1, the first sampling point of Wai Ha River under Contract 1.

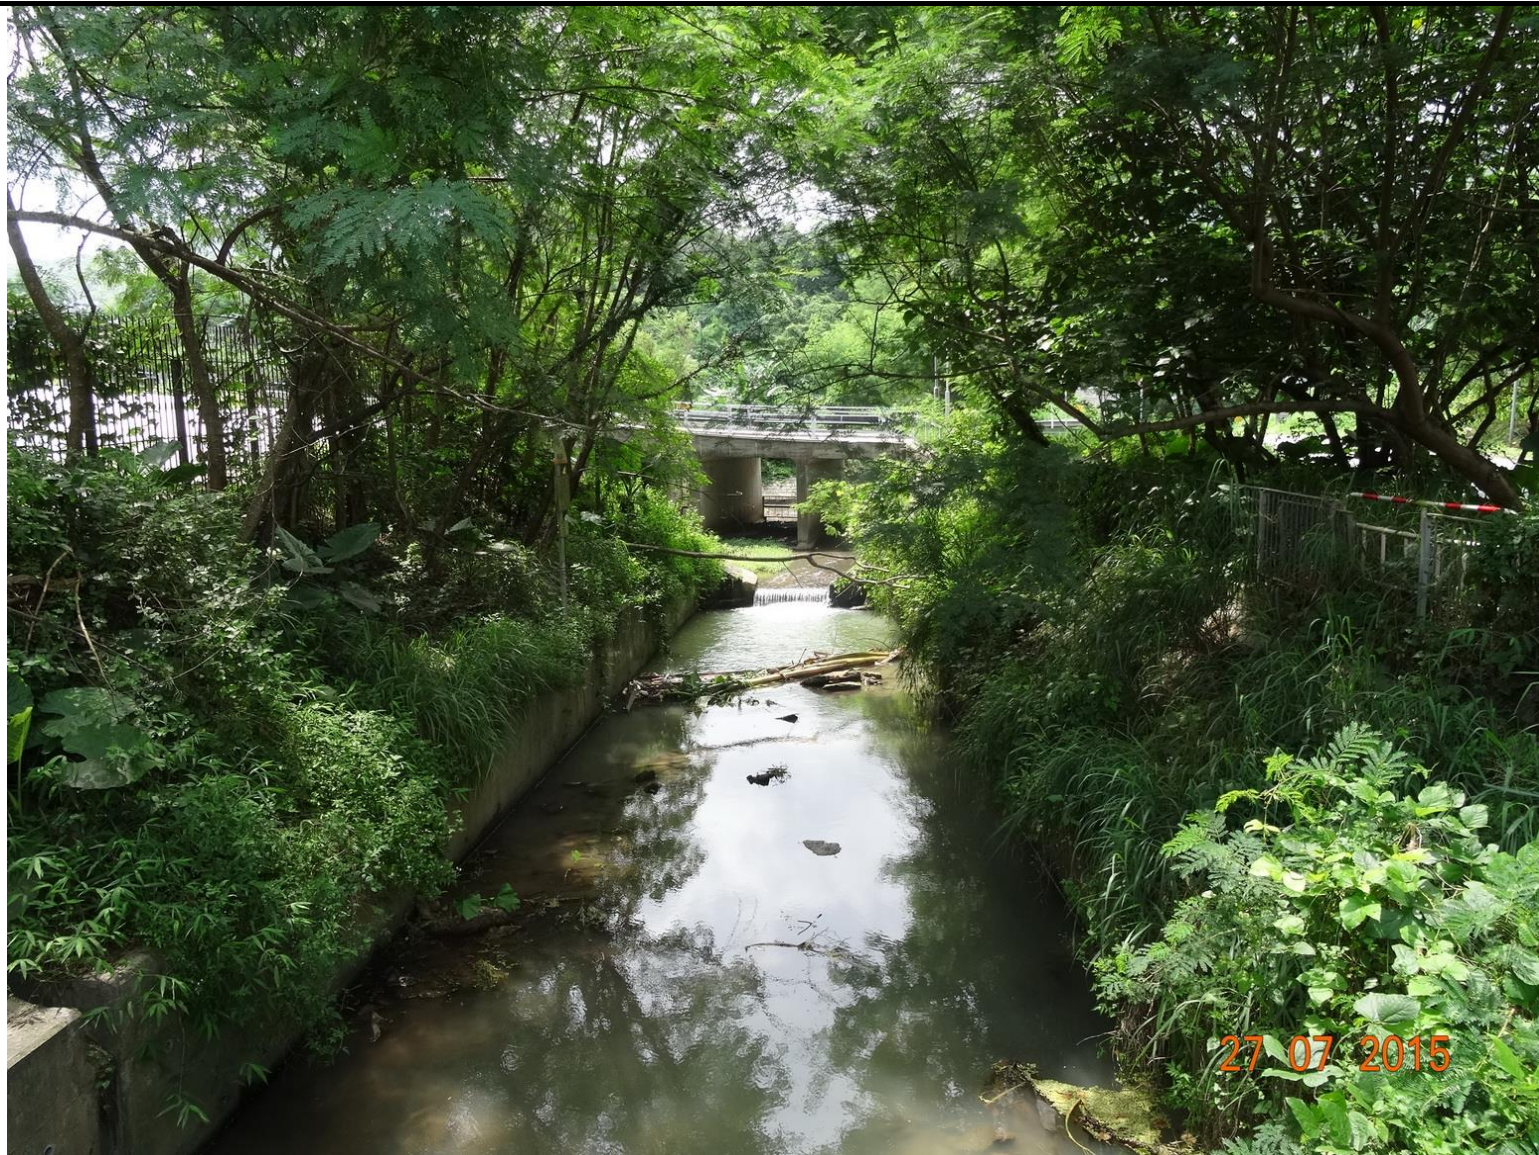
**Figure:** 3

**Title:** SEMP 4, the forth sampling point along Wai Ha River under Contract 2.

The second quarterly ecological impact monitoring under Contract 2 for operation phase was conducted in July 2015 and relevant flora and fauna data were collected according to project specification and EM&A Manual. As indicated by the low abundance and diversity of species within the work areas, habitats within the work boundary under Contract 2 offer few ecological opportunities for colonization of fauna and flora. On the other hand, the natural habitats in the 100 m buffer area are retained at acceptable condition, and hence the 100 m buffer area has not been significantly affected by the construction works. Currently, project work was completed. Thus, the impact on downstream of SEMP4 is anticipated to be insignificant.
