PROJECT No.: TCS/00553/11

**CONTRACT NO. DC/2010/02**  
**DRAINAGE IMPROVEMENT WORKS IN SHUEN WAN**  
**AND SHEK WU WAI**

**MONTHLY ENVIRONMENTAL MONITORING AND**  
**AUDIT REPORT FOR OPERATION PHASE-**  
**JANUARY 2016**

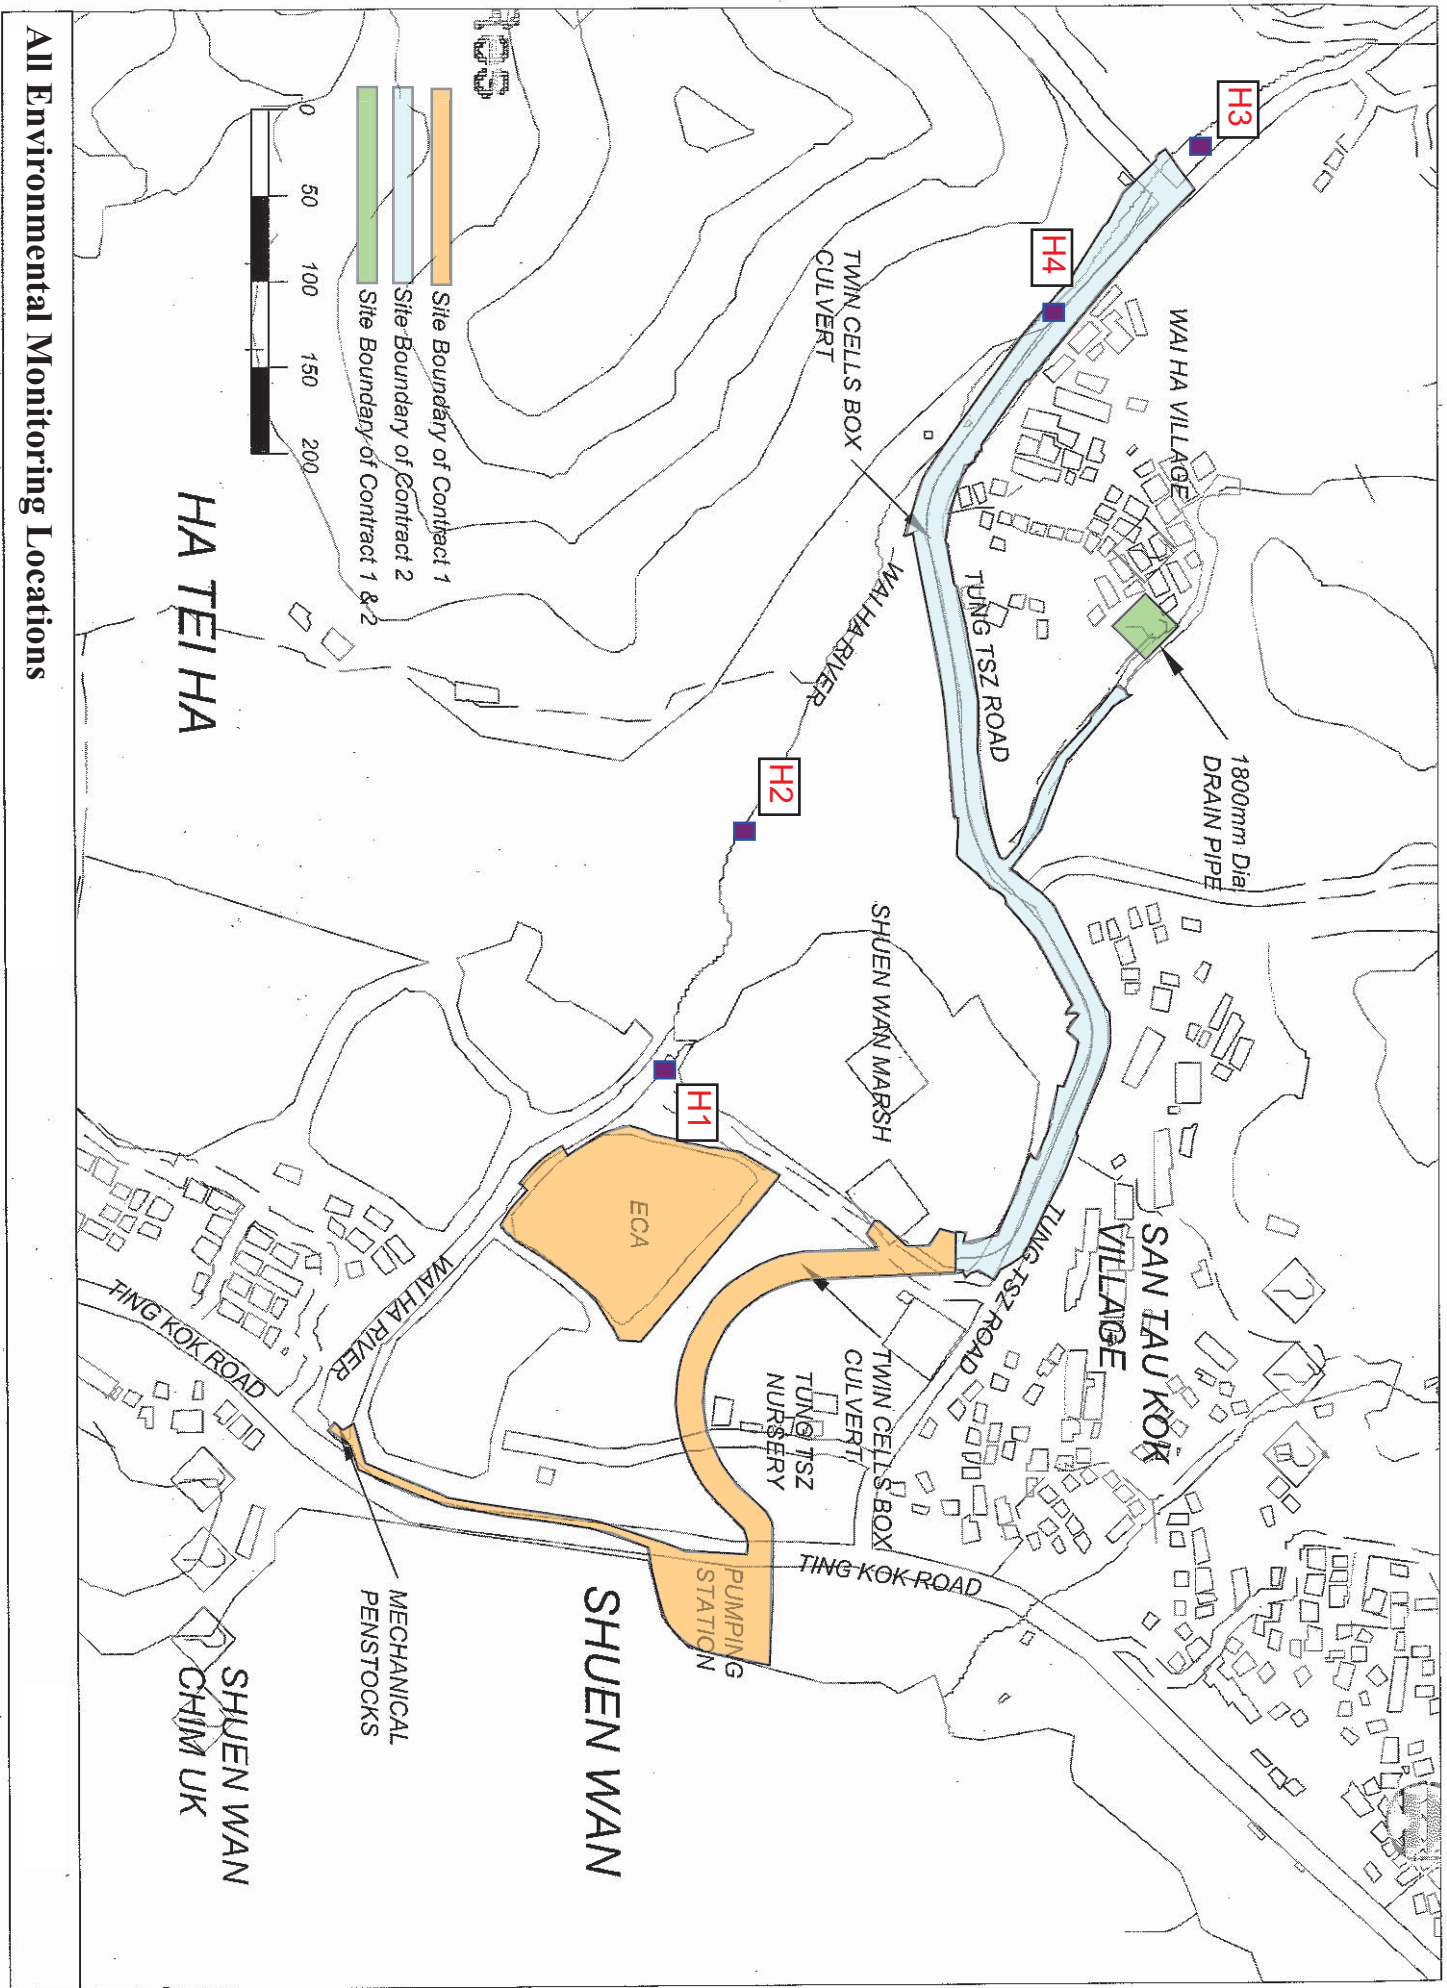
All Environmental Monitoring Locations

Aspect	Location ID	Address
Hydrological	H1	Between the Shuen Wan Marsh and ECA <ul style="list-style-type: none"> <li>Coordinates: E839306, N836379)</li> </ul>
	H2	Route 10 Sam Kung Temple <ul style="list-style-type: none"> <li>Coordinates: E839163, N836433</li> </ul>
	H3	Upstream of Tung Tze Shan Road <ul style="list-style-type: none"> <li>Coordinates: E838760, N836714</li> </ul>
	H4	Wai Ha Village 29D <ul style="list-style-type: none"> <li>Coordinates: E838865, N836621</li> </ul>
Ecology	Areas within 100m of the works boundary under Contract 1 and Contract 2	
Landscape & Visual	As within and adjacent to the construction sites and works areas under the Contract 1 and Contract 2

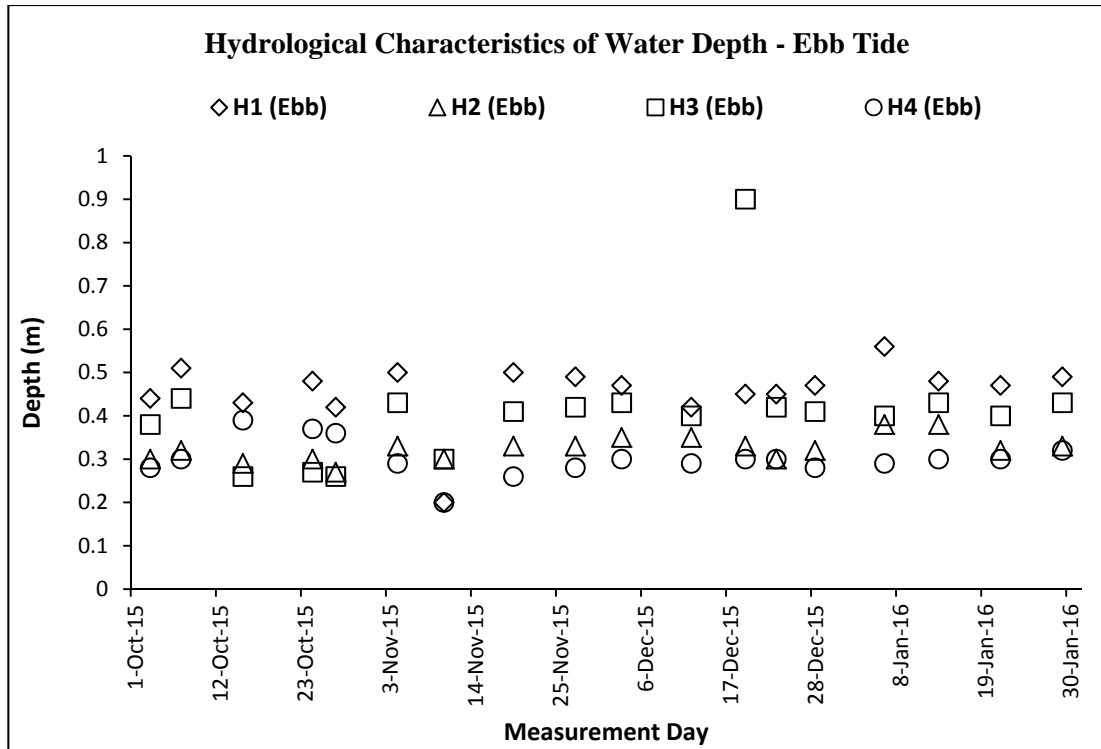
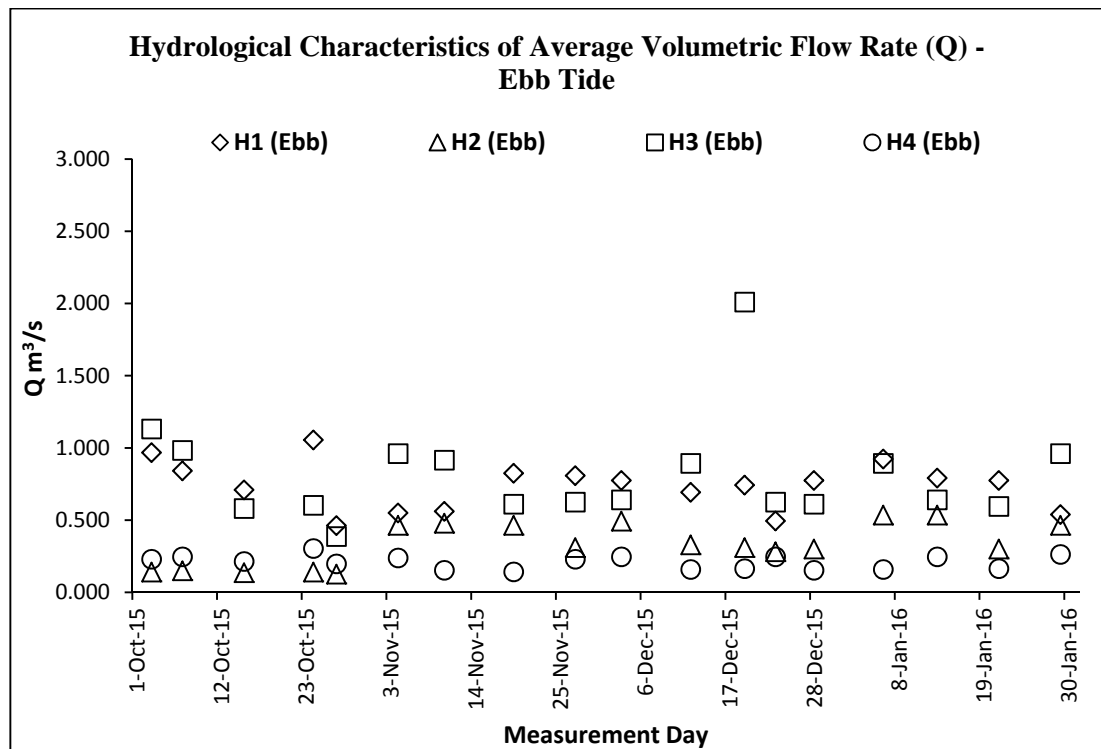
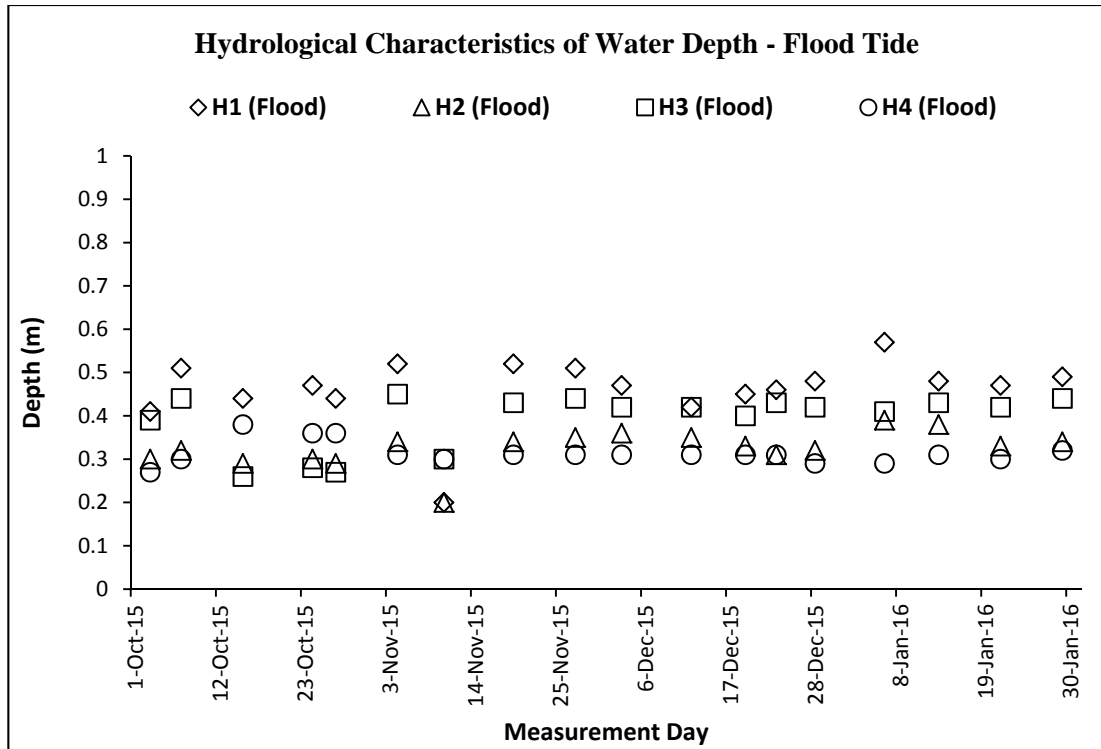
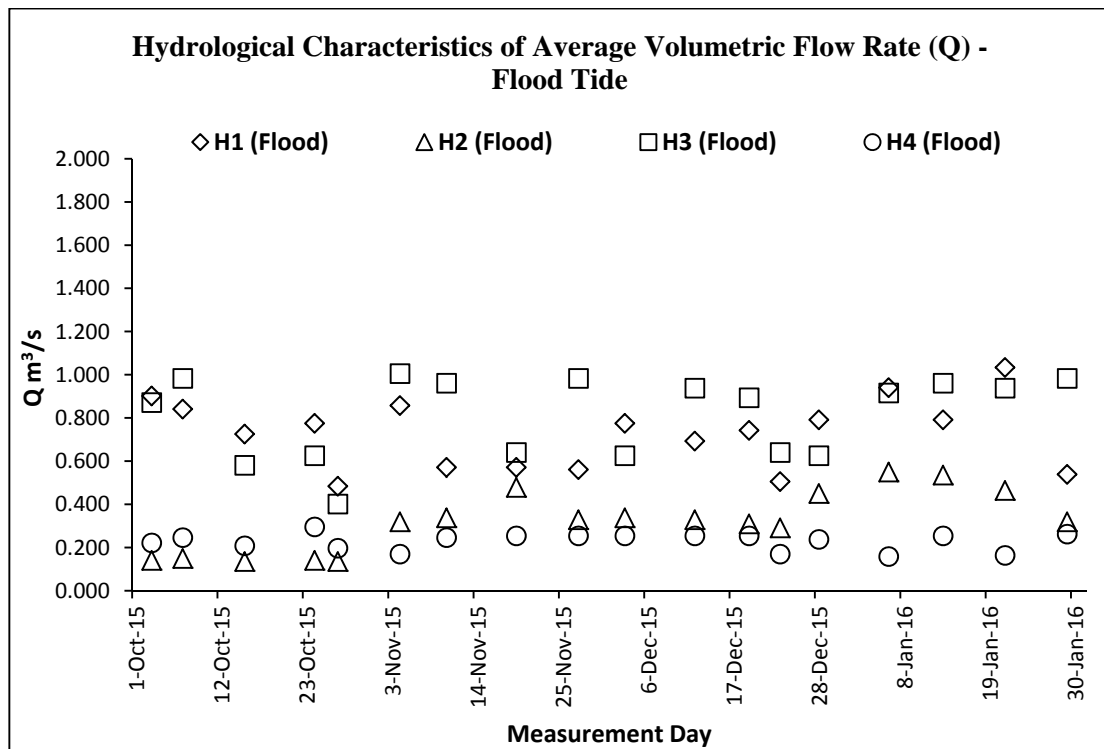
### **Graphical Plots of Hydrological Characteristics**

4.02 In this Reporting Period, hydrological characteristics measurements were carried out on **6, 13, 21 and 29 January 2016**. The detailed measurement results in this Reporting Period are presented in *Tables 4-1* and the graphical plot area shown in *Appendix E*.

4.04 To compare the monitoring data between the Reporting Period and baseline monitoring period, the currently water depth and volumetric flow rate has insignificant change.

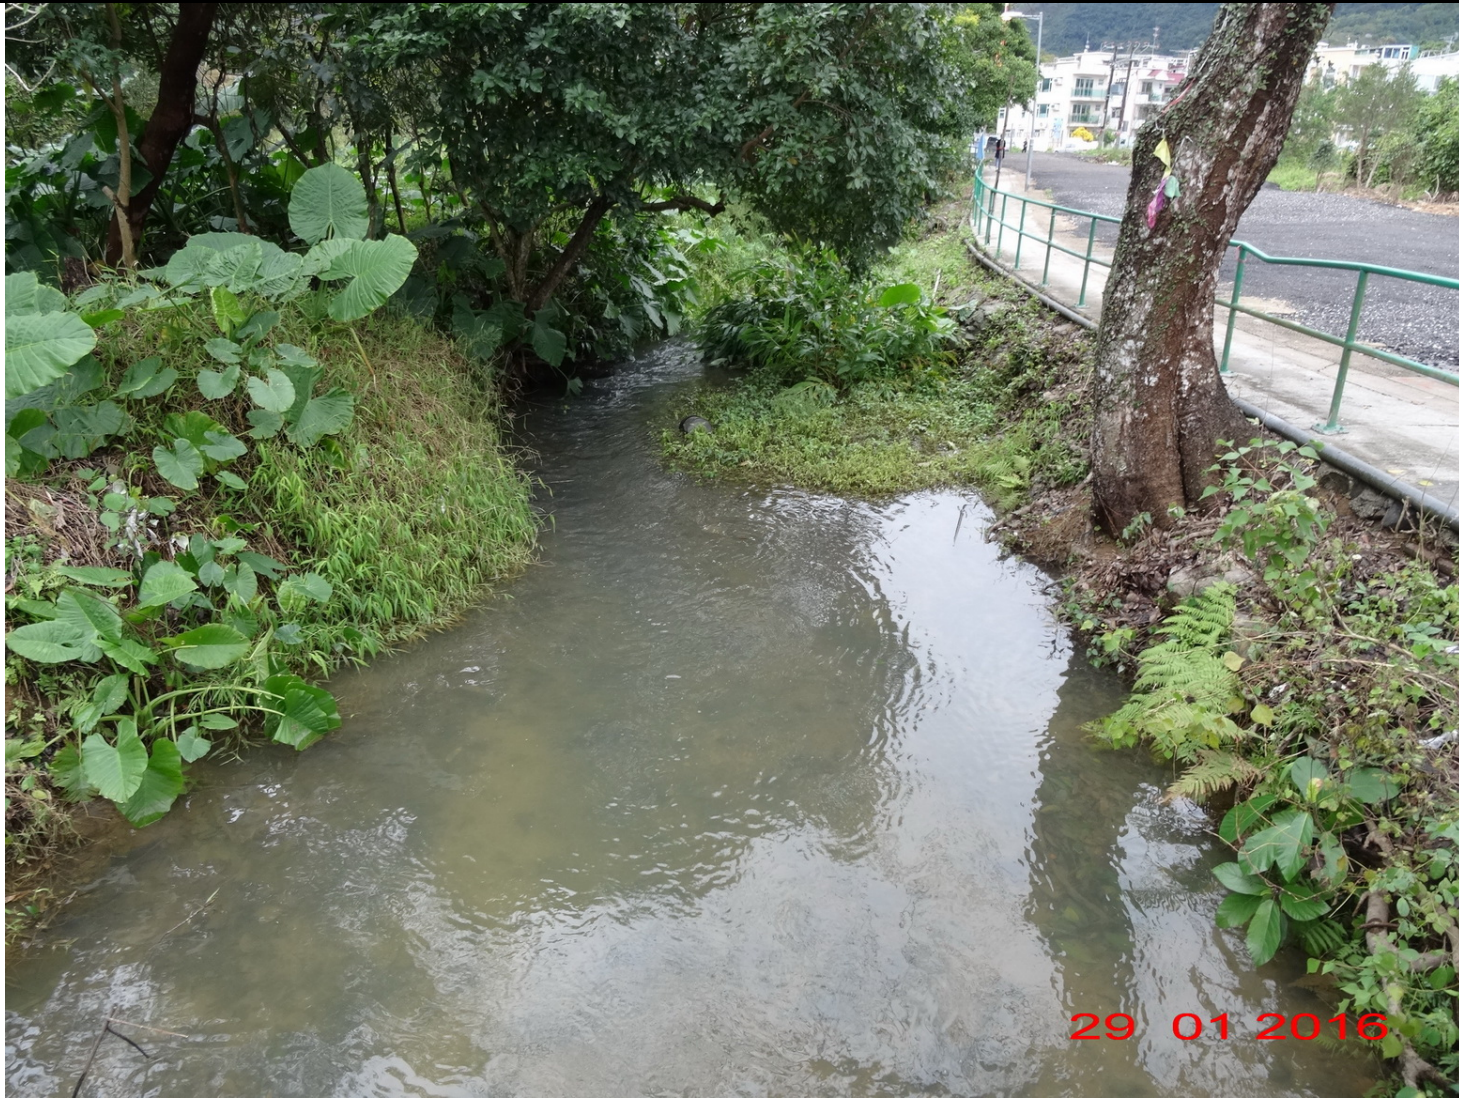
**Figure:** 2

**Title:** SEMP 3, the third sampling point of Wai Ha River under Contract 2.

Under Contract 2 (i.e. SEMP 3 & 4), a total of 13 fish species, 3 crustaceans, 1 gastropod, 1 bivalve and 1 arthropod were recorded and most of them were freshwater species (**Table 4**). *Carassius auratus* was commonly observed at SEMP 3 because of the traditional Buddhist practice from the nearby temple in which captured organisms were released back to nature. The density of fish species has slightly been reduced at SEMP 3 and SEMP 4 at current monitoring due to recent raining. Since no construction work was found in vicinity of the monitoring stream, fish density was anticipated restoring to normal level in coming month. Overall, no protected species were recorded.

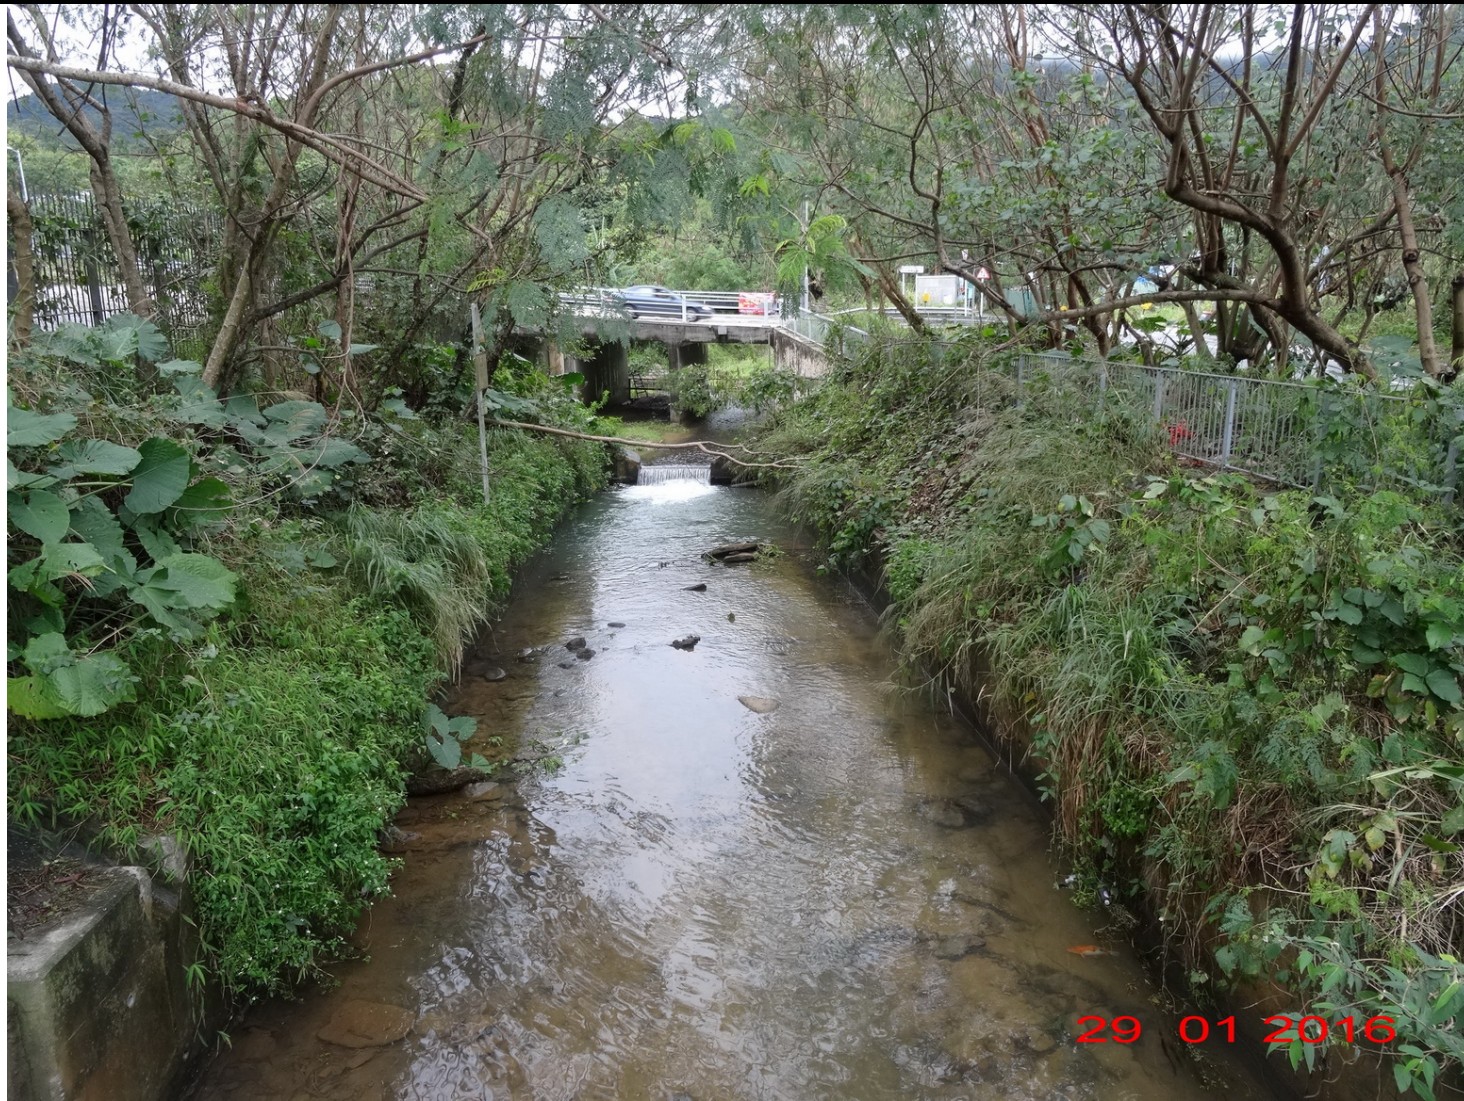
**Figure:** 3

**Title:** SEMP 4, the forth sampling point along Wai Ha River under Contract 2.
