**CONTRACT NO. DC/2009/22**  
**DRAINAGE IMPROVEMENT WORKS IN SHUEN**  
**WAN**

**CONTRACT NO. DC/2010/02 –**  
**DRAINAGE IMPROVEMENT IN SHUEN WAN AND**  
**SHEK WU WAI**

**FINAL ENVIRONMENTAL MONITORING & AUDIT**  
**SUMMARY REPORT UNDER EP-303/2008**

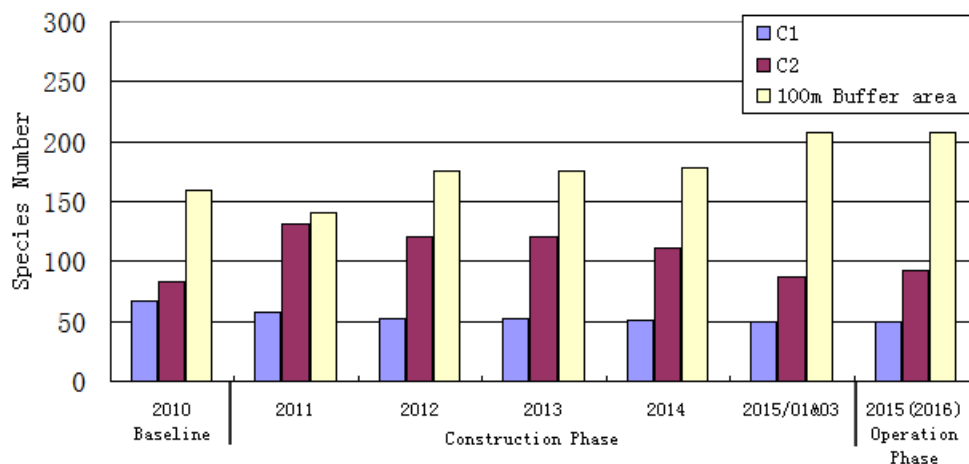
Figure 2 Number of plant species recorded during monitoring period

The habitats identified in areas under Contract 1 and 2 are river course, wooded area, mangrove, marsh and developed area (including villages). The coverage of riparian vegetation decreased due to the construction activities but recovered afterwards. Various flora species up to 209 were recorded within the buffer area, up to 120 species within the work areas under Contract 2, and as many as 61 species within the work areas under Contract 1. The recorded floras were generally in good health and the height of the dominated riparian grass and herb species were in a range from ~0.1m to over 3m as observed in the survey areas. Average numbers of flora species are shown in the **Figure 2**. There are no apparent species number changes during construction and operation phases.

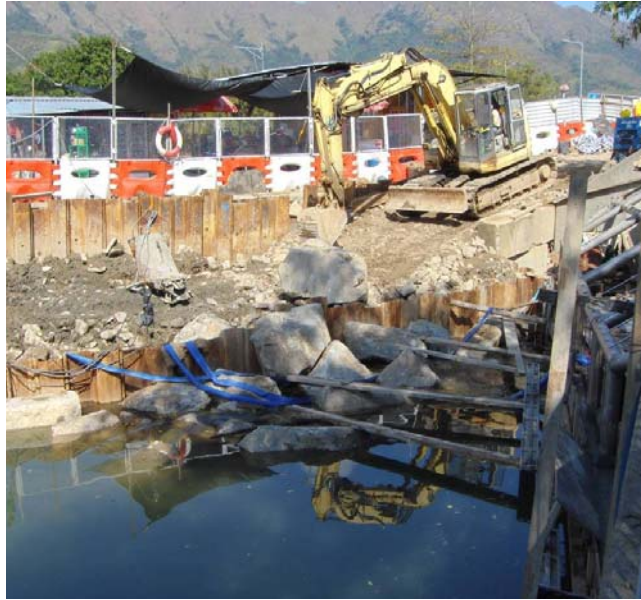
Photo 1. The Construction phase of Wai Ha River under Contract 1.

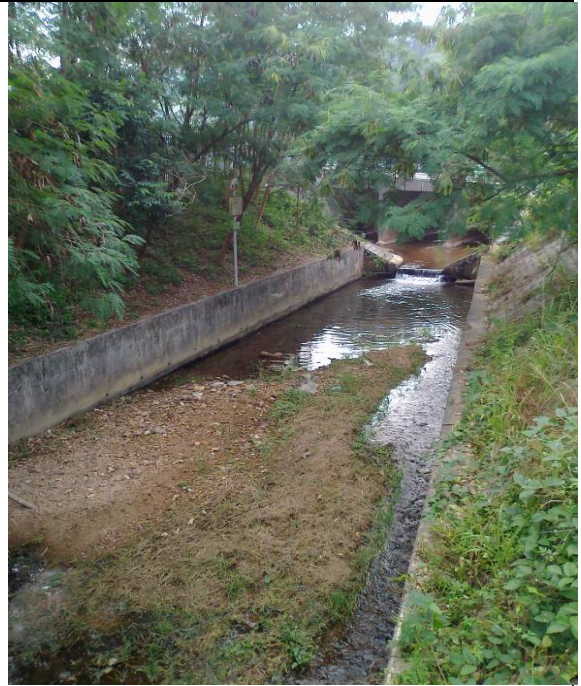
Photo 2. The Construction phase of Wai Ha River under Contract 2.

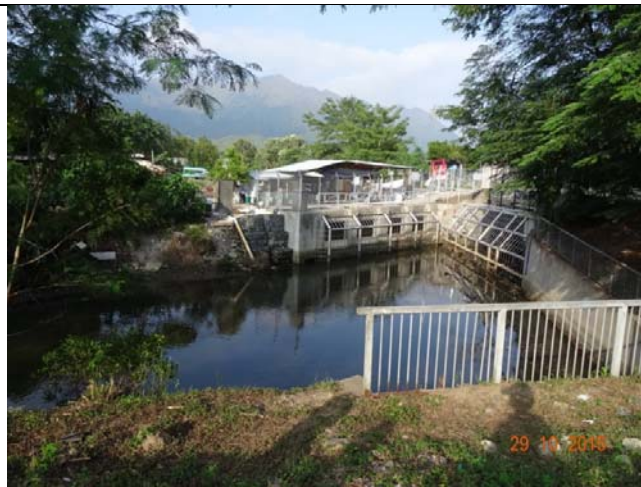
Photo 3. The Operation phase of Wai Ha River under Contract 1.

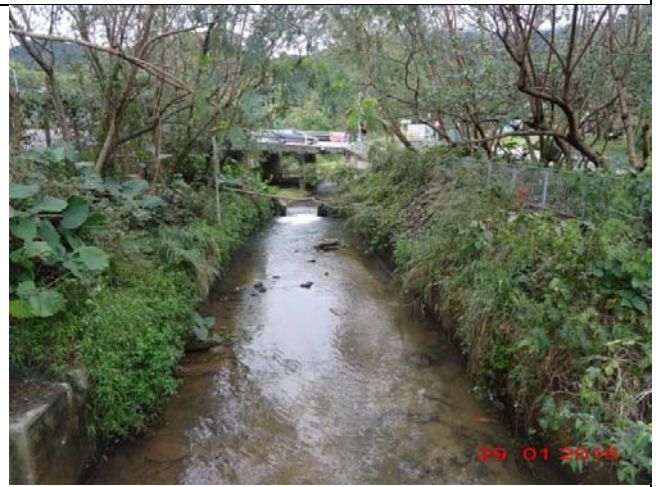
Photo 4. The Operation phase of Wai Ha River under Contract 2.

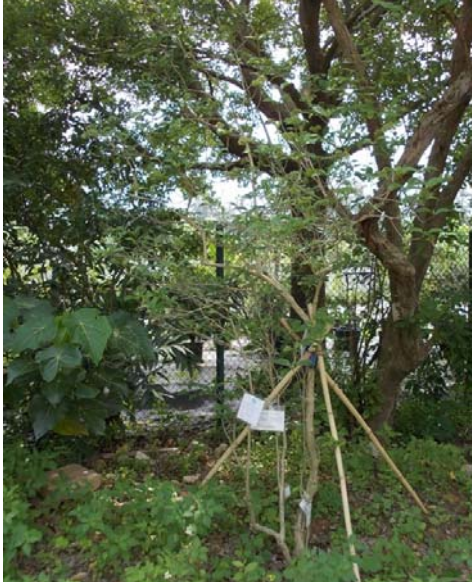
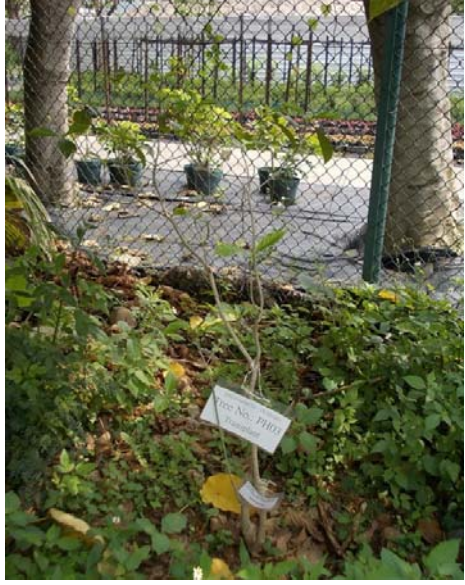
Three specimens of protected species *Pavetta hongkongensis* were transplanted from work area under Contract 2 to ECA at Zone D on 20<sup>th</sup> December 2011. Monthly monitoring was carried out and their overall conditions were fair during the monitoring period (Photo 5 & 6).

<p>Photo 5. Specimens 1 &amp; 2 (Transplanted <i>Pavetta Hongkongensis</i>)</p>	<p>Photo 6. Specimen 3 (Transplanted <i>Pavetta Hongkongensis</i>)</p>
