## Proposed Comprehensive Development at Wo Shang Wai, Yuen Long

Quarterly EM&A Summary Report for Feb 2013 – Apr 2013 (Rev. A)

May 2013  
Report No.: 266567/56/A

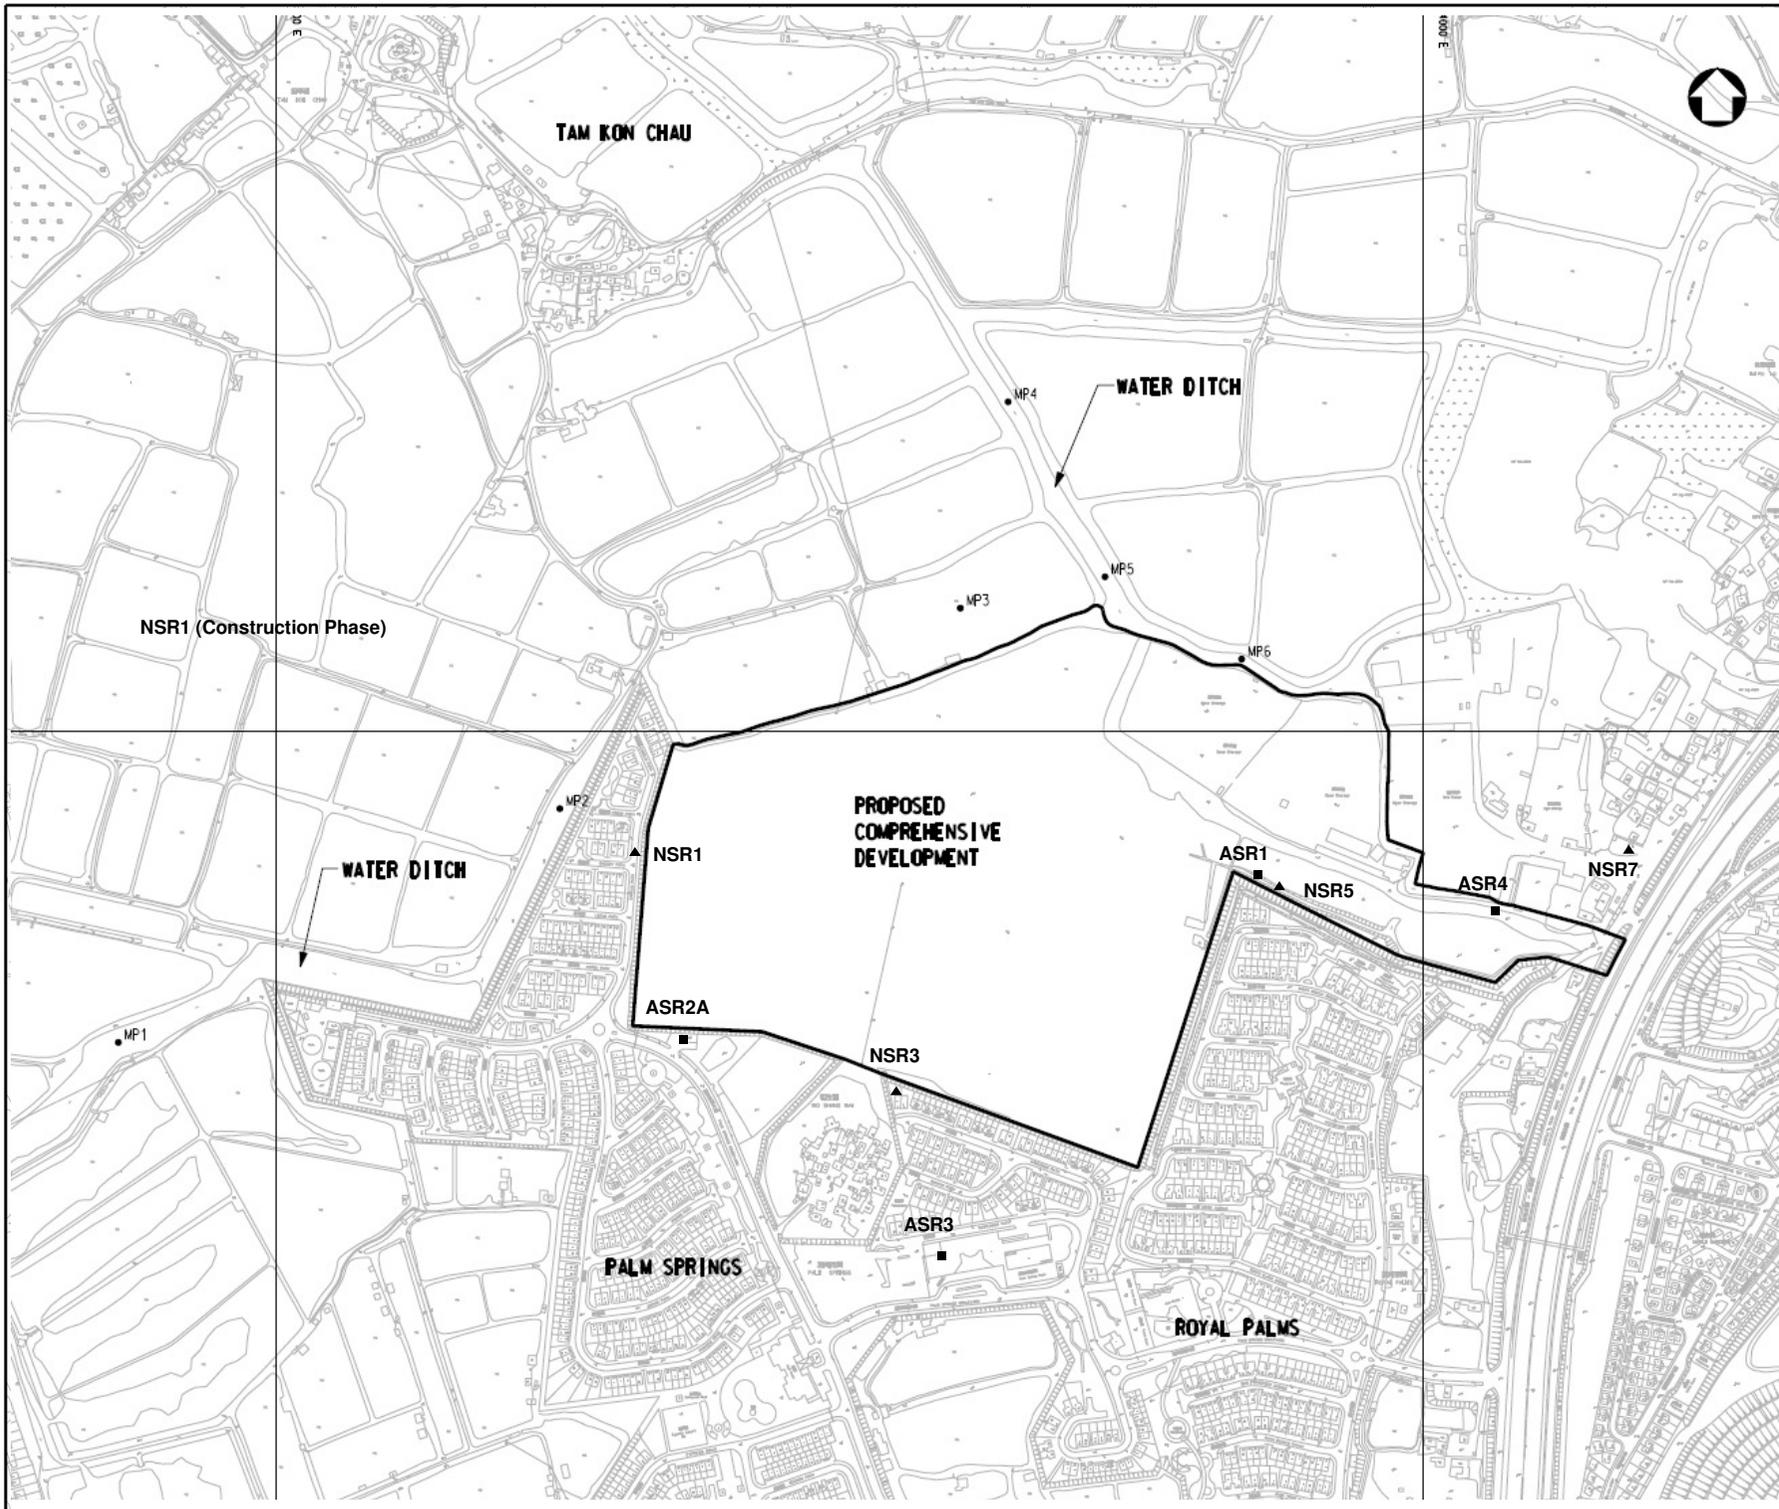
The Construction Works Programme of the Project is provided in [Appendix B](#). The general layout plan of the Project site is shown in [Figure 1.1](#).

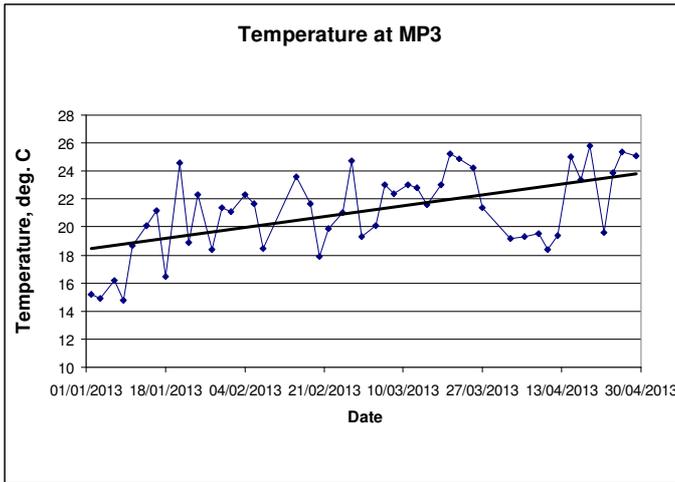
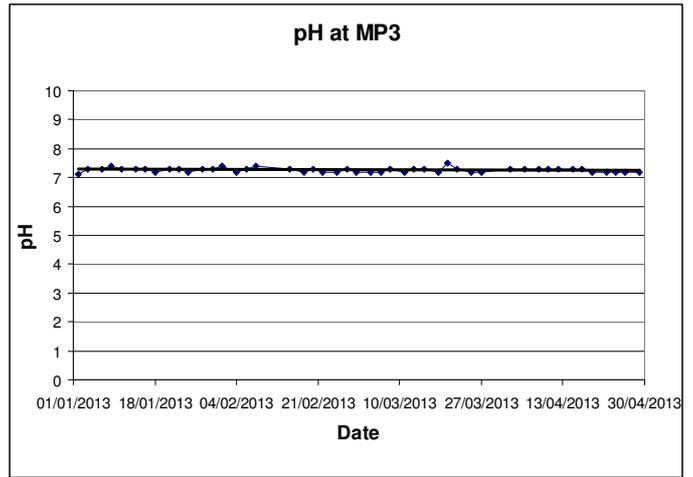
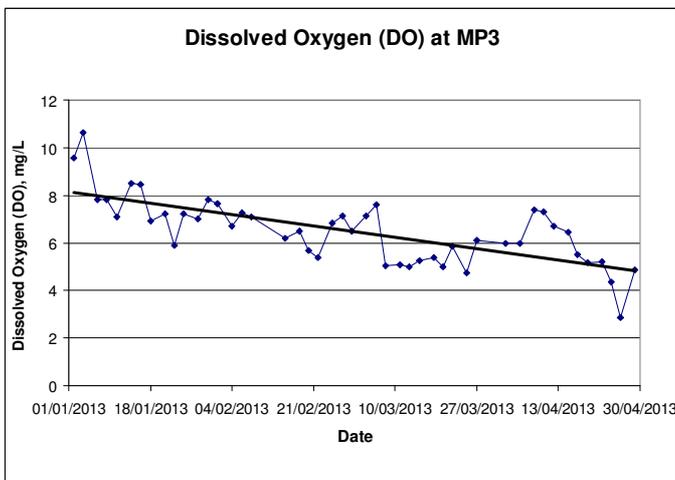
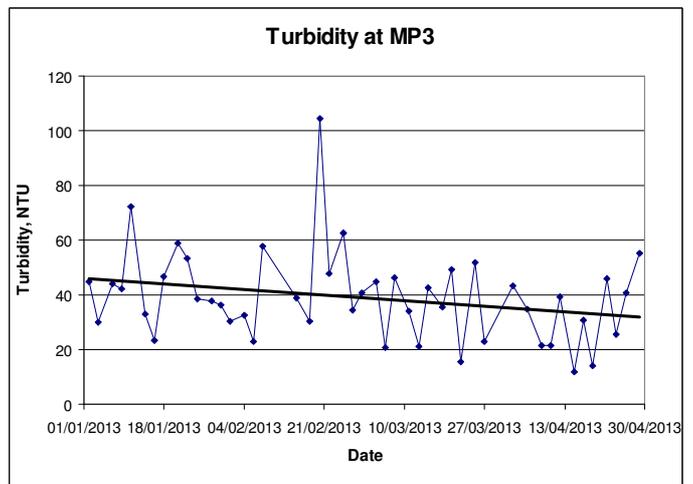
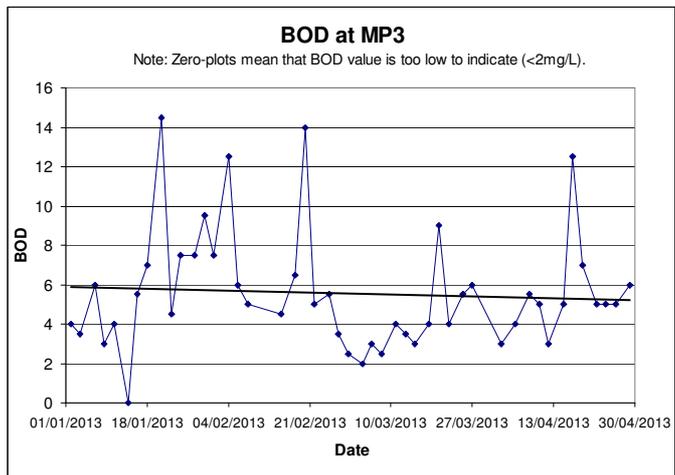
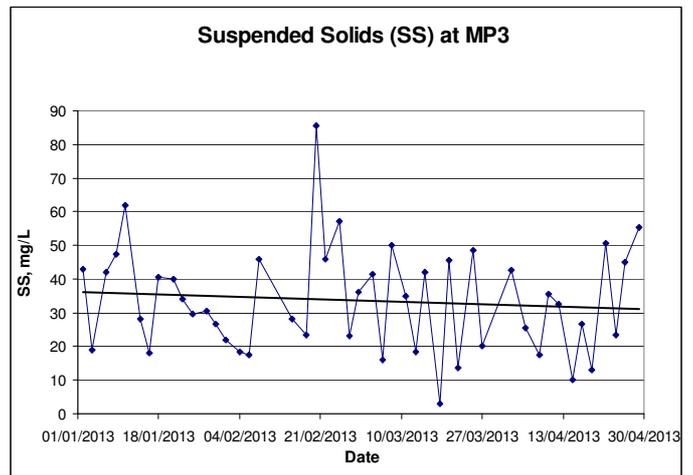
Exceedances of DO, SS and/or turbidity were observed. For MP3, five DO exceedances, one SS and one turbidity exceedance were recorded in February 2013. DO was exceeded on most monitoring dates in March 2013 and April 2013.
