**Environmental Team Services for
Contract No. CV/2011/01 Site Formation
and Infrastructural works near Tsing Lun
Road and Tsz Tin Road in Area 54, Tuen
Mun**

Monthly EM&A Report for December 2016 (Rev.
A)

January 2017

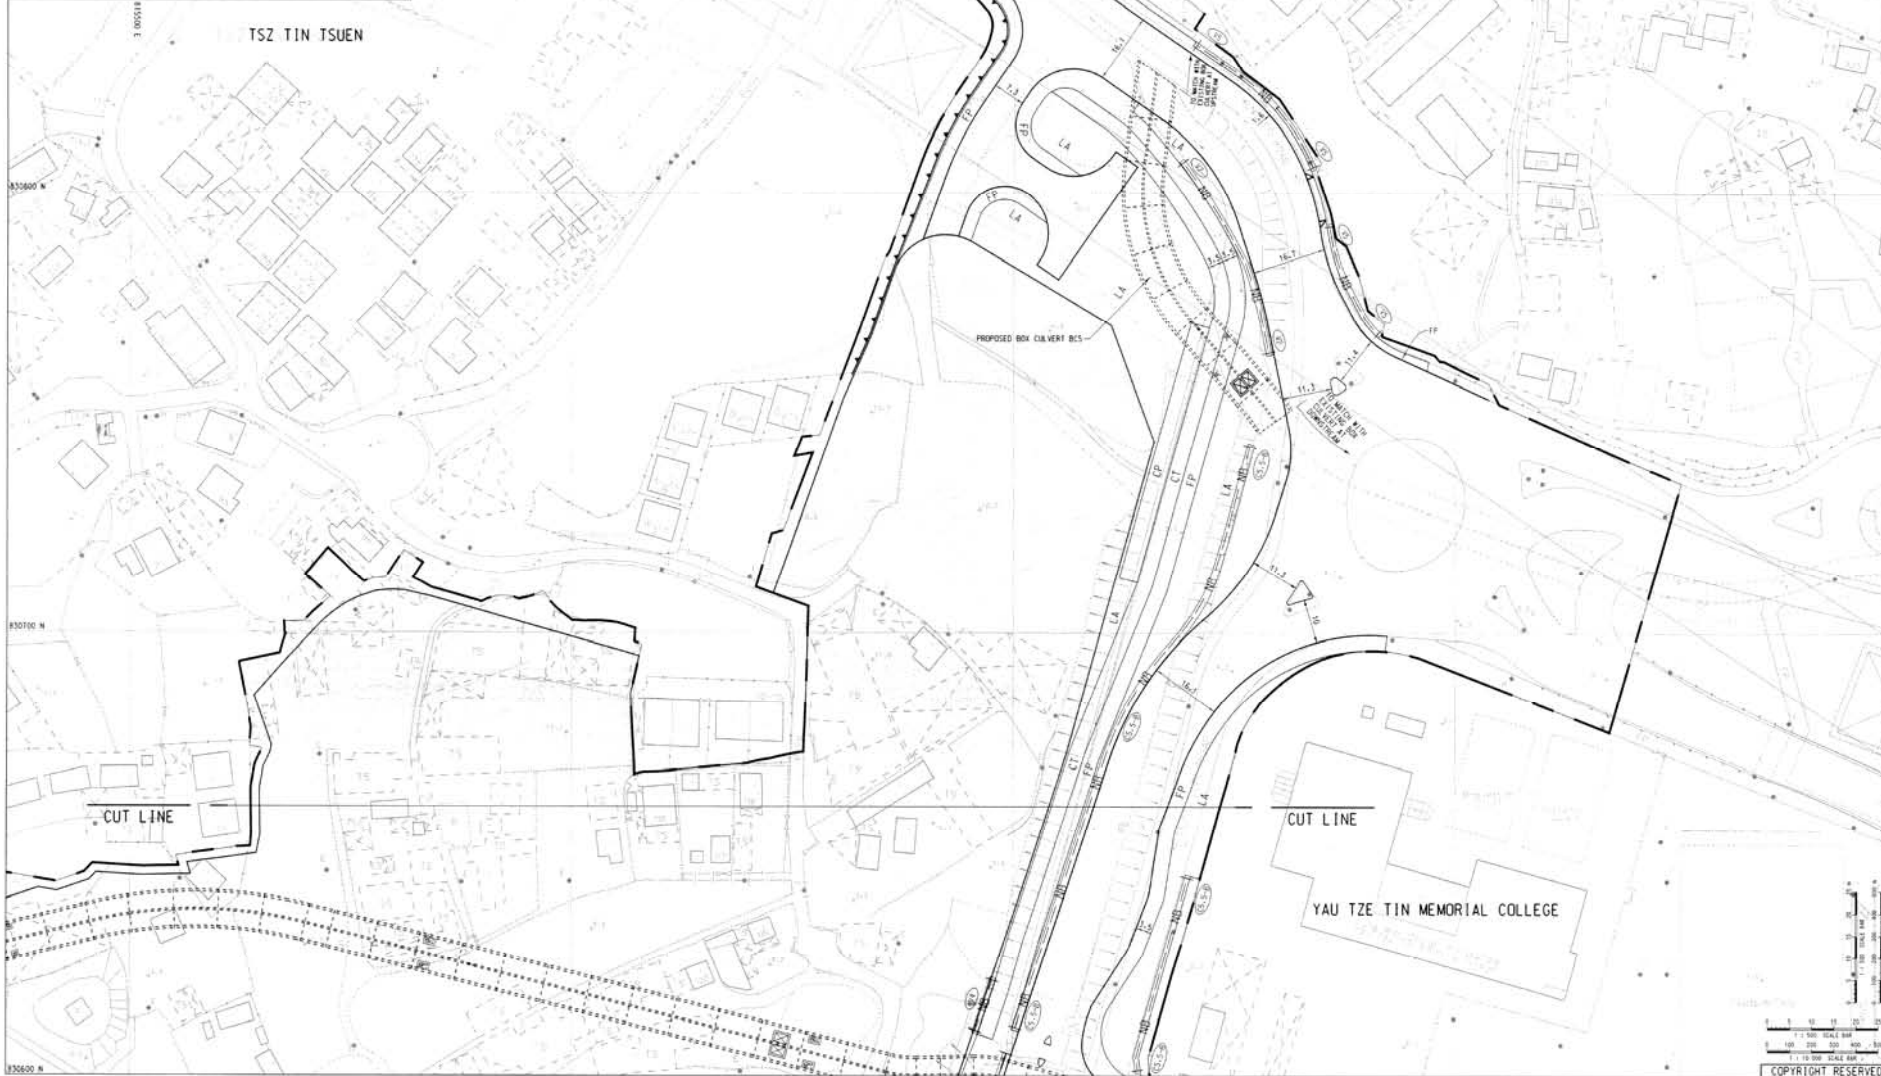
Figure 1.1
Site Layout (1)

drawing no. **LW 8841** scale 1:500 OR AS SHOWN
 office
 LAND WORKS DIVISION
 CIVIL ENGINEERING OFFICE

The Construction Works Programme of the Project is provided in **Appendix B**. A layout plan of the Project is provided in **Figure 1.1** and **Figure 1.2**.
