**Contract No. EP/SP/58/08 -
Sludge Treatment Facilities
Monthly Monitoring Report for October 2013**

**CONTRACT NO. EP/SP/58/08 DESIGN, BUILD AND OPERATE OF SLUDGE
TREATMENT FACILITIES
- MONTHLY ENVIRONMENTAL MONITORING AND AUDIT REPORT
(OCTOBER 2013)**

Contract No. EP/SP/58/08
Sludge Treatment Facilities
Environmental Monitoring and Audit Report
For
October 2013

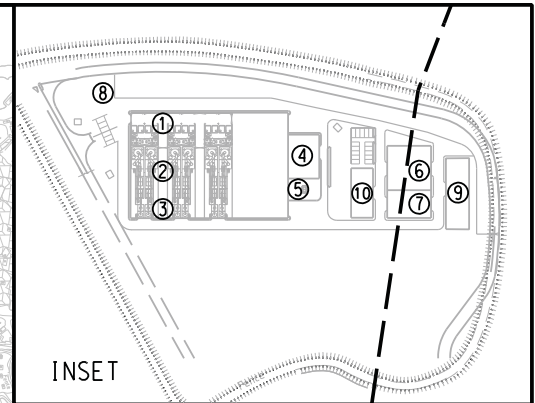
- ① DELIVERY BAY
- ② INCINERATORS AND AIR CONTROL EQUIPMENT
- ③ FUEL GAS RESIDUE SILOS, ASH SILOS & LOADING AREA
- ④ CHEMICAL / FUEL STORAGE AND FEEDING
- ⑤ STACK
- ⑥ ADMINISTRATION BUILDING & LABORATORY
- ⑦ MAINTENANCE WORKSHOP
- ⑧ UTILITY YARD
- ⑨ DESALINATION PLANT, SEAWATER PUMPING STATION & STORAGE TANK
- ⑩ SEWAGE TREATMENT WORKS

WENT LANDFILL
CONSULTATION ZONE
BOUNDARY

WENT LANDFILL
WASTE BOUNDARY

Excavation works has been carried out within the WENT landfill consultation zone for the following construction activities during the reporting period: (1) Portion 1 (Landscaping Pond). Landfill gas monitoring was carried out by a competent person during the excavation, operation in chamber and confined space within the WENT landfill control zone and no exceedance was found.
