**Contract No. EP/SP/58/08 – Sludge Treatment Facilities
Environmental Monitoring Results in Operation Phase – Monthly HCMP Reports
(June 2016)**

Contract EP/SP/58/08 Sludge Treatment Facilities

OPERATIONAL PHASE ECOLOGICAL MONITORING OF GREBE POND IN ACCORDANCE WITH THE APPROVED HABITAT CREATION AND MANAGEMENT PLAN

2016-06

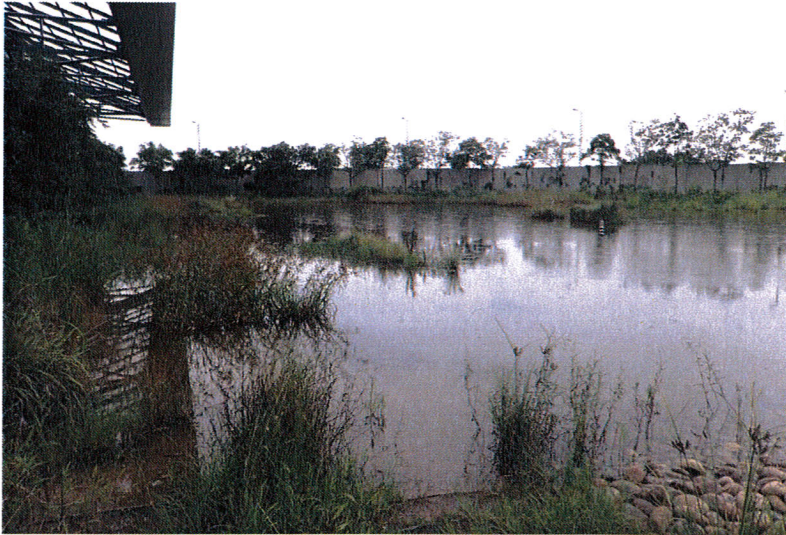
Plate 1

Management Activities Required	Action
Minor remedial work:	<ul style="list-style-type: none">No fish or fry were observed in the Pond (Plate 1).The Landscape Contractor should remove all snails and destroy egg masses during their routine maintenance work in the Pond. At least weekly removal of Apple Snails is recommended.As a routine maintenance practice, the landscape contractor should remove the unwanted climbers (<i>Mikania micrantha</i> and <i>Acacia concinna</i>) and the self-seeded small tree <i>Tamarix chinensis</i>. All vegetation should be disposed away from the Grebe Pond.A Red Imported Fire Ant (RIFA) nests was observed at the Pond gate (Plate 2). Any RIFA nest observed on site should be treated with pesticide as soon as possible to	<ul style="list-style-type: none">NAContractor Contractor Contractor

The Grebe Pond.

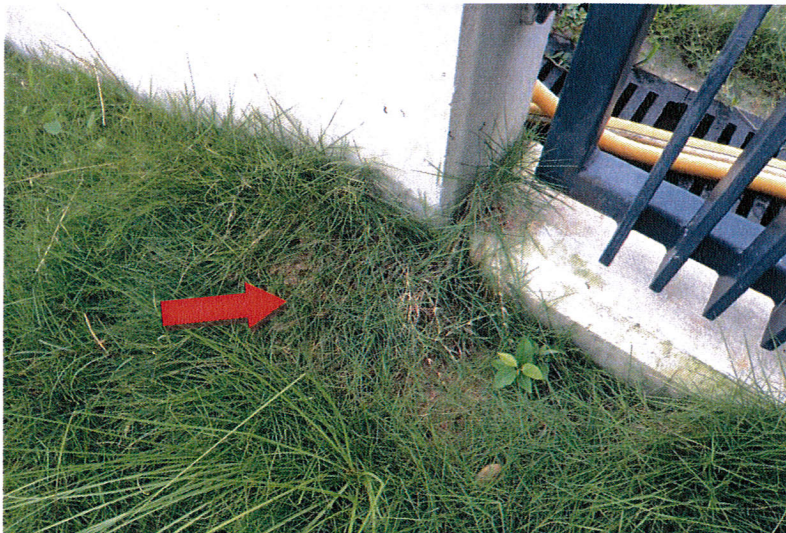
Plate 2

Red Imported Fire Ant (RIFA) nests were observed around the Little Grebe pond.

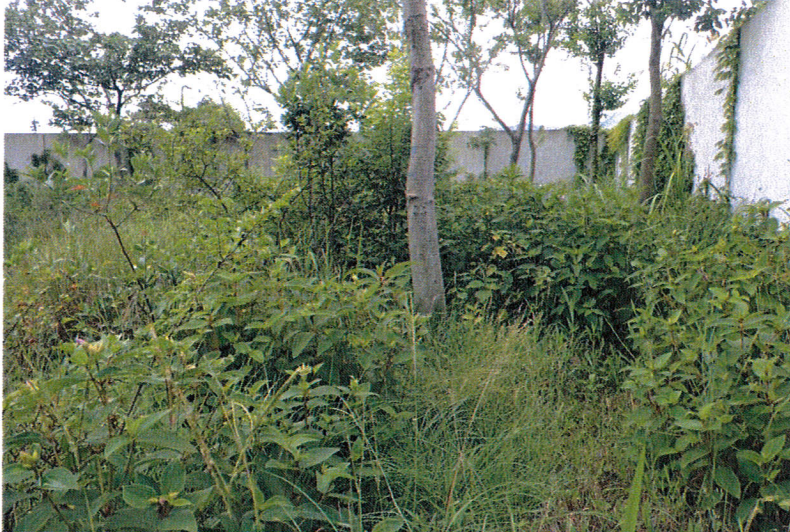
Plate 3

Grass around the Pond needs cutting.

<p>prevent further spreading.</p> <ul style="list-style-type: none"> Grass cutting is needed around the pond (Plate 3). 	<ul style="list-style-type: none"> Contractor
Minor Comments:	<ul style="list-style-type: none"> Less rubbish was noted in the Pond area. The Contractor should continue to remove the rubbish during the routine maintenance work. Grass cutting task from the May 2016 management plan has not been completed. 	<ul style="list-style-type: none"> Contractor Contractor
Water quality checks:	<ul style="list-style-type: none"> Water quality checks will normally form part of the Operational Phase monitoring of the Grebe Pond as per Section 8, Table 7 of the Habitat Creation and Management Plan. Summarised water quality results are shown in Table 2 below. The water temperature has reached the action level (30°C) due to hot weather. Monitoring will continue to check the health of aquatic species and the level of dissolved oxygen. No action is required from the Contractor. The water level of the pond is approximately at the +5.6mPD level, no water level adjustment is required. As a reminder, only freshwater can be pumped into the Grebe Pond. The contractor should regularly check the salinity level of the pumped water and avoid pumping water with high salinity level. 	<ul style="list-style-type: none"> NA NA Contractor Contractor
