EP-337/2009 – New Distributor Roads Serving the Planned KTD

Contract No. KL/2012/02  
Kai Tak Development – Stage 3A Infrastructure at Former  
North Apron Area

Monthly EM&A Report

December 2013

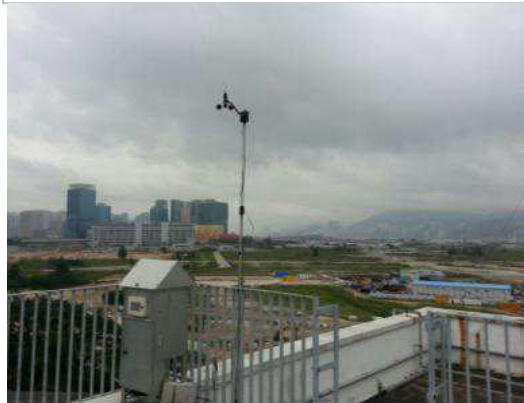
Anemometer Station from The Hong Kong Observatory
