EP-344/2009 – New Sewage Pumping Stations Serving KTD and
EP-337/2009 – New Distributor Roads Serving the Planned KTD

Contract No. KL/2012/03
Kai Tak Development – Stage 4 Infrastructure at
Former North Apron Area

Monthly EM&A Report

August 2014

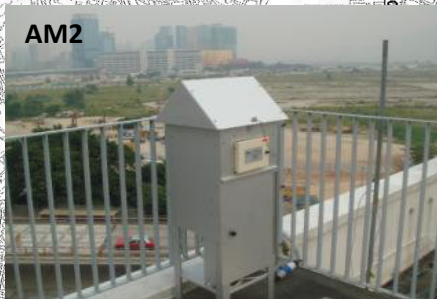
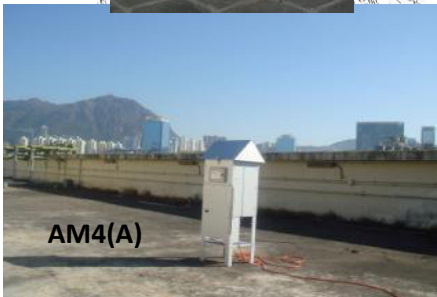
Title Contract No. KL/2012/03
 Kai Tak Development –Stage 4 Infrastructure at Former North Apron Area
 Air Quality Monitoring Stations under this Project

Location		Northing	Easting
AM2	Lee Kau Yan Memorial School	821441.245	838153.917
AM3(A)	Holy Trinity Bradbury Centre	820769.390	837522.115
AM4(A)	EMSD Workshops	820147.495	838155.791
AM5(A)	Po Leung Kuk Ngan Po Ling College	819300.323	837659.613

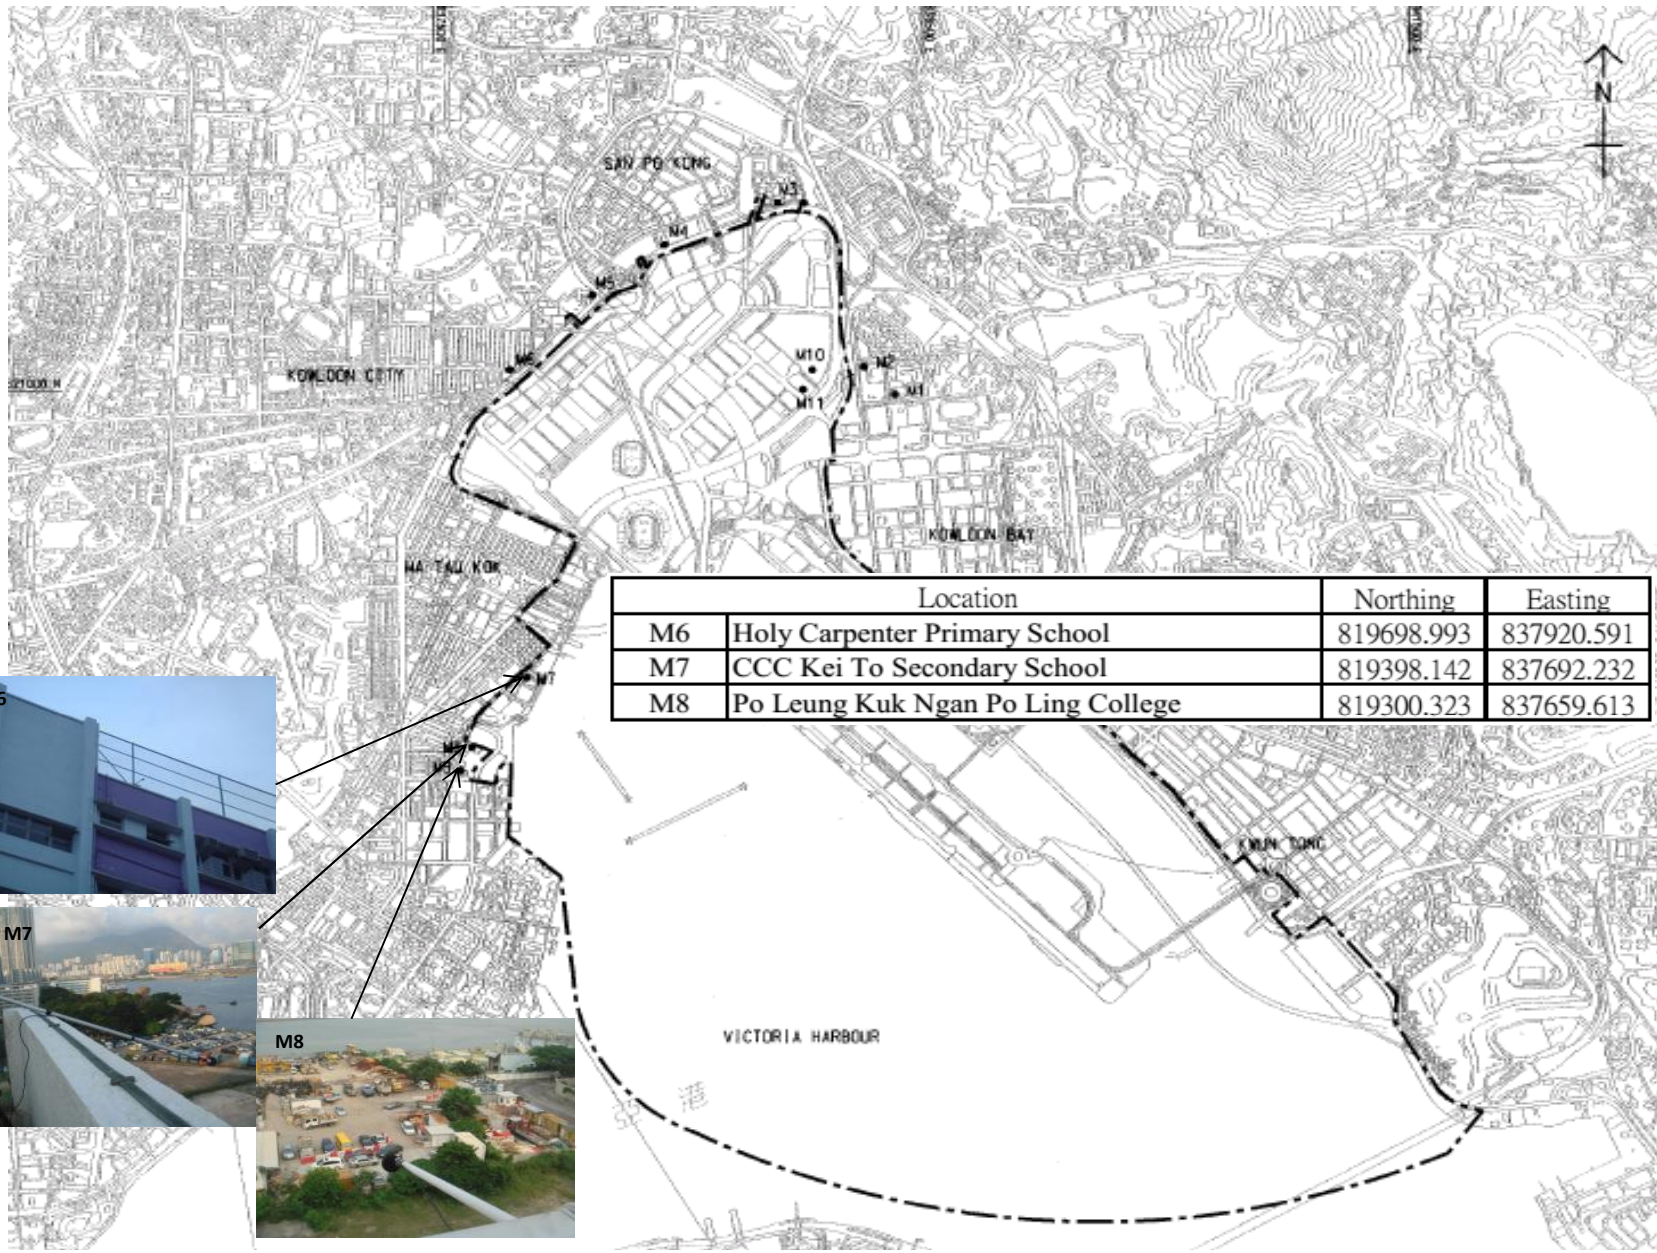
Scale	N.T.S	Project No.	MA13056
Date	Dec-13	Figure	3

Location		Northing	Easting
M6	Holy Carpenter Primary School	819698.993	837920.591
M7	CCC Kei To Secondary School	819398.142	837692.232
M8	Po Leung Kuk Ngan Po Ling College	819300.323	837659.613

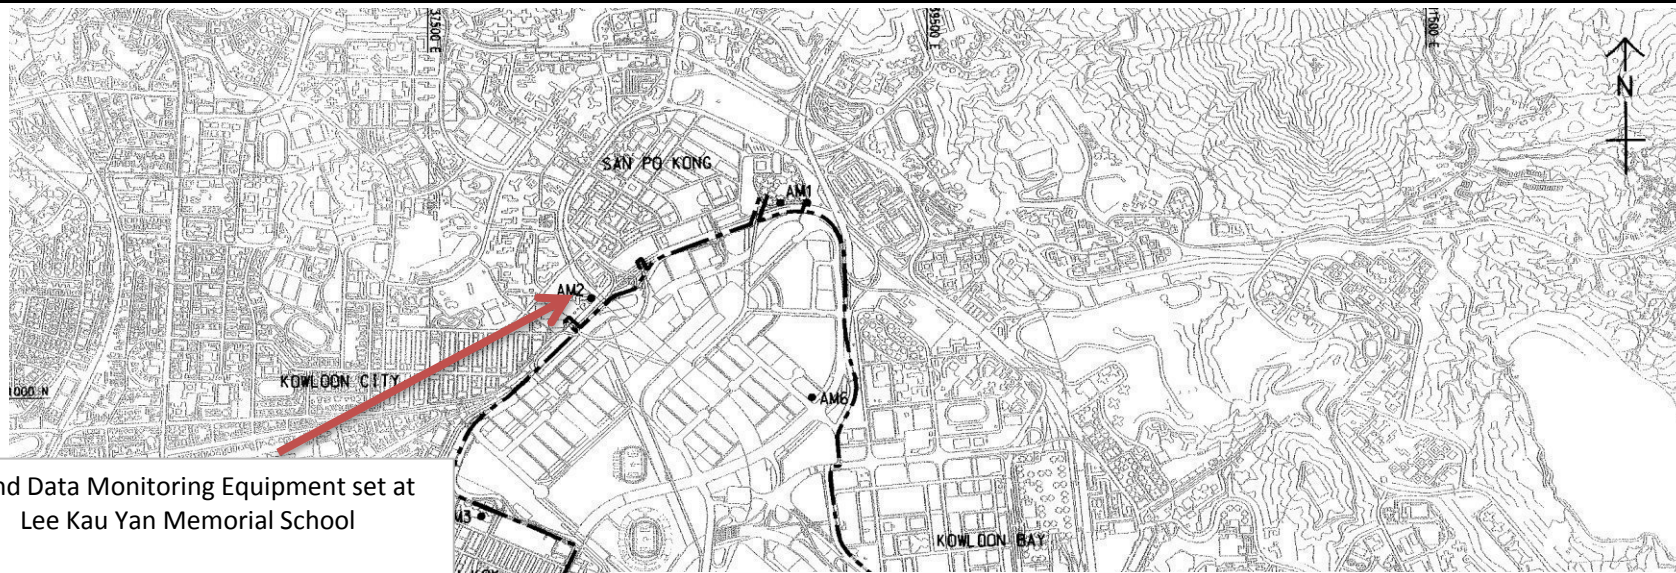
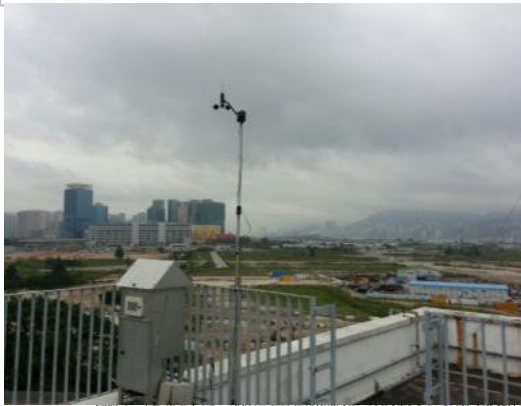
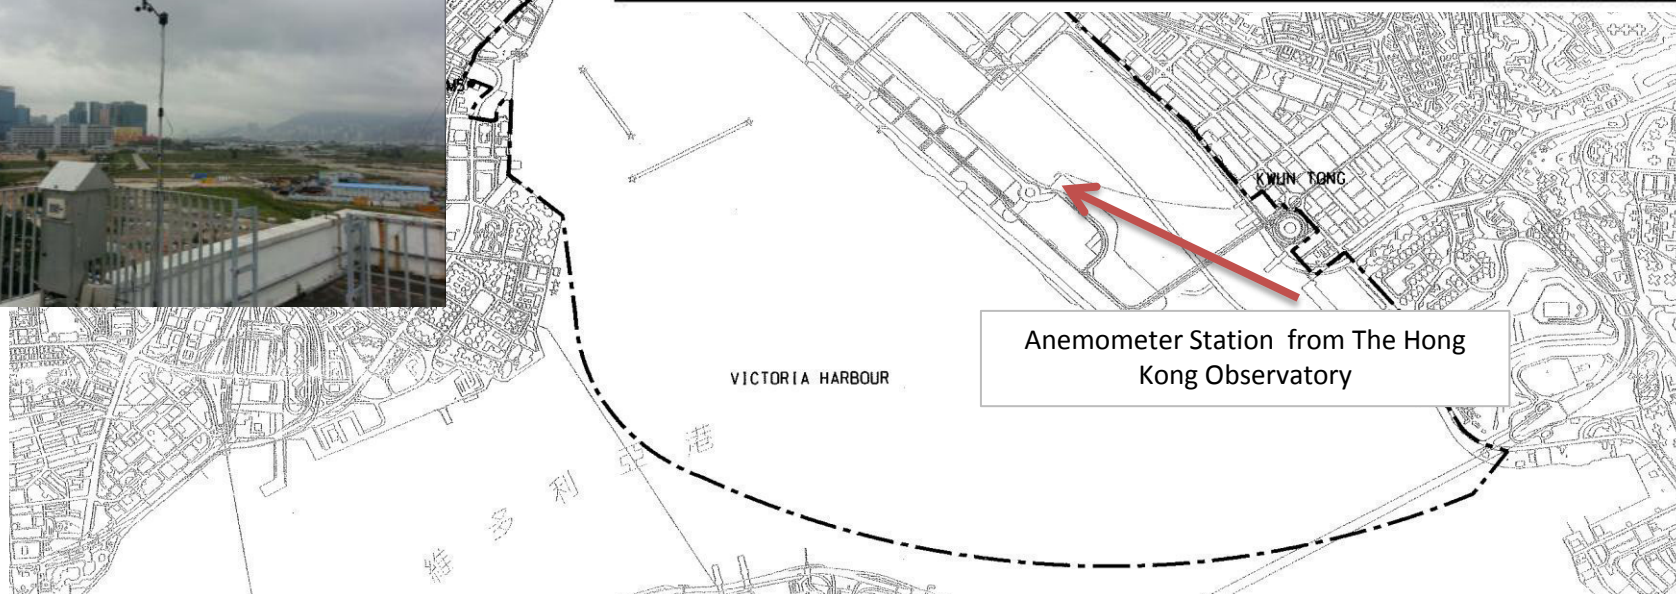
Title	Contract No. KL/2012/03		Scale	Project	CINOTECH
	Kai Tak Development –Stage 4 Infrastructure at Former North Apron Area		N.T.S	No. MA13056	
	Location of Wind Data Monitoring Equipment		Date	Figure	
			Dec-13	4

Wind Data Monitoring Equipment set at Lee Kau Yan Memorial School

Wind Monitoring Location	Northing	Easting
Lee Kau Yan Memorial School	821441.245	838153.917

Anemometer Station from The Hong Kong Observatory

- 2.21 The air temperature, precipitation and the relative humidity data was obtained from Hong Kong Observatory where the wind speed and wind direction were recorded by the installed Wind Anemometer set at rooftop (about 8/F) Lee Kau Yan Memorial School. The location is shown in **Figure 4**. This weather information for the reporting month is summarized in **Appendix C**.

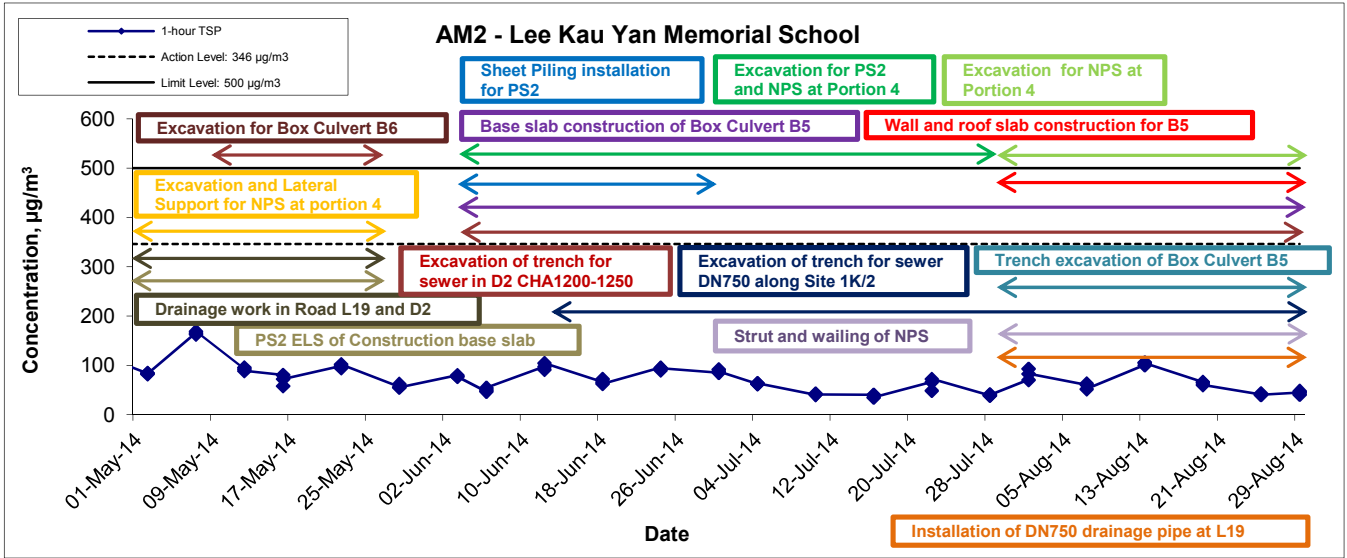
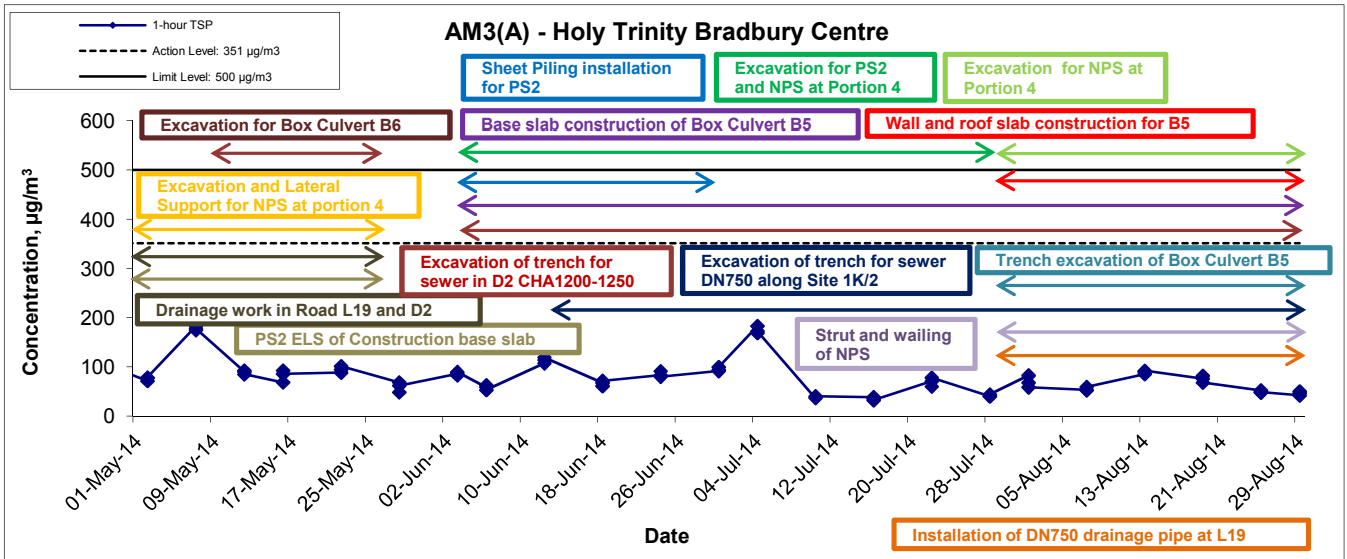
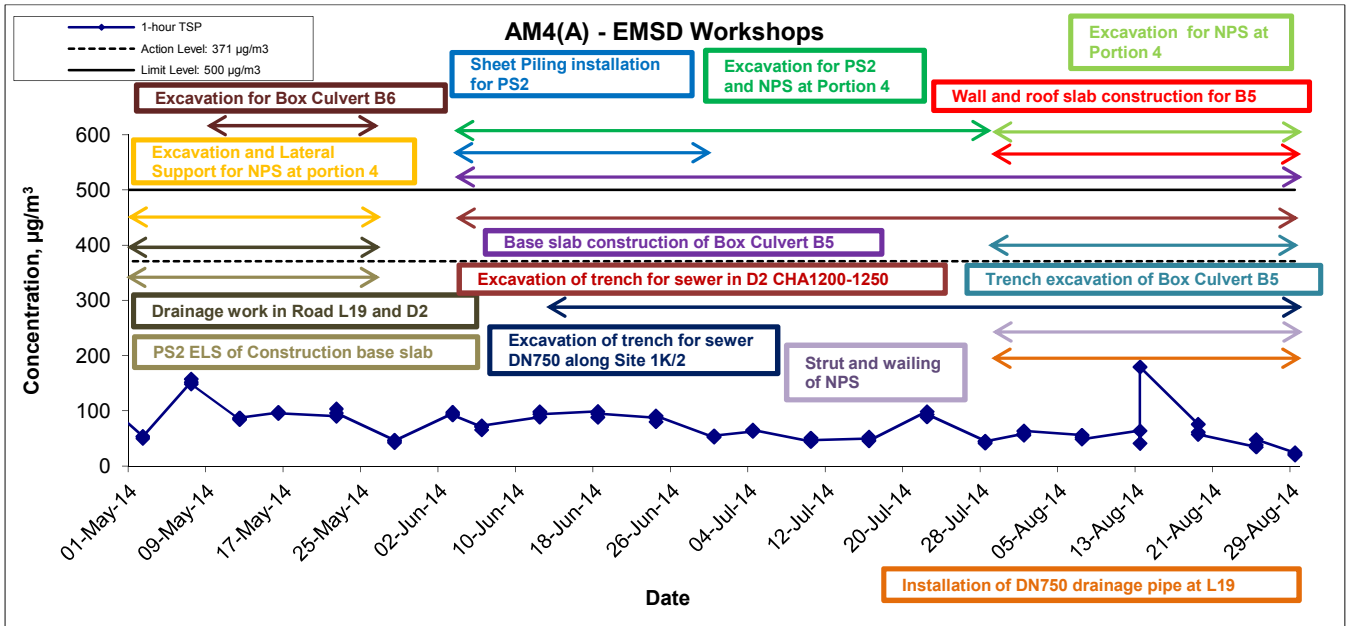
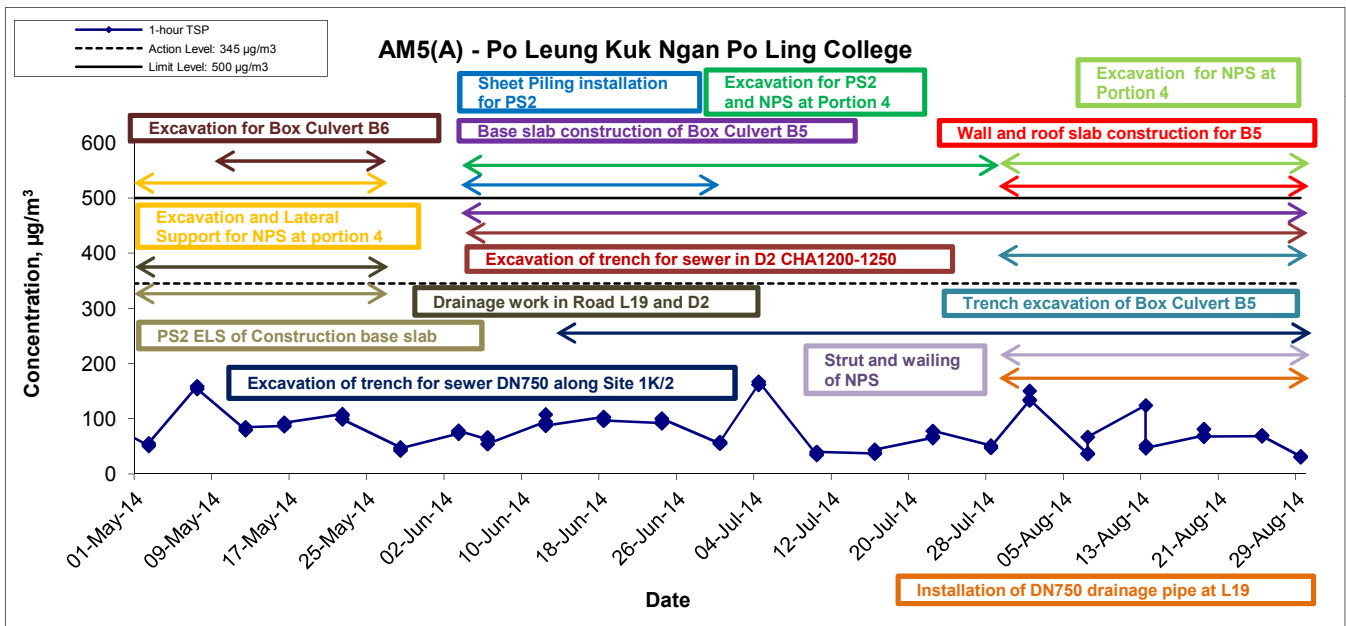
Title	Contract No. KLN/2013/16	Scale	N.T.S	Project No.	MA14008	CINOTECH
	Environmental Monitoring Works for Kai Tak Development	Date	Aug 14	Appendix	E	
Graphical Presentation of 1-hour TSP Monitoring Results

1-hr TSP Concentration Levels

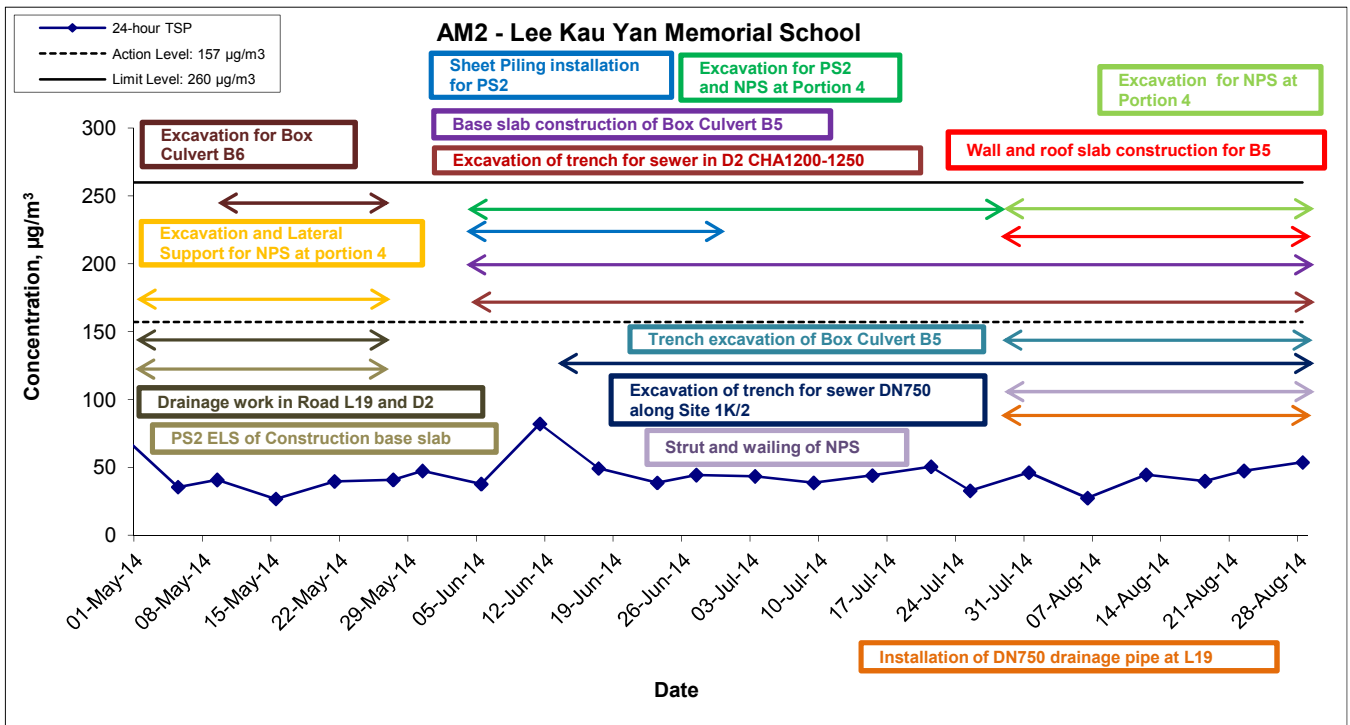
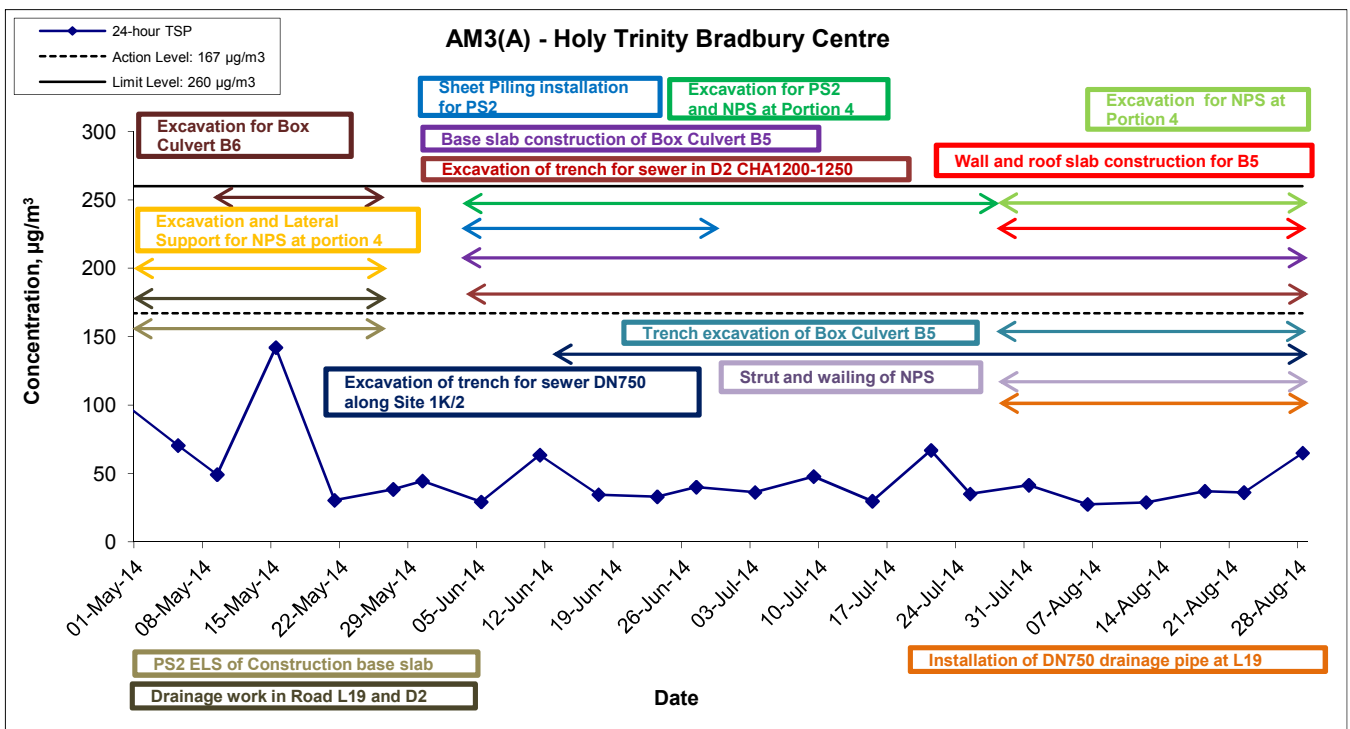
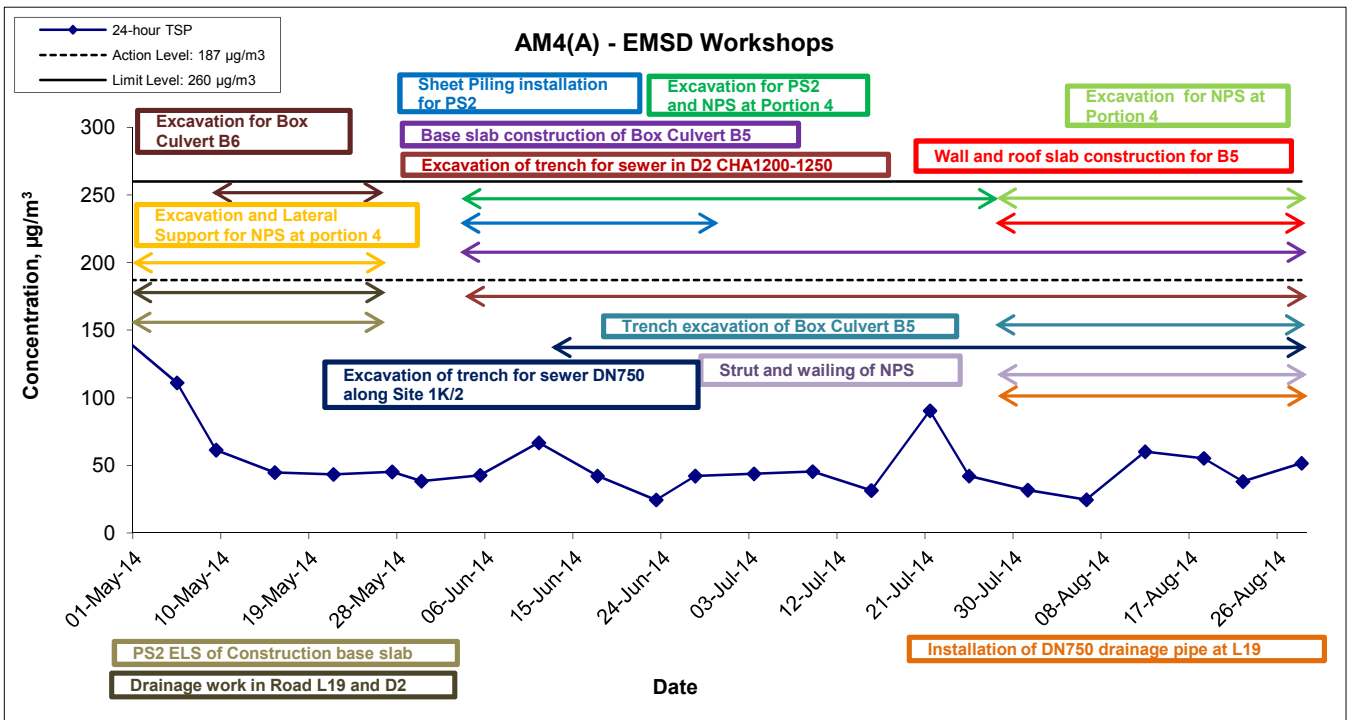
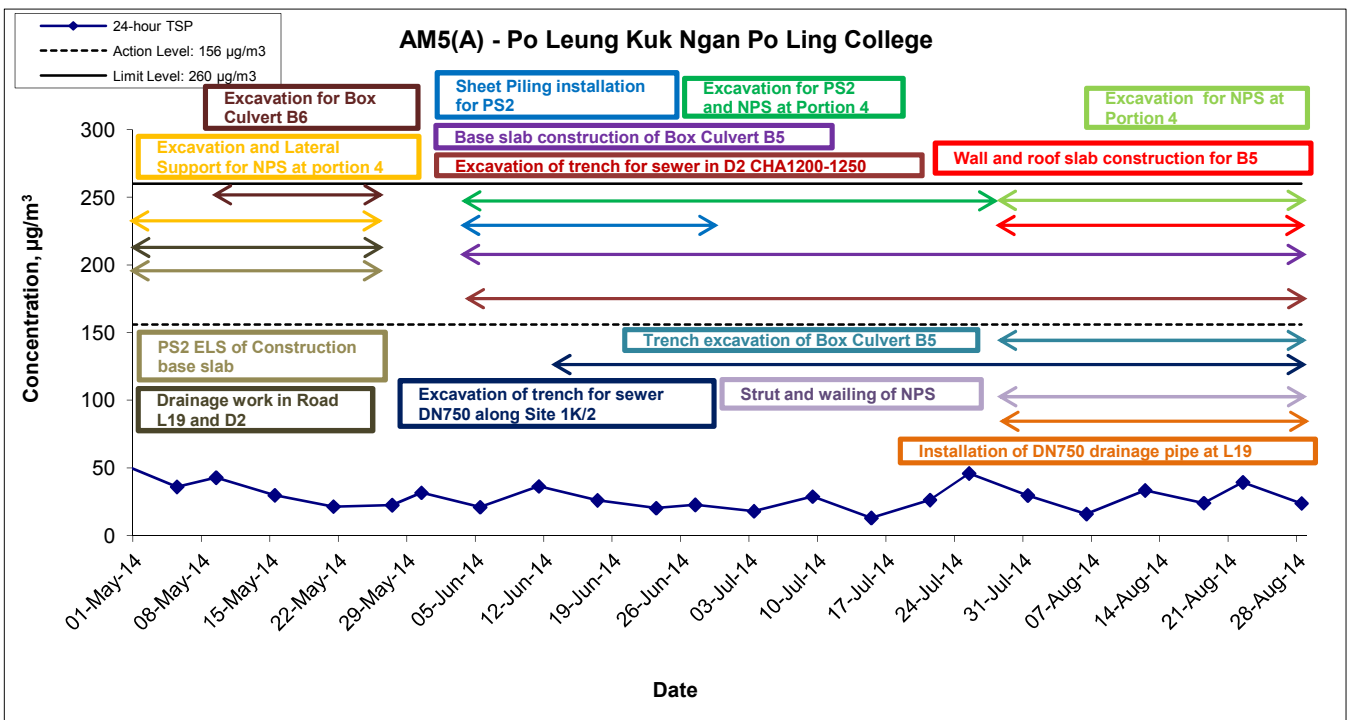
Title	Contract No. KLN/2013/16	Scale	N.T.S	Project No.	MA14008	CINOTECH
	Environmental Monitoring Works for Kai Tak Development	Date	Aug 14	Appendix	F	
Graphical Presentation of 24-hour TSP Monitoring Results

24-hr TSP Concentration Levels

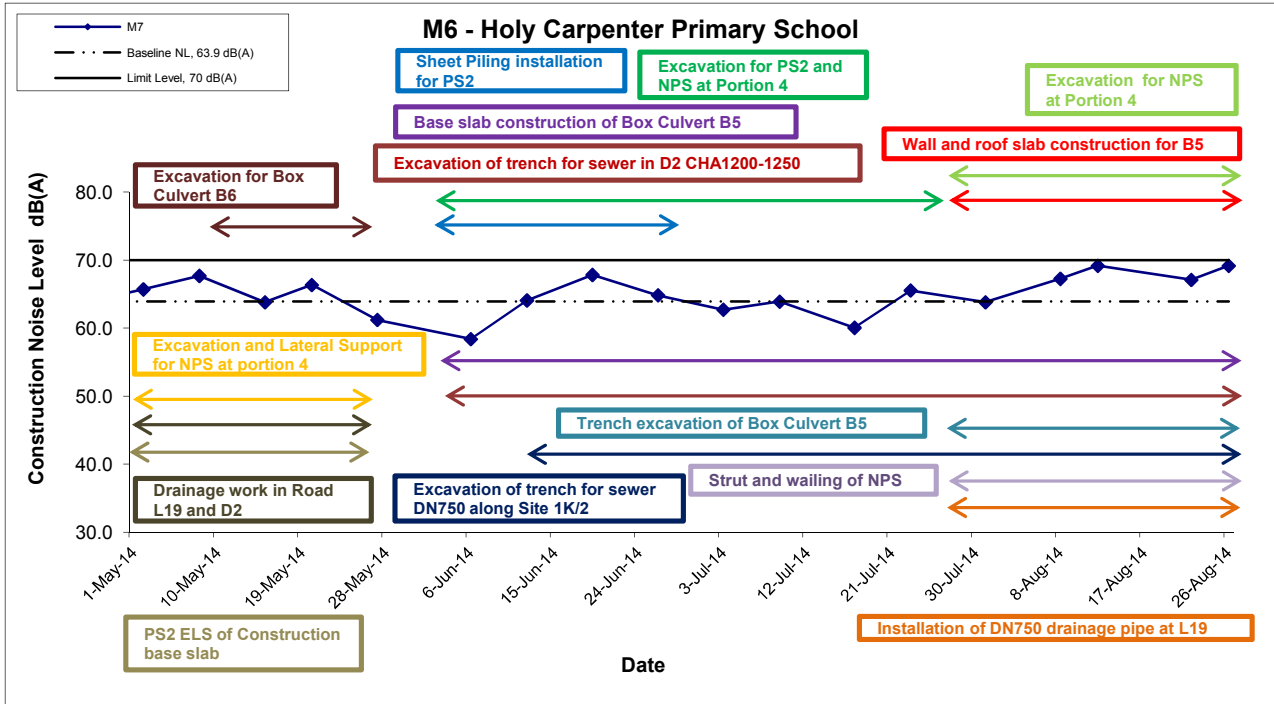
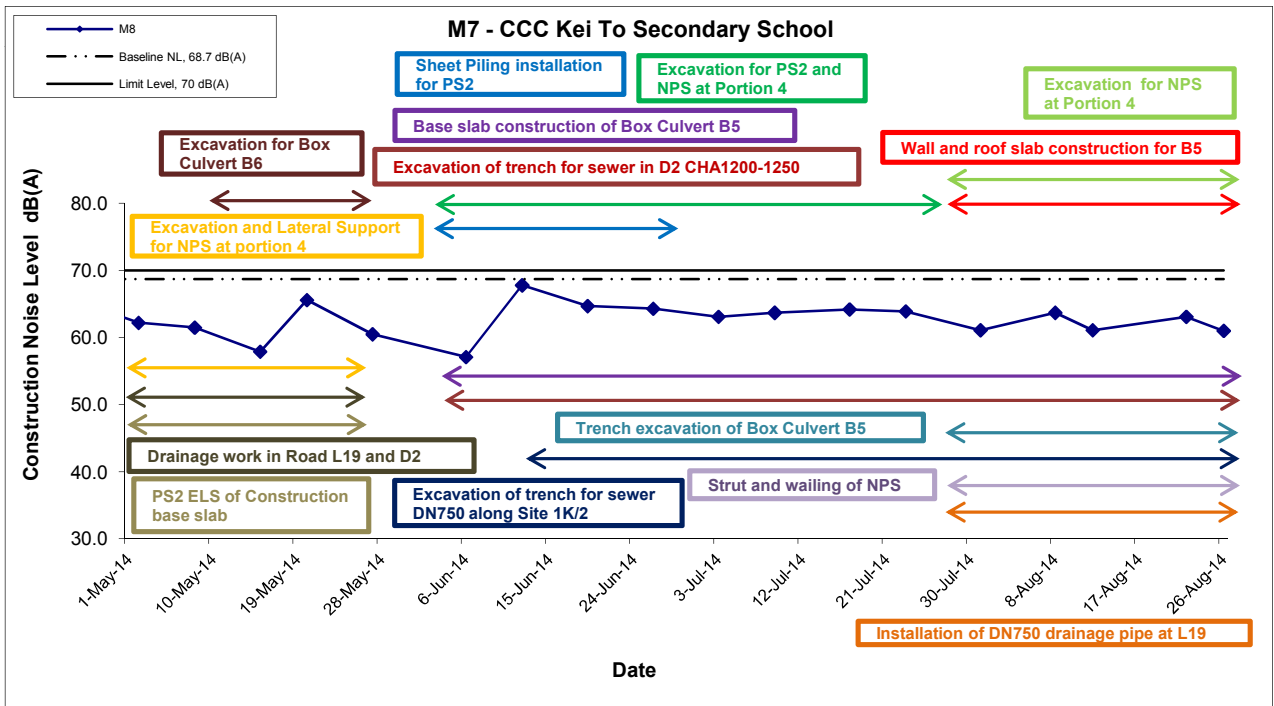
Title Contract No. KLN/2010/04 Environmental Monitoring Works for Kai Tak Development Graphical Presentation of Construction Noise Monitoring Results	Scale N.T.S	Project No. MA14008	CINOTECH
	Date Aug 14	Appendix G

Noise Levels

Remarks: The construction noise levels in the Tables in Appendix G were adopted for plotting the graphs

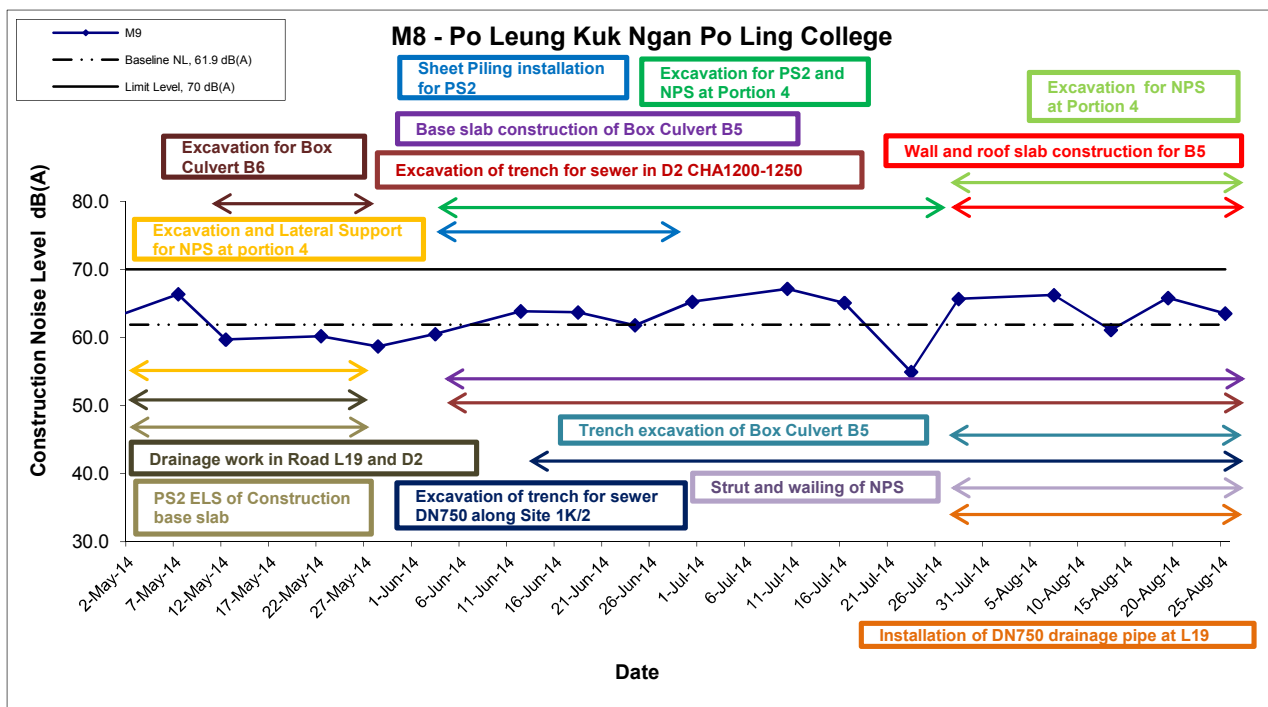
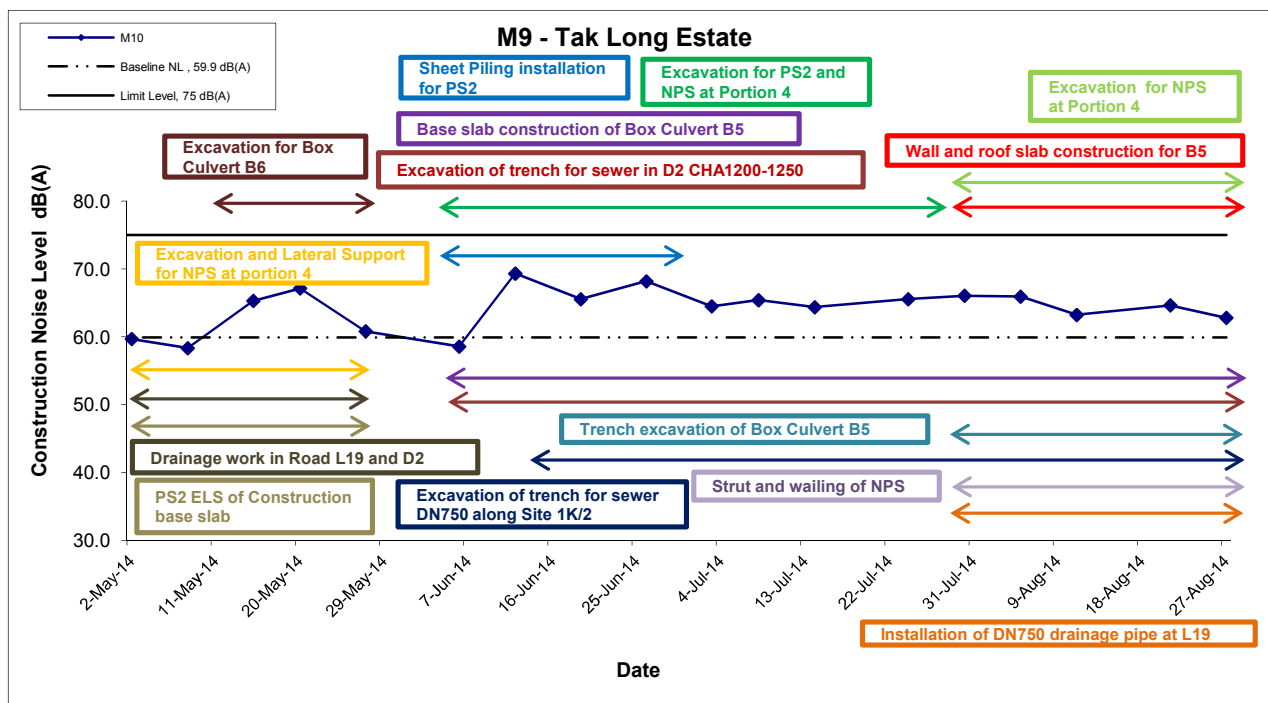
Title Contract No. KLN/2010/04 Environmental Monitoring Works for Kai Tak Development Graphical Presentation of Construction Noise Monitoring Results	Scale N.T.S	Project No. MA14008	CINOTECH
	Date Aug 14	Appendix G

Noise Levels

Remarks: The construction noise levels in the Tables in Appendix G were adopted for plotting the graphs
