EP-337/2009 - New Distributor Roads Serving the Planned KTD

Contract No. KL/2012/02 Kai Tak Development –Stage 3A Infrastructure at Former North Apron Area

Monthly EM&A Report

September 2014

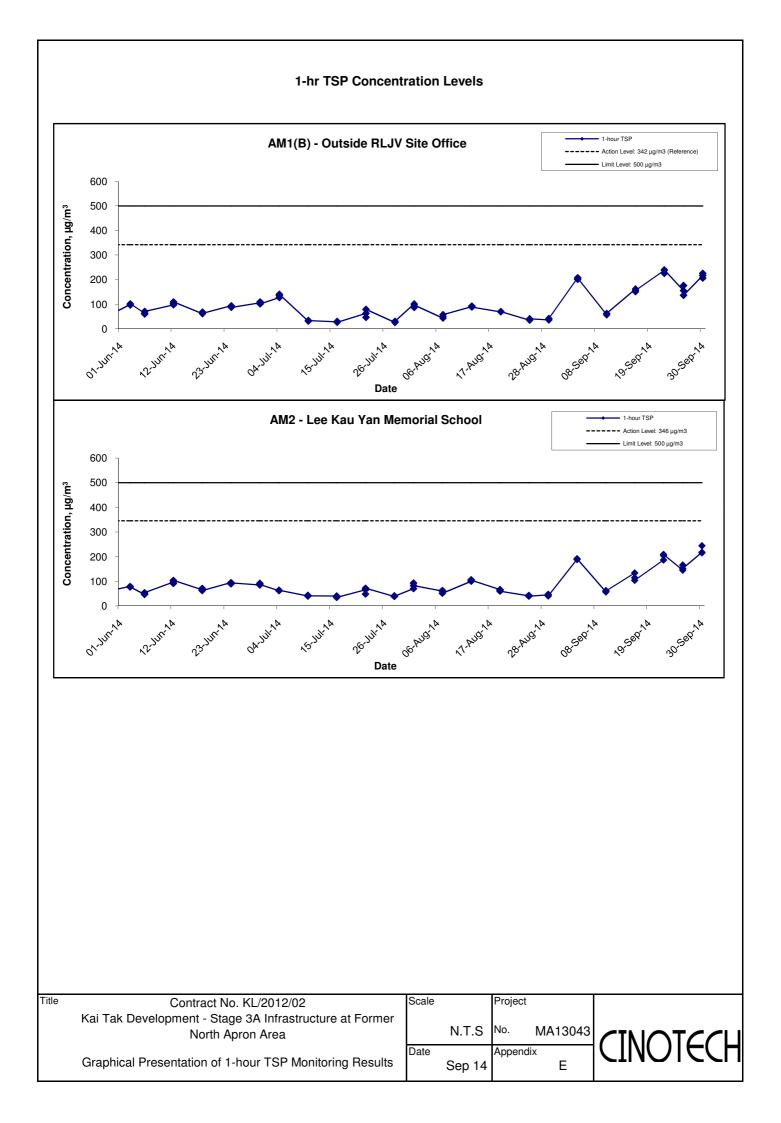
# Appendix E - 1-hour TSP Monitoring Results

Location AM2 -	Lee Kau Yar	n Memorial School	
Date	Time	Weather	Particulate Concentration ( $\mu$ g/m <sup>3</sup> )
4-Sep-14	9:00	Cloudy	189.4
4-Sep-14	10:00	Cloudy	189.1
4-Sep-14	11:00	Cloudy	192.0
10-Sep-14	13:35	Sunny	57.3
10-Sep-14	14:35	Sunny	61.8
10-Sep-14	15:35	Sunny	60.7
16-Sep-14	13:00	Rainy	134.2
16-Sep-14	14:00	Rainy	114.5
16-Sep-14	15:00	Rainy	104.3
22-Sep-14	13:03	Cloudy	186.9
22-Sep-14	14:03	Cloudy	204.5
22-Sep-14	15:03	Cloudy	209.5
26-Sep-14	9:00	Cloudy	145.4
26-Sep-14	10:00	Cloudy	165.6
26-Sep-14	11:00	Cloudy	152.3
30-Sep-14	13:30	Cloudy	217.9
30-Sep-14	14:30	Cloudy	244.5
30-Sep-14	15:30	Cloudy	215.9
		Average	158.1
		Maximum	244.5
		Minimum	57.3

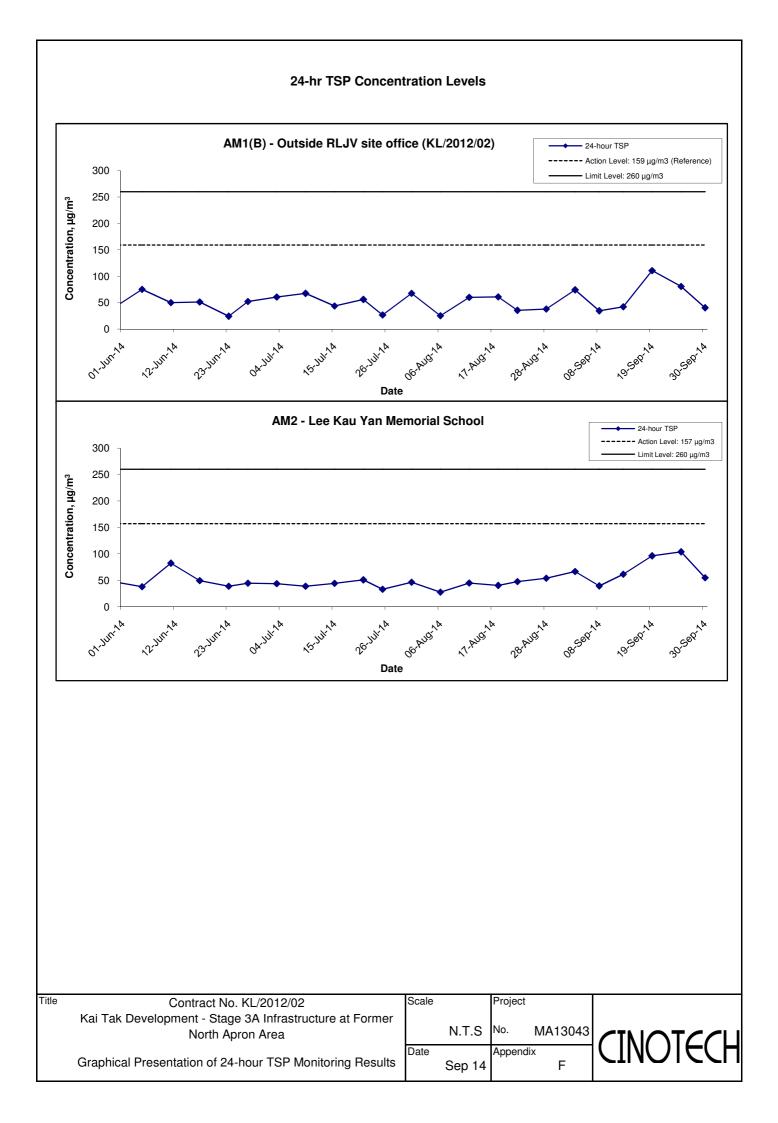
#### Appendix F - 24-hour TSP Monitoring Results

Max 103.5 Average 70.2

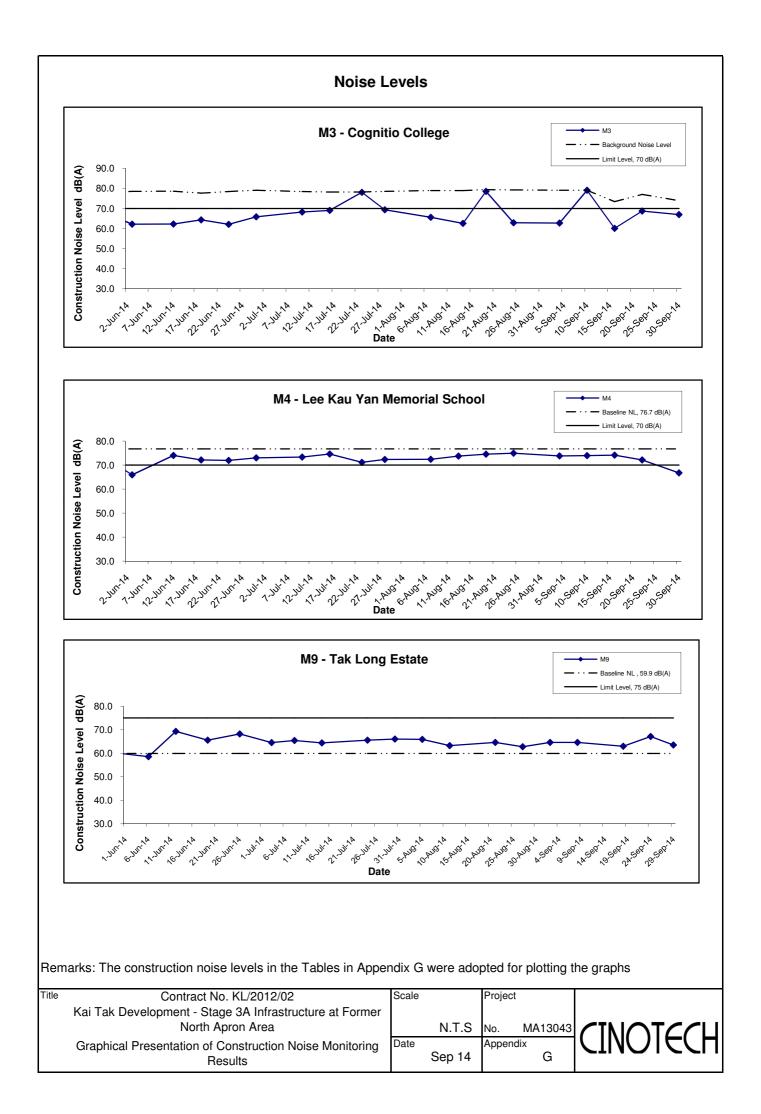
#### Appendix G - Noise Monitoring Results

Un	it: dB (A) (30-min)	
Date	Time	Weather	Mea	sured Noise	Level	Baseline Level	Construction Noise Leve
			L <sub>eq</sub>	L <sub>10</sub>	L <sub>90</sub>	L <sub>eq</sub>	L <sub>eq</sub>
2-Sep-14	13:10	Sunny	65.9	66.3	64.2		64.6
8-Sep-14	9:15	Sunny	65.9	67.8	63.4		64.6
18-Sep-14	9:15	Sunny	64.7	66.4	62.8	59.9	63.0
24-Sep-14	13:00	Cloudy	67.9	68.3	60.7		67.2
29-Sep-14	9:15	Sunny	65.1	66.9	62.7		63.5
