EP-337/2009 - New Distributor Roads Serving the Planned KTD

Contract No. KL/2012/02 Kai Tak Development –Stage 3A Infrastructure at Former North Apron Area

Quarterly EM&A Report

May 2015 to July 2015

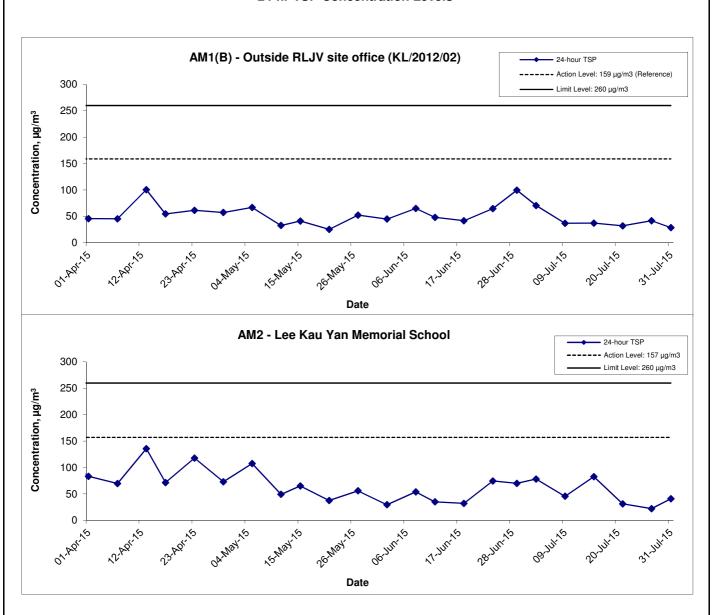
24-hr TSP Concentration Levels

Title Contract No. KL/2012/02 Kai Tak Development - Stage 3A Infrastructure at Former	Scale	Project No.	451054
North Apron Area	N.T.S	MA13043	ICINIOTEC
Graphical Presentation of 24-hour TSP Monitoring Results	Date Jul 15	Appendix C

- 3.4 24-hr TSP monitoring at 2 monitoring stations, AM1(B) and AM2, was also conducted as schedule in the reporting period. No Action/Limit Level exceedance was recorded for 24-hr TSP monitoring in the reporting quarter.
- 3.5 The graphical presentations of the air quality monitoring results are shown in **Appendix C**.
