EP-337/2009 - New Distributor Roads Serving the Planned KTD

Contract No. KL/2012/02

Kai Tak Development –Stage 3A Infrastructure at Former

Monthly EM&A Report

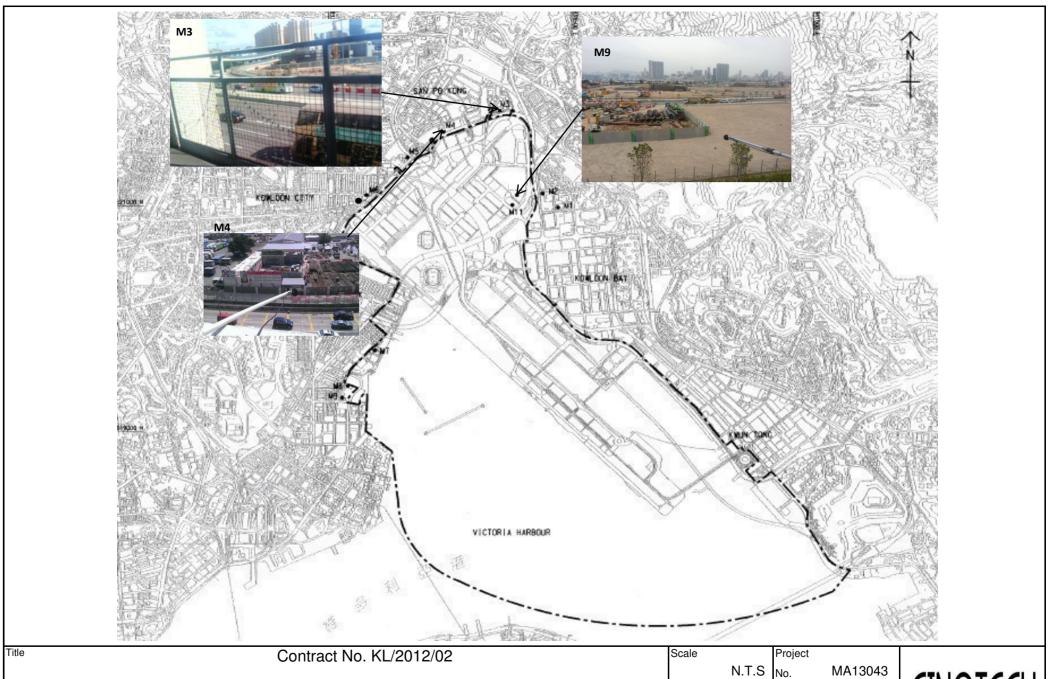
Date Figure 3

Noise Monitoring Stations under Contract No.: KLN/2013/16

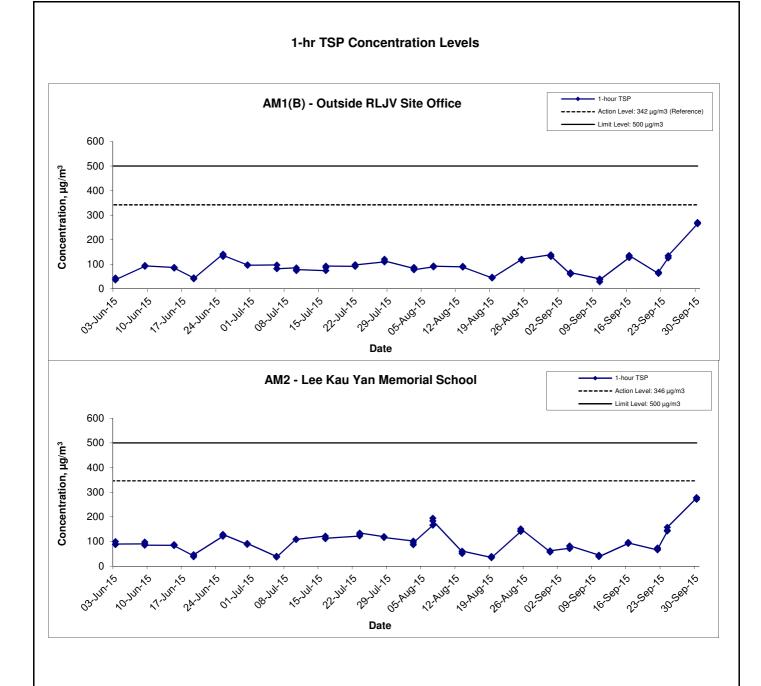
Title Contract No. KL/2012/02
Kai Tak Development - Stage 3A Infrastructure at Former North Apron Area
Graphical Presentation of 1-hour TSP Monitoring Results

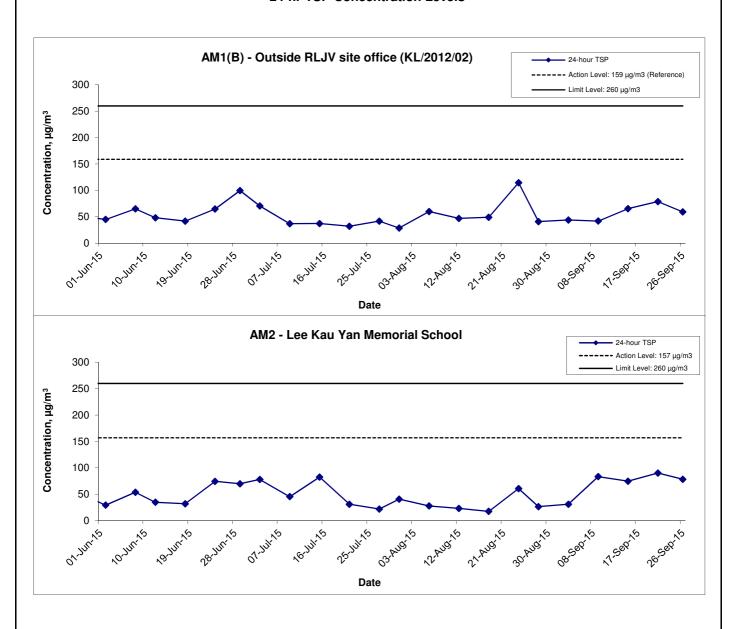
24-hr TSP Concentration Levels

Title	Contract No. KL/2012/02 Kai Tak Development - Stage 3A Infrastructure at Former North Apron Area	Scale	N.T.S	Project No.	MA13043	CINOTECH
	Graphical Presentation of 24-hour TSP Monitoring Results	Date	Sep 15	Appendi	F	CINOISCU
