EP-337/2009 -- New Distributor Roads Serving the Planned KTD

Contract No. KL/2012/02

Kai Tak Development -- Stage 3A Infrastructure at Former
North Apron Area

Monthly EM&A Report

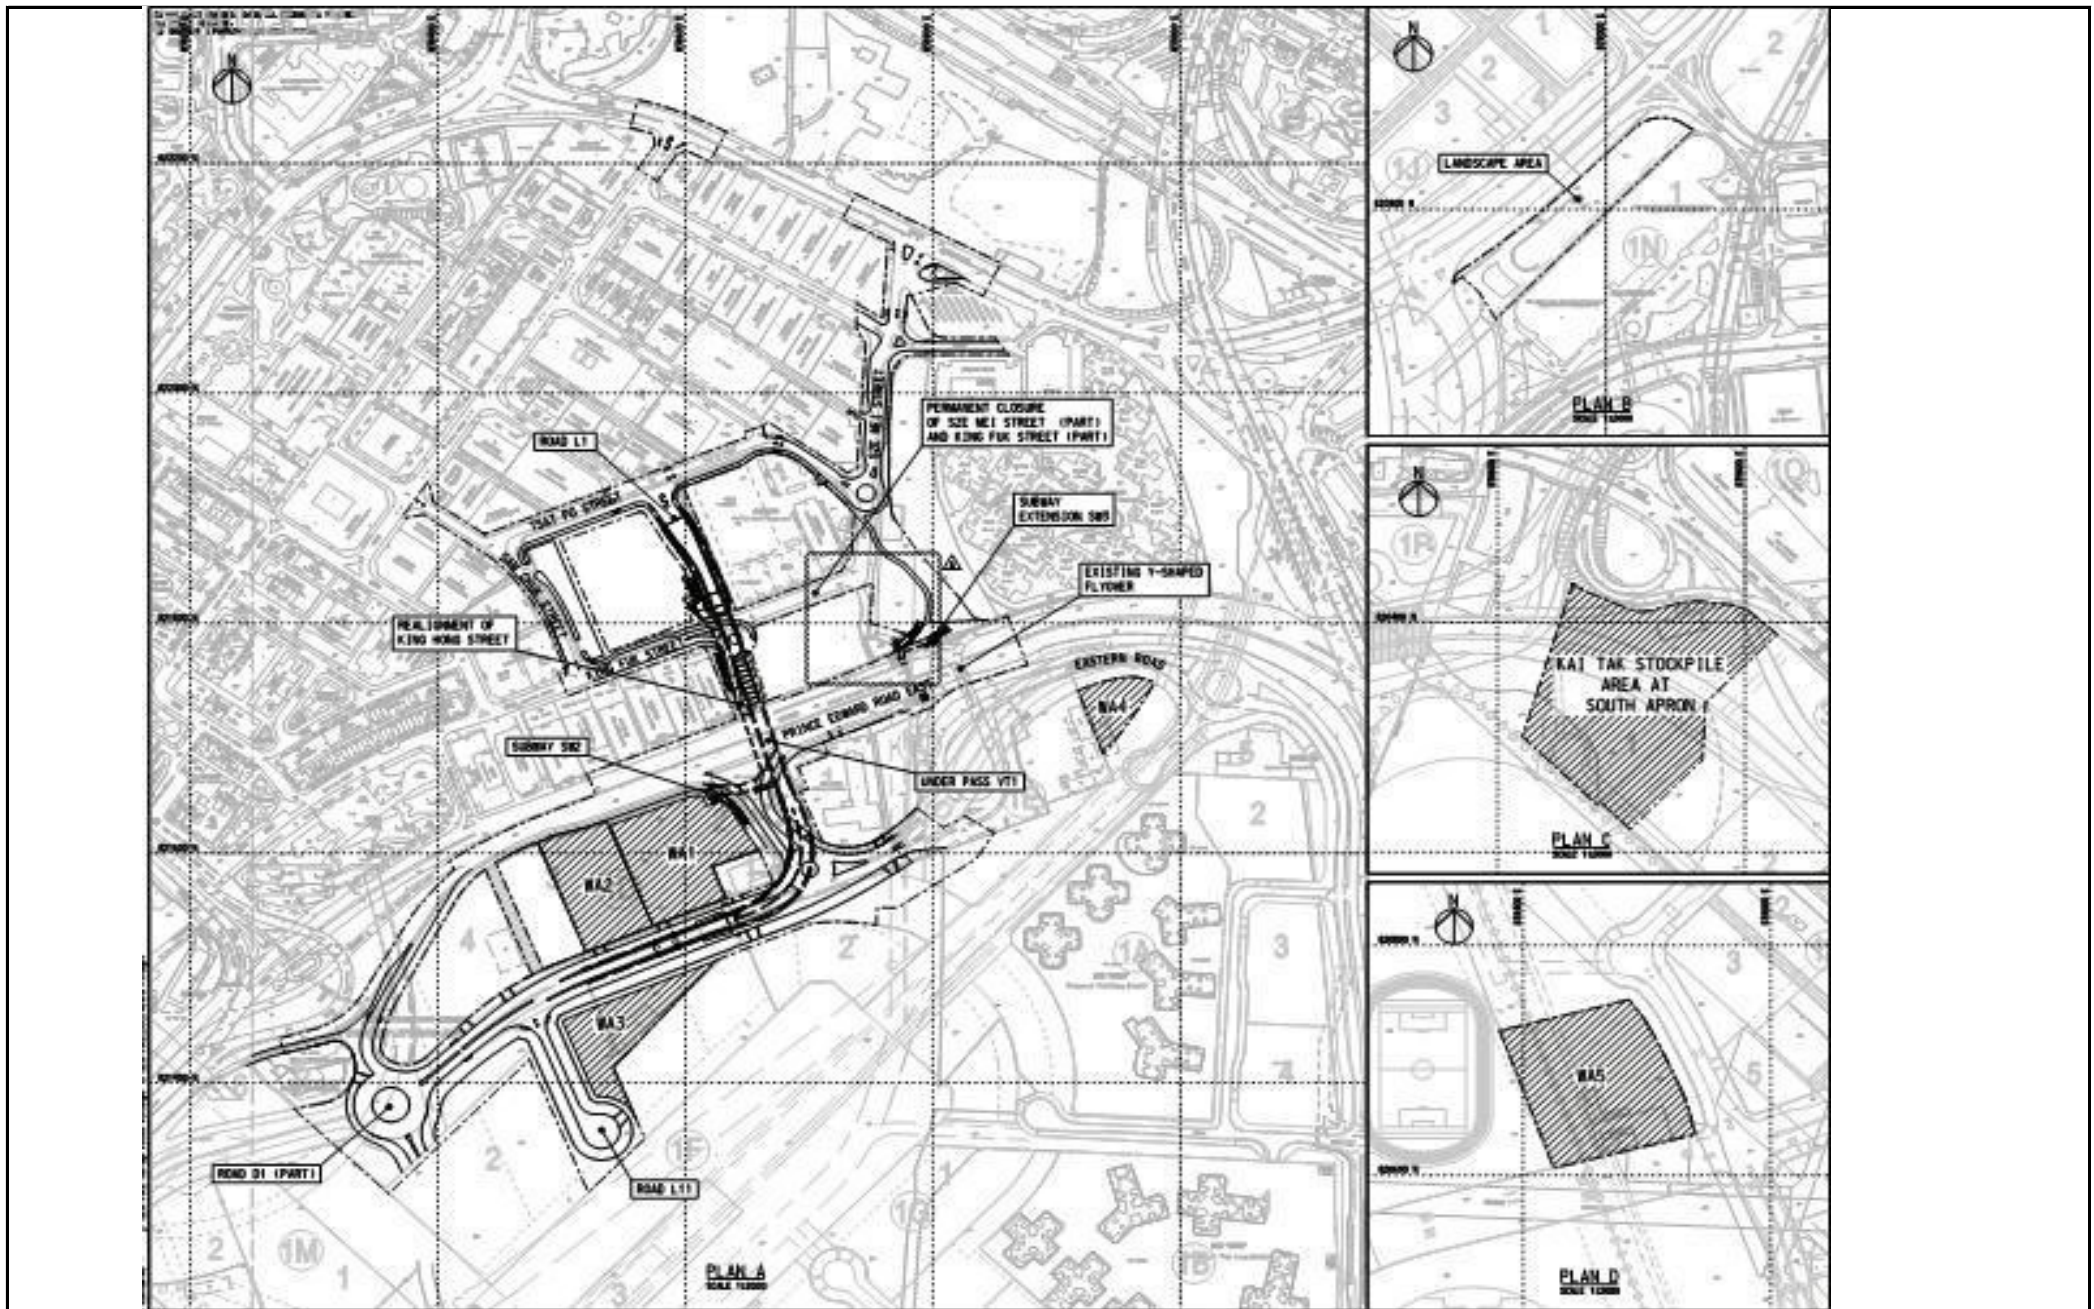
Title	Contract No. KL/2012/02		Scale	Project
	Kai Tak Development –Stage 3A Infrastructure at Former North Apron Area		N.T.S	No. MA13043
Site Layout Plan			Date	Figure
			Aug-13	1

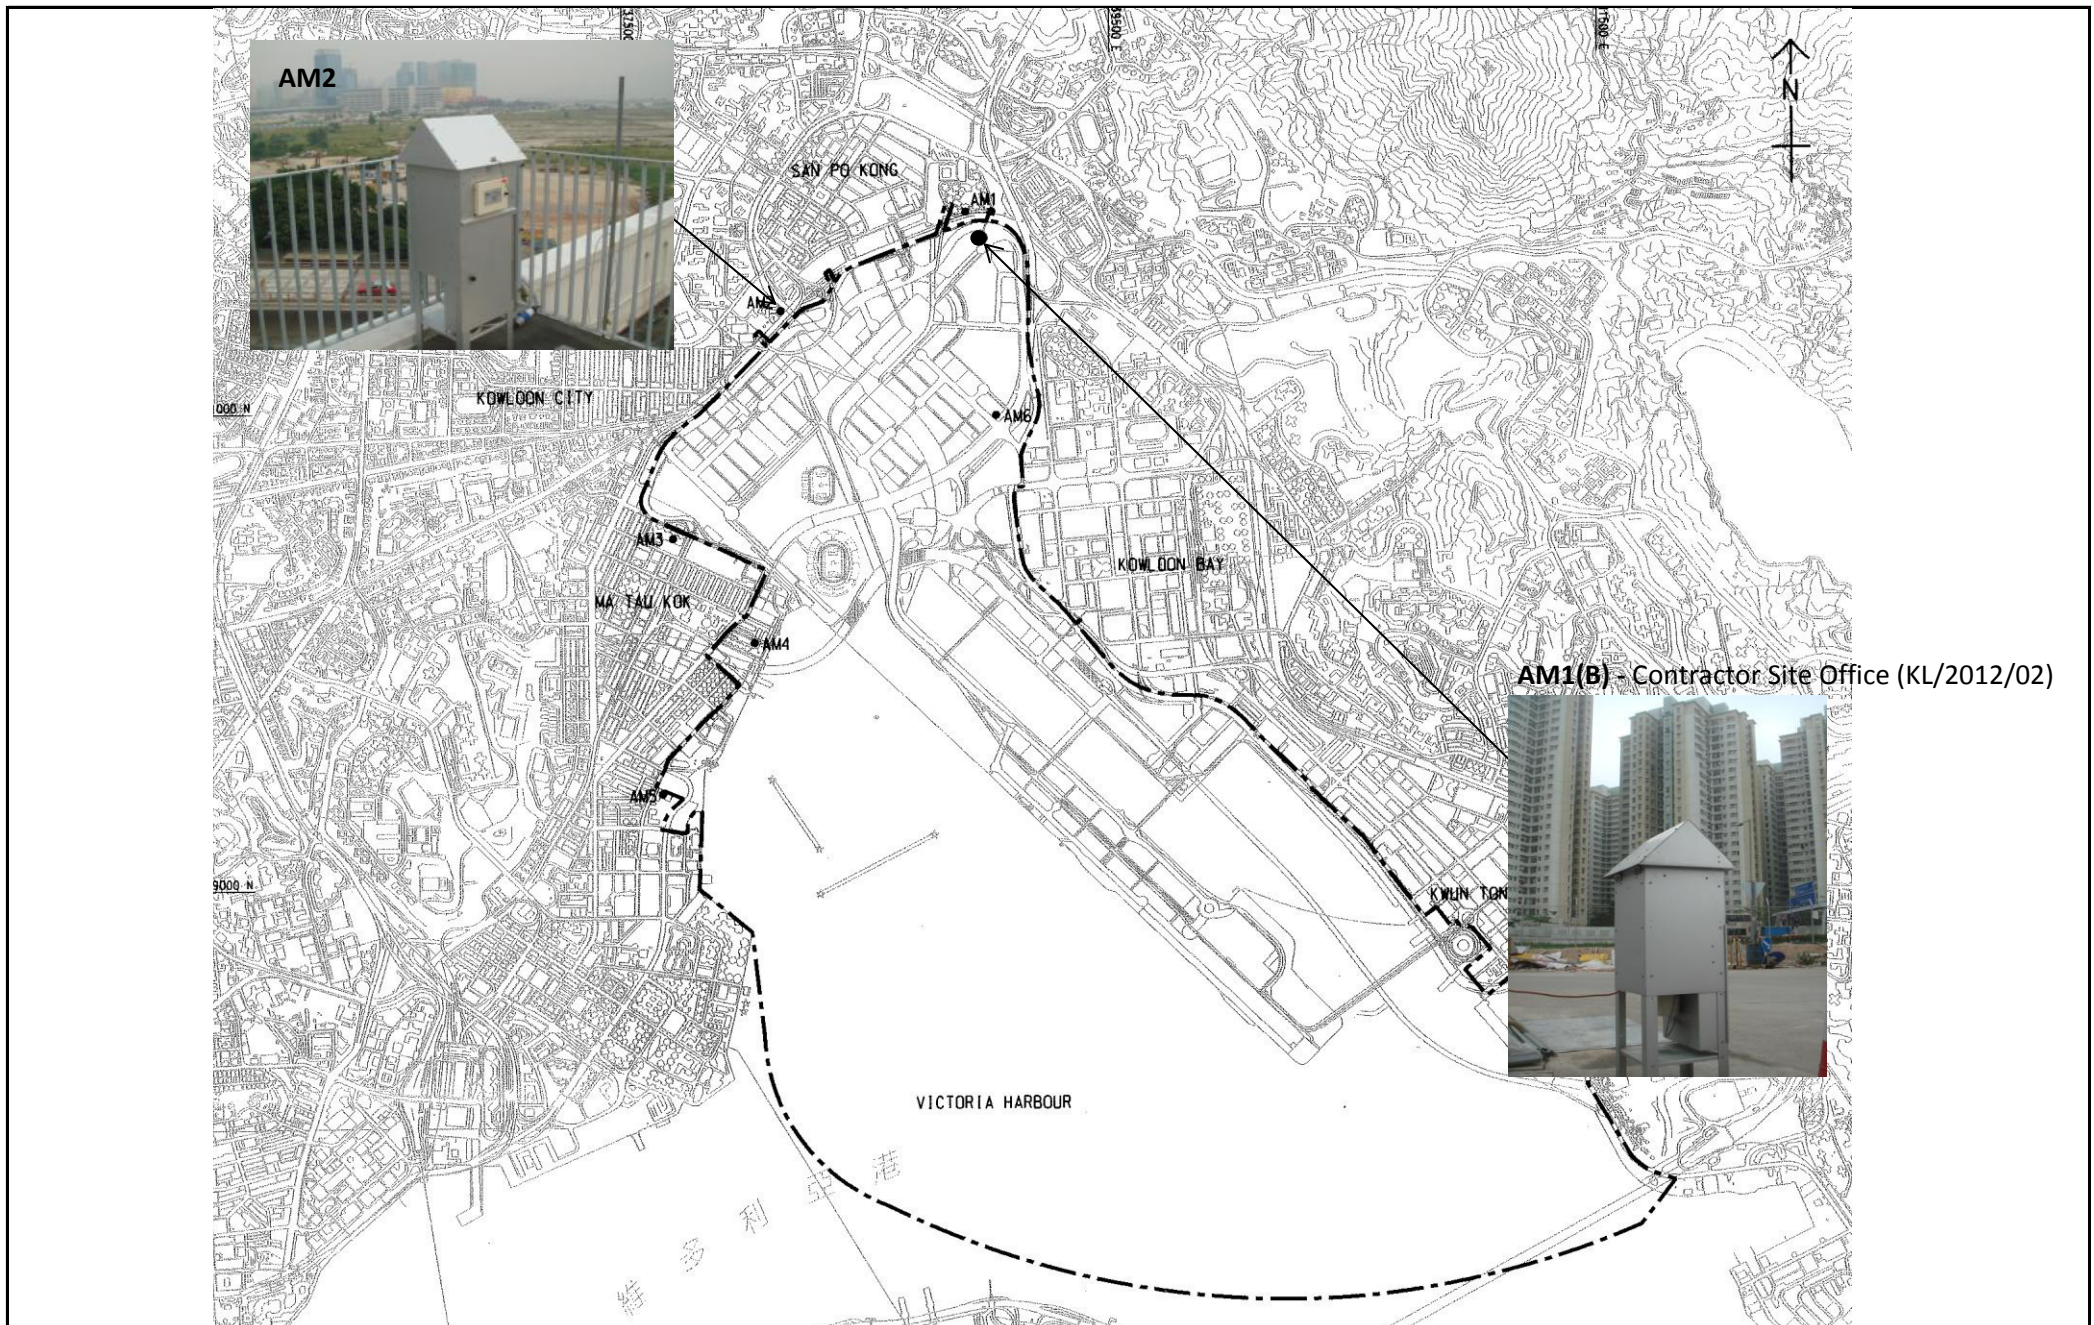
Title	Contract No. KL/2012/02		Scale	Project
	Kai Tak Development –Stage 3A Infrastructure at Former North Apron Area		N.T.S	No. MA13043
Date			Figure	
Air Quality Monitoring Stations under Contract No.: KLN/2013/16		Apr-14	2	CINOTECH

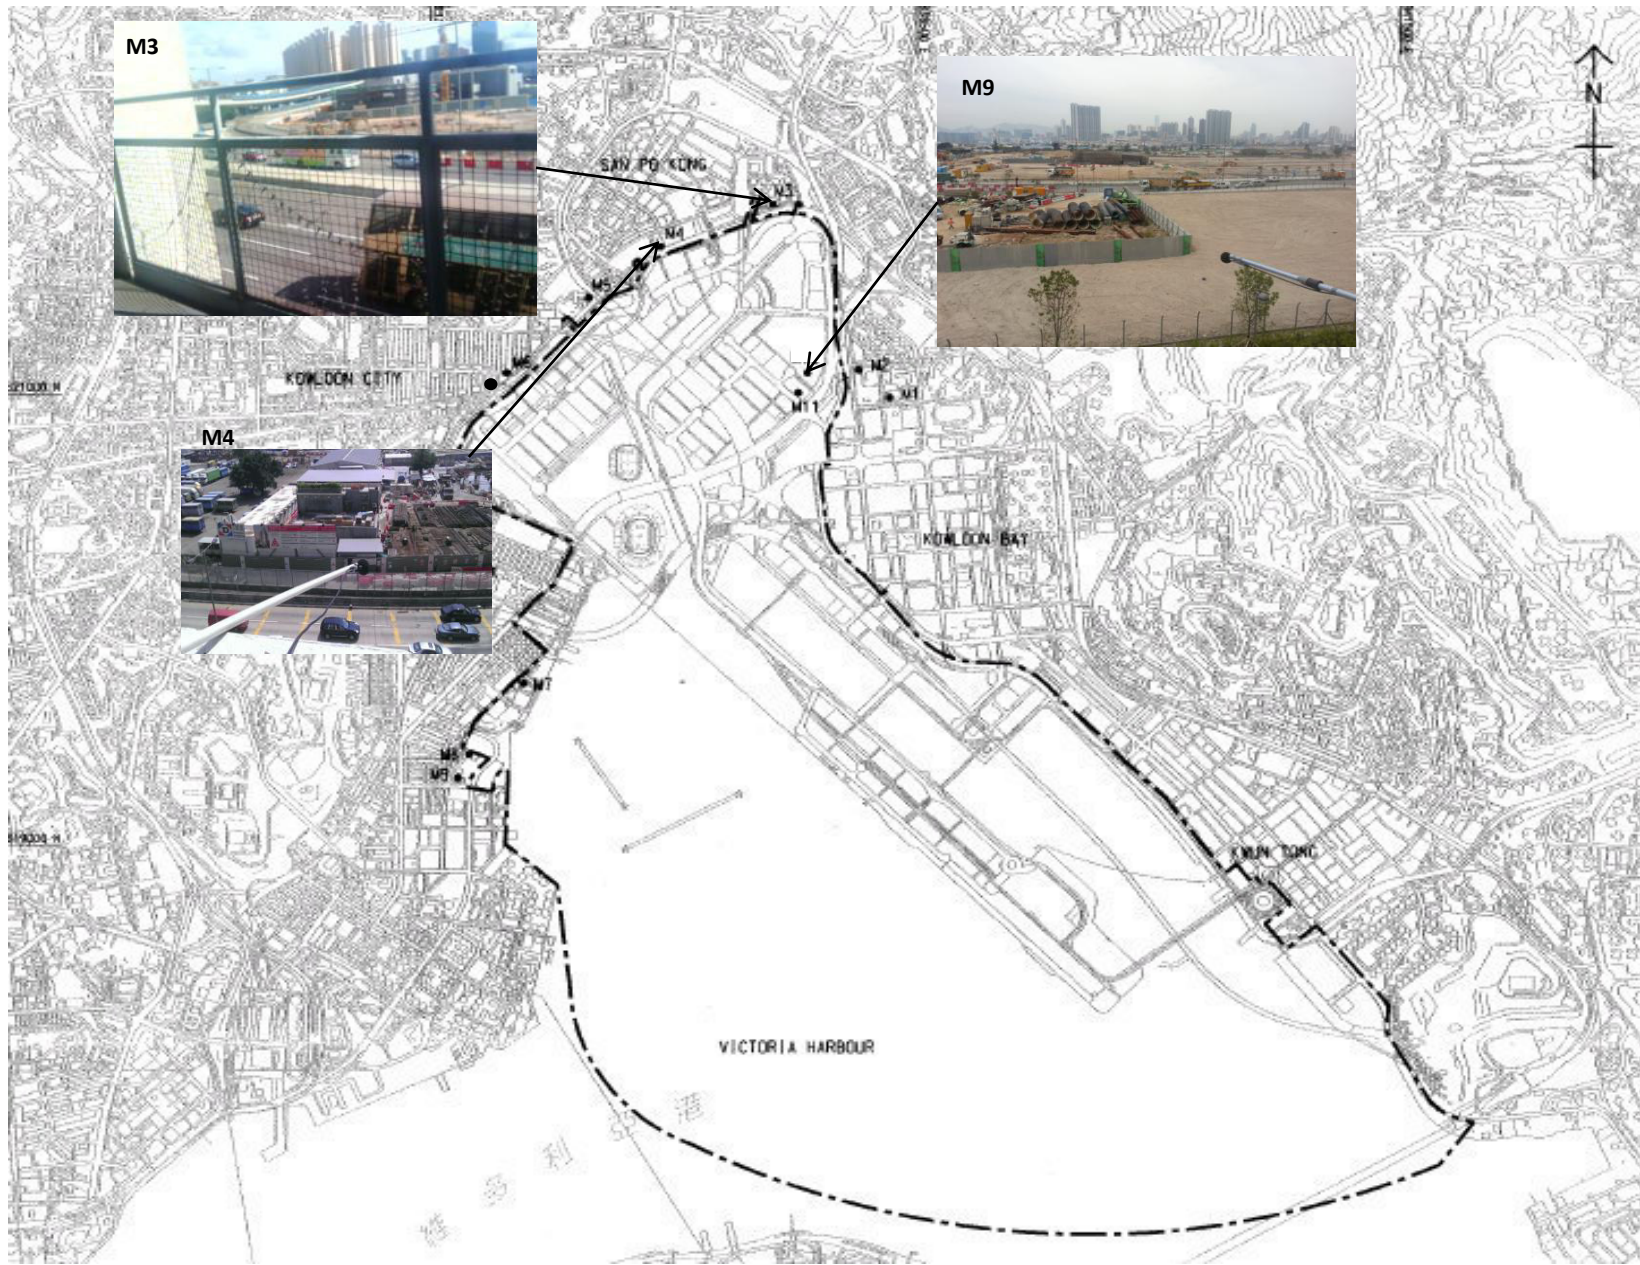
Date Apr-14	Figure 3

Title Contract No. KL/2012/02 Kai Tak Development –Stage 3A Infrastructure at Former North Apron Area Noise Monitoring Stations under Contract No.: KLN/2013/16	Scale N.T.S	Project No. MA13043

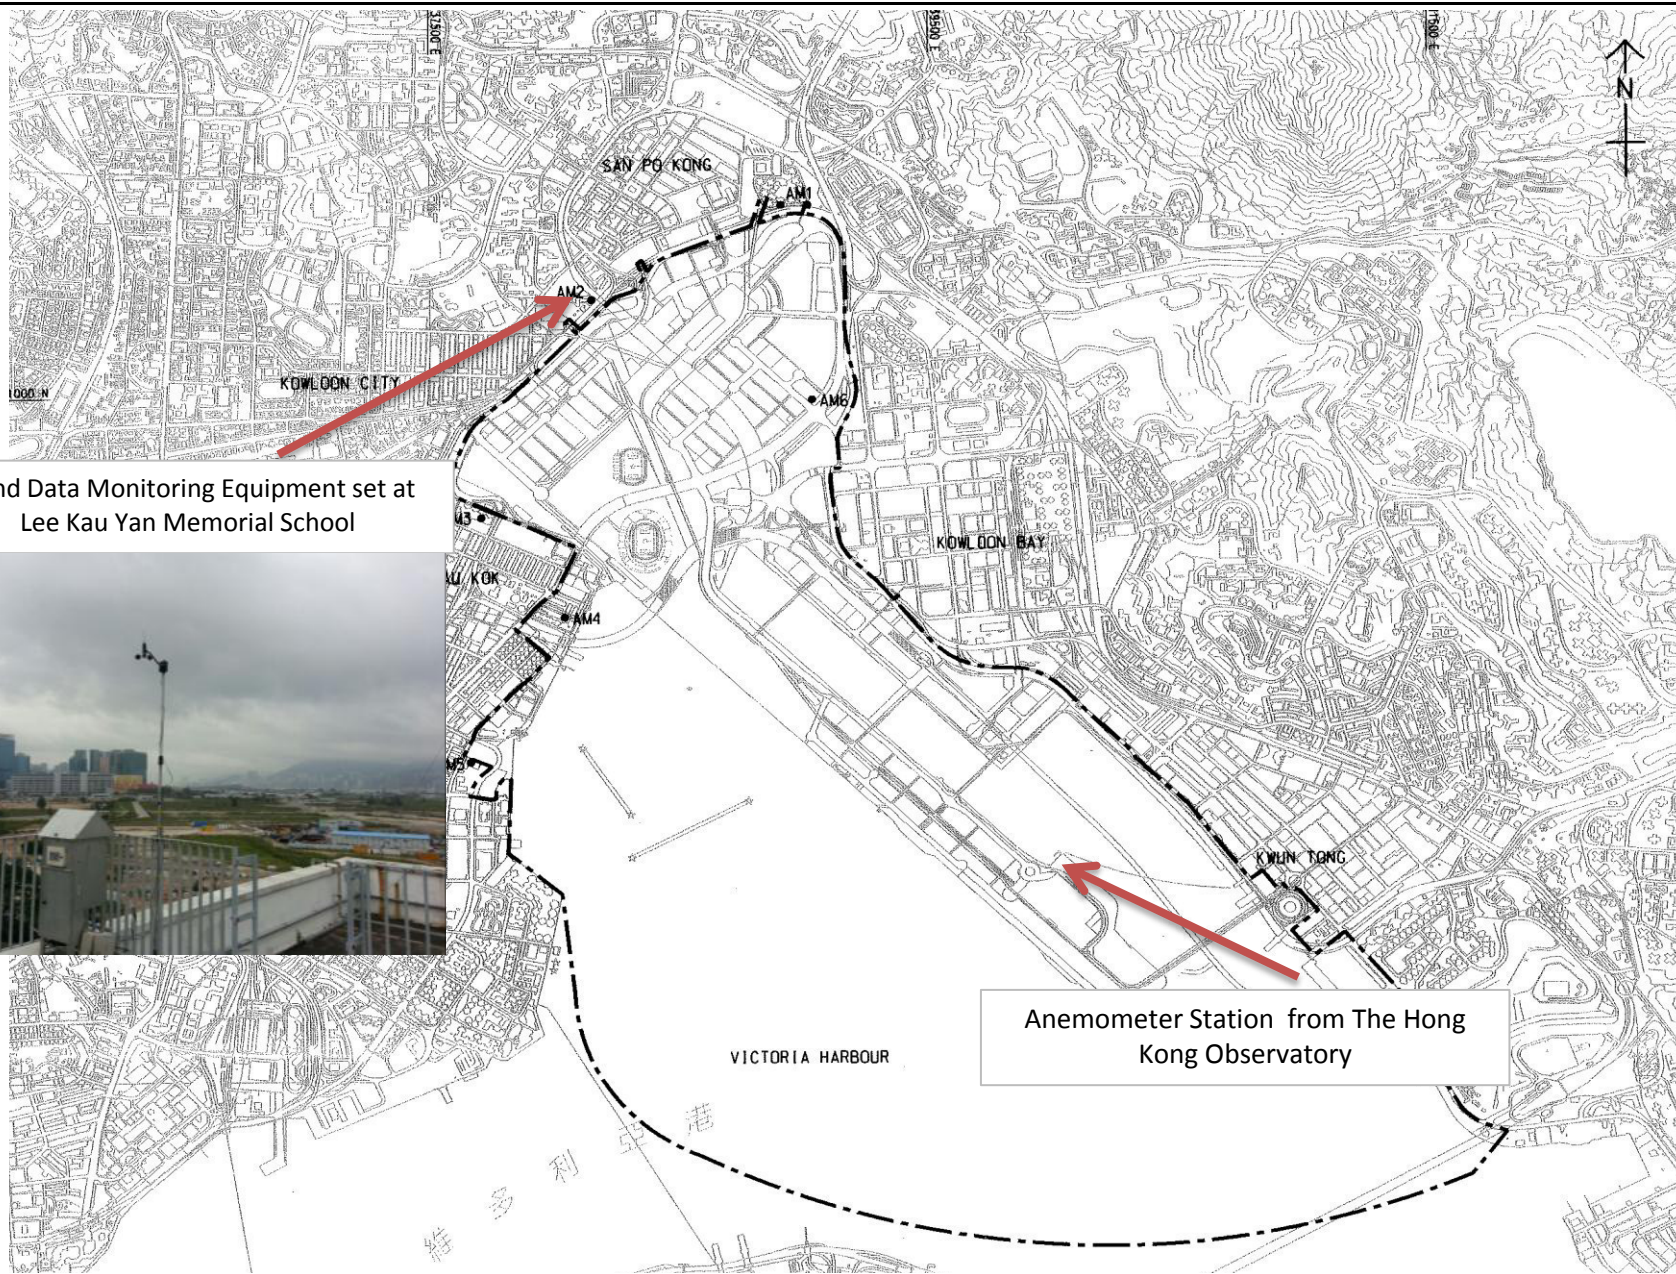
Wind Data Monitoring Equipment set at Lee Kau Yan Memorial School

2.19 The air temperature, precipitation and the relative humidity data was obtained from Hong Kong Observatory where the wind speed and wind direction were recorded by the installed Wind Anemometer set at rooftop (about 8/F) Lee Kau Yan Memorial School. The location is shown in **Figure 4**. This weather information for the reporting month is summarized in **Appendix C**.

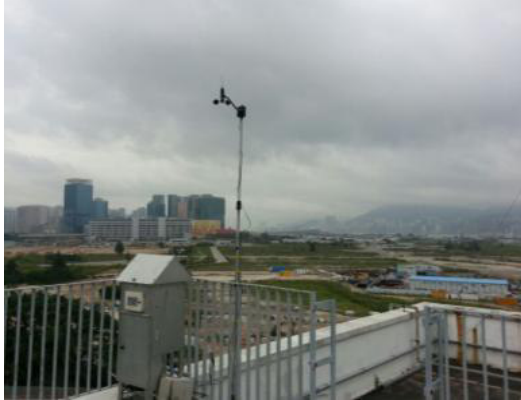
Anemometer Station from The Hong Kong Observatory

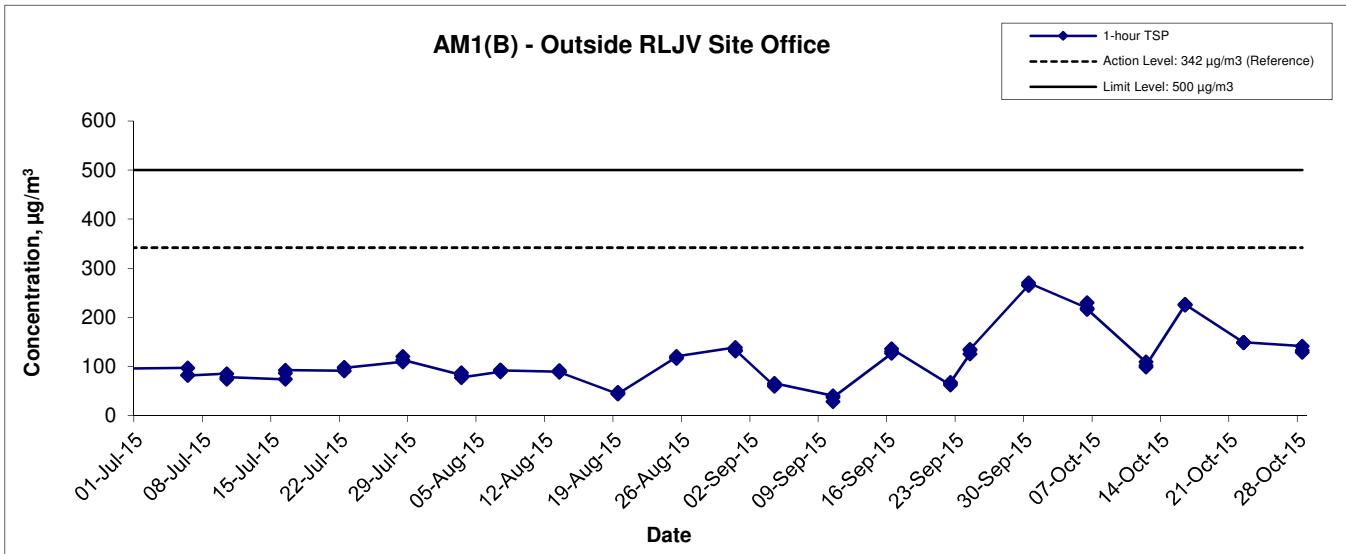
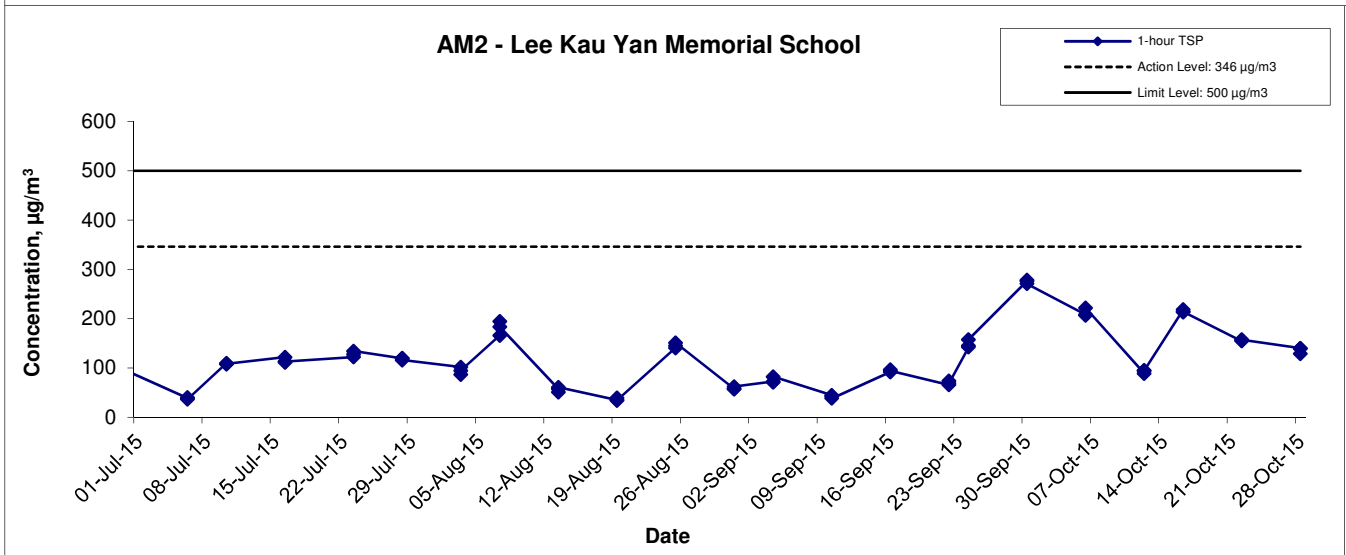
1-hr TSP Concentration Levels

Title Contract No. KL/2012/02 Kai Tak Development - Stage 3A Infrastructure at Former North Apron Area Graphical Presentation of 1-hour TSP Monitoring Results	Scale N.T.S	Project No. MA13043	
	Date Oct 15	Appendix E

Location AM2 - Lee Kau Yan Memorial School			
Date	Time	Weather	Particulate Concentration ($\mu\text{g}/\text{m}^3$)
6-Oct-15	13:00	Cloudy	208.3
6-Oct-15	14:00	Cloudy	206.6
6-Oct-15	15:00	Cloudy	221.7
12-Oct-15	13:00	Cloudy	88.7
12-Oct-15	14:00	Cloudy	93.6
12-Oct-15	15:00	Cloudy	95.2
16-Oct-15	9:00	Sunny	218.6
16-Oct-15	10:00	Sunny	212.9
16-Oct-15	11:00	Sunny	214.2
22-Oct-15	13:55	Sunny	154.6
22-Oct-15	14:55	Sunny	155.8
22-Oct-15	15:55	Sunny	157.2
28-Oct-15	13:00	Sunny	140.1
28-Oct-15	14:00	Sunny	128.7
28-Oct-15	15:00	Sunny	139.1
		Average	162.4
		Maximum	221.7
		Minimum	88.7

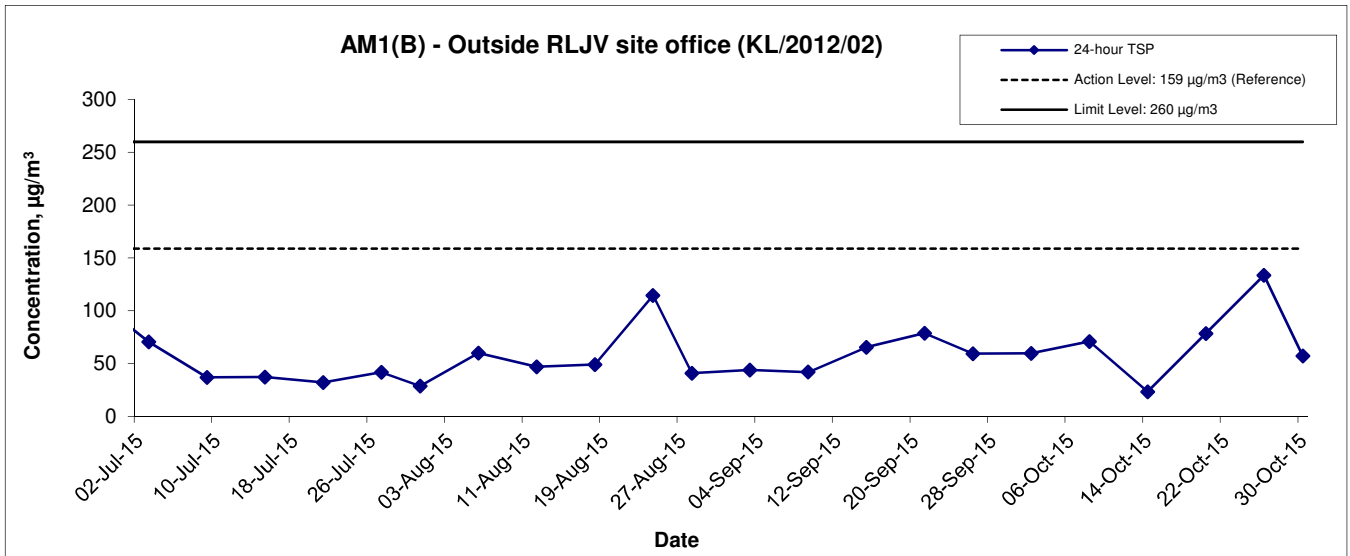
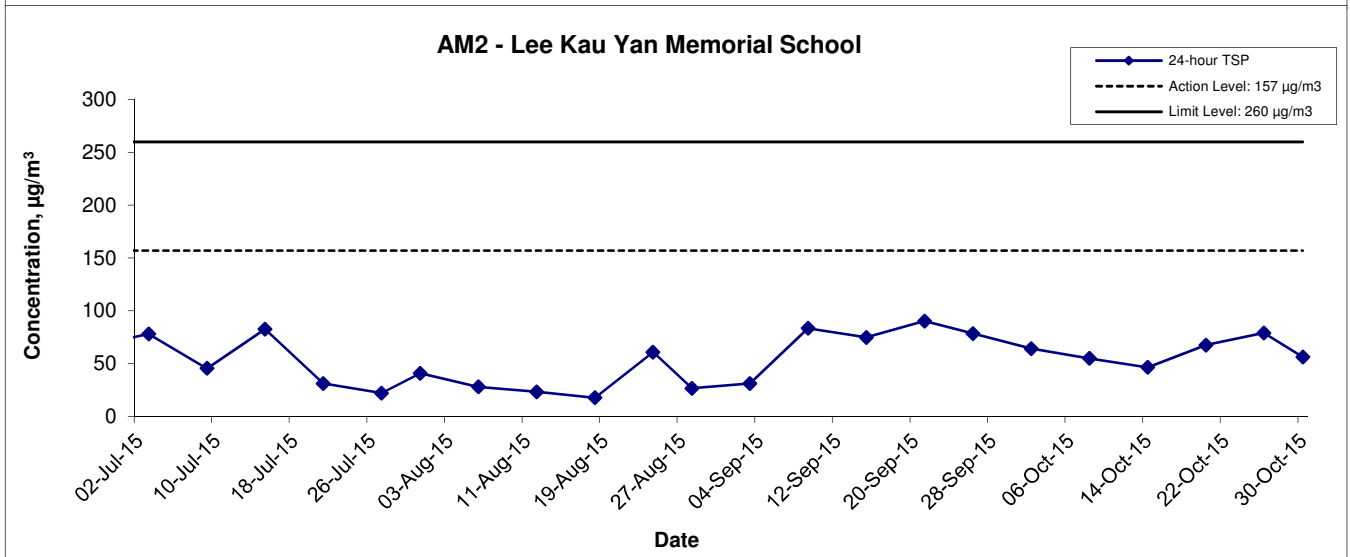
24-hr TSP Concentration Levels

Title Contract No. KL/2012/02 Kai Tak Development - Stage 3A Infrastructure at Former North Apron Area Graphical Presentation of 24-hour TSP Monitoring Results	Scale N.T.S	Project No. MA13043	
	Date Oct 15	Appendix F

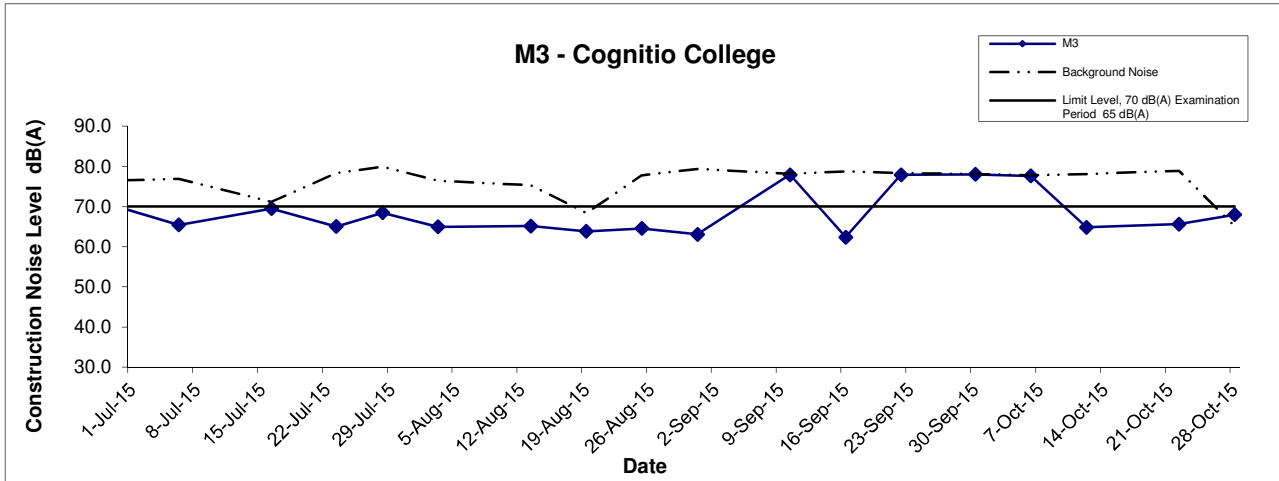
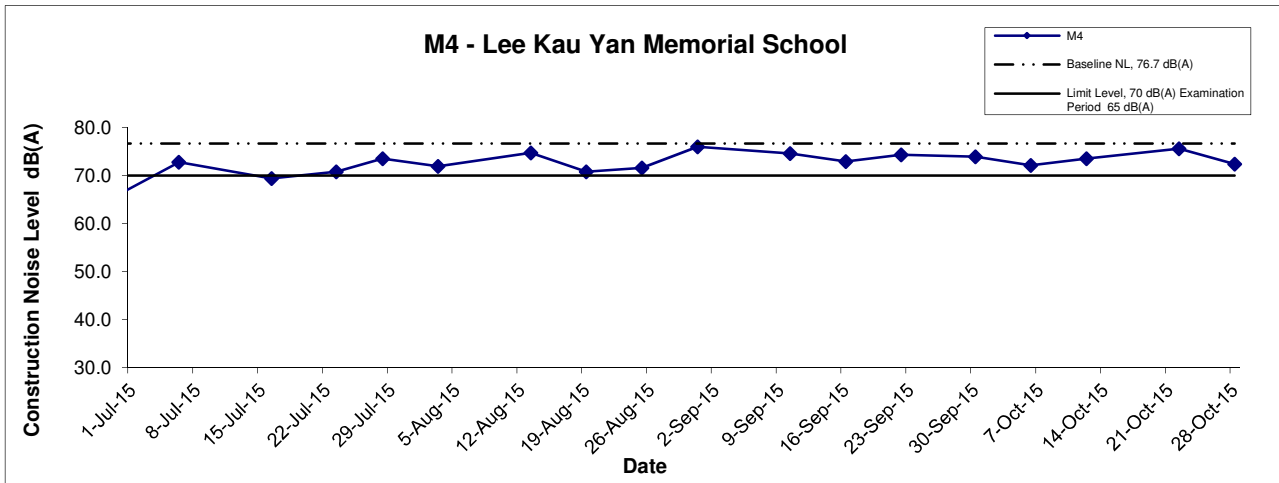
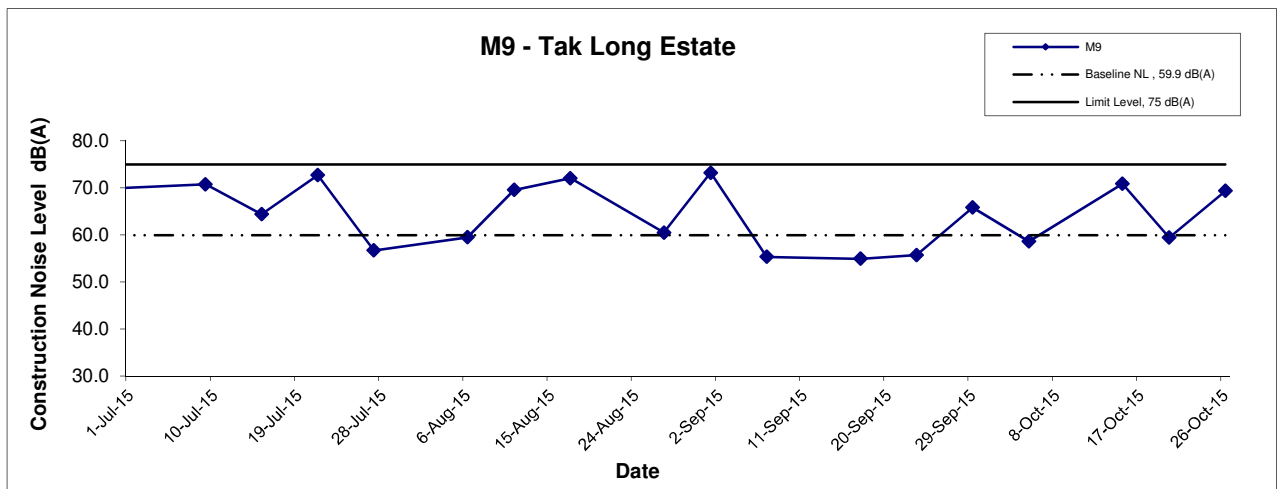
Noise Levels

Remarks: The construction noise levels in the Tables in Appendix G were adopted for plotting the graphs

Title Contract No. KL/2012/02 Kai Tak Development - Stage 3A Infrastructure at Former North Apron Area Graphical Presentation of Construction Noise Monitoring Results	Scale N.T.S	Project No. MA13043	CINOTECH
	Date Oct 15	Appendix G

Location M9 - Tak Long Estate							
Date	Time	Weather	Unit: dB (A) (30-min)				
			Measured Noise Level			Baseline Level	Construction Noise Level
			L _{eq}	L ₁₀	L ₉₀	L _{eq}	L _{eq}
5-Oct-15	13:40	Cloudy	62.3	63.4	59.5	59.9	58.6
15-Oct-15	13:30	Sunny	71.2	72.9	65.6		70.9
20-Oct-15	14:00	Cloudy	59.4	60.8	57.4		59.4 Measured ≤ Baseline
26-Oct-15	09:30	Cloudy	69.8	71.2	69.3		69.3
