4th CONSOLIDATED MONTHLY EM&A REPORT

February 2017

EP No. : EP-337/2009 –
New Distributor Roads Serving the Planned Kai Tak
Development Area

Contract No. : KLN/2016/05 –
Independent Environmental Checker for
Contract No. KL/2015/02 Kai Tak Development –
Stage 5A Infrastructure at Former North Apron Area

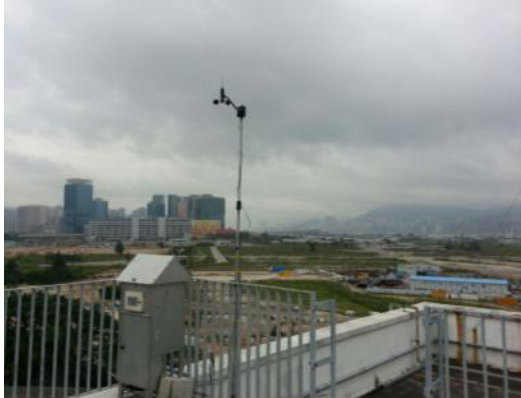
Wind Data Monitoring Equipment set at Lee Kau Yan Memorial School

Anemometer Station from The Hong Kong Observatory

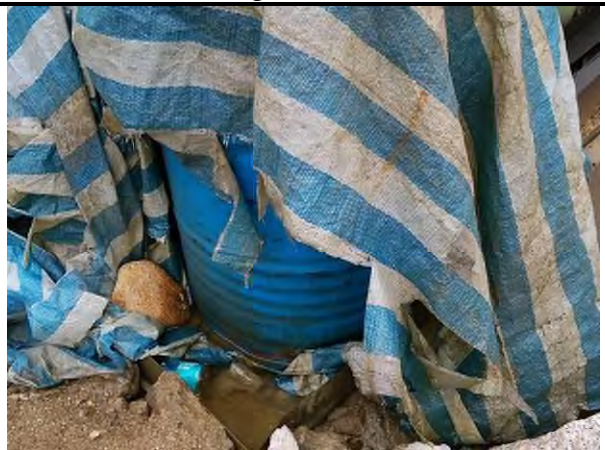
<p>To prevent any surface runoff discharge into any stream course.</p>	<p>Follow-up measure(s) after identification of wastewater discharges from site.</p>

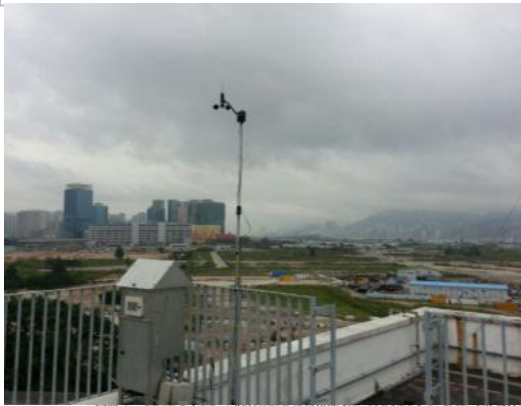
Wind Data Monitoring Equipment set at Lee Kau Yan Memorial School

Wind Monitoring Location	Northing	Easting
Lee Kau Yan Memorial School	821441.245	838153.917

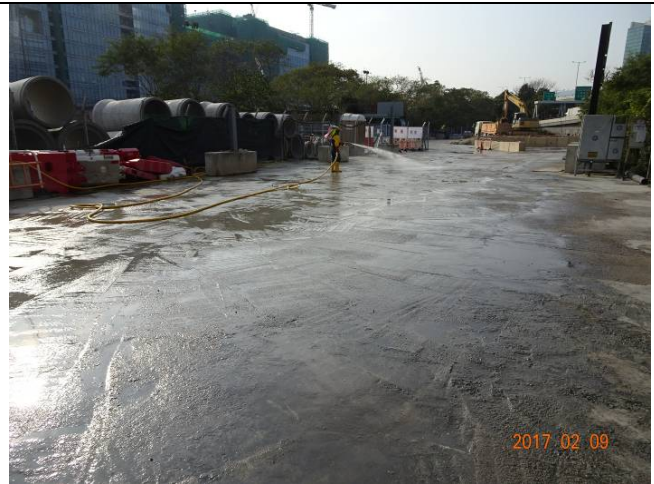
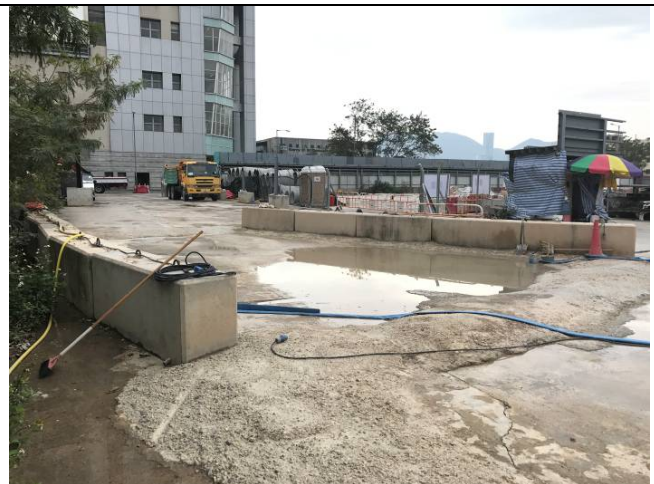
Vehicle washing facilities were observed at the Site on 9th February 2017. The area where vehicle washing takes place and the section of road between the washing facilities and the exit point were paved with hardcores. Vehicles were washed at site exit before leaving the Site.

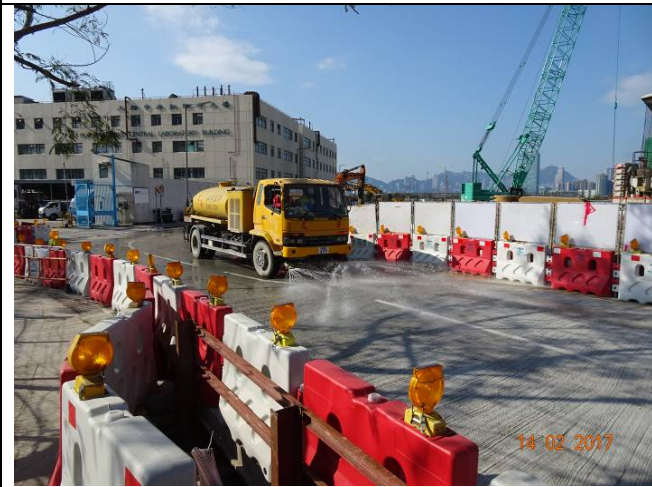
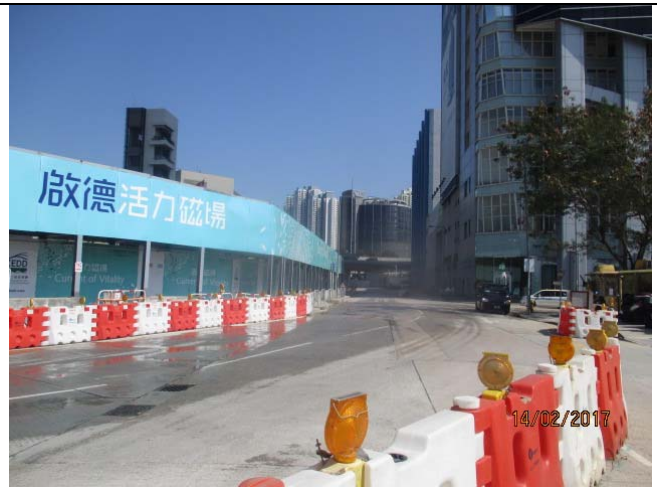
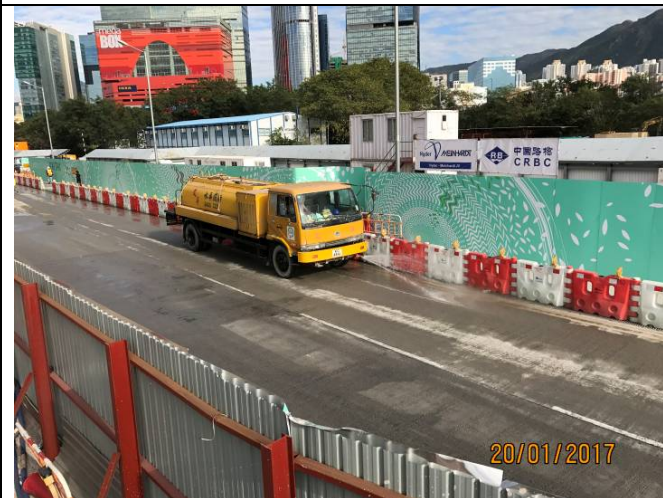
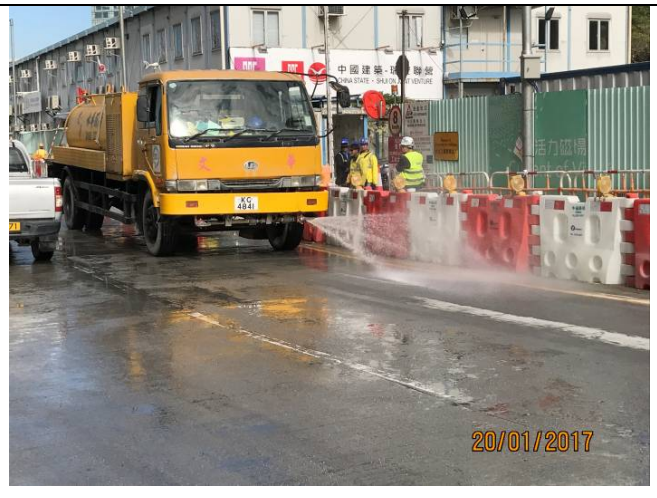
Cleaning of Cheung Yip Street by street sweep vehicles was carried out by the Contractor on 20th January 2017 and 14th February 2017.

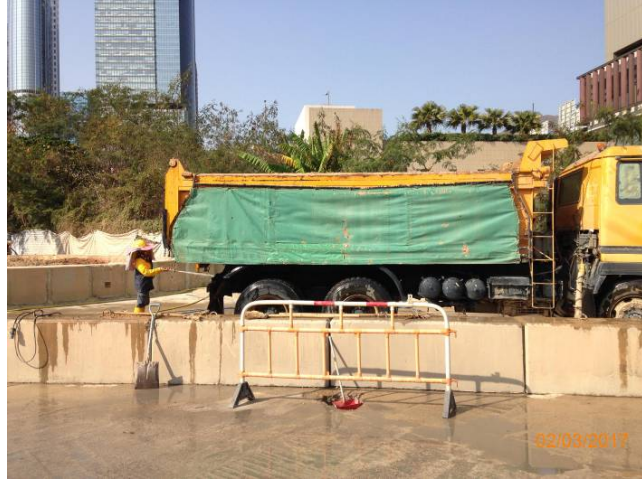
Thorough washing of vehicles before leaving the Site was observed by ET on 2nd March 2017.

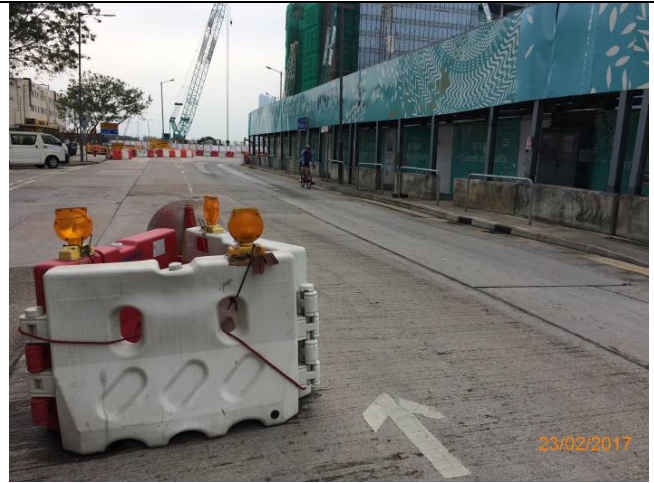
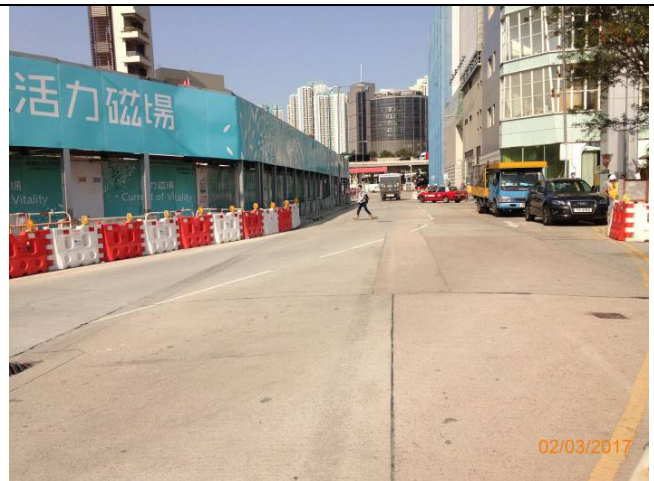
No dust or mud was observed by ET at the entrance of the Site and Cheung Yip Street on 23rd February 2017 and 2nd March 2017.

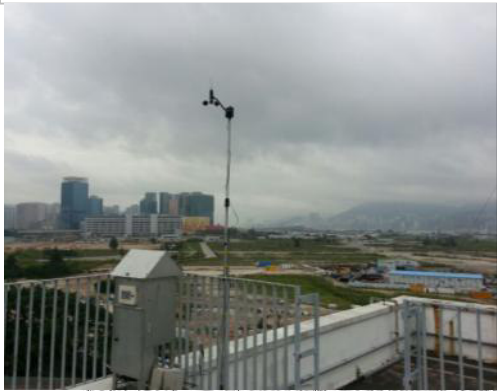
Wind Data Monitoring Equipment set at Lee Kau Yan Memorial School

Anemometer Station from The Hong Kong Observatory
