## 7<sup>th</sup> CONSOLIDATED MONTHLY EM&A REPORT

May 2017

**EP No.** : EP-337/2009 –  
New Distributor Roads Serving the Planned Kai Tak  
Development Area

**Contract No.** : KLN/2016/05 –  
Independent Environmental Checker for  
Contract No. KL/2015/02 Kai Tak Development –  
Stage 5A Infrastructure at Former North Apron Area

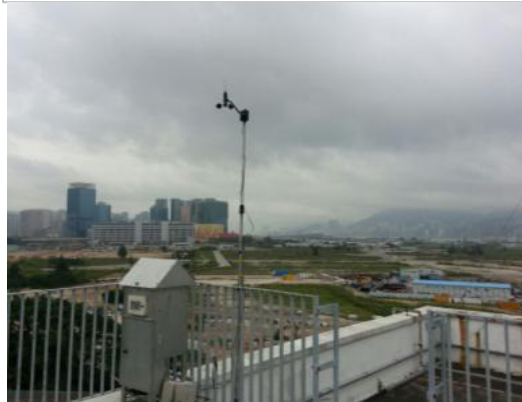
Scale	N.T.S	Project No.	MA13043
Date	Oct-13	Figure	4

Wind Data Monitoring Equipment set at Lee Kau Yan Memorial School

Anemometer Station from The Hong Kong Observatory

2.21 The air temperature, precipitation and the relative humidity data was obtained from Hong Kong Observatory where the wind speed and wind direction were recorded by the installed Wind Anemometer set at rooftop (about 8/F) Lee Kau Yan Memorial School. The location is shown in **Figure 4**. This weather information for the reporting month is summarized in **Appendix C**.

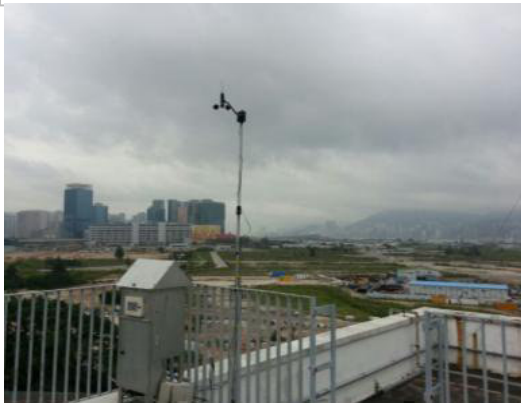
Scale	N.T.S	Project No.	MA13056
Date	Dec-13	Figure	4

Wind Data Monitoring Equipment set at Lee Kau Yan Memorial School

Wind Monitoring Location	Northing	Easting
Lee Kau Yan Memorial School	821441.245	838153.917

Anemometer Station from The Hong Kong Observatory

- 2.23 The air temperature, precipitation and the relative humidity data were obtained from Hong Kong Observatory where the wind speed and wind direction were recorded by the installed Wind Anemometer set at rooftop (about 8/F) Lee Kau Yan Memorial School. The location is shown in **Figure 4**. This weather information for the reporting month is summarized in **Appendix C**.

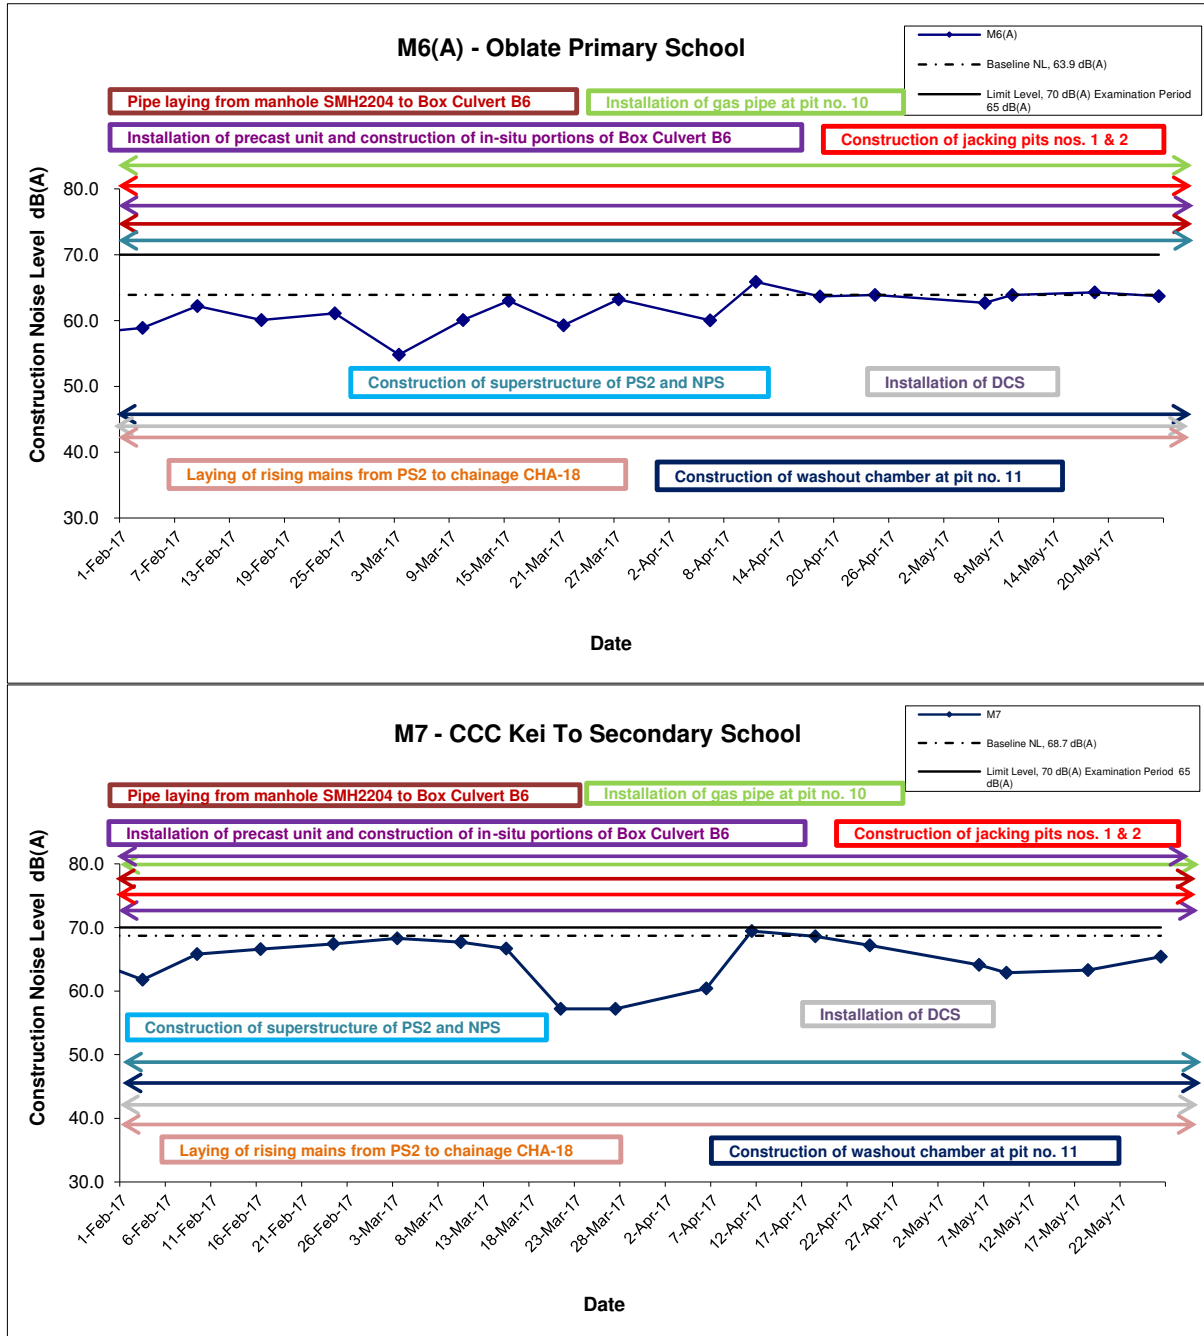
Remarks: The construction noise levels in the Tables in Appendix G were adopted for plotting the graphs

Title Kai Tak Development –Stage 4 Infrastructure at Former North Apron Area	Contract No. KL/2012/03	Scale N.T.S	Project No. MA13056	<b>CINOTECH</b>
	Graphical Presentation of Construction Noise Monitoring Results	Date May-17	Appendix G

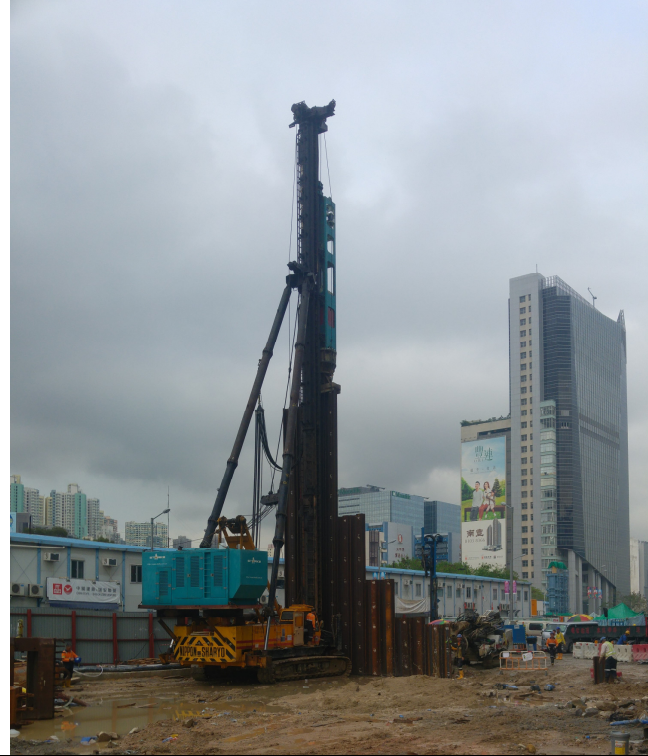
Site inspection photo of 4<sup>th</sup> May 2017

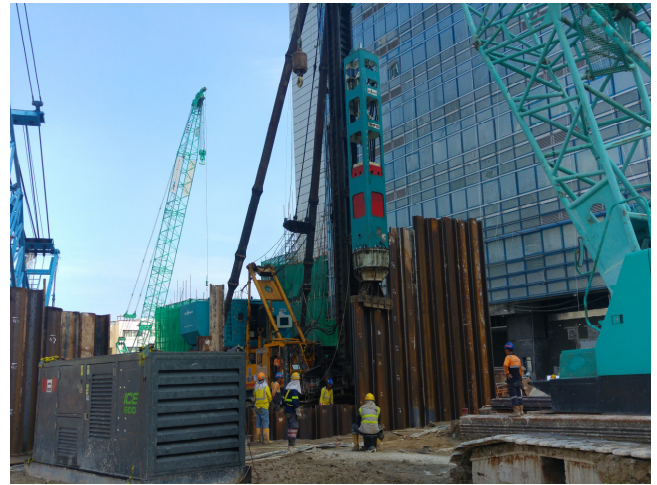
Site inspection photo of 11<sup>th</sup> May 2017

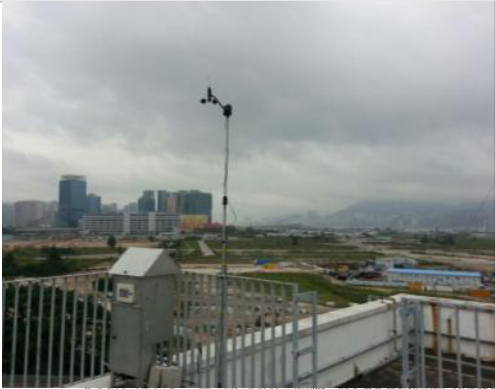
Title	Contract No. KLN/2016/04		Scale	Project No.	MA16043	
	Environmental Monitoring Works for Contract No. KL/2015/02					
Location of Wind Data Monitoring Equipment	Kai Tak Development –Stage 5A Infrastructure at Former North Apron Area		Date	Figure	4	
			Jan-17

Wind Data Monitoring Equipment set at Lee Kau Yan Memorial School

Anemometer Station from The Hong Kong Observatory

2.21 The air temperature, precipitation and the relative humidity data was obtained from Hong Kong Observatory where the wind speed and wind direction were recorded by the installed Wind Anemometer set at rooftop (about 8/F) Lee Kau Yan Memorial School. The location is shown in **Figure 4**. This weather information for the reporting month is summarized in **Appendix C**.
