10th CONSOLIDATED MONTHLY EM&A REPORT

August 2017

EP No. : EP-337/2009 –
New Distributor Roads Serving the Planned Kai Tak
Development Area

Contract No. : KLN/2016/05 –
Independent Environmental Checker for
Contract No. KL/2015/02 Kai Tak Development –
Stage 5A Infrastructure at Former North Apron Area

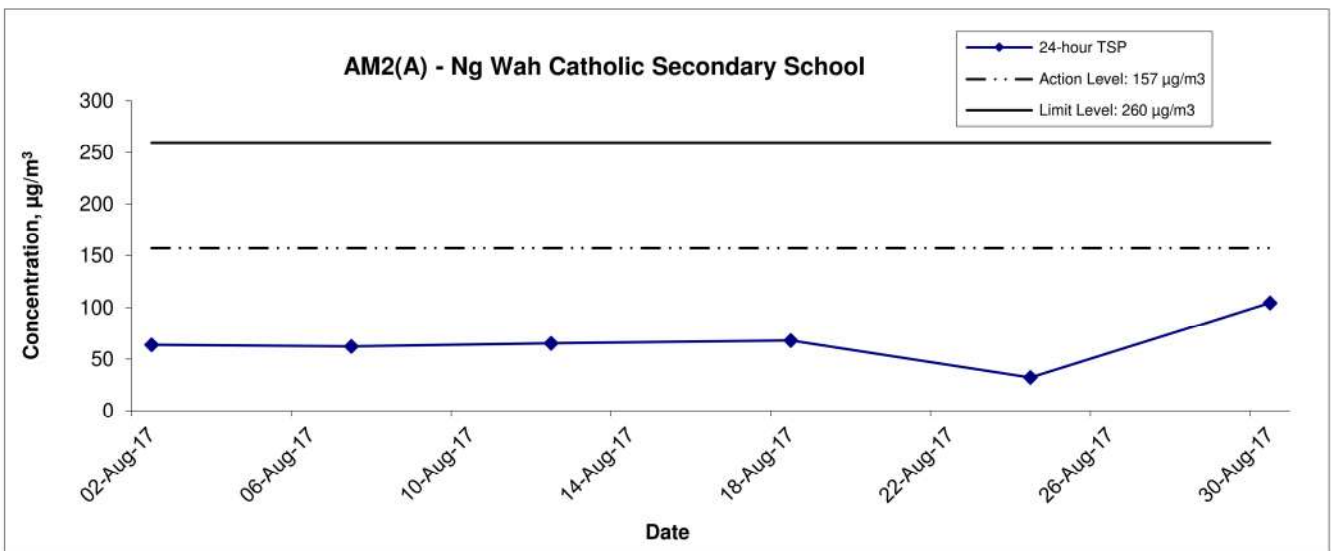
24-hr TSP Concentration Levels

Title Kai Tak Development - Stage 3A Infrastructure at Former North Apron Area Graphical Presentation of 24-hour TSP Monitoring Results	Contract No. KL/2012/02	Scale N.T.S	Project No. MA13043	
	Date Aug 17	Appendix F

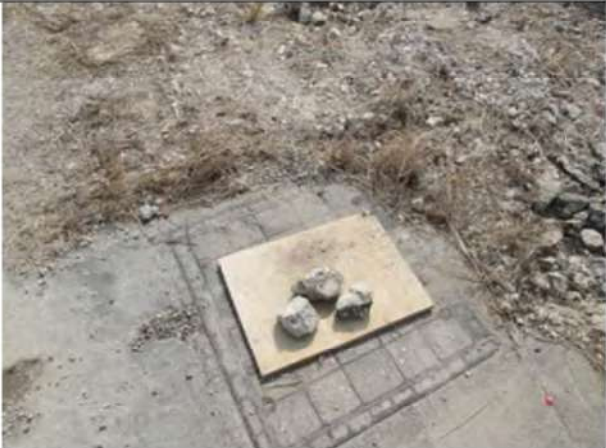
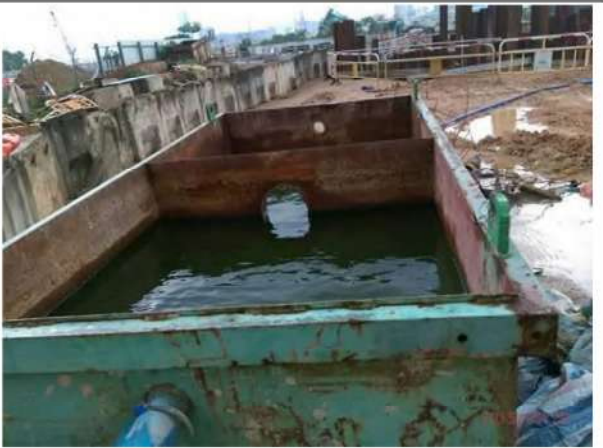
<p>To prevent any surface runoff discharge into any stream course.</p>	<p>Follow-up measure(s) after identification of wastewater discharges from site.</p>

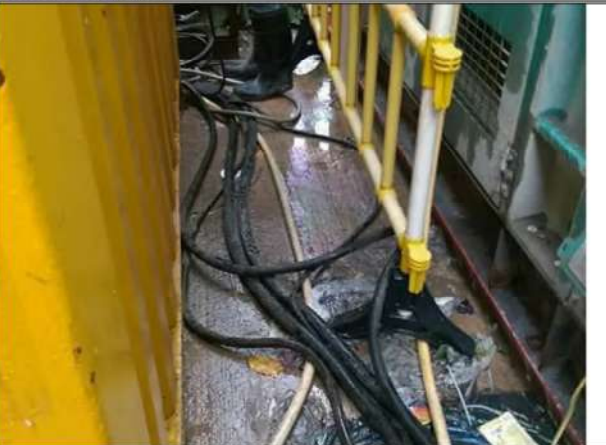
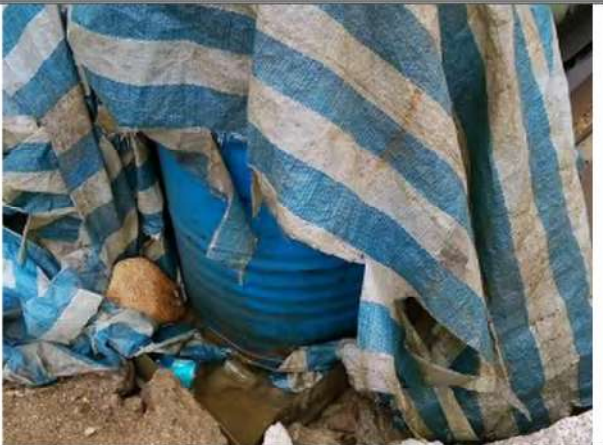
<p>To avoid any discharge or accidental spillage of chemical waste or oil directly from the site</p>	<p>To avoid improper handling or storage of oil drum on site</p>

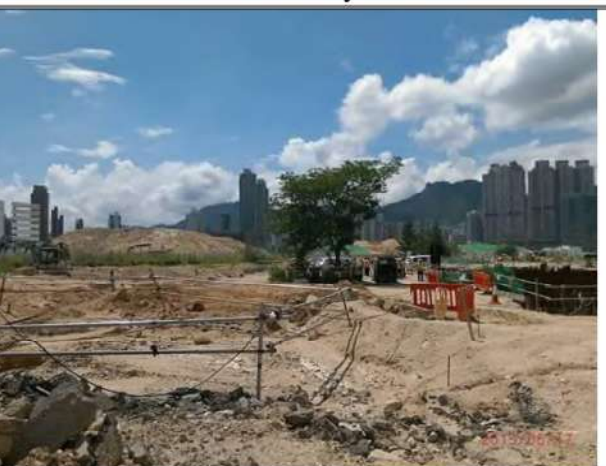
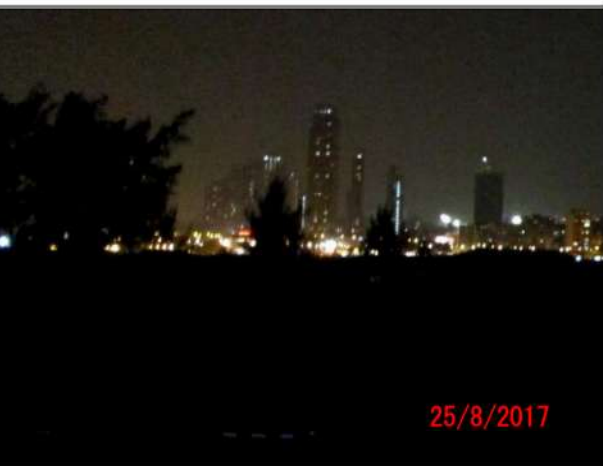
<p style="text-align: right; color: red;">25/8/2017</p>
<p>To protect the existing trees to be retained</p>	<p>To control of night-time lighting</p>

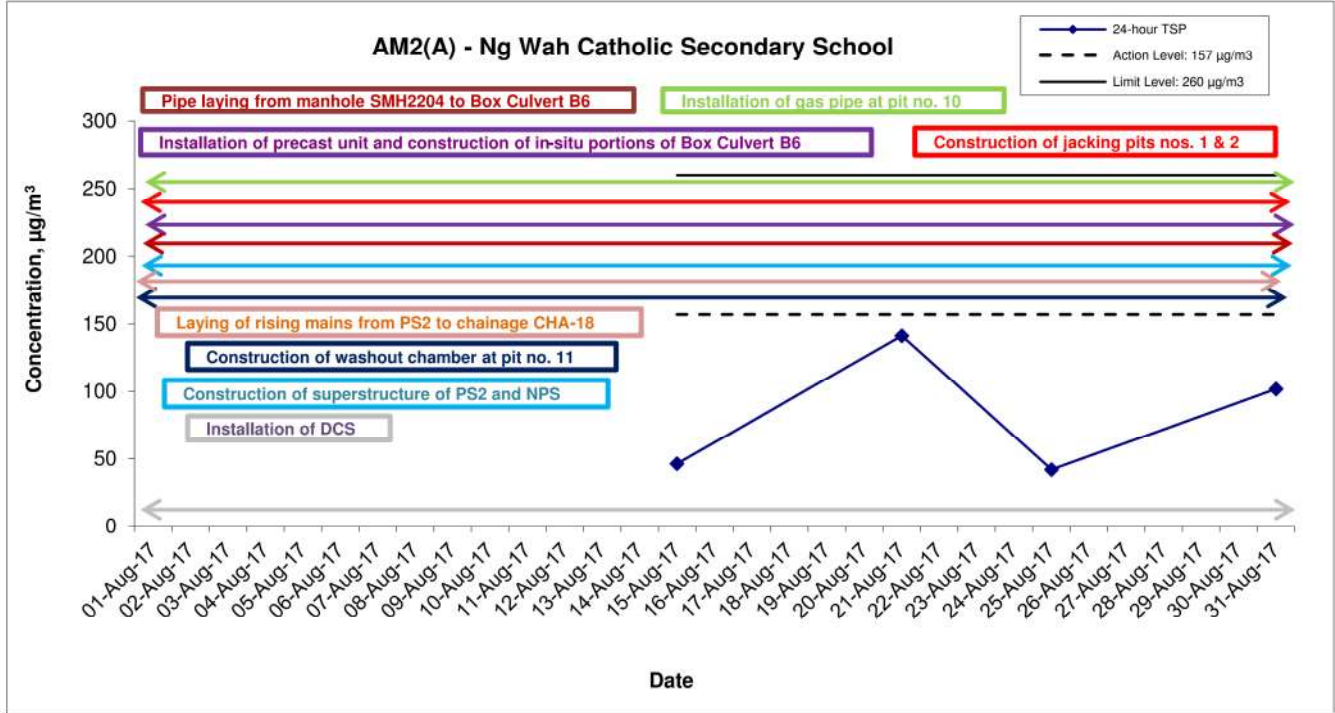
24-hr TSP Concentration Levels

Title	Contract No. KL/2012/03	Scale	Project	CINOTECH
	Kai Tak Development –Stage 4 Infrastructure at Former North Apron Area	N.T.S	No. MA13056	
Graphical Presentation of 24-hour TSP Monitoring Results	Date	Aug 17	Appendix F
