## 15<sup>th</sup> CONSOLIDATED MONTHLY EM&A REPORT

January 2018

**EP No.** : EP-337/2009 –  
New Distributor Roads Serving the Planned Kai Tak  
Development Area

**Contract No.** : KLN/2016/05 –  
Independent Environmental Checker for  
Contract No. KL/2015/02 Kai Tak Development –  
Stage 5A Infrastructure at Former North Apron Area

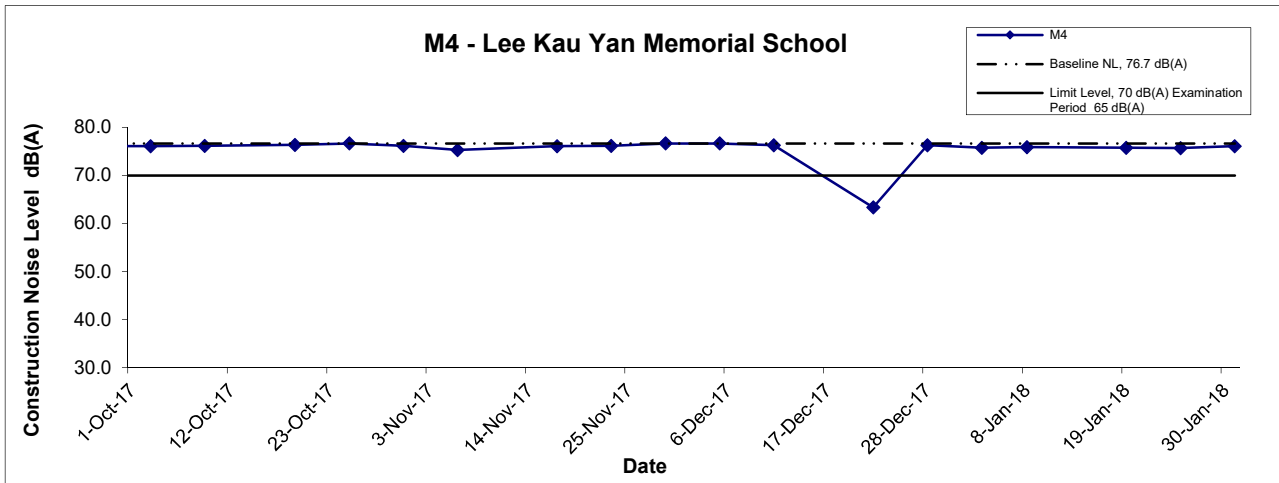
Remarks: The construction noise levels in the Tables in Appendix G were adopted for plotting the graphs

Title Kai Tak Development - Stage 3A Infrastructure at Former North Apron Area Graphical Presentation of Construction Noise Monitoring Results	Contract No. KL/2012/02	Scale N.T.S	Project No. MA13043	
	Date Jan 18	Appendix G
