## 16<sup>th</sup> CONSOLIDATED MONTHLY EM&A REPORT

February 2018

**EP No.** : EP-337/2009 –  
New Distributor Roads Serving the Planned Kai Tak  
Development Area

**Contract No.** : KLN/2016/05 –  
Independent Environmental Checker for  
Contract No. KL/2015/02 Kai Tak Development –  
Stage 5A Infrastructure at Former North Apron Area

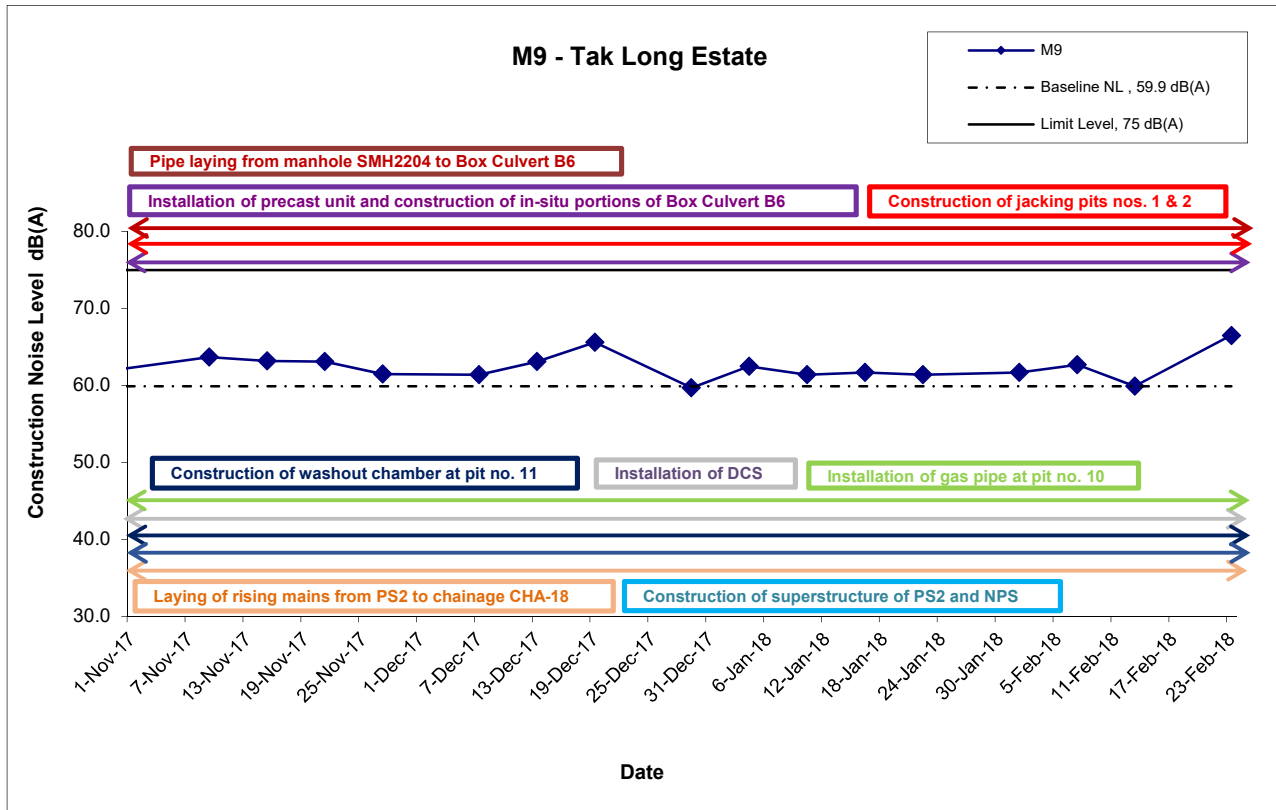
Title Contract No. KL/2012/03 Kai Tak Development –Stage 4 Infrastructure at Former North Apron Area  Graphical Presentation of Construction Noise Monitoring Results	Scale N.T.S	Project No. MA13056	
	Date Feb 18	Appendix G

Remarks: The construction noise levels in the Tables in Appendix G were adopted for plotting the graphs
