17th CONSOLIDATED MONTHLY EM&A REPORT

March 2018

EP No. : EP-337/2009 –
New Distributor Roads Serving the Planned Kai Tak
Development Area

Contract No. : KLN/2016/05 –
Independent Environmental Checker for
Contract No. KL/2015/02 Kai Tak Development –
Stage 5A Infrastructure at Former North Apron Area

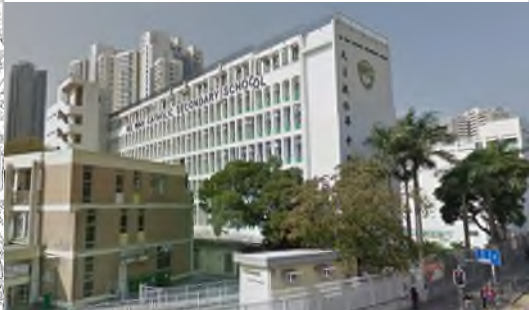
Anemometer Station from The Hong Kong Observatory

Title Contract No. KL/2012/02
 Kai Tak Development –Stage 3A Infrastructure at Former North Apron Area
 Location of Wind Monitoring Location

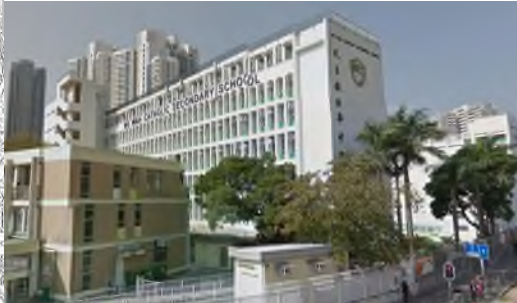
Anemometer Station from The Hong Kong Observatory

Title Contract No. KL/2012/03
 Kai Tak Development –Stage 4 Infrastructure at Former North Apron Area

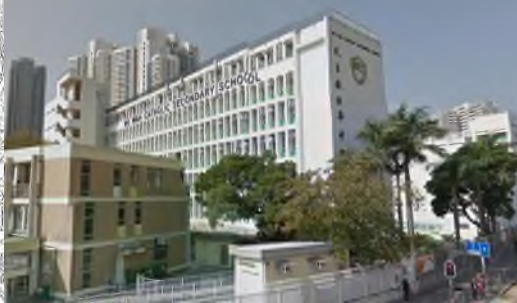
Anemometer Station from The Hong Kong Observatory

Title Contract No. KLN/2016/04
 Environmental Monitoring Works for Contract No. KL/2015/02
 Kai Tak Development – Stage 5A Infrastructure at Former North Apron Area
 Location of Wind Data Monitoring Equipment
