22nd CONSOLIDATED MONTHLY EM&A REPORT

August 2018

EP No. : EP-337/2009 –
New Distributor Roads Serving the Planned Kai Tak
Development Area

Contract No. : KLN/2016/05 –
Independent Environmental Checker for
Contract No. KL/2015/02 Kai Tak Development –
Stage 5A Infrastructure at Former North Apron Area

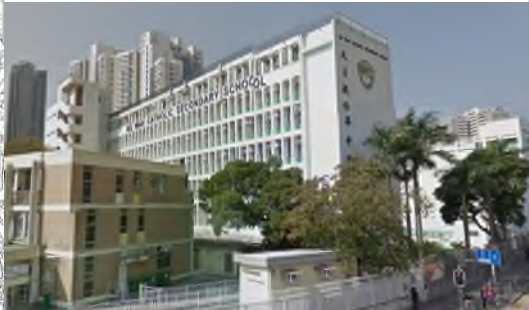
Anemometer Station from The Hong Kong Observatory

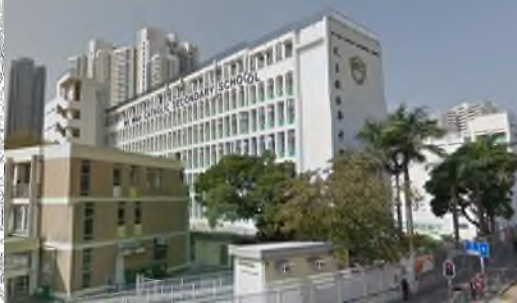
Anemometer Station from The Hong Kong Observatory
