## 23<sup>rd</sup> CONSOLIDATED MONTHLY EM&A REPORT

September 2018

**EP No.** : EP-337/2009 –  
New Distributor Roads Serving the Planned Kai Tak  
Development Area

**Contract No.** : KLN/2016/05 –  
Independent Environmental Checker for  
Contract No. KL/2015/02 Kai Tak Development –  
Stage 5A Infrastructure at Former North Apron Area

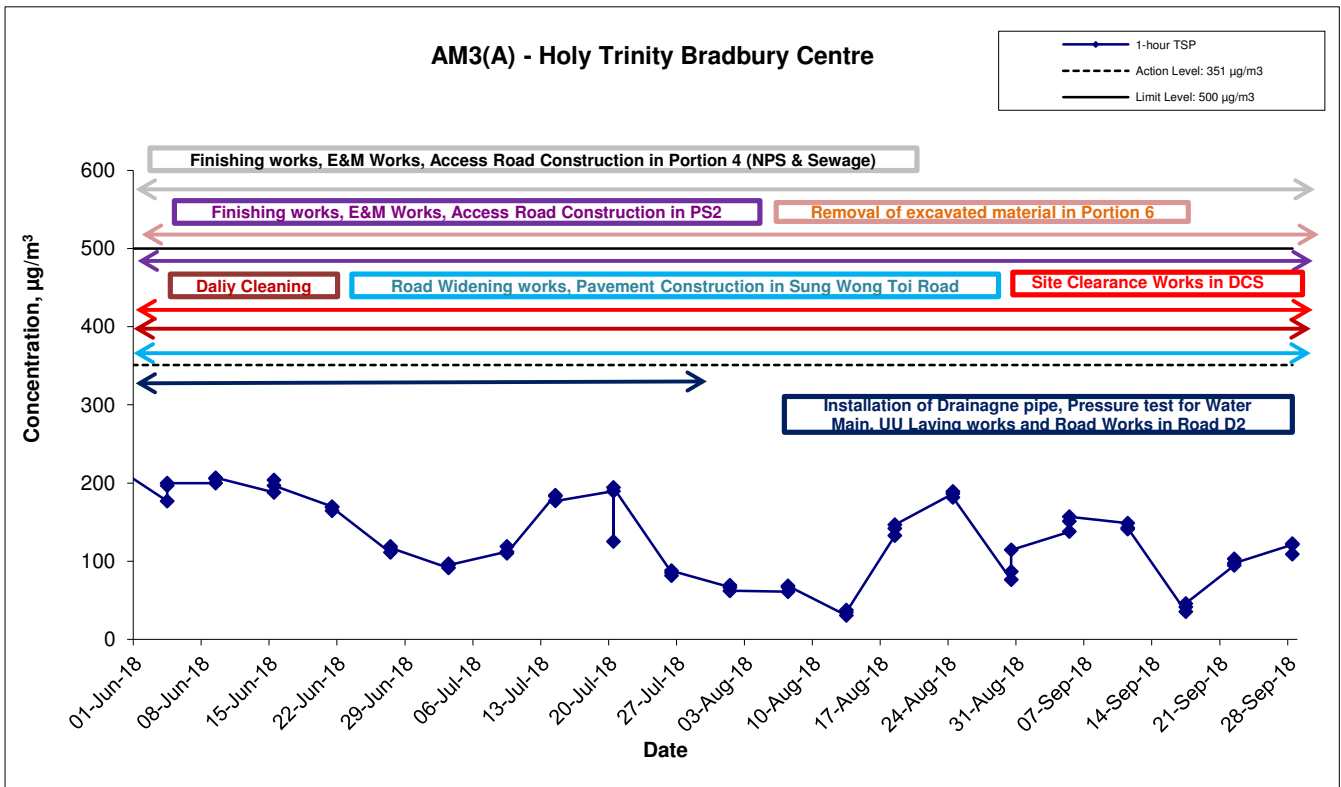
### 1-hr TSP Concentration Levels

Title Contract No. KL/2012/03 Kai Tak Development –Stage 4 Infrastructure at Former North Apron Area  Graphical Presentation of 1-hour TSP Monitoring Results	Scale N.T.S	Project No. MA13056	CINOTECH
	Date Sep 18	Appendix E
