MONTHLY EM&A REPORT

November 2018

Client	:	Civil Engineering and Development Department, HKSAR		
Contract No.	:	KLN/2015/07		
Contract Name	:	Environmental Monitoring Works for Contract KL/2014/03 – Kai Tak Development – Stage 3 Infrastructure Works for Developments at the Southern Part of the Former Runway		
Report No.	:	0405/15/ED/1135A		
EP-337/2009		Distributor Roads Serving the Planned Kai Tak elopment Area		
EP-339/2009/A	Build	commissioning of the Remaining Parts (Ex-GFS ilding, Radar Station and Hong Kong Aviation Club) the former Kai Tak Airport		
	- .

EP-451/2013 Trunk Road T2

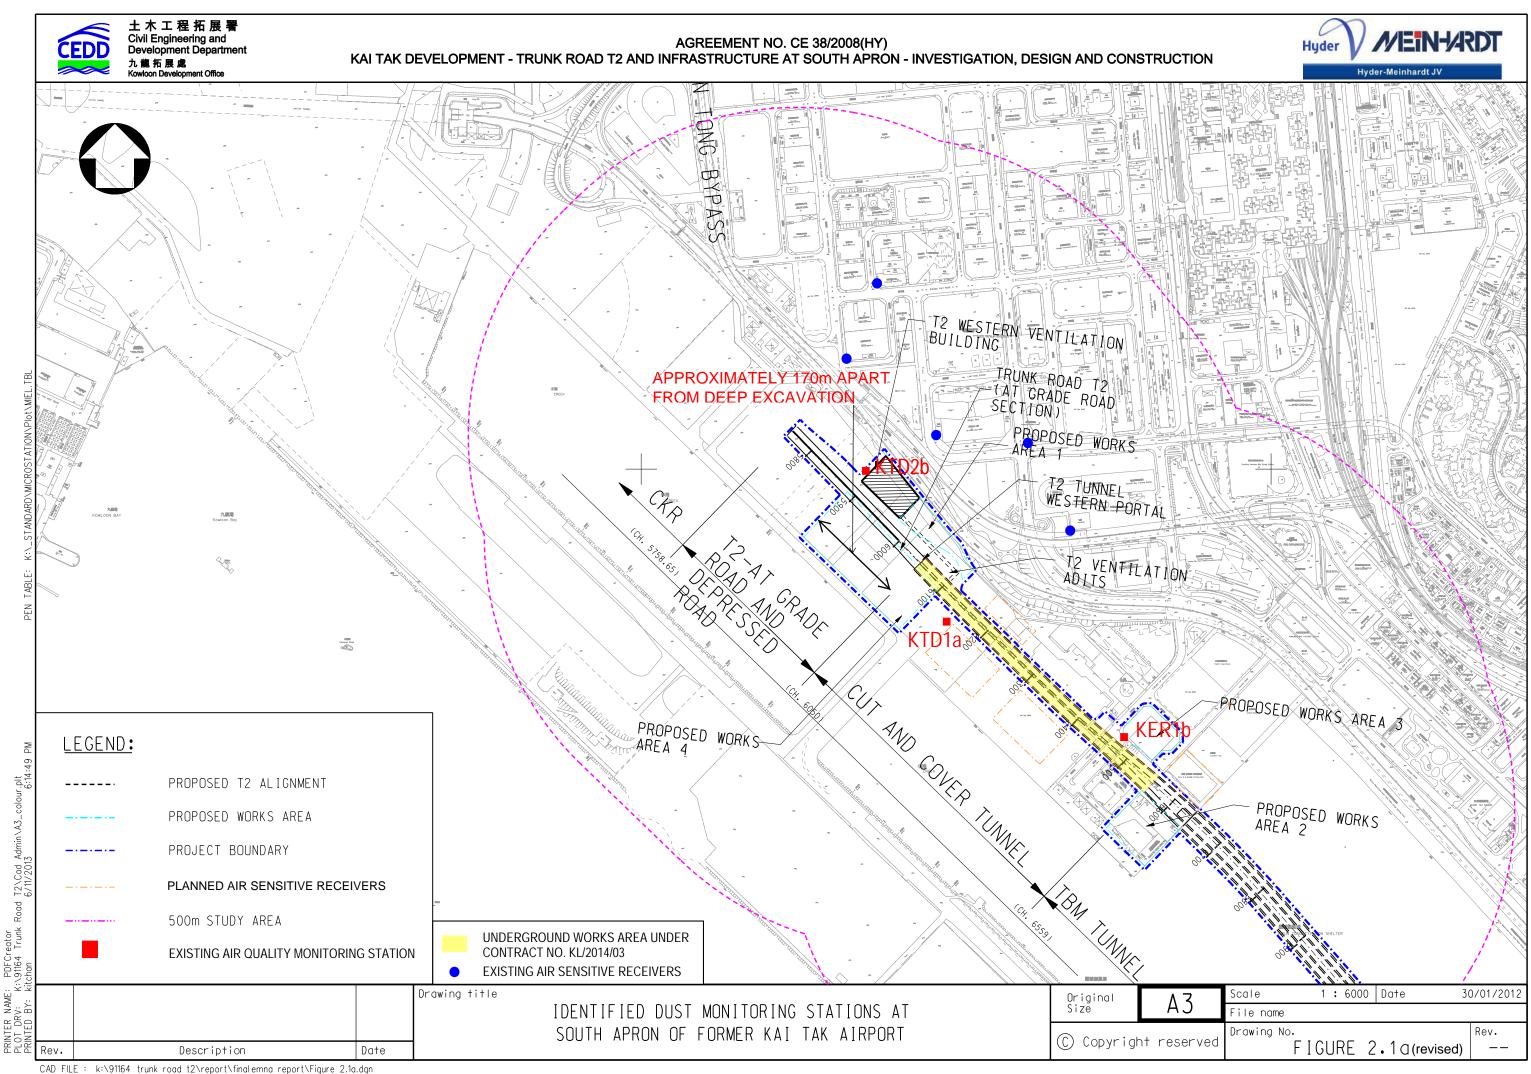
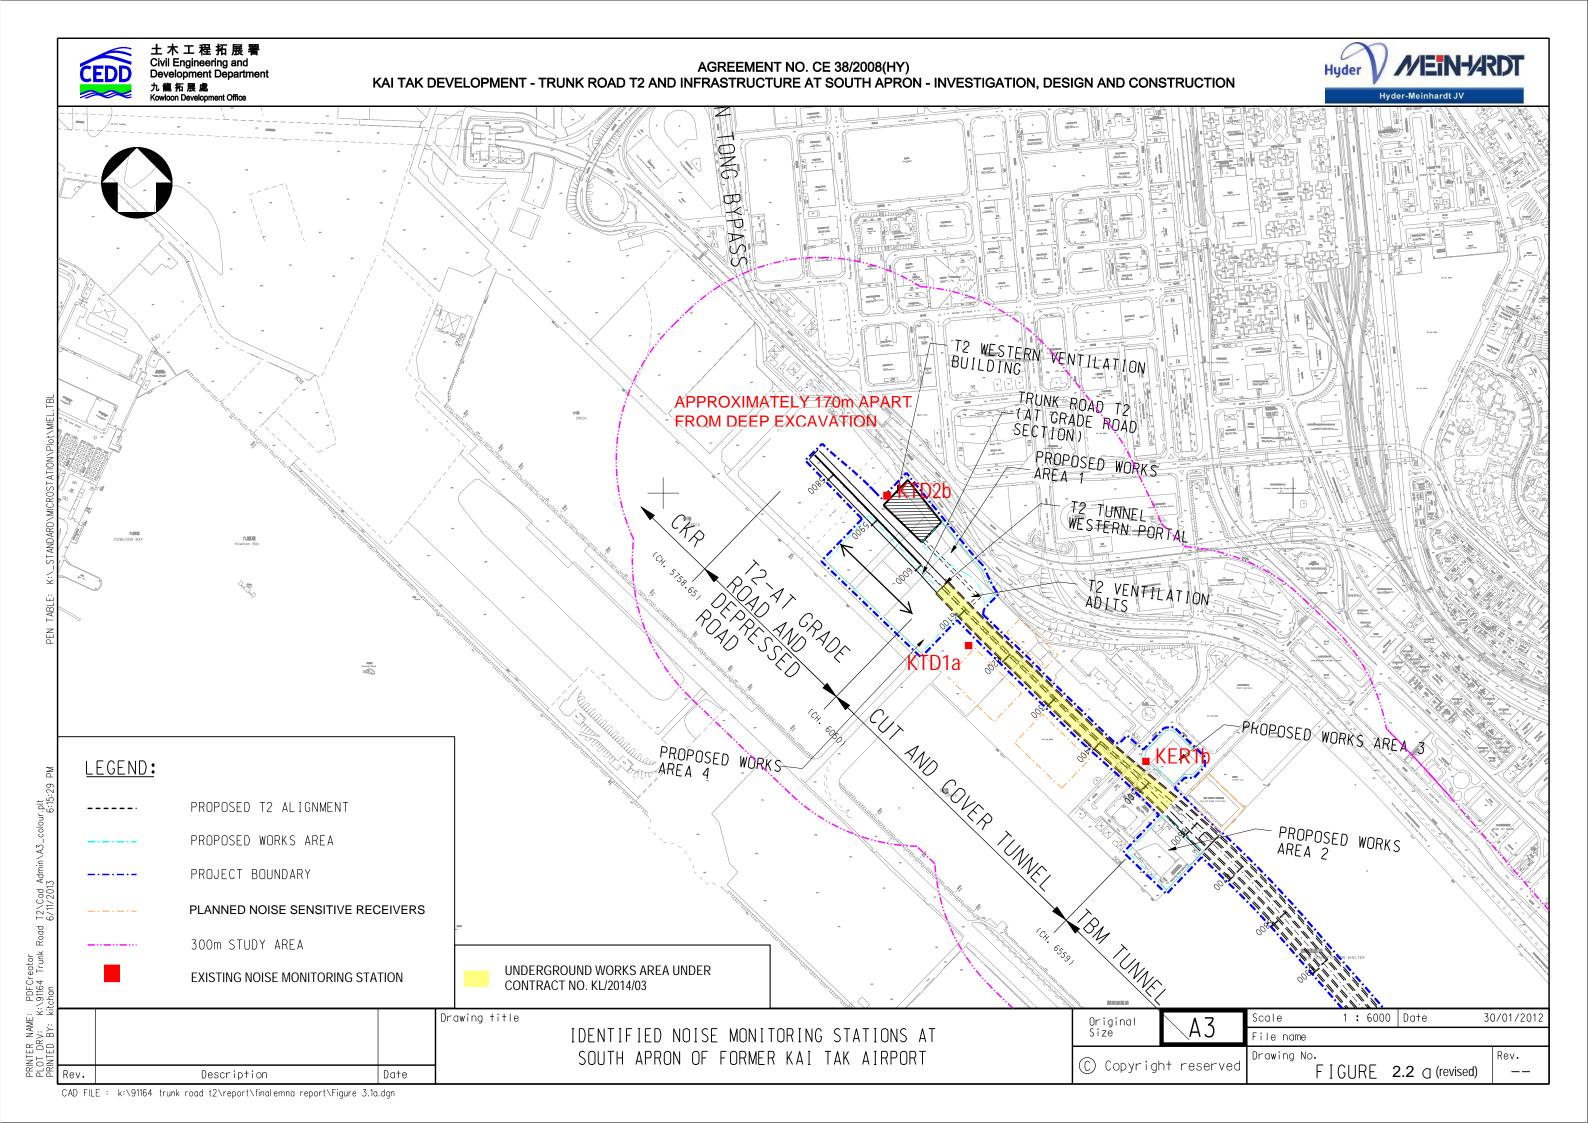
Air and Noise Monitoring Locations

- 2.5.2 According to the approved alternative baseline air quality and noise monitoring locations (EPD reference: () in EP2/K19/A/21 pt.5), the original monitoring locations (KTD1, KTD2 and KER1) are proposed to be replaced by alternative monitoring locations (KTD1a, KTD2a and KER1a) for air quality monitoring.

- 3.6.2 According to the approved alternative baseline air quality and noise monitoring locations (EPD reference: () in EP2/K19/A/21 pt.5), the original monitoring locations (KTD1, KTD2 and KER1) are proposed to be replaced by alternative monitoring locations (KTD1a, KTD2a and KER1a) for noise monitoring.
