26th CONSOLIDATED MONTHLY EM&A REPORT

December 2018

EP No. : EP-337/2009 –
New Distributor Roads Serving the Planned Kai Tak
Development Area

Contract No. : KLN/2016/05 –
Independent Environmental Checker for
Contract No. KL/2015/02 Kai Tak Development –
Stage 5A Infrastructure at Former North Apron Area

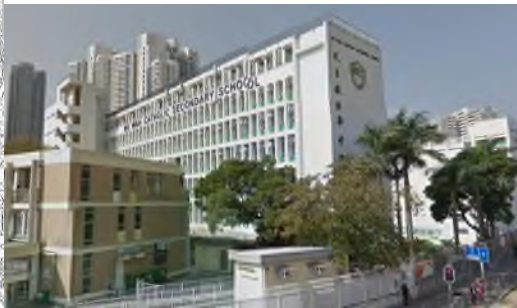
Anemometer Station from The Hong Kong Observatory

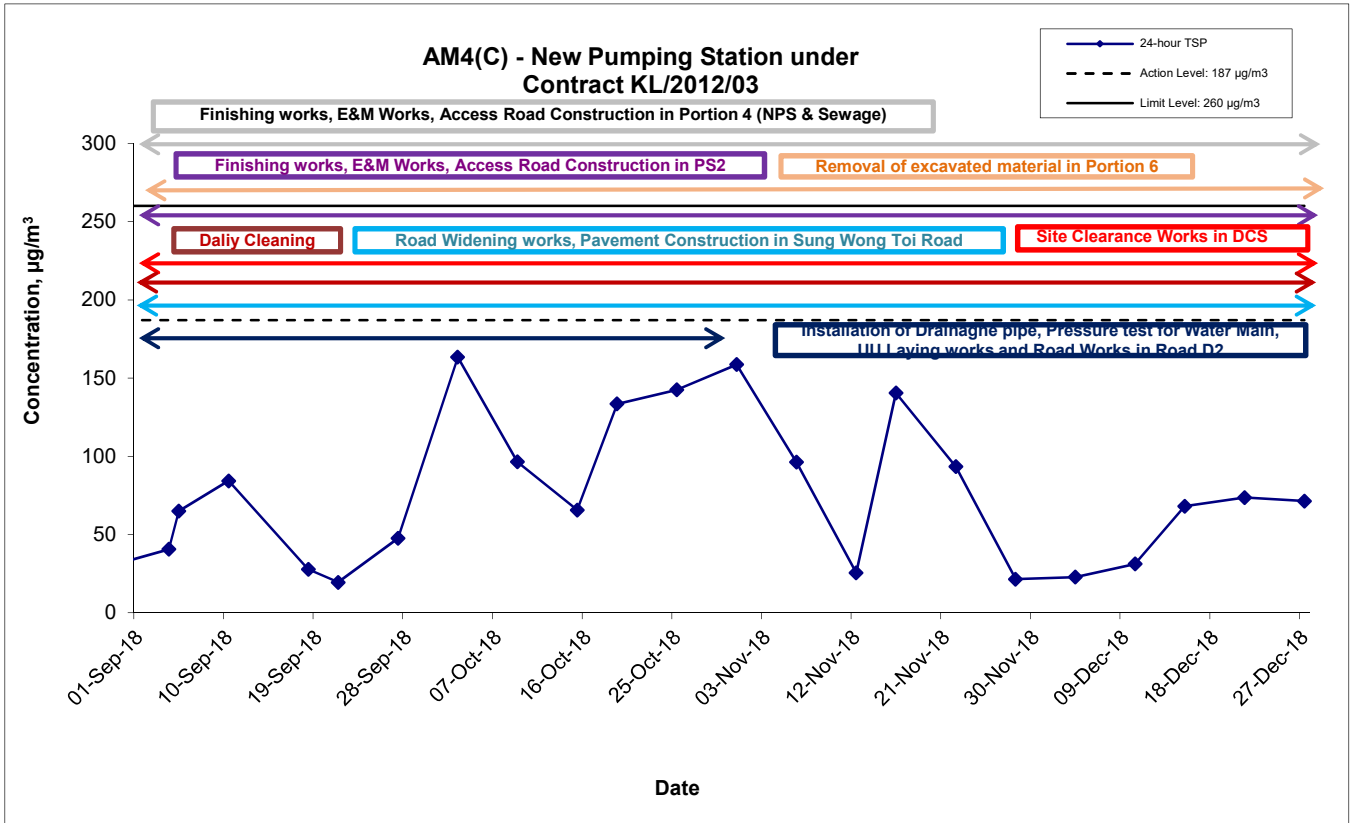
Title Contract No. KL/2012/03 Kai Tak Development –Stage 4 Infrastructure at Former North Apron Area Graphical Presentation of 24-hour TSP Monitoring Results	Scale	Project		
		N.T.S		No. MA13056
	Date	Dec 18		Appendix F

24-hr TSP Concentration Levels

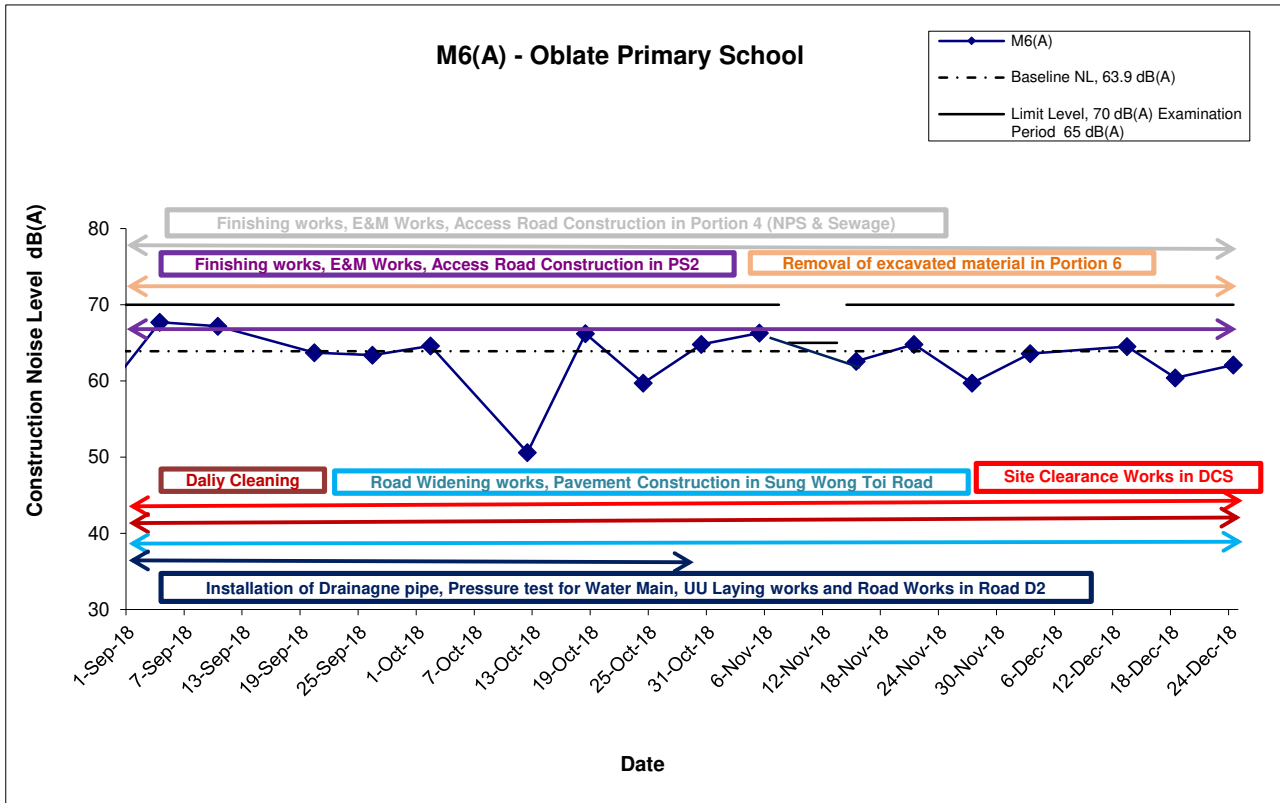
Title Contract No. KL/2012/03 Kai Tak Development –Stage 4 Infrastructure at Former North Apron Area Graphical Presentation of Construction Noise Monitoring Results	Scale N.T.S Date Dec 18	Project No. MA13056 Appendix G	
---	----------------------------------	---	--

Noise Levels

Remarks: The construction noise levels in the Tables in Appendix G were adopted for plotting the graphs

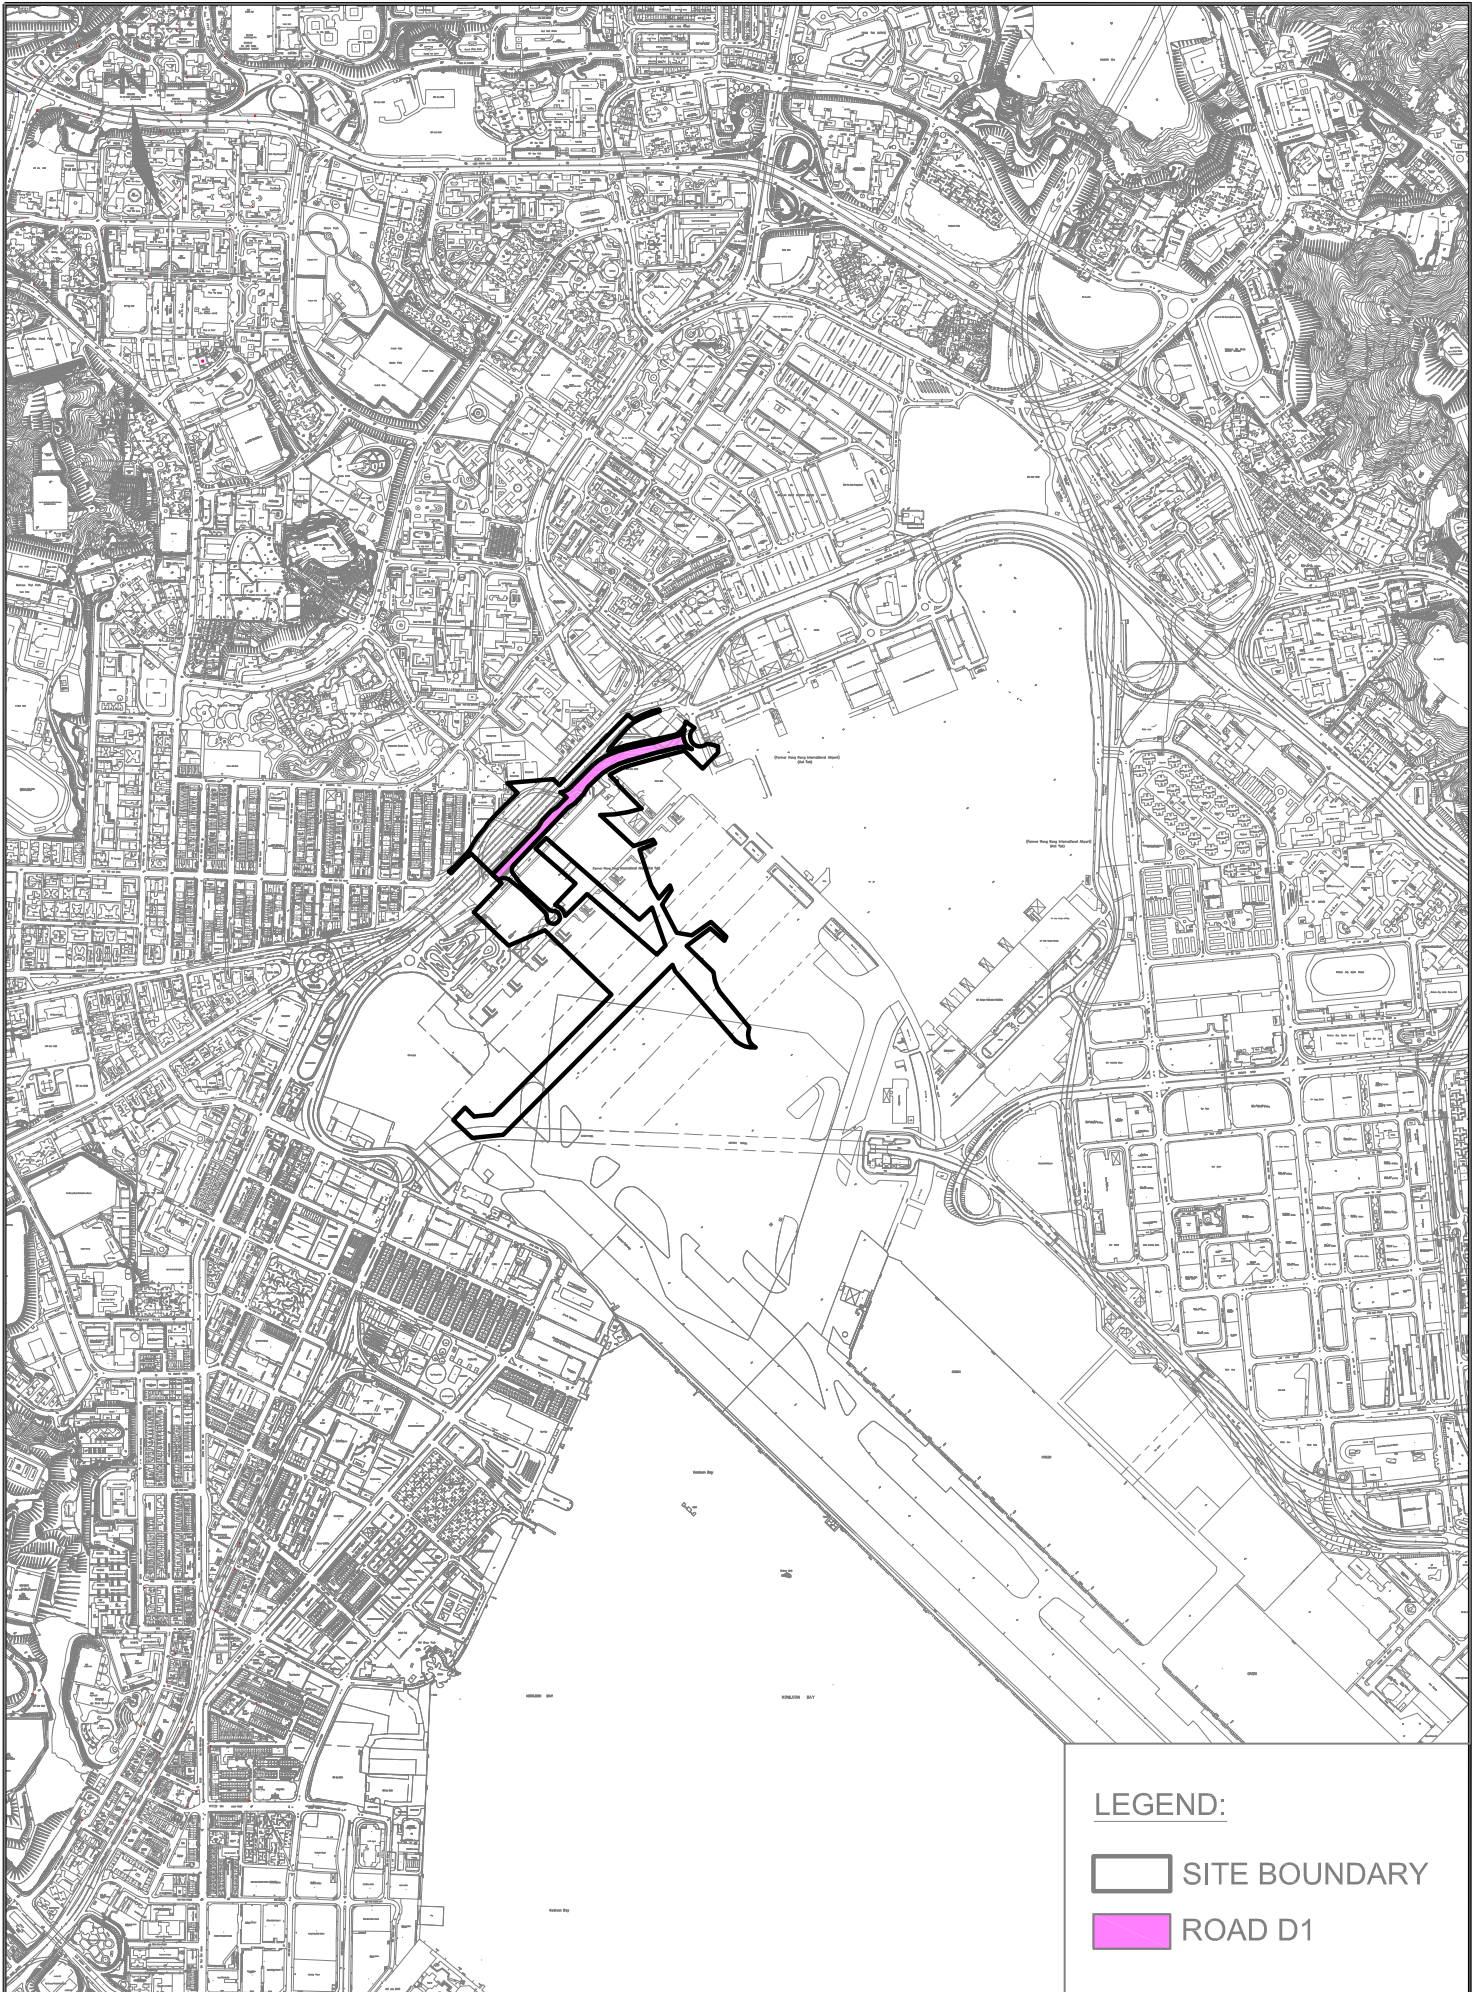
SCALE	1:1500@A4	DATE	DEC 2016
CHECK	KC	DRAWN	JW
JOB No.	MA16043	FIGURE NO.	1
		REV	-

SITE LAYOUT PLAN

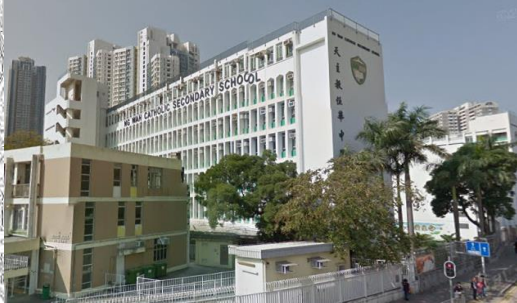
Anemometer Station from The Hong Kong Observatory
