28th CONSOLIDATED MONTHLY EM&A REPORT

February 2019

EP No. : EP-337/2009 –
New Distributor Roads Serving the Planned Kai Tak
Development Area

Contract No. : KLN/2016/05 –
Independent Environmental Checker for
Contract No. KL/2015/02 Kai Tak Development –
Stage 5A Infrastructure at Former North Apron Area

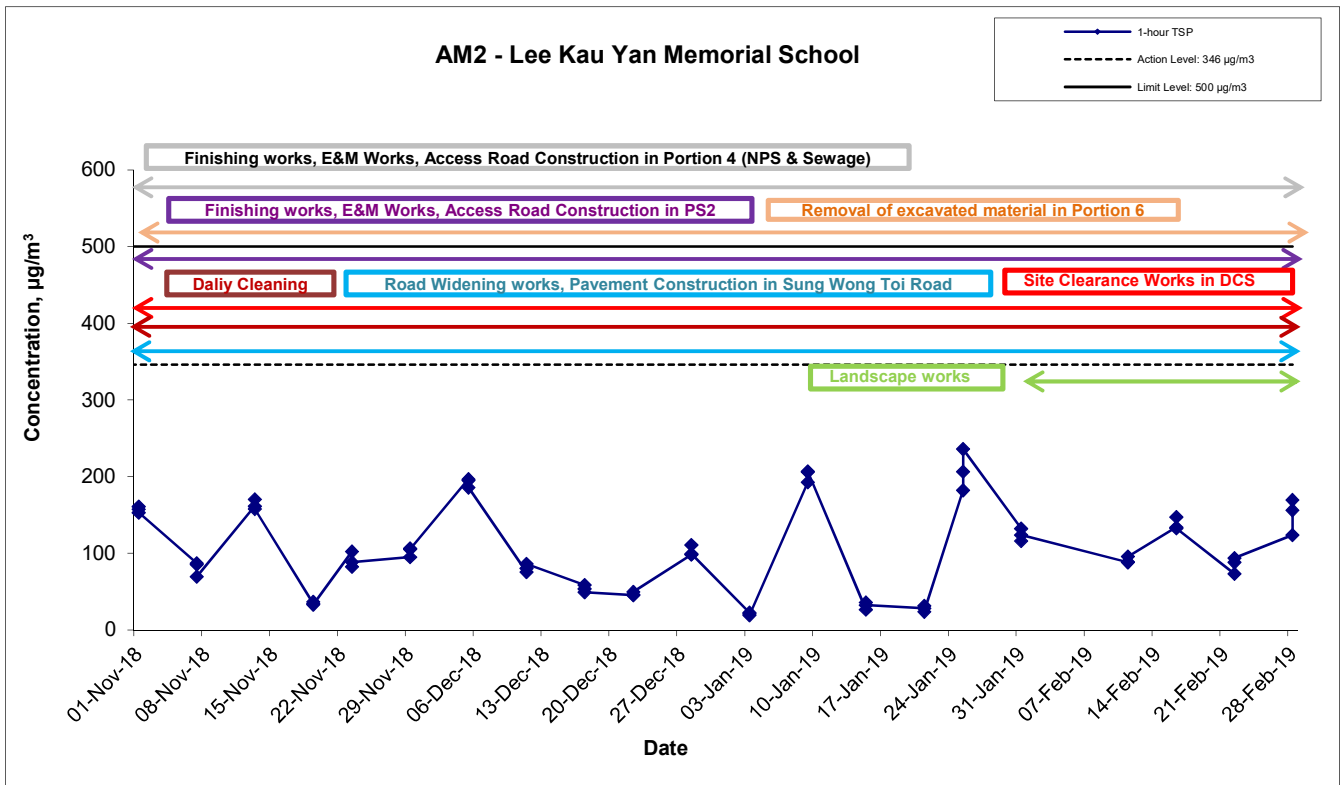
1-hr TSP Concentration Levels

Title	Contract No. KL/2012/03	Scale	Project	
	Kai Tak Development –Stage 4 Infrastructure at Former North Apron Area	N.T.S	No. MA13056	
Graphical Presentation of 1-hour TSP Monitoring Results		Date	Appendix	
		Feb 19	E
