## 34<sup>th</sup> CONSOLIDATED MONTHLY EM&A REPORT

August 2019

**EP No.** : EP-337/2009 –  
New Distributor Roads Serving the Planned Kai Tak  
Development Area

**Contract No.** : KLN/2016/05 –  
Independent Environmental Checker for  
Contract No. KL/2015/02 Kai Tak Development –  
Stage 5A Infrastructure at Former North Apron Area

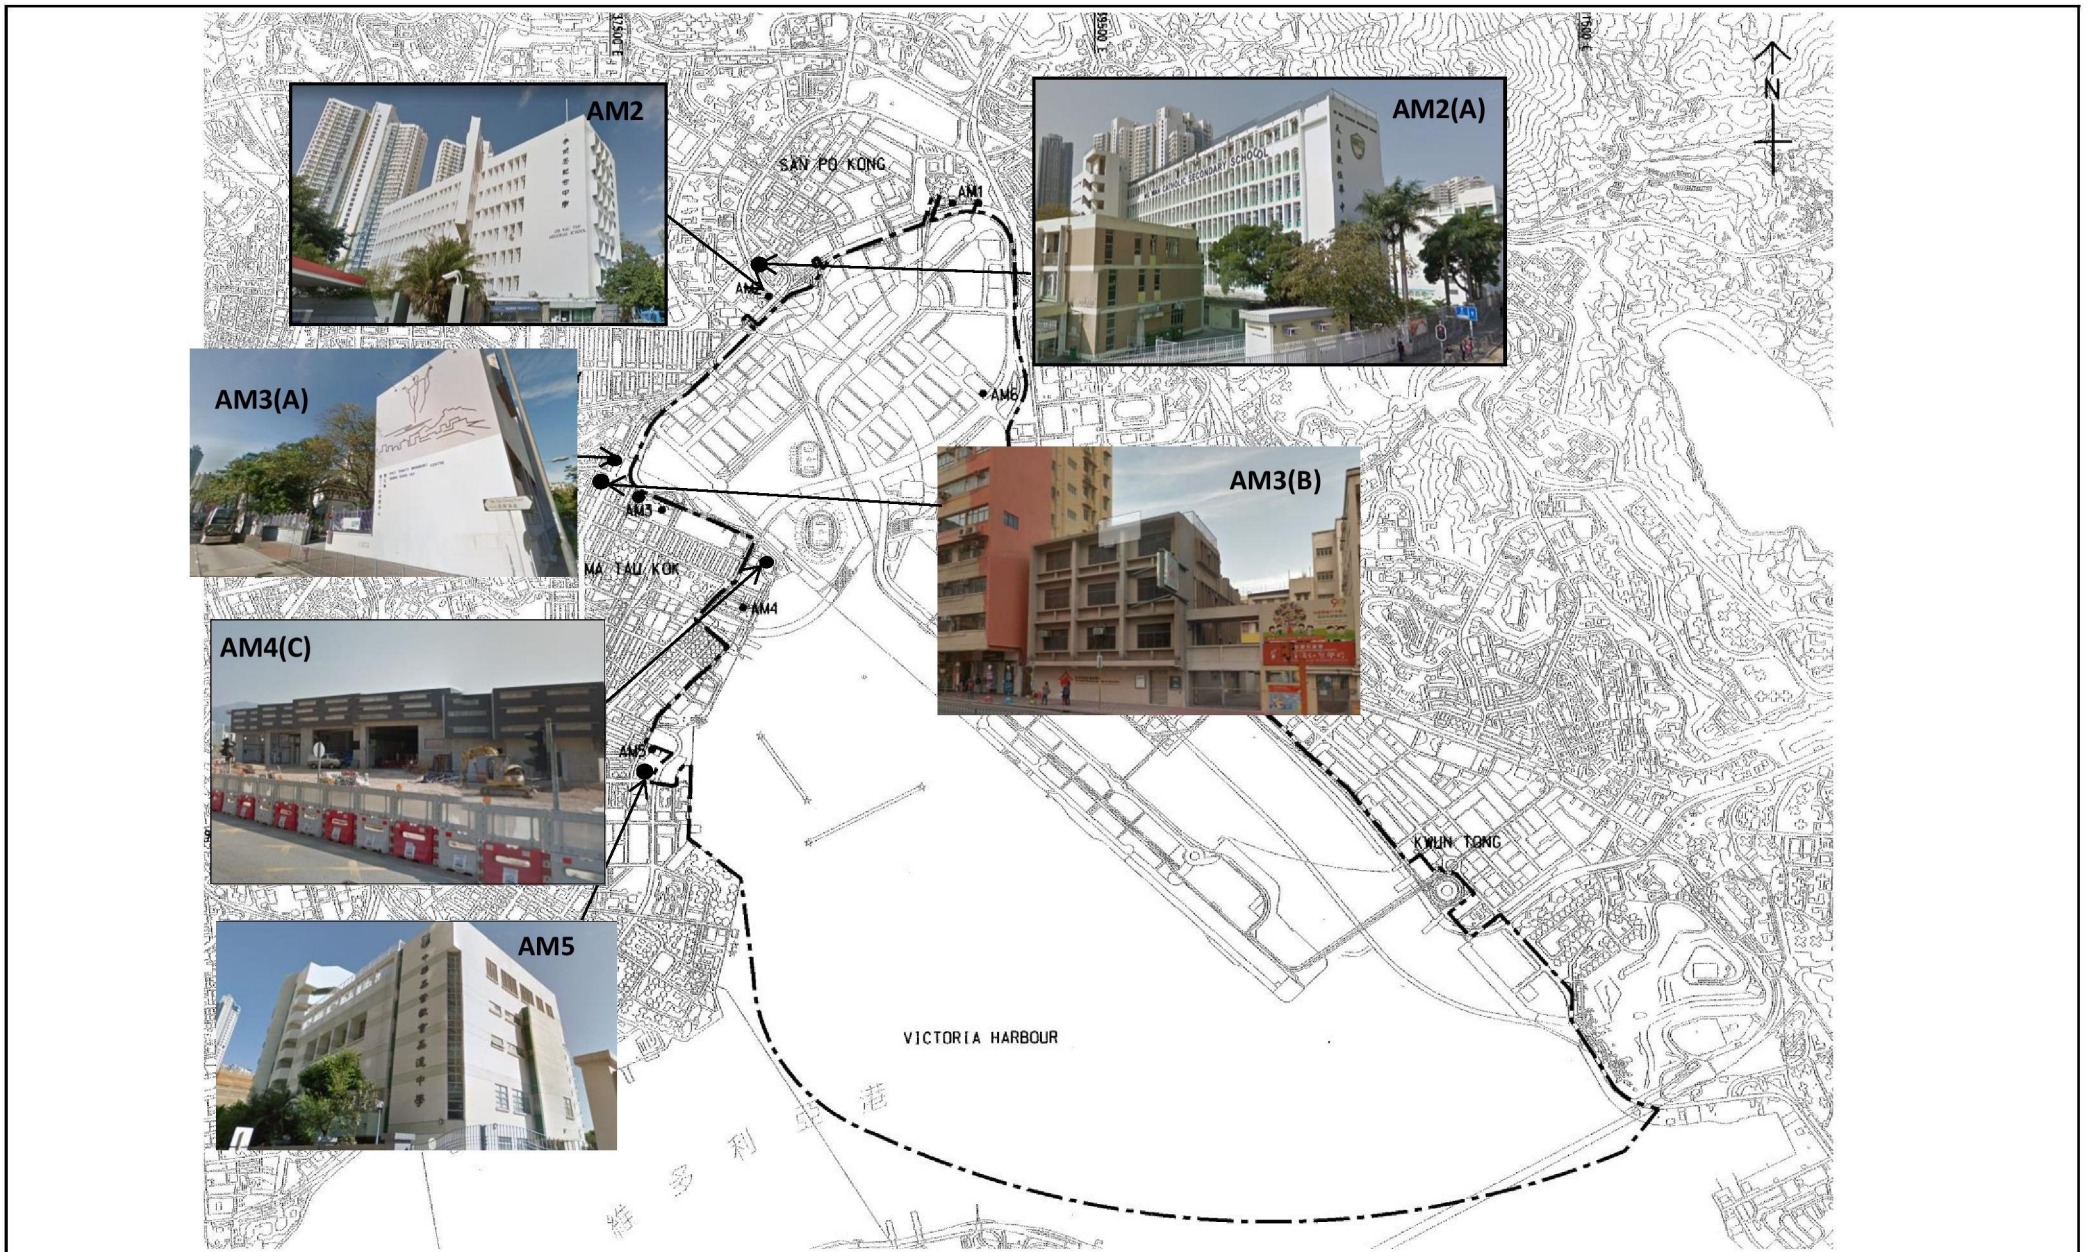
Title	Contract No. KL/2012/03		Scale	Project	
	Kai Tak Development –Stage 4 Infrastructure at Former North Apron Area		N.T.S	No. MA13056	
	Air Quality Monitoring Stations under this Project		Date	Figure	
			Dec-17	2

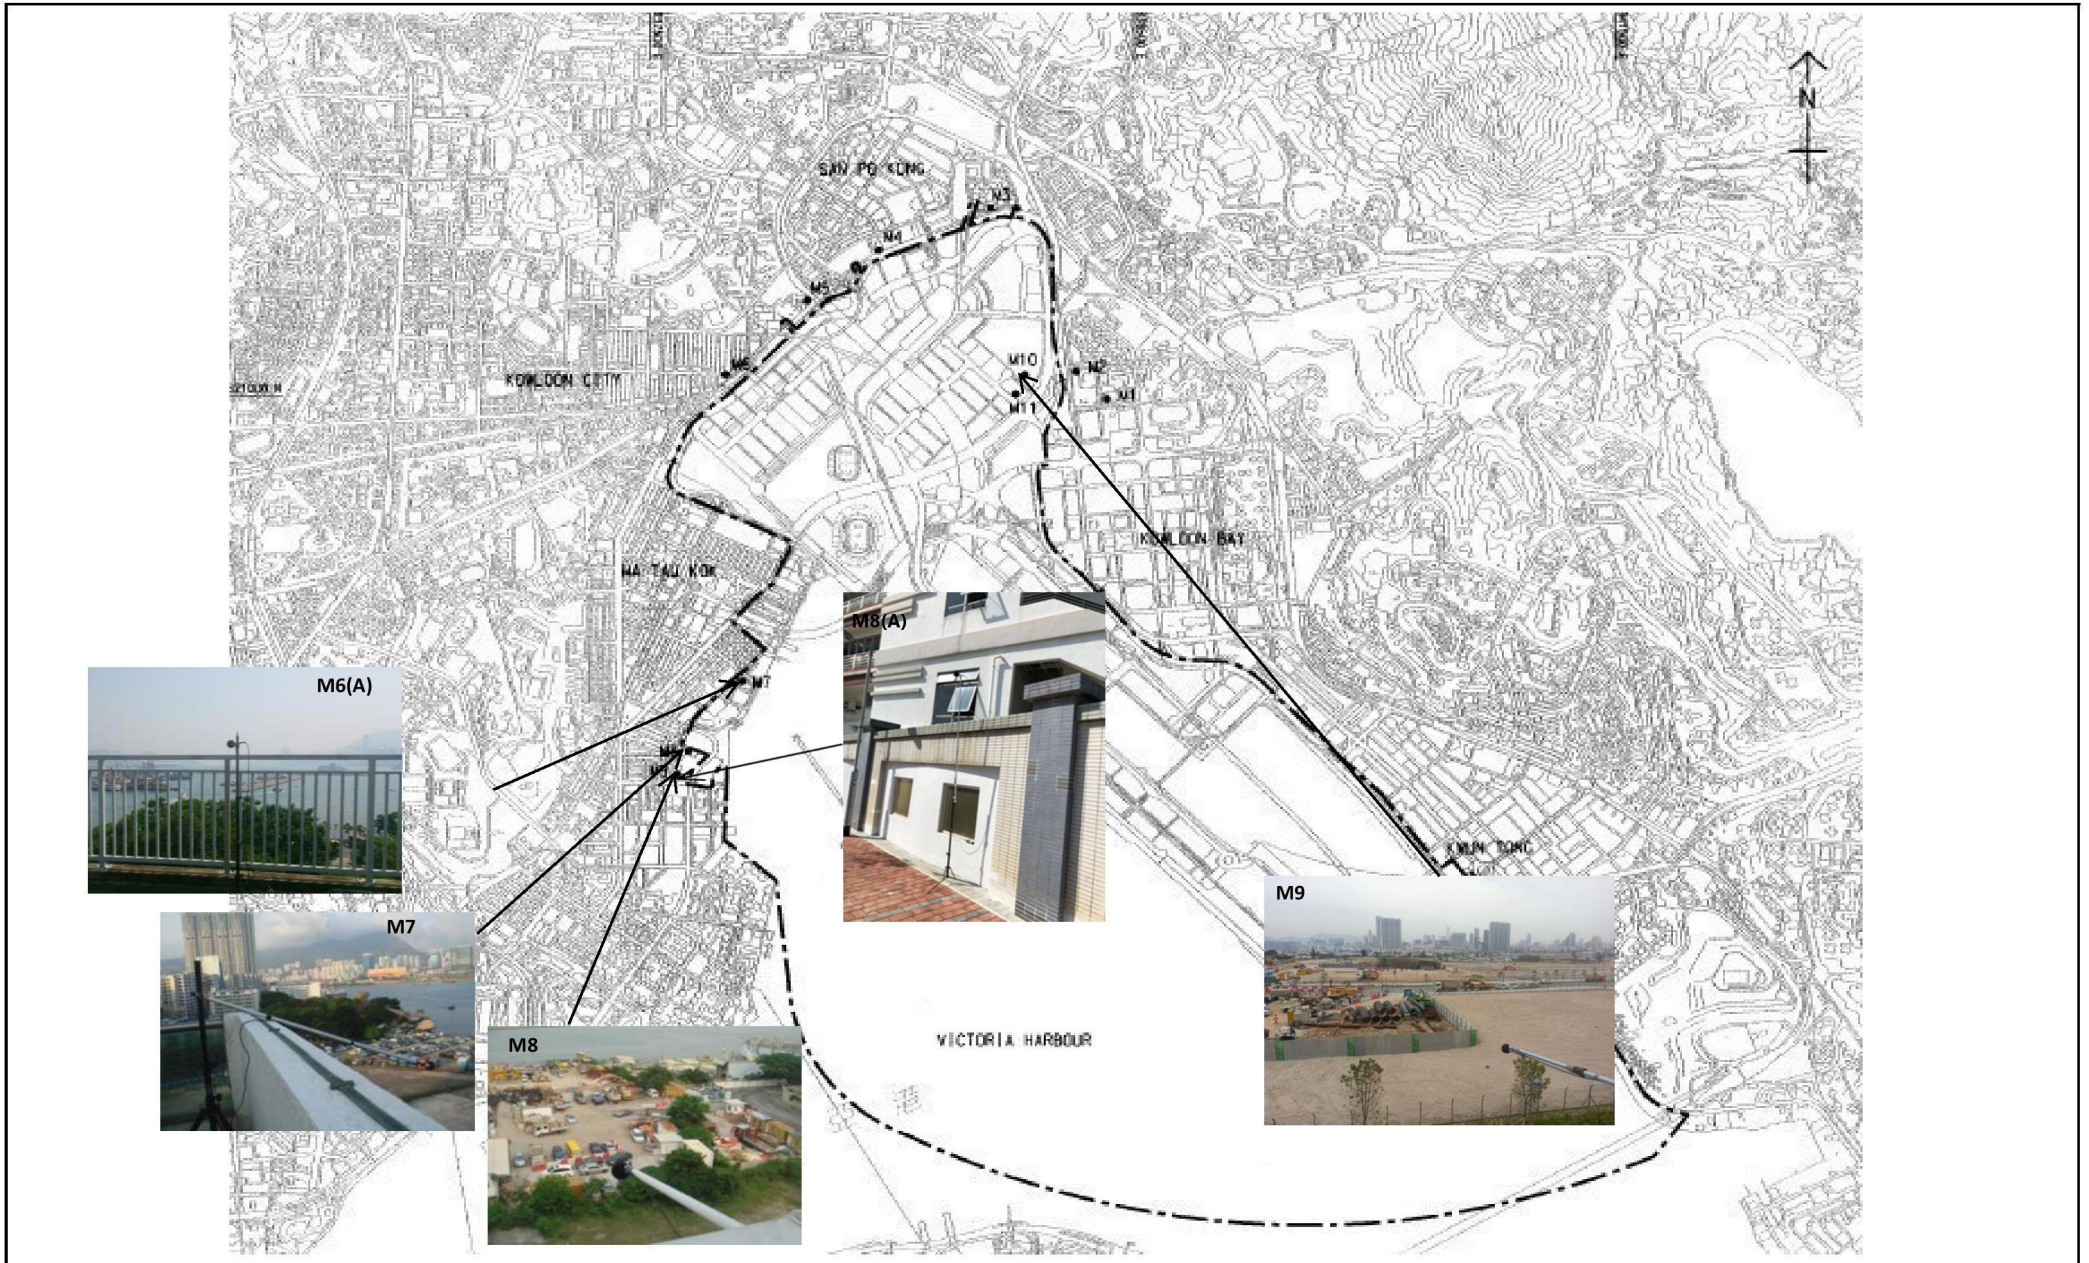
Title	Contract No. KL/2012/03		Scale	Project
	Kai Tak Development –Stage 4 Infrastructure at Former North Apron Area		N.T.S	No. MA13056
	Noise Monitoring Stations under this Project		Date	Figure
			Dec-16	3

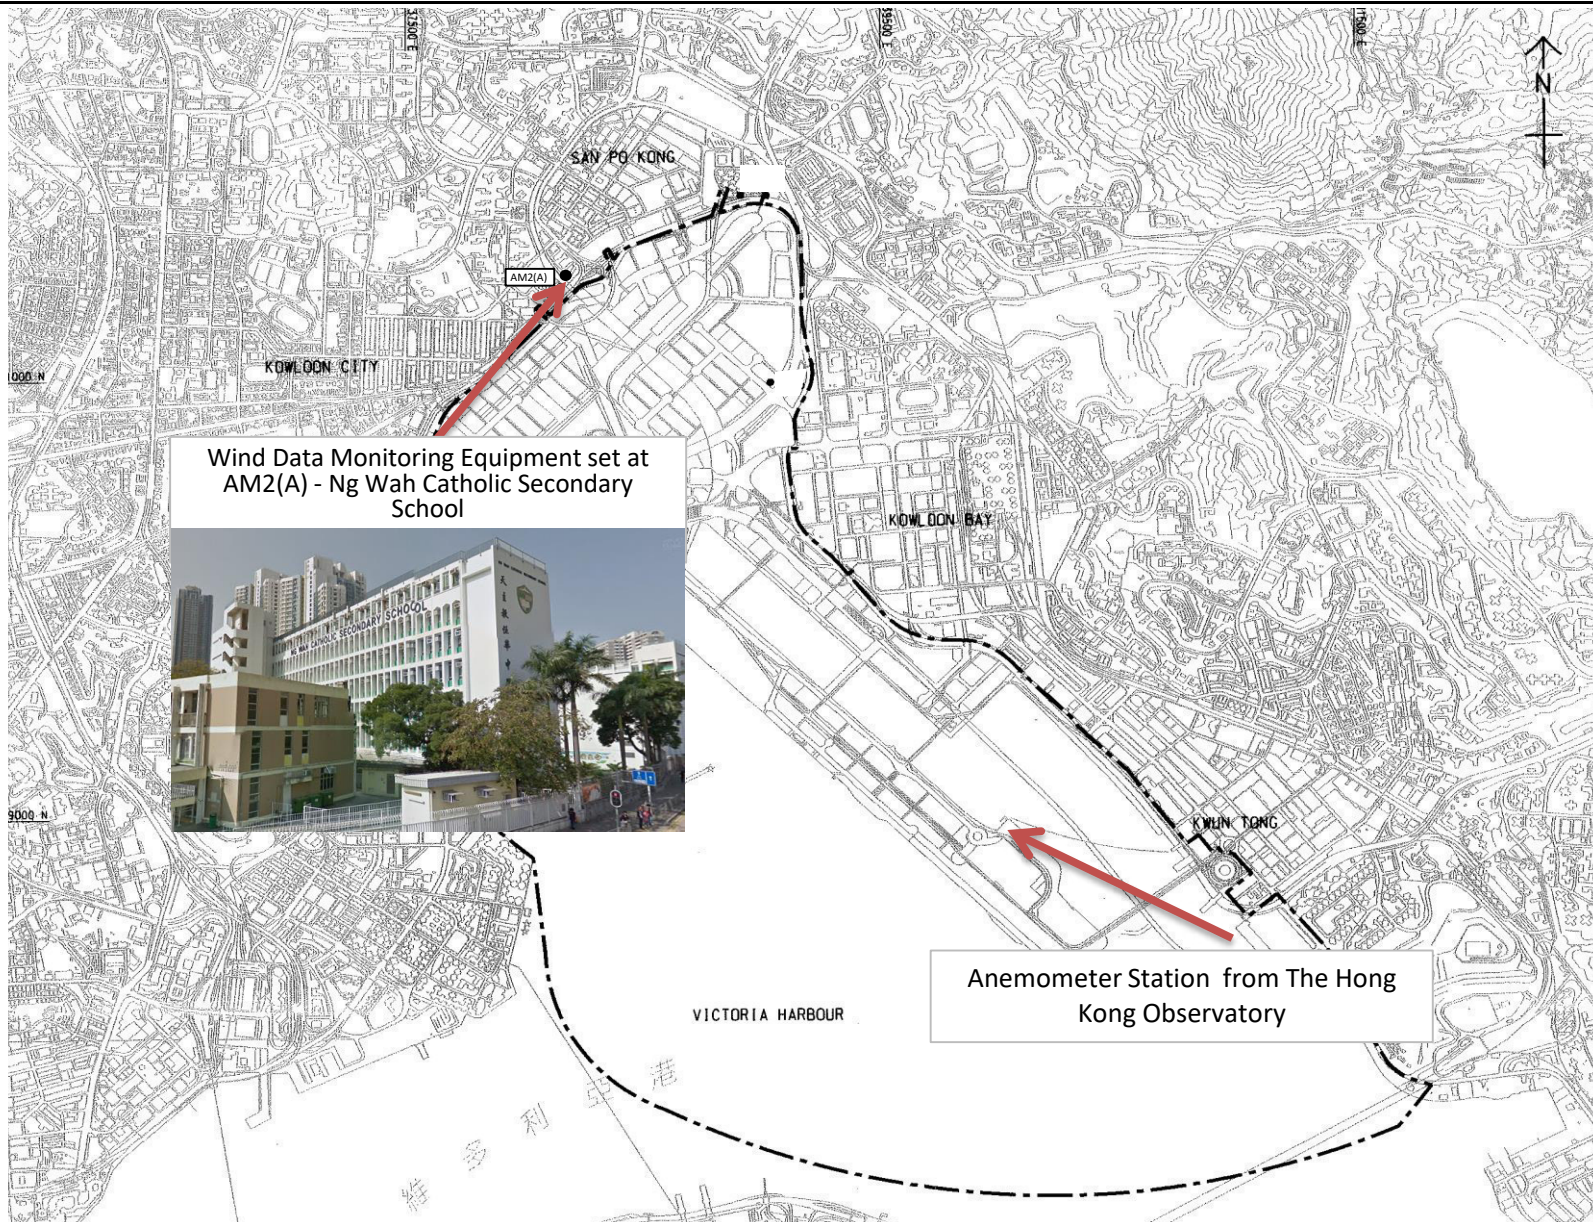
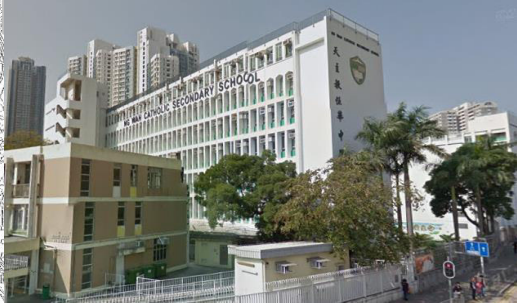
Wind Data Monitoring Equipment set at AM2(A) - Ng Wah Catholic Secondary School

Anemometer Station from The Hong Kong Observatory

Title	Contract No. KL/2012/03		Scale	Project		
	Kai Tak Development –Stage 4 Infrastructure at Former North Apron Area		N.T.S	No.	MA13056	
	Location of Wind Data Monitoring Equipment		Date	Figure		
			Aug-17	4

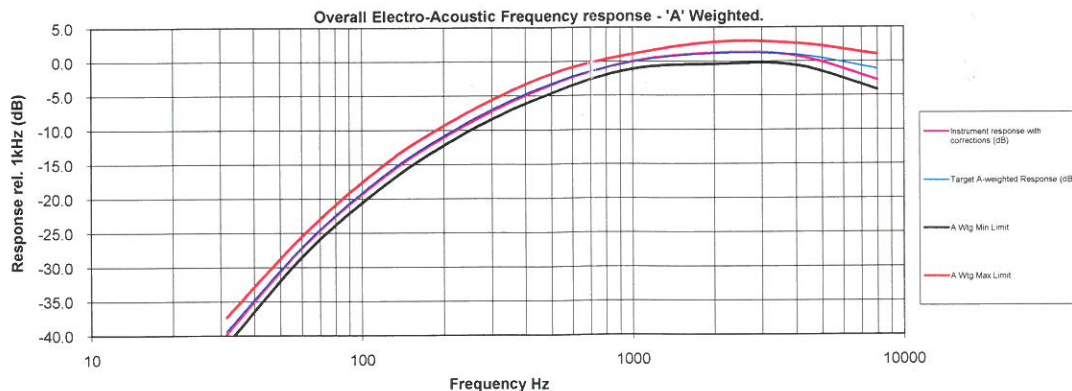
Combined Electro-Acoustic Frequency Response - A Weighted (IEC 61672-3:2006)

The following A-Weighted frequency response graph shows this instruments overall frequency response based upon the application of multi-frequency pressure field calibrations. The microphones Pressure to Free field correction coefficients are applied to pressure response. Reference level taken at 1kHz.

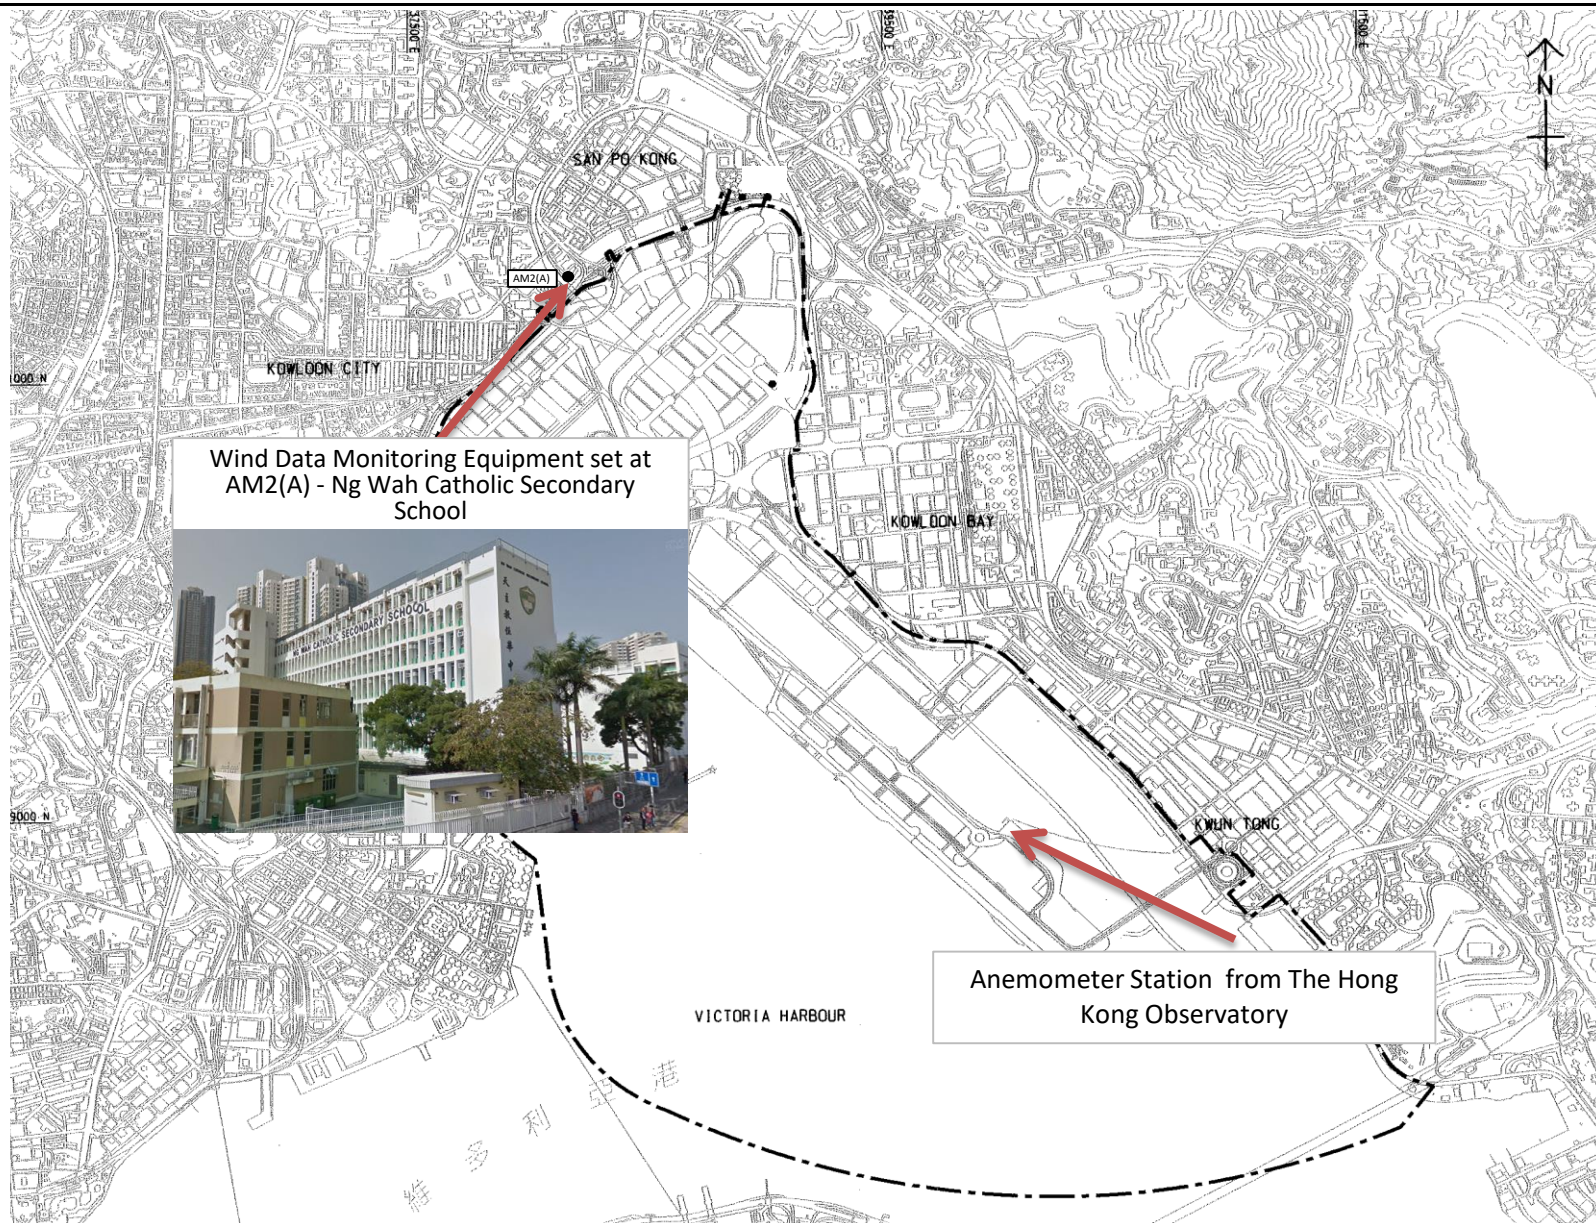
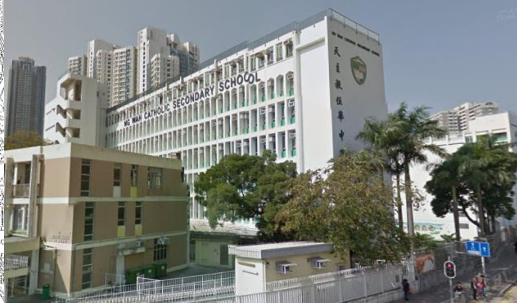
Wind Data Monitoring Equipment set at AM2(A) - Ng Wah Catholic Secondary School

Anemometer Station from The Hong Kong Observatory

Title  
 Contract No. KLN/2016/04  
 Environmental Monitoring Works for Contract No. KL/2015/02  
 Kai Tak Development – Stage 5A Infrastructure at Former North Apron Area  
 Location of Wind Data Monitoring Equipment

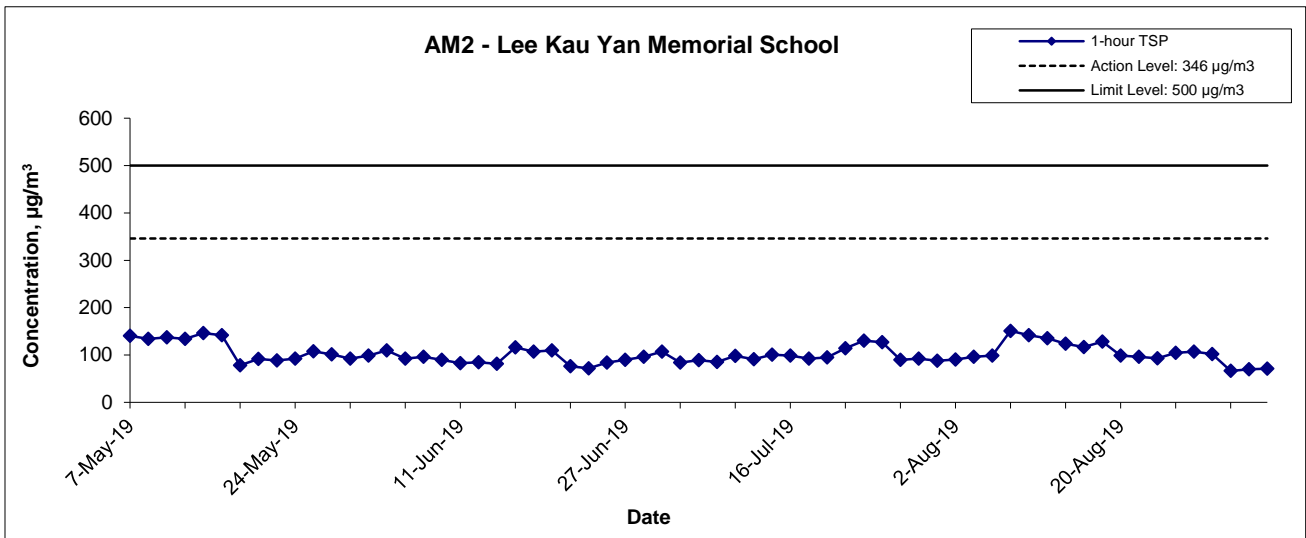
### 1-hr TSP Concentration Levels

Title  
 Contract No. KLN/2016/04  
 Environmental Monitoring Works for Contract No. KL/2015/02  
 Kai Tak Development –Stage 5A Infrastructure at Former North Apron Area  
 Graphical Presentation of 1-hour TSP Monitoring Results

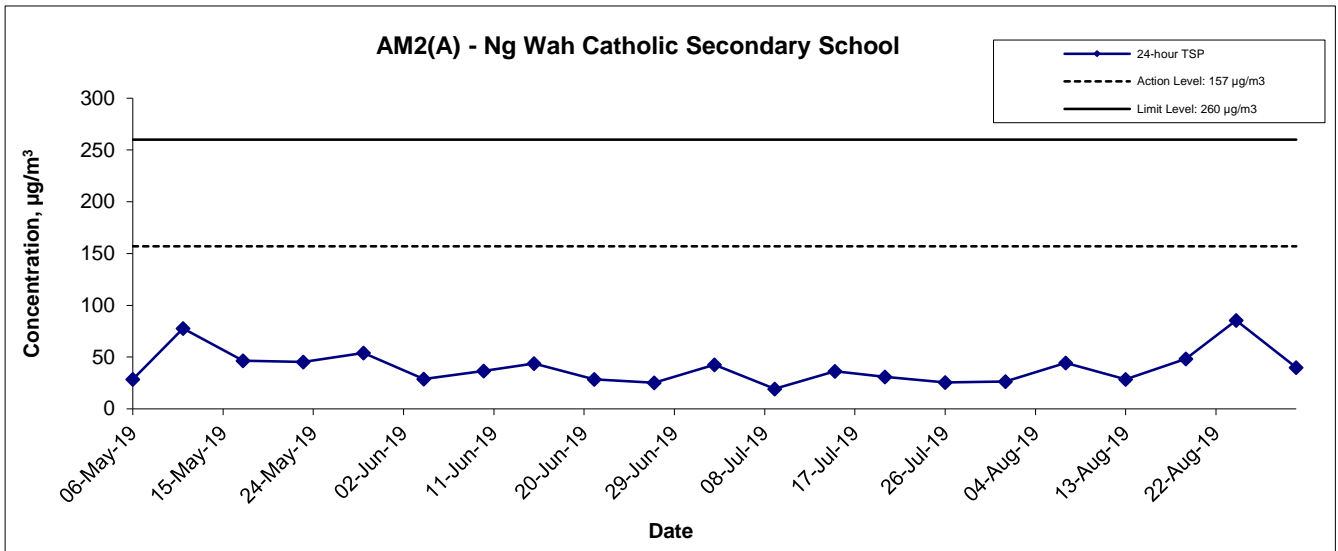
### 24-hr TSP Concentration Levels

Title Contract No. KLN/2016/04 Environmental Monitoring Works for Contract No. KL/2015/02 Kai Tak Development –Stage 5A Infrastructure at Former North Apron Area  Graphical Presentation of 24-hour TSP Monitoring Results	Scale	N.T.S	Project No.	MA16043	CINOTECH
	Date	Aug 19	Appendix	F

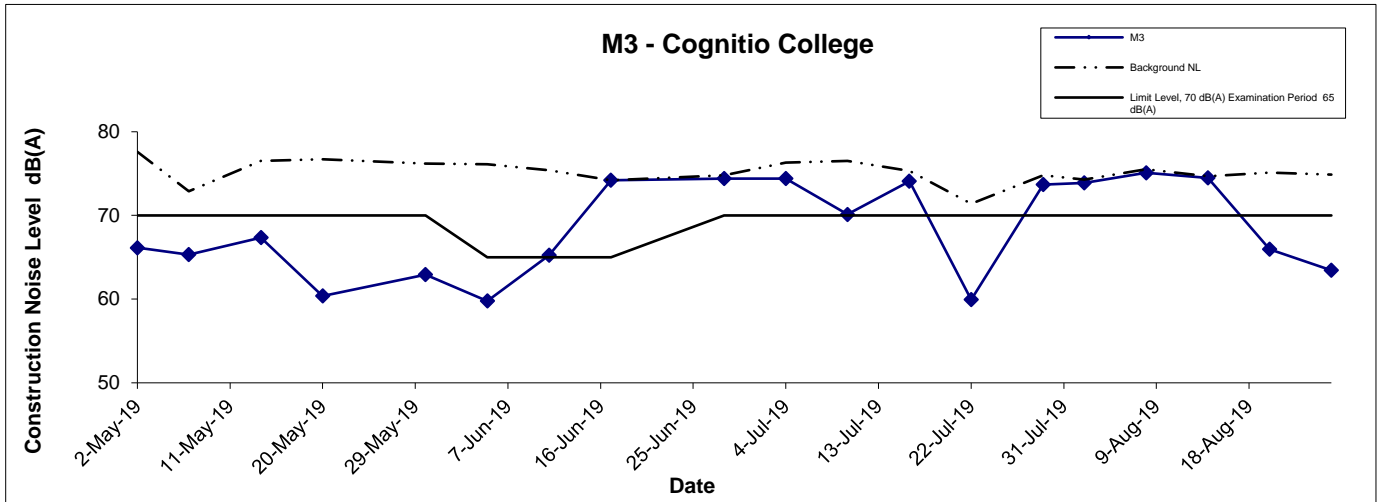
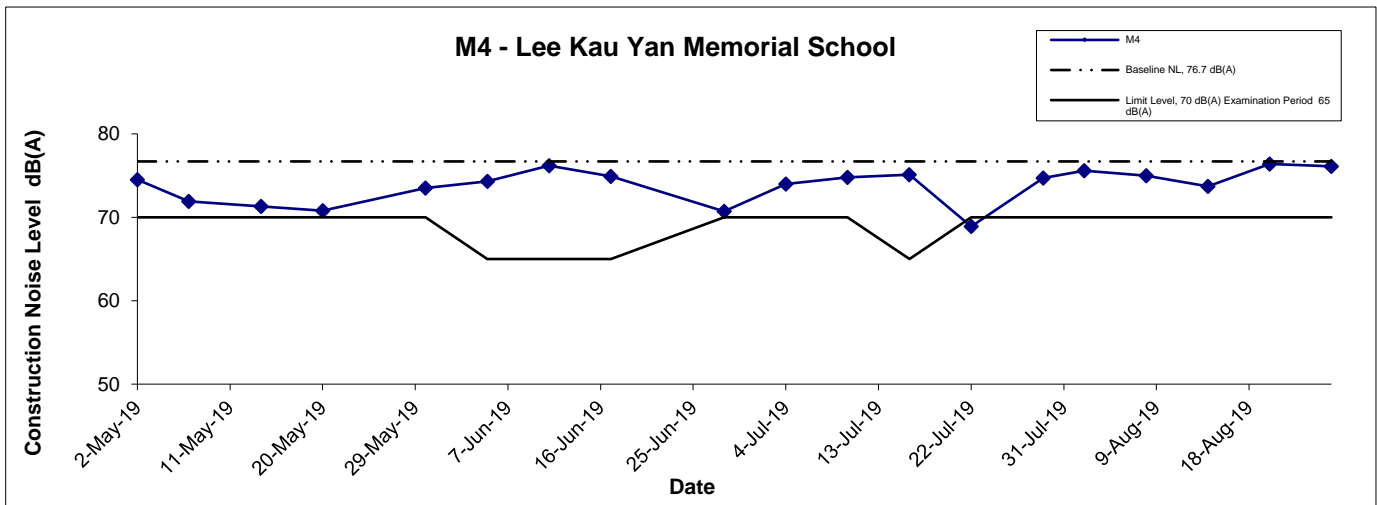
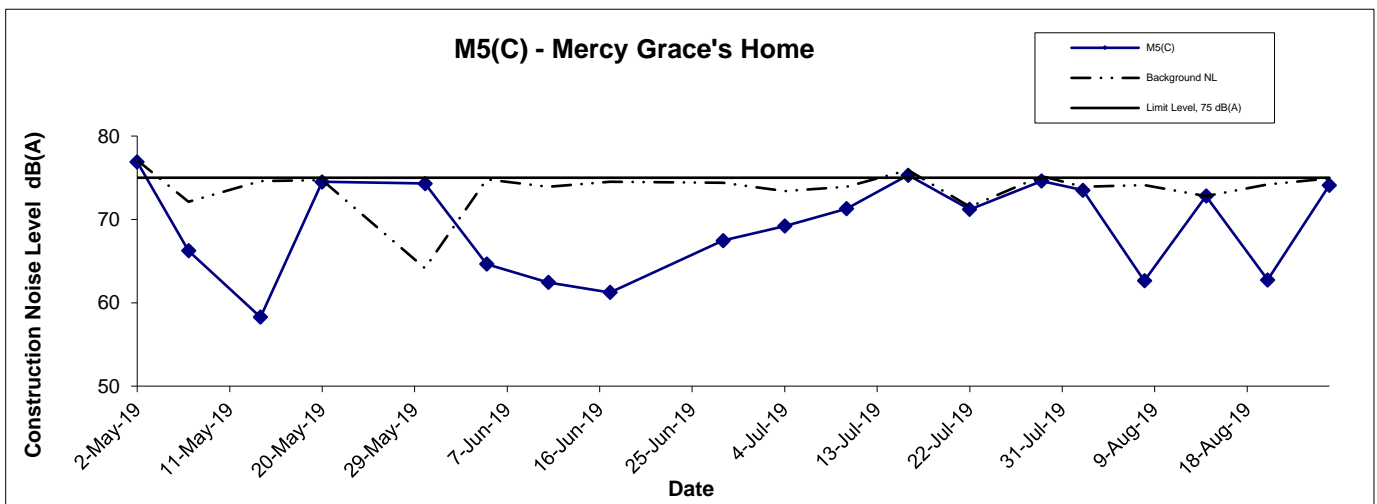
## Noise Levels

Remarks: The construction noise levels in the Tables in Appendix G were adopted for plotting the graphs

Title Contract No. KLN/2016/04 Environmental Monitoring Works for Contract No. KL/2015/02 Kai Tak Development –Stage 5A Infrastructure at Former North Apron Area Graphical Presentation of Construction Noise Monitoring Results	Scale N.T.S	Project No. MA16043	CINOTECH
	Date Aug 19	Appendix G
