36th CONSOLIDATED MONTHLY EM&A REPORT

October 2019

New Distributor Roads Serving the Planned Kai Tak

Contract No. KL/2015/02 Kai Tak Development – Stage 5A Infrastructure at Former North Apron Area

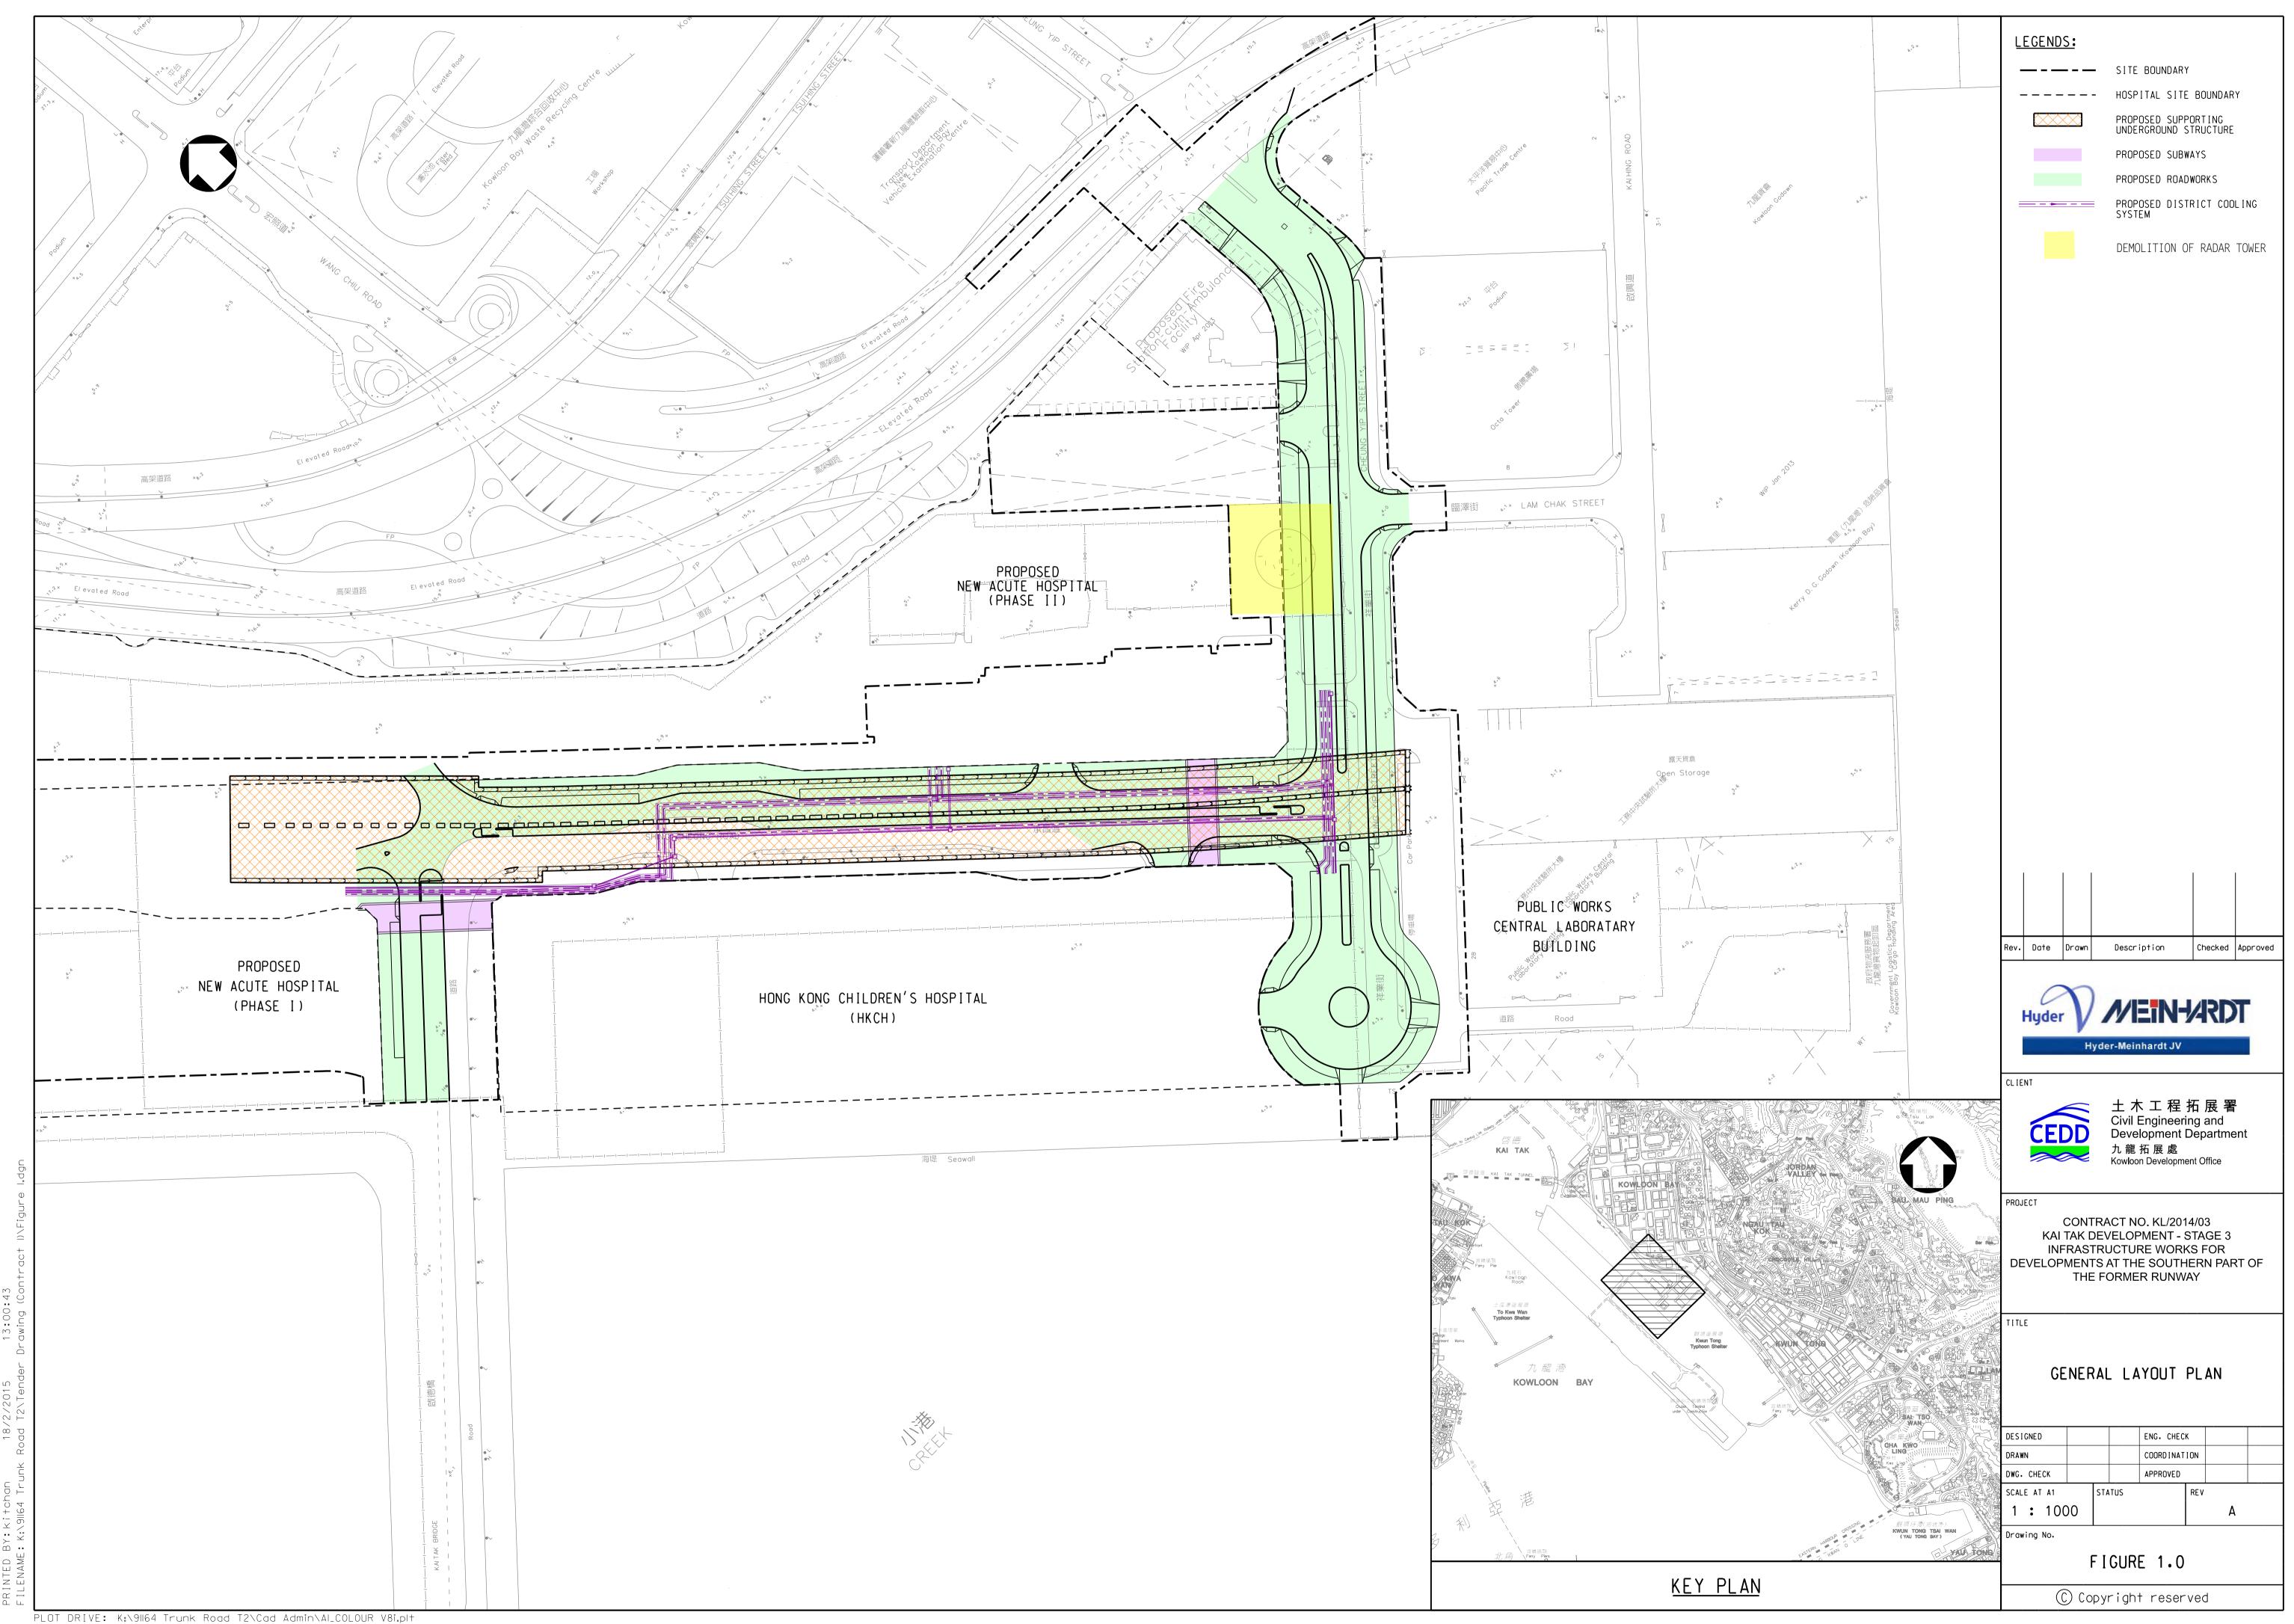
Figure 1

Project General Layout

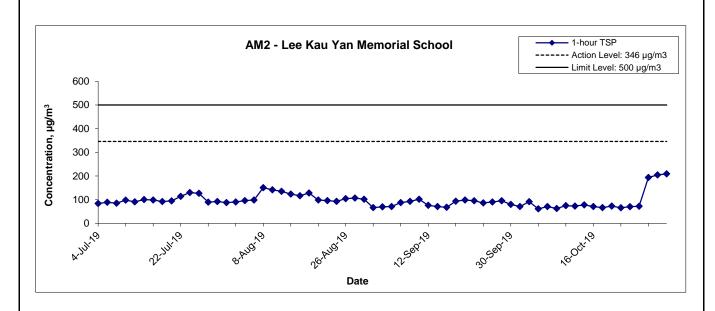
Title Contract No. KLN/2016/04
Environmental Monitoring Works for Contract No. KL/2015/02
Kai Tak Development –Stage 5A Infrastructure at Former North Apron Area
Graphical Presentation of 1-hour TSP Monitoring Results

1-hr TSP Concentration Levels

Location AM2 -	Location AM2 - Lee Kau Yan Memorial School								
Date	Time	Weather	Particulate Concentration (μg/m3)						
4-Oct-19	9:00	Sunny	61						
4-Oct-19	10:00	Sunny	71						
4-Oct-19	11:00	Sunny	63						
10-Oct-19	13:00	Sunny	75						
10-Oct-19	14:00	Sunny	73						
10-Oct-19	15:00	Sunny	78						
16-Oct-19	14:00	Sunny	71						
16-Oct-19	15:00	Sunny	66						
16-Oct-19	16:00	Sunny	73						
22-Oct-19	13:00	Sunny	66						
22-Oct-19	14:00	Sunny	70						
22-Oct-19	15:00	Sunny	73						
28-Oct-19	14:00	Rainy	194						
28-Oct-19	15:00	Rainy	205						
28-Oct-19	16:00	Rainy	209						
		Average	97						
		Maximum	209						
		Minimum	61

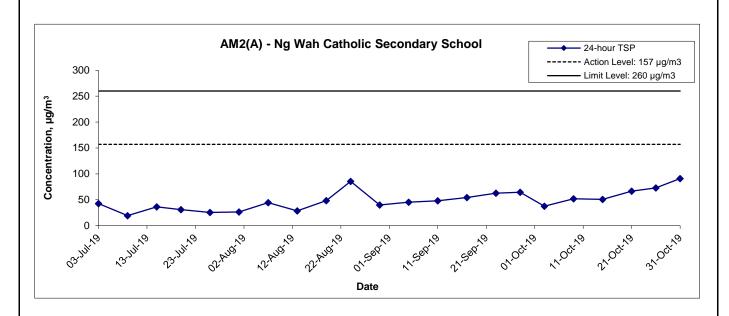
Title Contract No. KLN/2016/04
Environmental Monitoring Works for Contract No. KL/2015/02
Kai Tak Development –Stage 5A Infrastructure at Former North Apron Area

24-hr TSP Concentration Levels

Graphical Presentation of 24-hour TSP Monitoring Results
