**EP-337/2009 – New Distributor Roads Serving the  
Planned KTD**

**Contract No. KL/2012/02  
Kai Tak Development – Stage 3A Infrastructure at  
Former North Apron Area**

Final EM&A Review Report

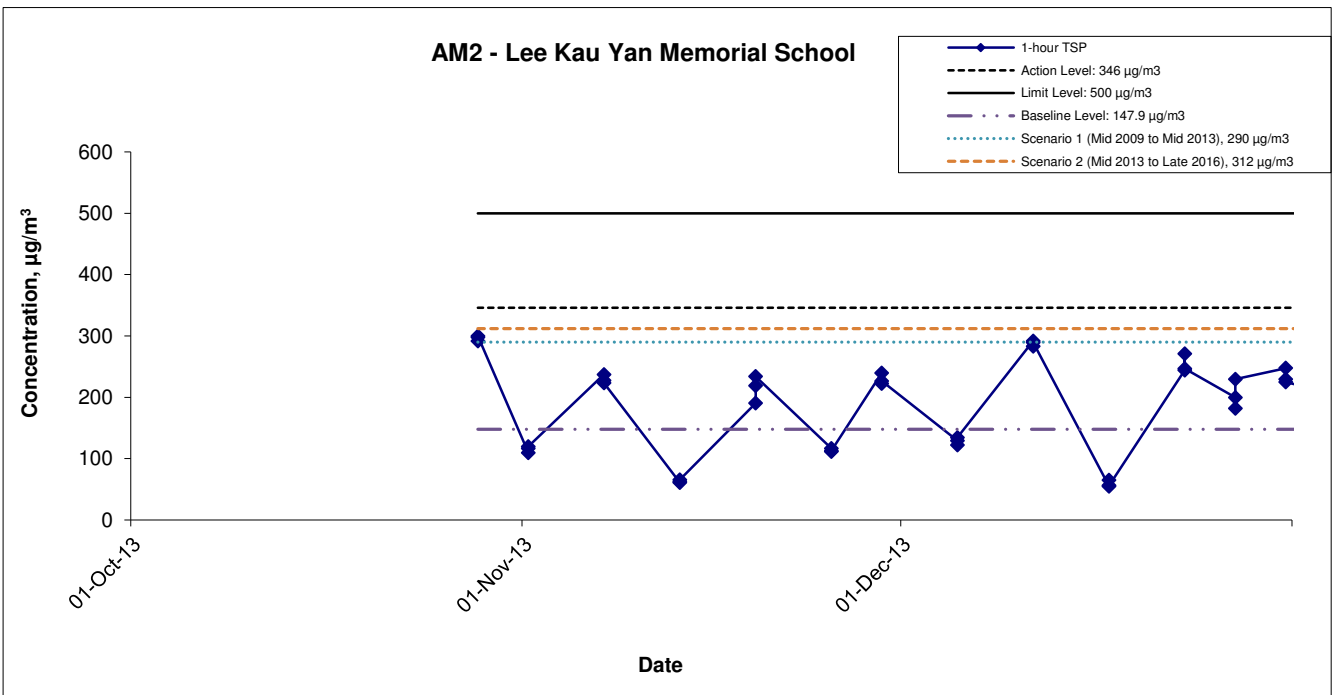
| | Year<br>2013 | Appendix<br>C | | |

| Title<br>Kai Tak Development - Stage 3A Infrastructure at Former North Apron Area<br><br>Graphical Presentation of 1-hour TSP Monitoring Results | Contract No. KL/2012/02 | Scale<br>N.T.S | Project No.<br>MA13043 | <b>CINOTECH</b> |

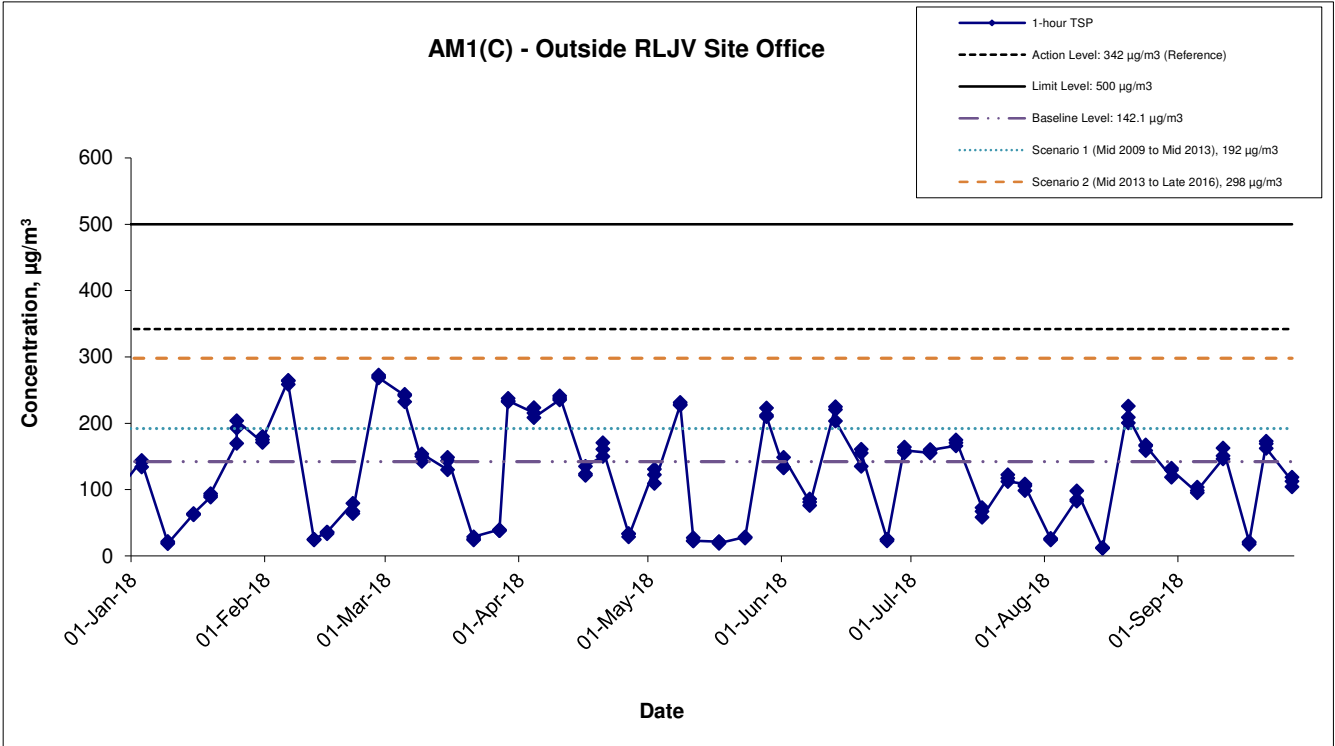
| | Year<br>2018 | Appendix<br>C | |

| Title<br>Contract No. KL/2012/02<br>Kai Tak Development - Stage 3A Infrastructure at Former North Apron Area<br><br>Graphical Presentation of 1-hour TSP Monitoring Results | Scale<br>N.T.S | Project No.<br>MA13043 | |

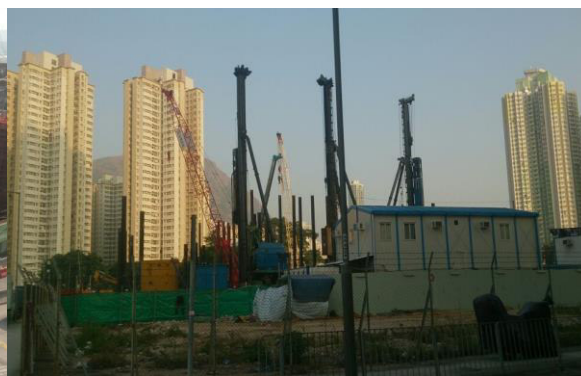
- During the 1<sup>st</sup> and repeated noise monitoring conducted at 15:00 and 15:30, bar bending machines and tower crane were found operating in the nearby Kai Tak Development project site (Contract No. SS W304). By which no major noise was generated from it and the photograph record is shown in Photo 1.
- According to the field staff observation, the major noise source came from percussive piling which operating in the building construction site located at the junction between Prince Edward Road East and King Kong Street. (Shown in Photo 2.)
- As the construction site with the major noise source located outside the project area of Kai Tak Development Area, the exceedance recorded at Station M3 - Cognito College was considered to be non-Project related.

(Photo 2: Building construction site at the junction between Prince Edward Road East and King Kong Street)

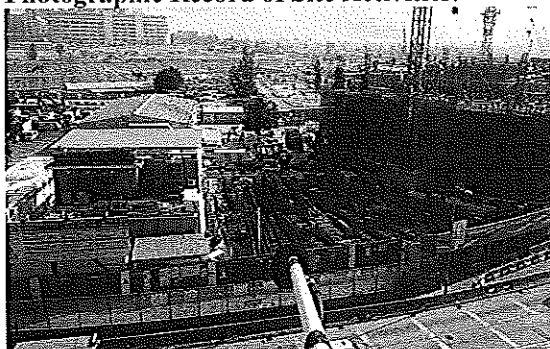
- During the 1<sup>st</sup> and repeated noise monitoring conducted at 15:00 and 15:30, bar bending machines and tower crane were found operating in the nearby Kai Tak Development project site (Contract No. SS W304). By which no major noise was generated from it and the photograph record is shown in Photo 1.
- According to the field staff observation, the major noise source came from percussive piling which operating in the building construction site located at the junction between Prince Edward Road East and King Kong Street. (Shown in Photo 2.)
- As the construction site with the major noise source located outside the project area of Kai Tak Development Area, the exceedance recorded at Station M3 - Cognitio College was considered to be non-Project related.

(Photo 1: Contract No. SS W304)

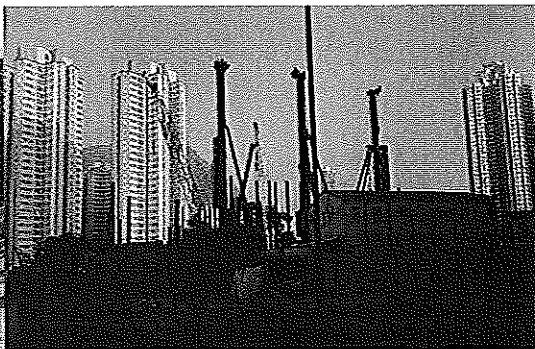
(Photo 2: Building construction site at the junction between Prince Edward Road East and King Kong Street)
