EP-344/2009 – New Sewage Pumping Stations Serving KTD and EP-337/2009 – New Distributor Roads Serving the Planned KTD

Contract No. KL/2012/03 Kai Tak Development –Stage 4 Infrastructure at Former North Apron Area

Monthly EM&A Report

January 2014

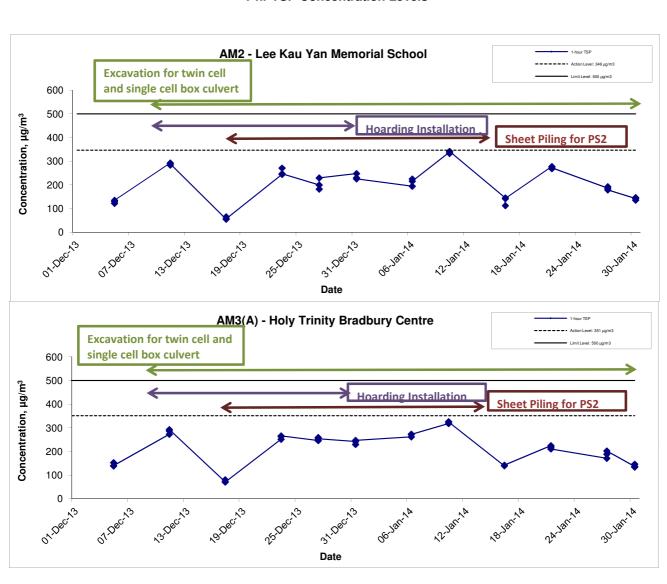
1-hr TSP Concentration Levels

Title Contract No. KL/2012/03 Kai Tak Development –Stage 4 Infrastructure at Former North Apron Area	Scale		Project No.	MA13056	CINOTECH
Graphical Presentation of 1-hour TSP Monitoring Results	Date	Jan 14	Append	ix E	CINOICCI

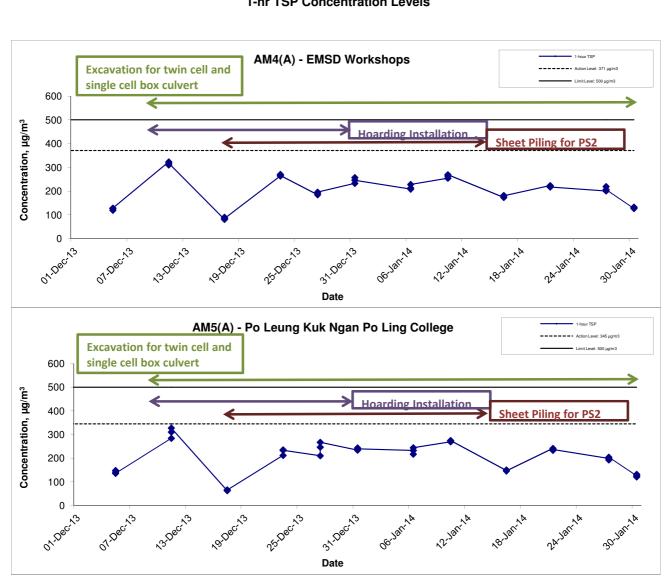
1-hr TSP Concentration Levels

Graphical Presentation of 1-hour TSP Monitoring Results

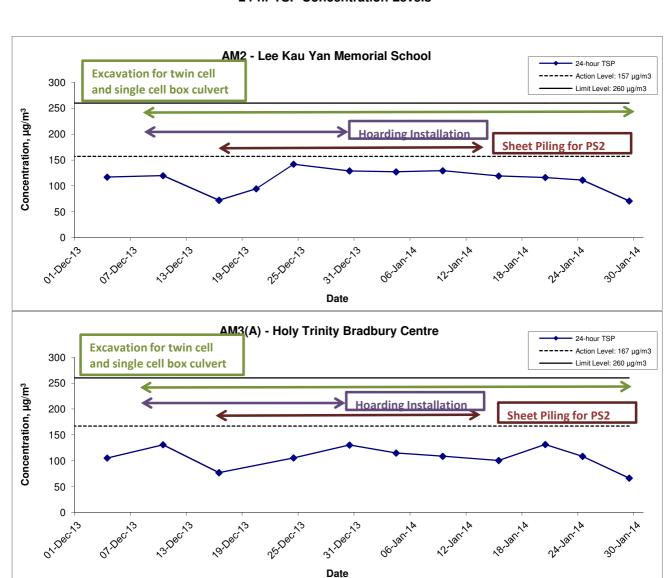
24-hr TSP Concentration Levels

Title Contract No. KL/2012/03
Kai Tak Development –Stage 4 Infrastructure at Former
North Apron Area
Graphical Presentation of 24-hour TSP Monitoring Results

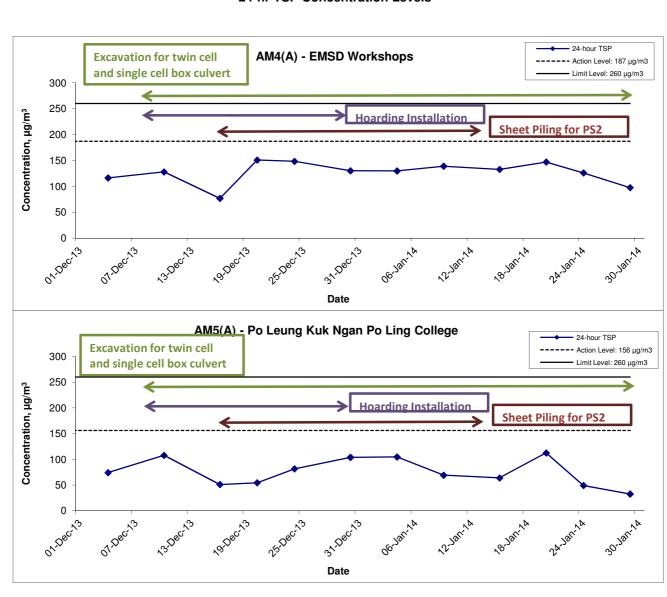
24-hr TSP Concentration Levels

Graphical Presentation of 24-hour TSP Monitoring Results

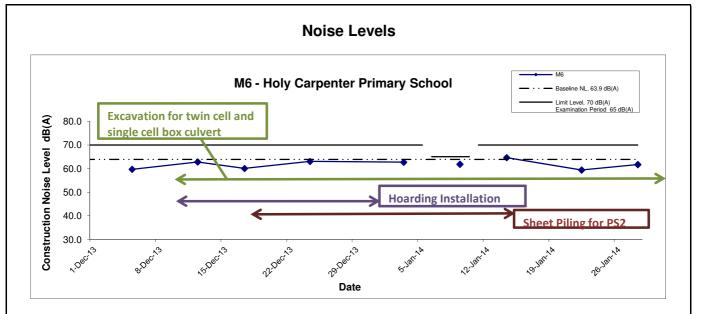
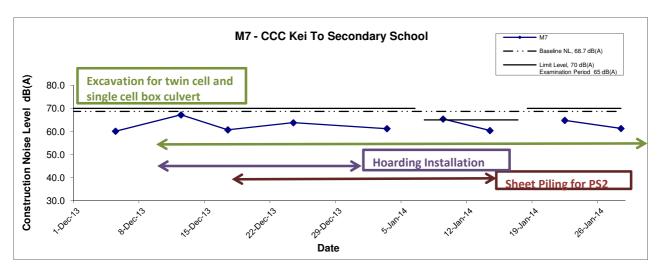
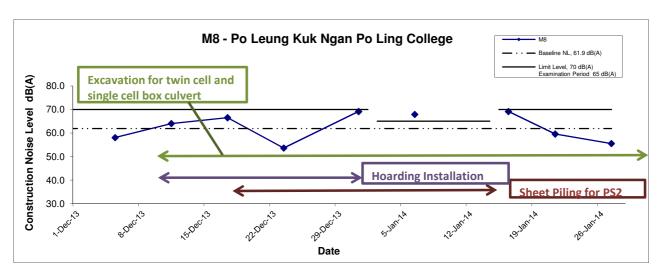
Remarks: The construction noise levels in the Tables in Appendix G were adopted for plotting the graphs

Title Contract No. KL/2012/03
Kai Tak Development –Stage 4 Infrastructure at Former
North Apron Area
Graphical Presentation of Construction Noise Monitoring
Results

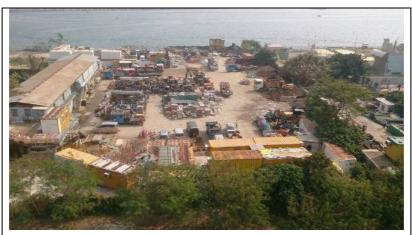
The exceedance was considered non-related to the Project works:

- During the noise monitoring conducted at 11:27 a.m., mobile excavators were found operating in the open ground outside of the work areas of this Project as shown in Photo 1.
- According to field staffs' observation, major noise source identified was the loading and unloading works from the mobile excavator as shown in Photo 2.
- As the major noise source was located outside the work areas of this Project, the exceedance recorded at Station M8 - Po Leung Kuk Ngan Po Ling College was considered to be non-Project related.

Photo 1 (Construction works conducting outside KTD Project Area.)

No further mitigation measures would be required.
