EP-344/2009 – New Sewage Pumping Stations Serving KTD and EP-337/2009 – New Distributor Roads Serving the Planned KTD

Contract No. KL/2012/03 Kai Tak Development –Stage 4 Infrastructure at Former North Apron Area

Monthly EM&A Report

September 2014

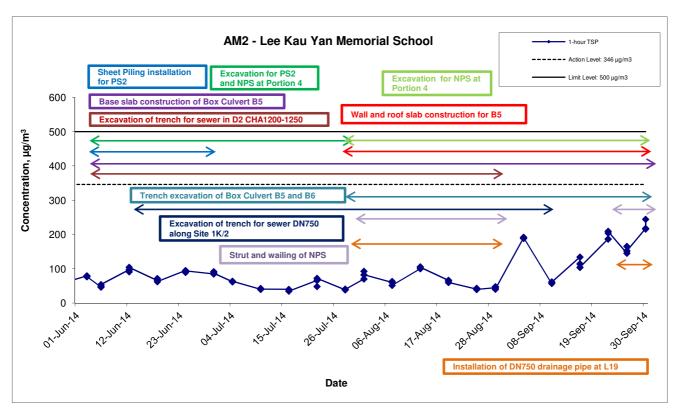
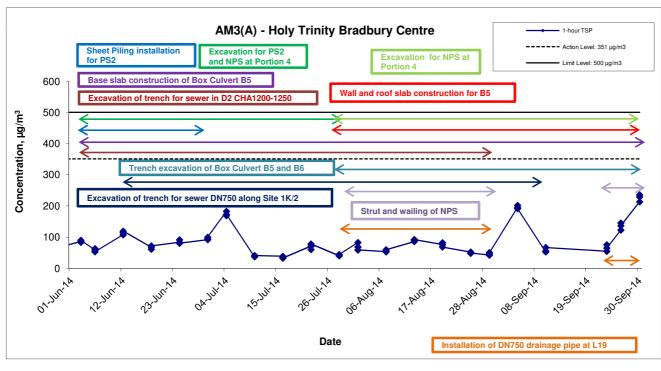
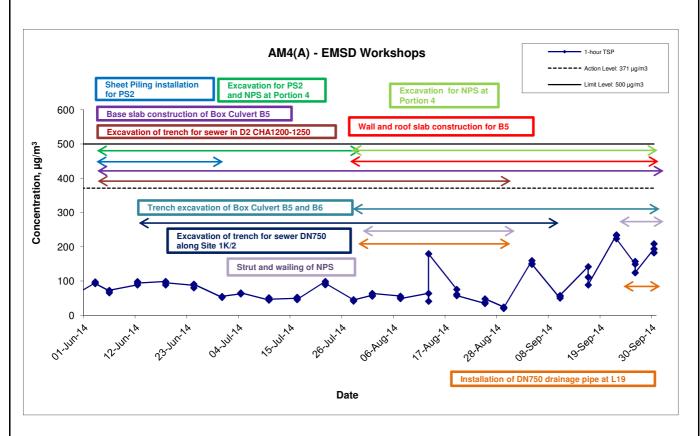
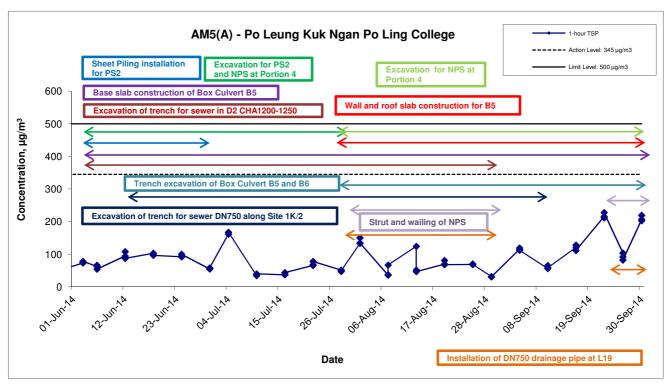
1-hr TSP Concentration Levels

Graphical Presentation of 1-hour TSP Monitoring Results

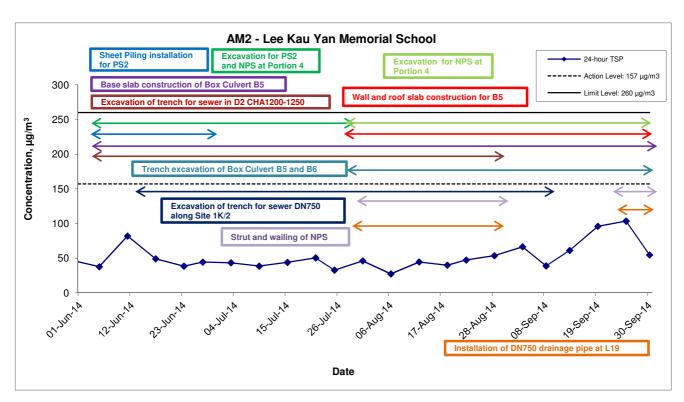
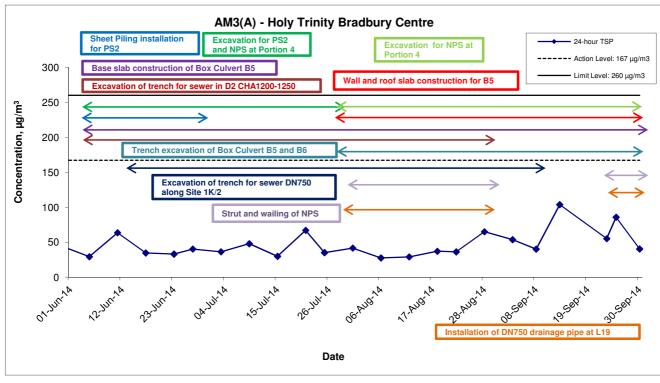
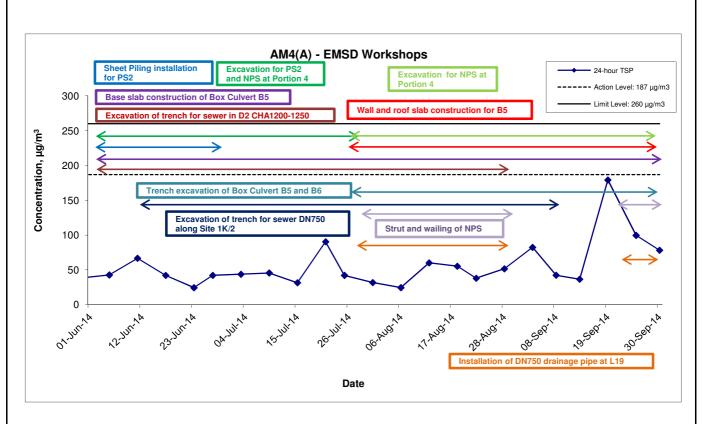
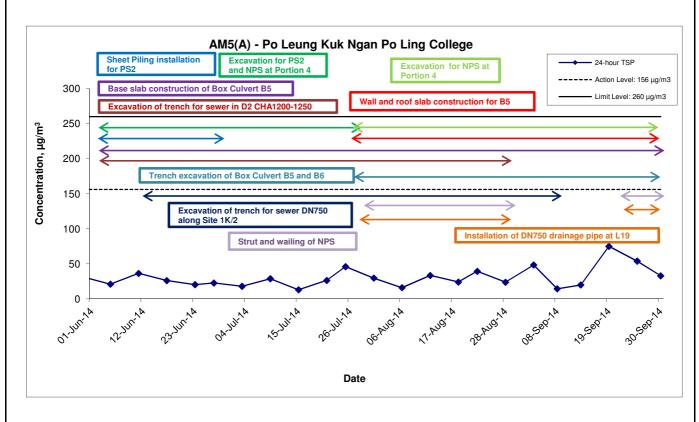
24-hr TSP Concentration Levels

Title Contract No. KL/2012/03 Kai Tak Development –Stage 4 Infrastructure at Former North Apron Area	Scale		Project No. MA13056	CINOTECH
Graphical Presentation of 24-hour TSP Monitoring Results	Date	Sep 14	Appendix F

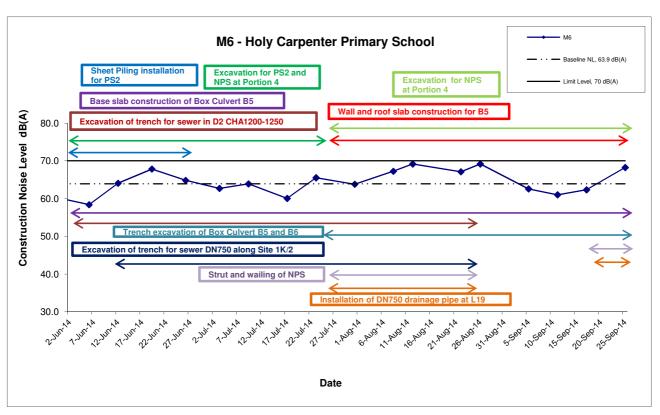
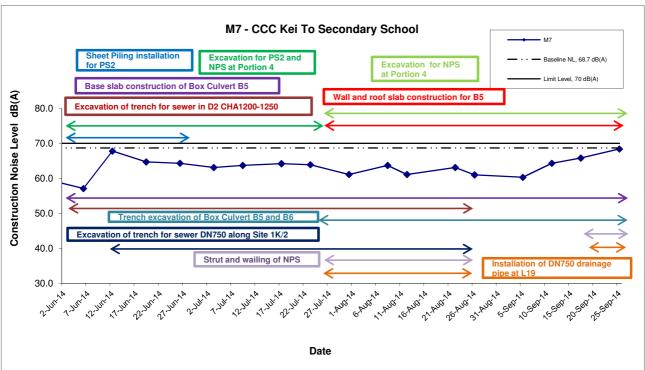
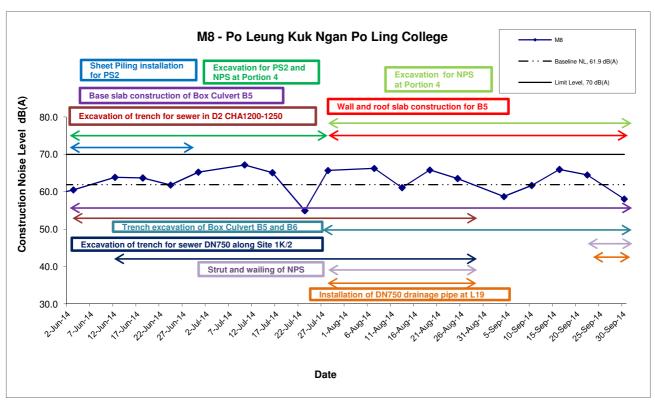
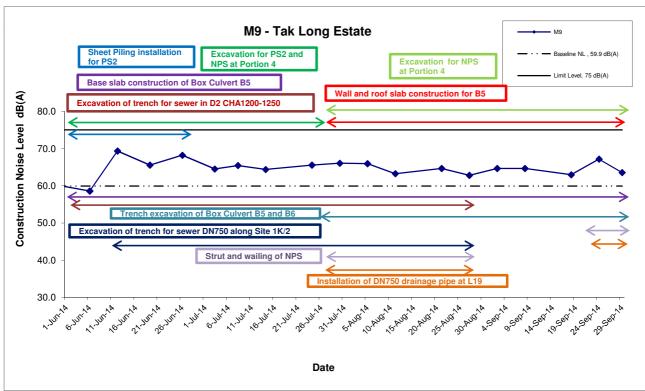
Noise Levels

Remarks: The construction noise levels in the Tables in Appendix G were adopted for plotting the graphs

Ī	Title Contract No. KL/2012/03 Kai Tak Development –Stage 4 Infrastructure at Former North Apron Area	Scale N.T.S	Project No. MA13056		
	Graphical Presentation of Construction Noise Monitoring Results	Date Sep 14	Appendix G	CINOICCI
