EP-344/2009 – New Sewage Pumping Stations Serving KTD and
EP-337/2009 – New Distributor Roads Serving the Planned KTD

Contract No. KL/2012/03
Kai Tak Development – Stage 4 Infrastructure at
Former North Apron Area

Monthly EM&A Report

October 2014

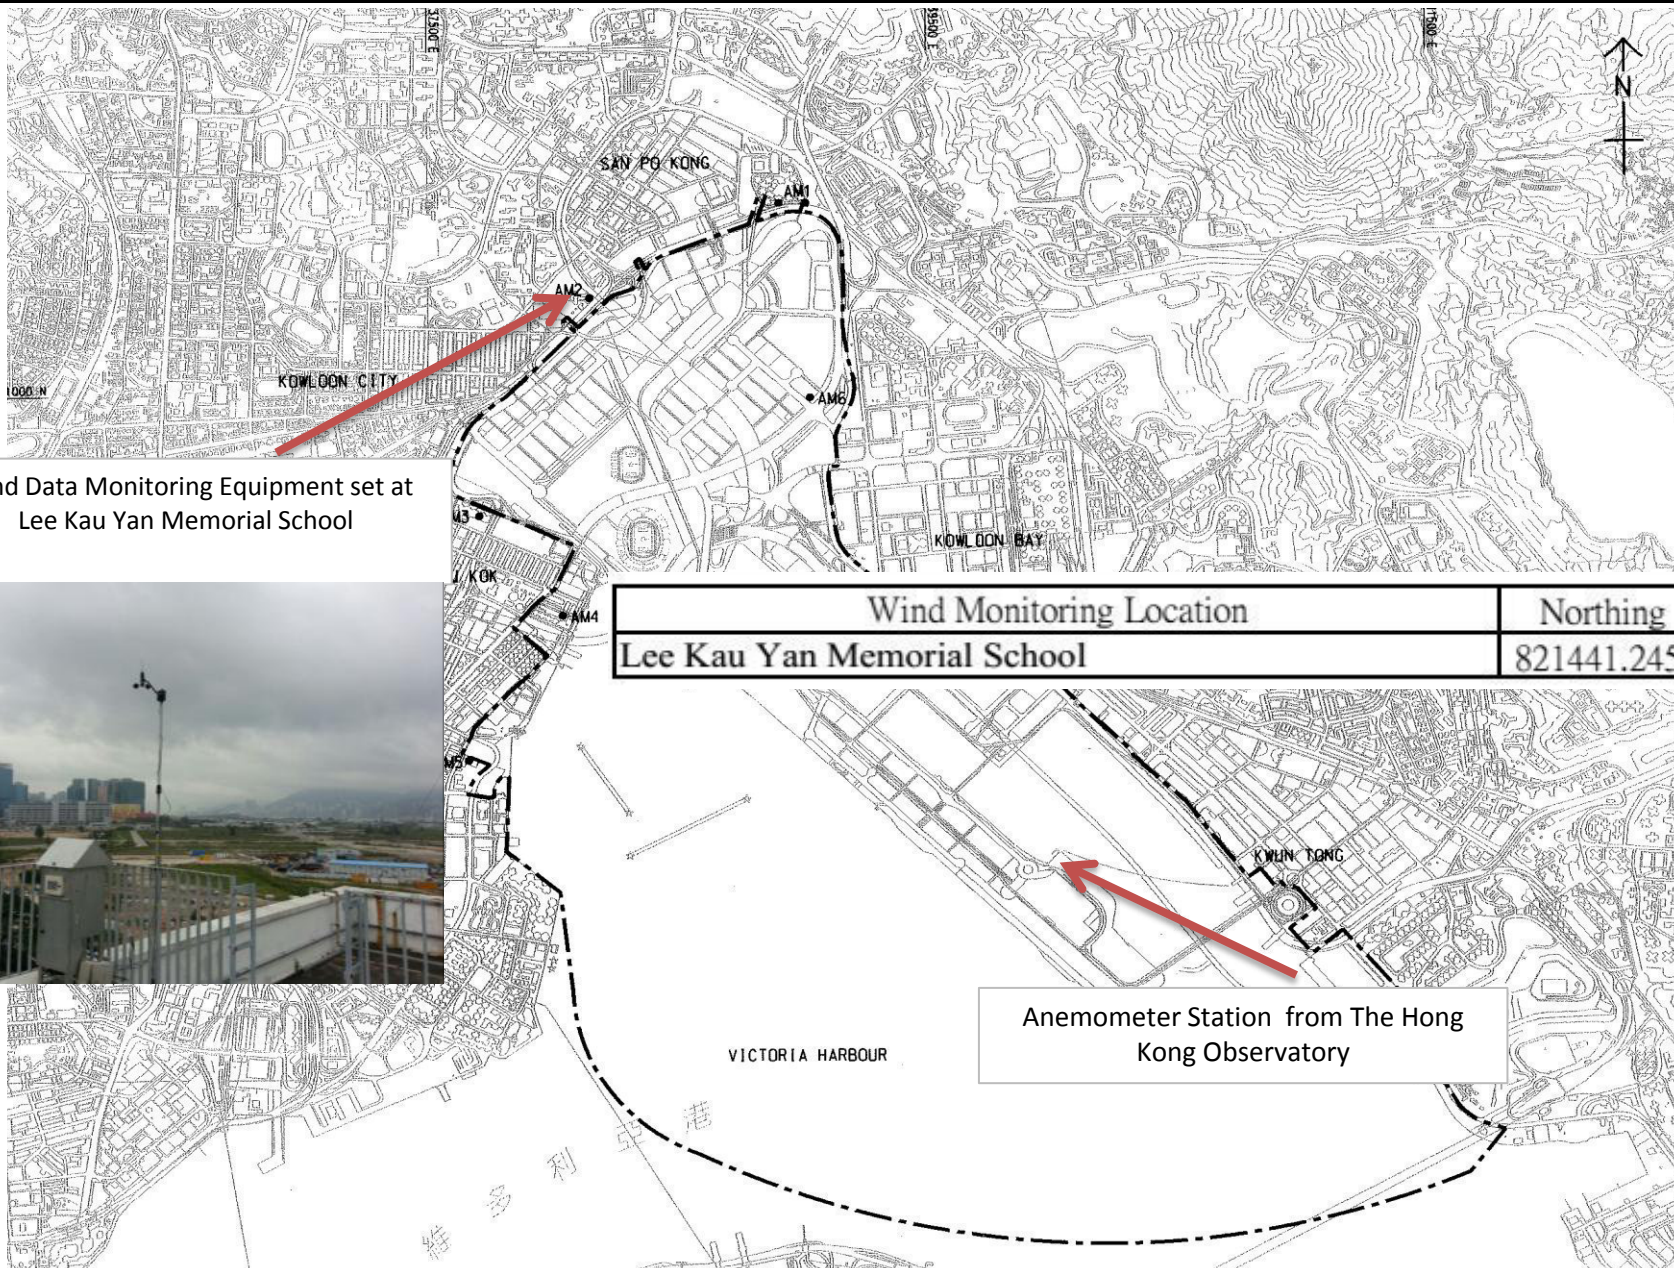
Wind Data Monitoring Equipment set at
Lee Kau Yan Memorial School

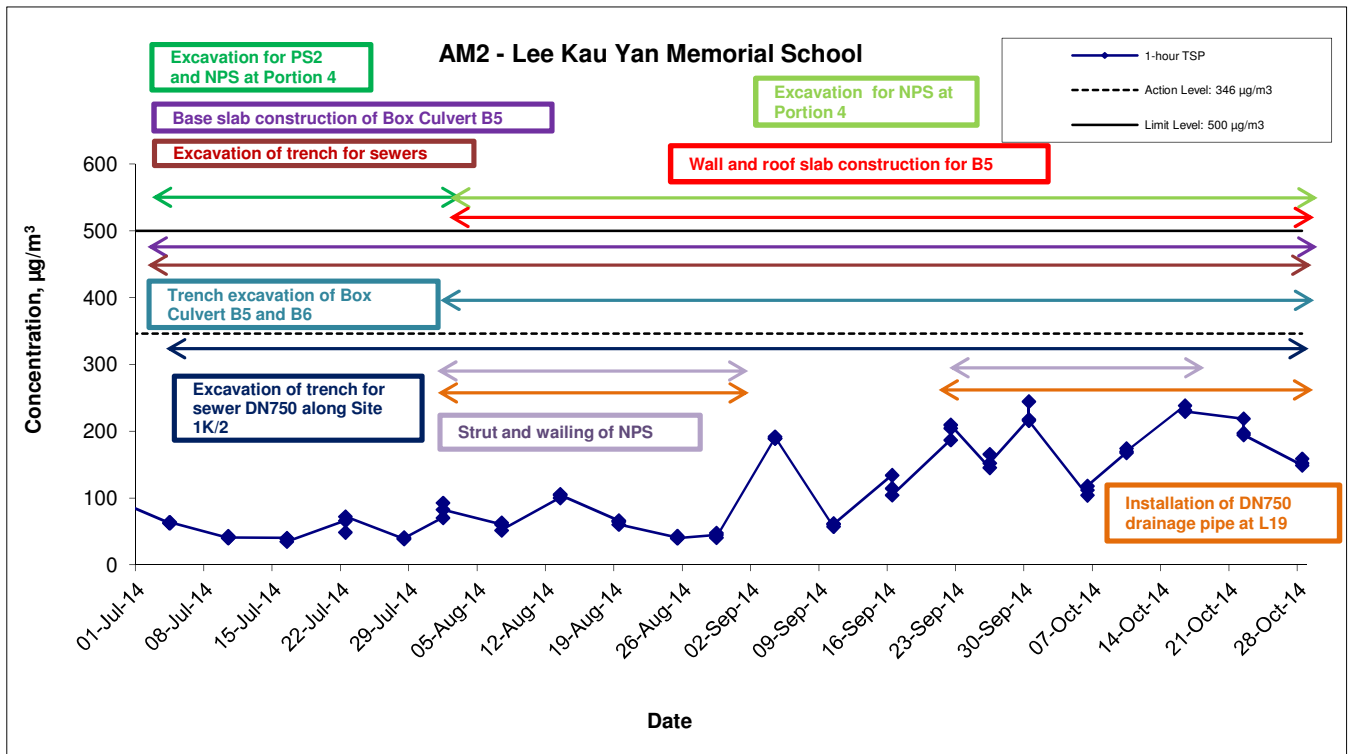
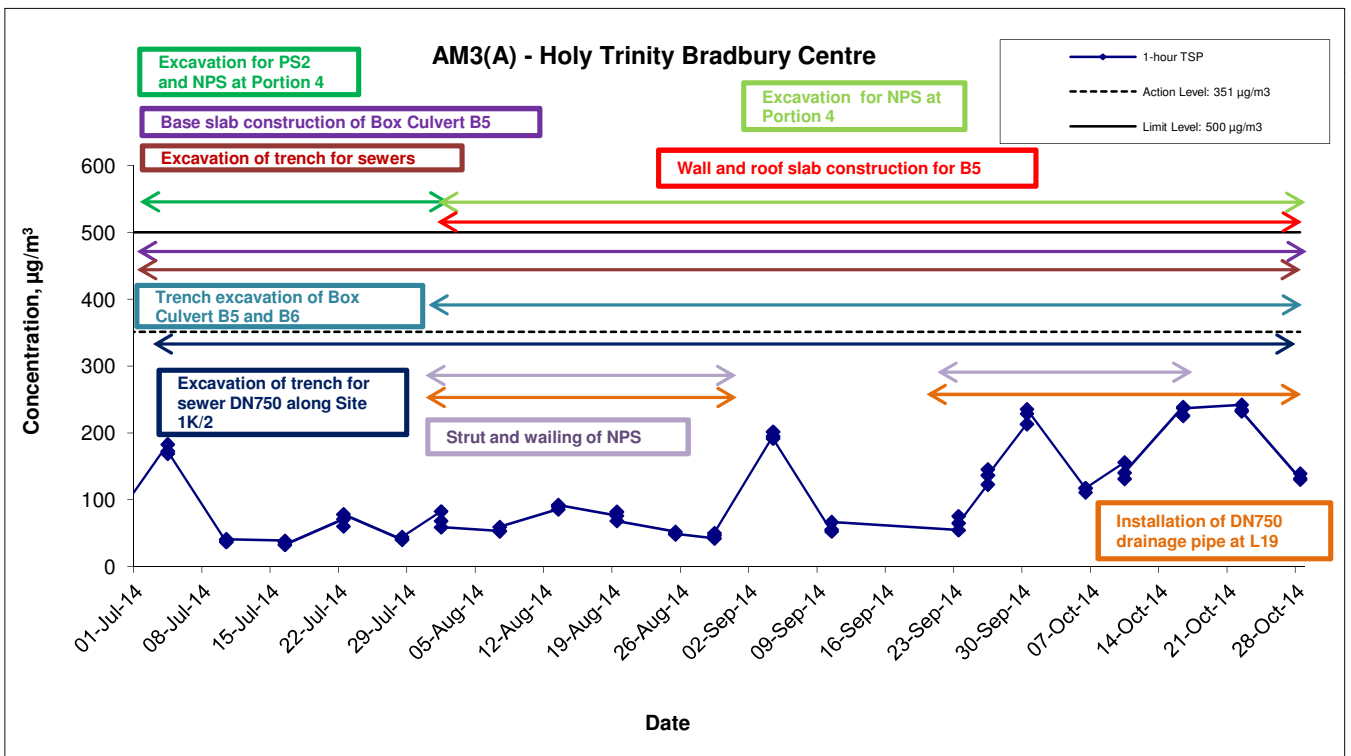
1-hr TSP Concentration Levels

| Title Contract No. KL/2012/03 Kai Tak Development –Stage 4 Infrastructure at Former North Apron Area Graphical Presentation of 1-hour TSP Monitoring Results | Scale N.T.S | Project No. MA13056 | |

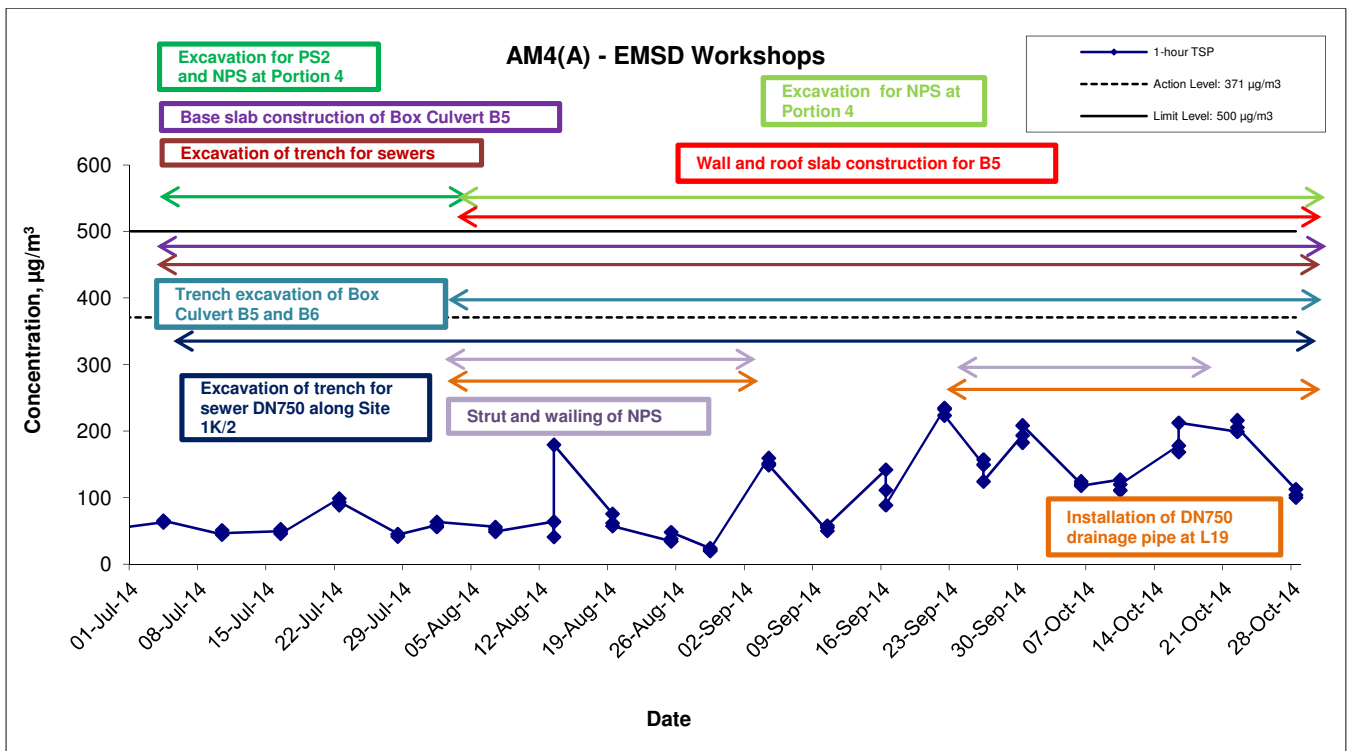
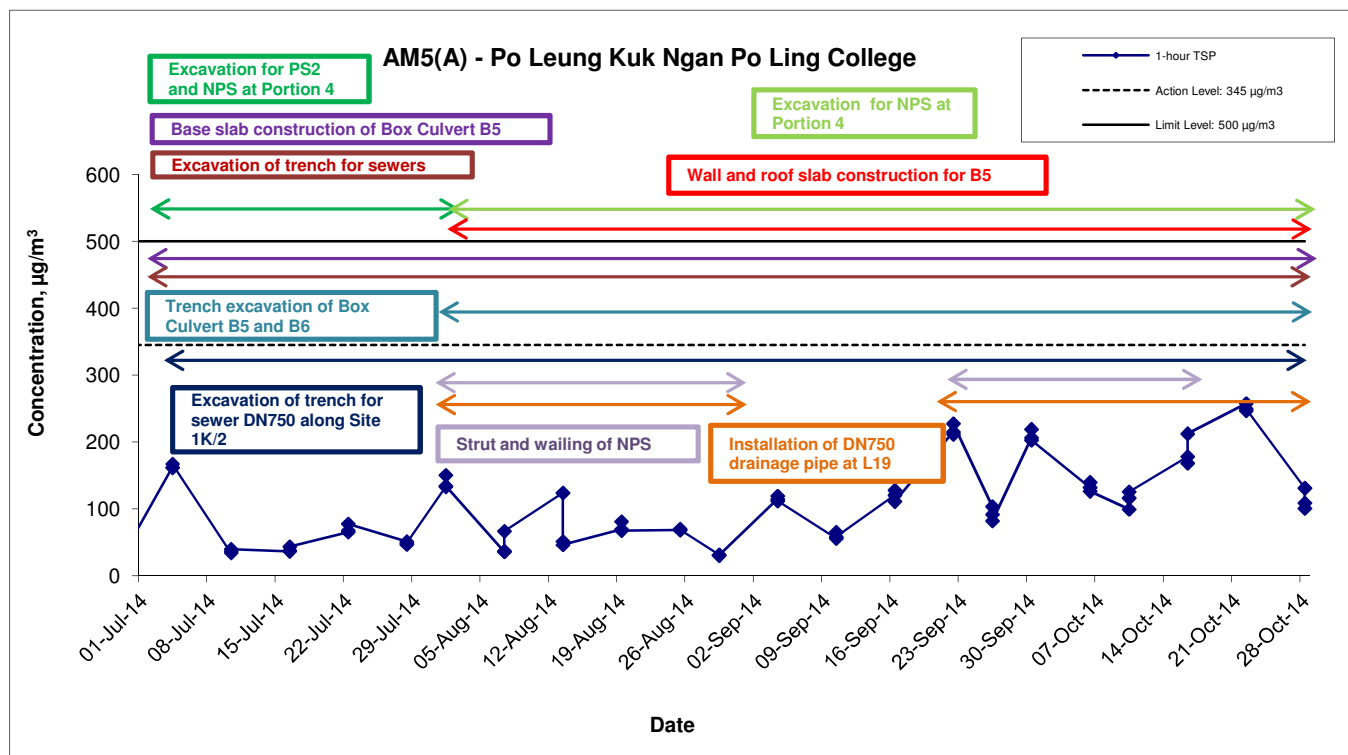
1-hr TSP Concentration Levels

| Title Contract No. KL/2012/03 Kai Tak Development –Stage 4 Infrastructure at Former North Apron Area Graphical Presentation of 1-hour TSP Monitoring Results | Scale N.T.S | Project No. MA14008 | CINOTECH |

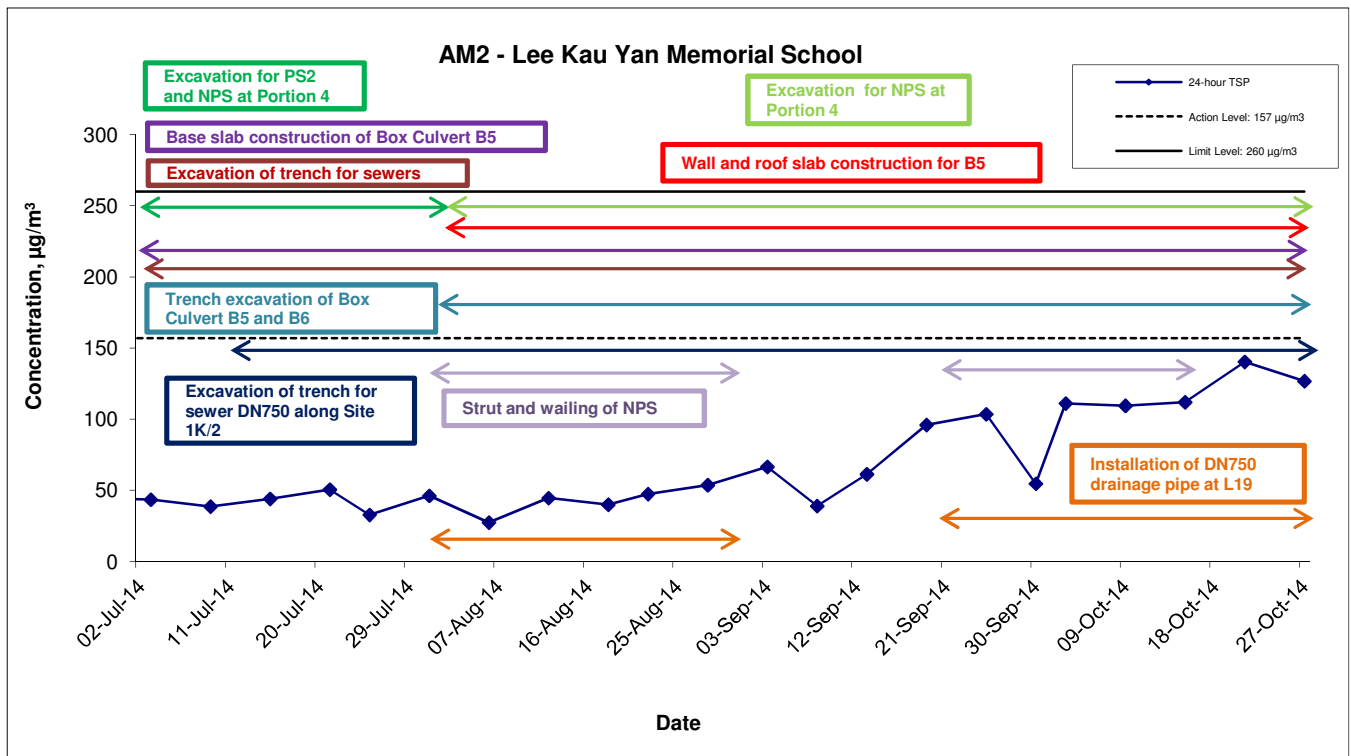
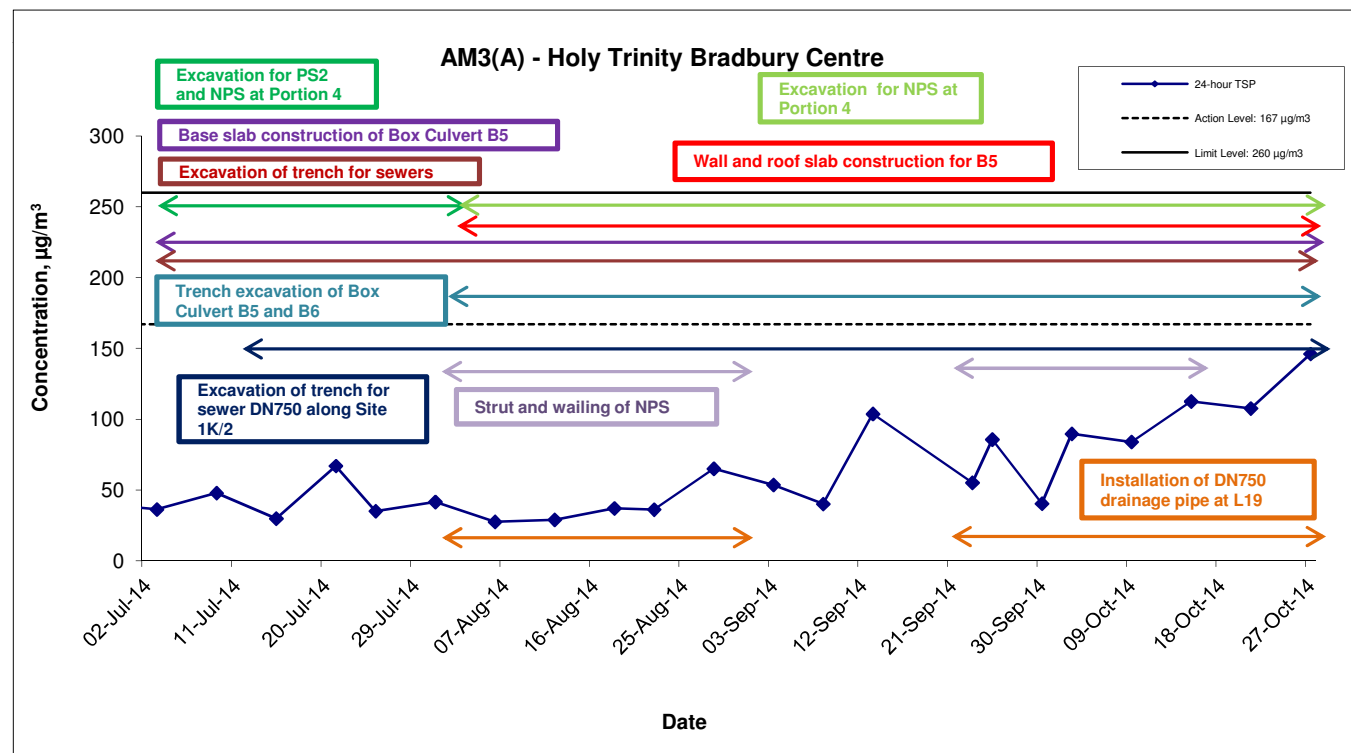
24-hr TSP Concentration Levels

| Title Contract No. KL/2012/03 Kai Tak Development –Stage 4 Infrastructure at Former North Apron Area Graphical Presentation of 24-hour TSP Monitoring Results | Scale N.T.S | Project No. MA13056 | |

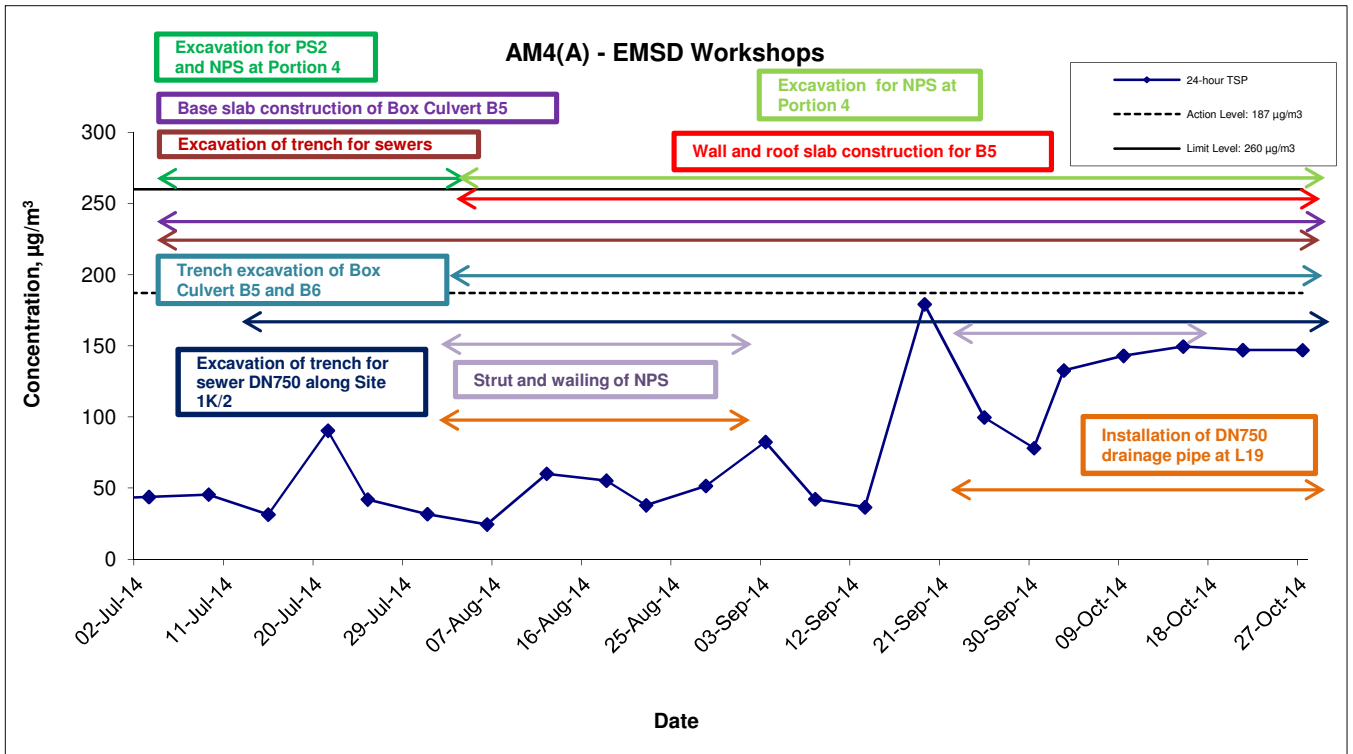
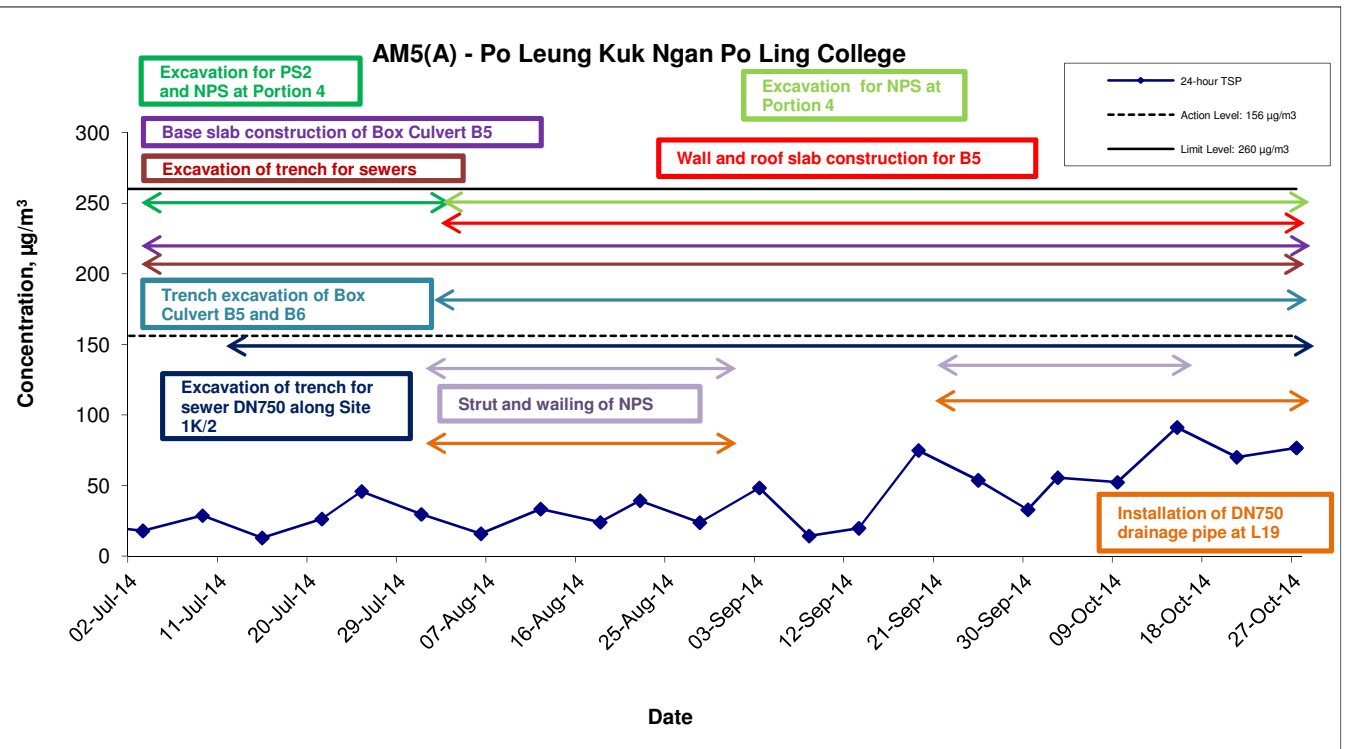
24-hr TSP Concentration Levels

| Title Contract No. KL/2012/03 Kai Tak Development –Stage 4 Infrastructure at Former North Apron Area Graphical Presentation of 24-hour TSP Monitoring Results | Scale N.T.S | Project No. MA13056 | |

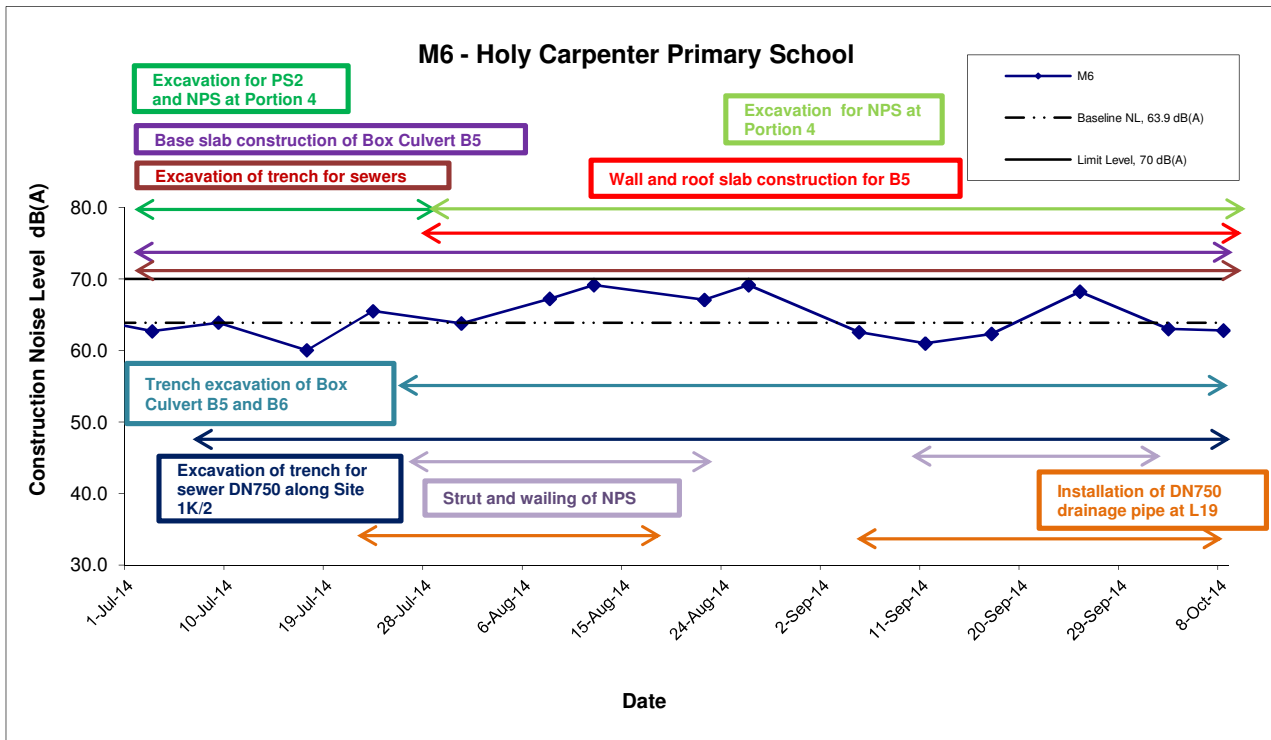
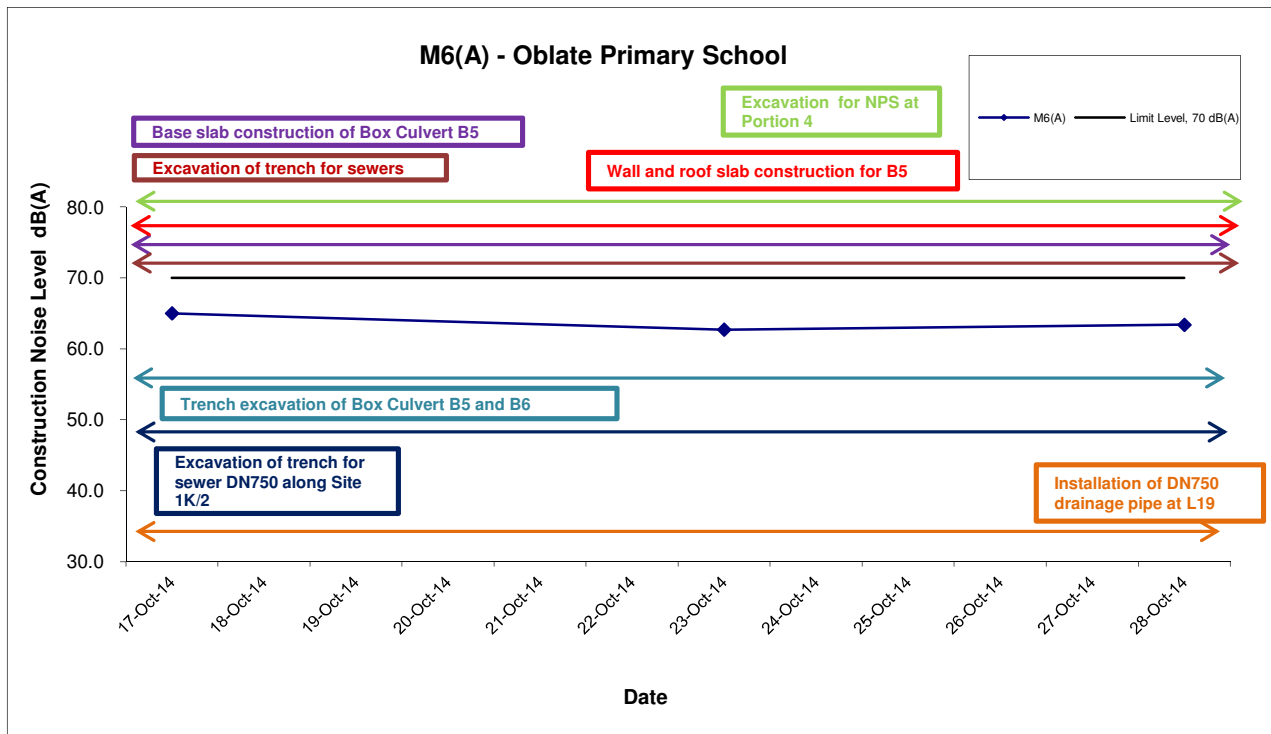
Noise Levels

Remarks: The construction noise levels in the Tables in Appendix G were adopted for plotting the graphs

| Title Contract No. KL/2012/03 Kai Tak Development –Stage 4 Infrastructure at Former North Apron Area Graphical Presentation of Construction Noise Monitoring Results | Scale | Project No. | CINOTECH |

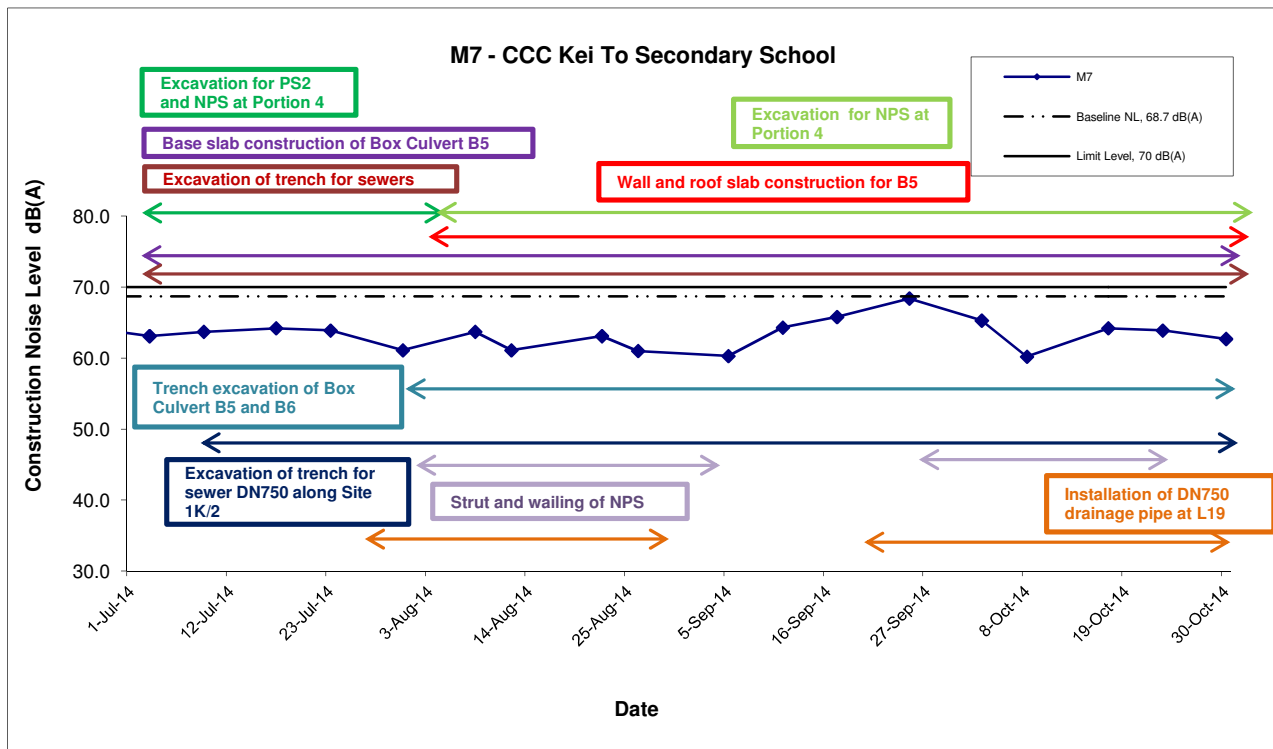
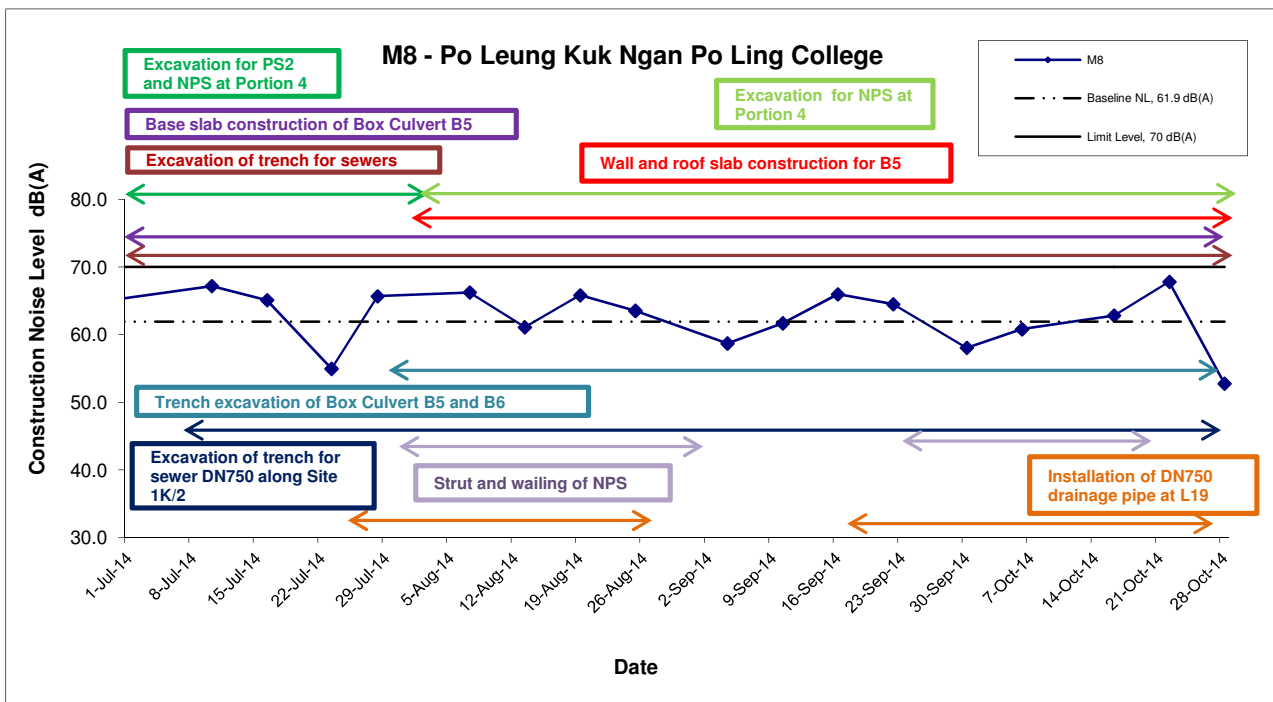
Noise Levels

Remarks: The construction noise levels in the Tables in Appendix G were adopted for plotting the graphs

| Title Contract No. KL/2012/03 Kai Tak Development –Stage 4 Infrastructure at Former North Apron Area Graphical Presentation of Construction Noise Monitoring Results | Scale N.T.S | Project No. MA13056 | CINOTECH |

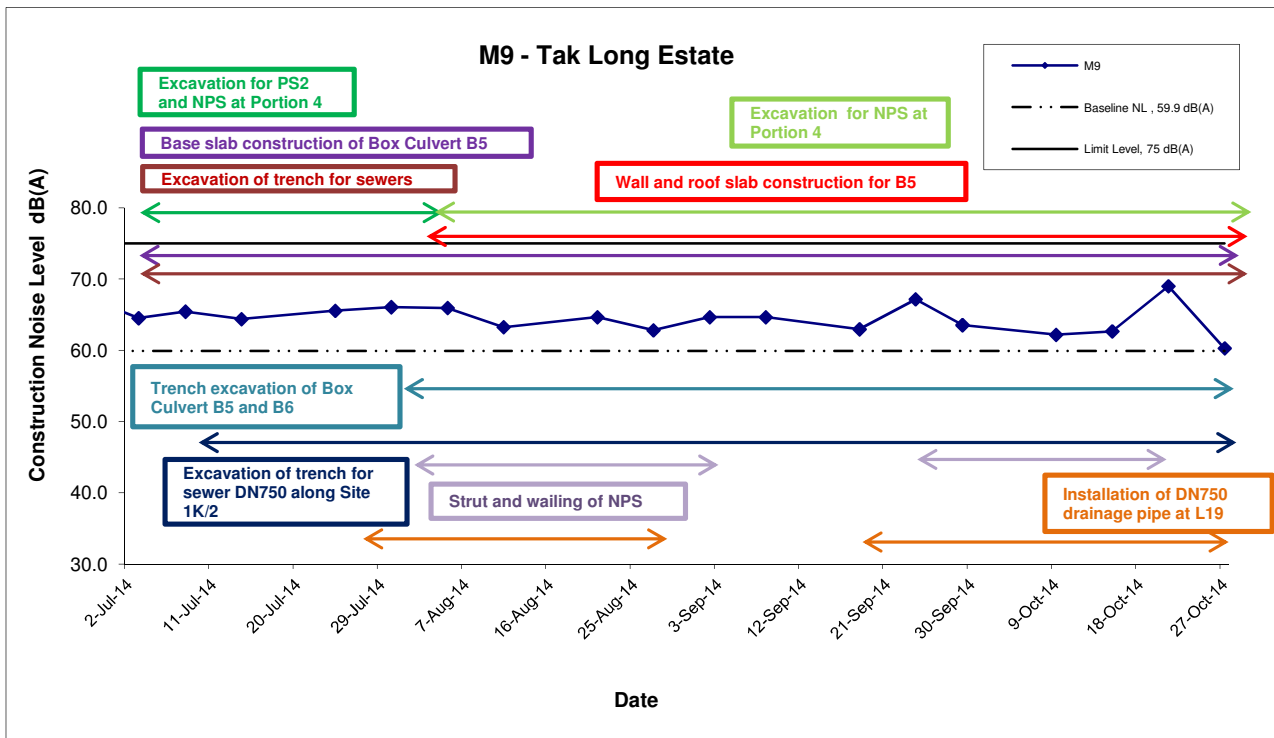
Noise Levels

Remarks: The construction noise levels in the Tables in Appendix G were adopted for plotting the graphs

| Title Contract No. KL/2012/03 Kai Tak Development –Stage 4 Infrastructure at Former North Apron Area Graphical Presentation of Construction Noise Monitoring Results | Scale N.T.S | Project No. MA13056 | CINOTECH |
