EP-344/2009 – New Sewage Pumping Stations Serving KTD and EP-337/2009 – New Distributor Roads Serving the Planned KTD

Contract No. KL/2012/03 Kai Tak Development –Stage 4 Infrastructure at Former North Apron Area

Quarterly EM&A Summary Report

December 2014 - February 2015

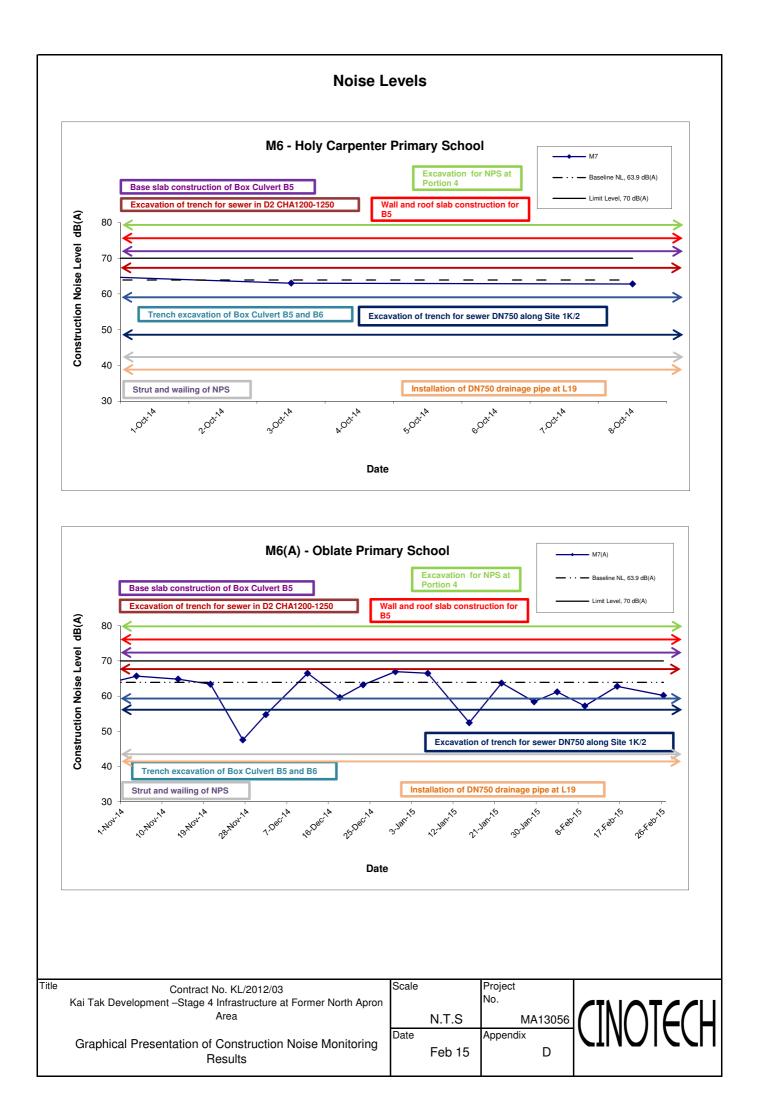
Kai Tak Development –Stage 4 Infrastructure at Former North Apron Area	Scale Project No. N.T.S M.	
Graphical Presentation of Construction Noise Monitoring Results	Date Appendix Feb 15

- 3.7 Noise monitoring at the 4 monitoring stations M6, M7, M8 and M9, was conducted as schedule in the reporting period. Construction noise monitoring at Station M6 Holy Carpenter Primary School was rejected by the premise owner on 6th October 2014. The monitoring works were relocated and carried out at a proposed alternative noise monitoring station M6(A) Oblate Primary School since 10th October 2014.
- 3.8 No Action/Limit Level exceedance was recorded for noise monitoring in the reporting quarter.
- 3.9 The graphical presentations of the noise monitoring results are shown in **Appendix D**.
