EP-337/2009 – New Distributor Roads Serving the Planned KTD

Contract No. KL/2012/02  
Kai Tak Development – Stage 3A Infrastructure at Former  
North Apron Area

Monthly EM&A Report

February 2015

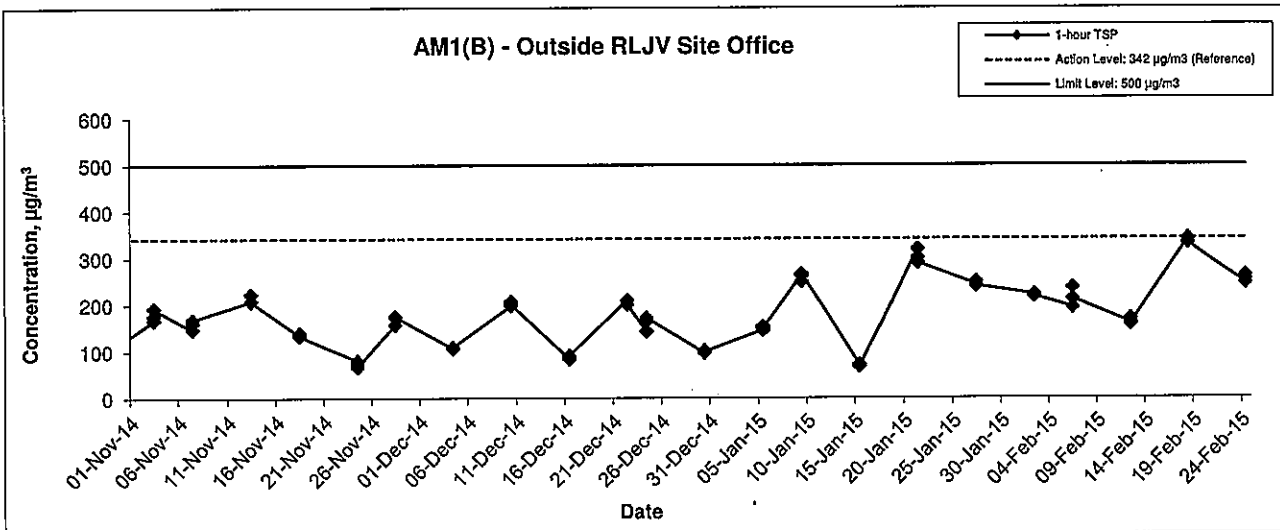
### 1-hr TSP Concentration Levels

<b>Title</b> Contract No. KL/2012/02 Kai Tak Development - Stage 3A Infrastructure at Former North Apron Area  Graphical Presentation of 1-hour TSP Monitoring Results	<b>Scale</b> N.T.S	<b>Project</b> No. MA13043	
	<b>Date</b> Feb 15	<b>Appendix</b> E

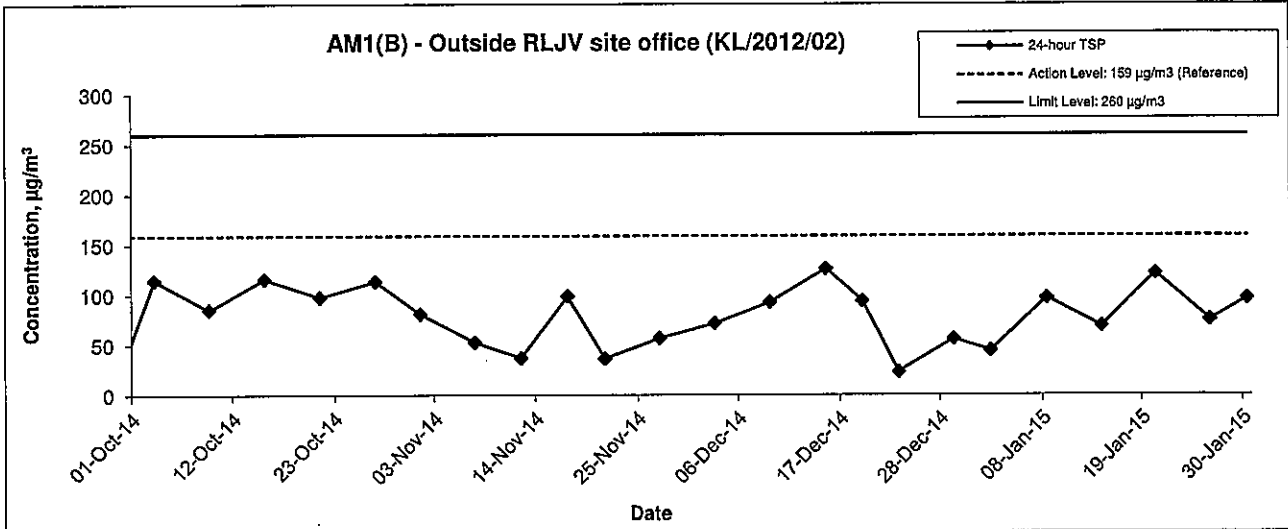
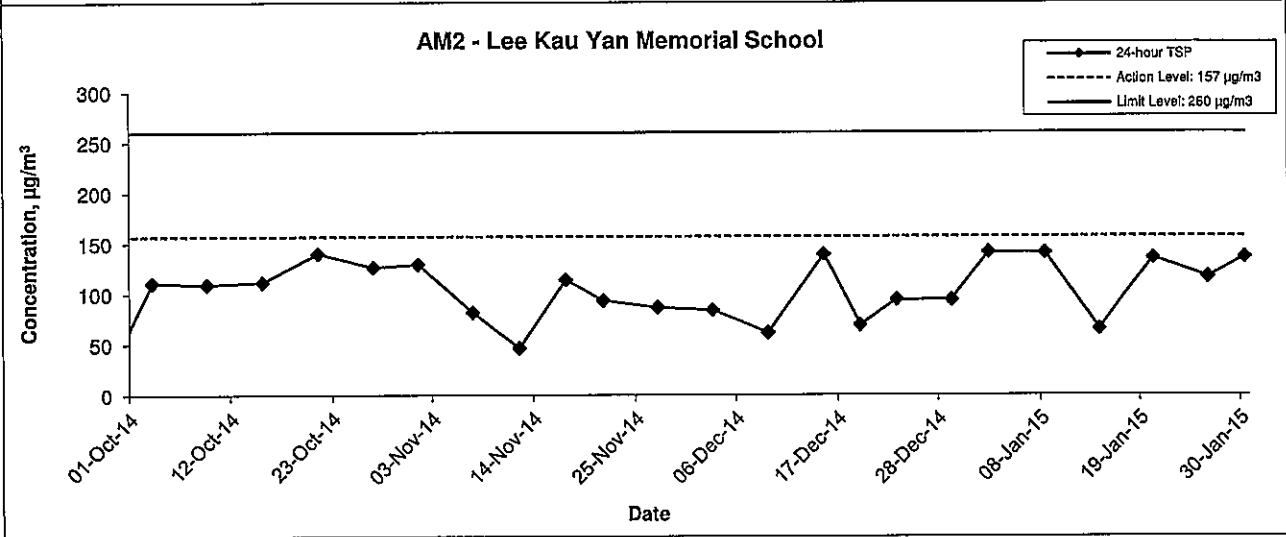
### 24-hr TSP Concentration Levels

Title Contract No. KL/2012/02 Kai Tak Development - Stage 3A Infrastructure at Former North Apron Area Graphical Presentation of 24-hour TSP Monitoring Results	Scale	Project	CINOTECH
	N.T.S	No. MA13043	
	Date Jan 15	Appendix F

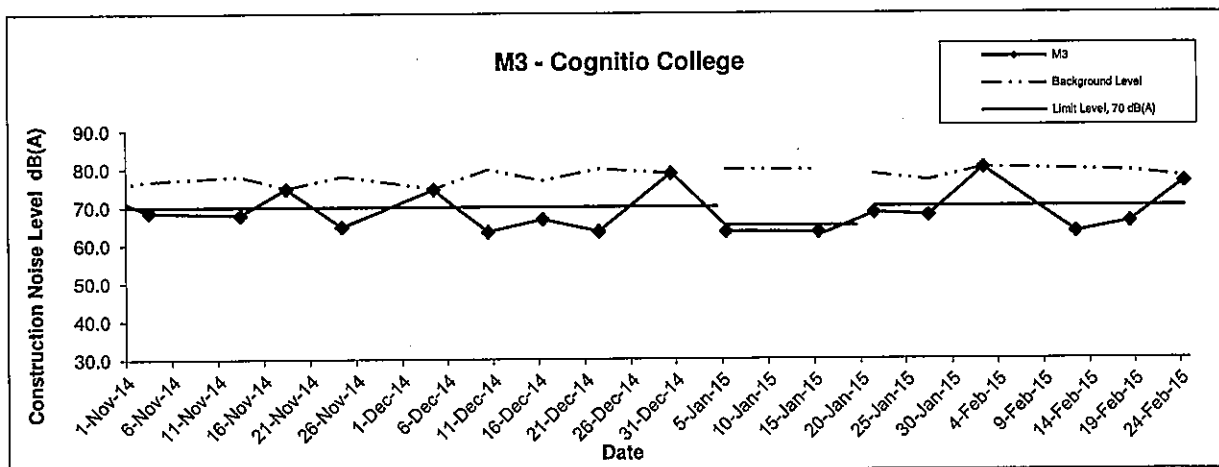
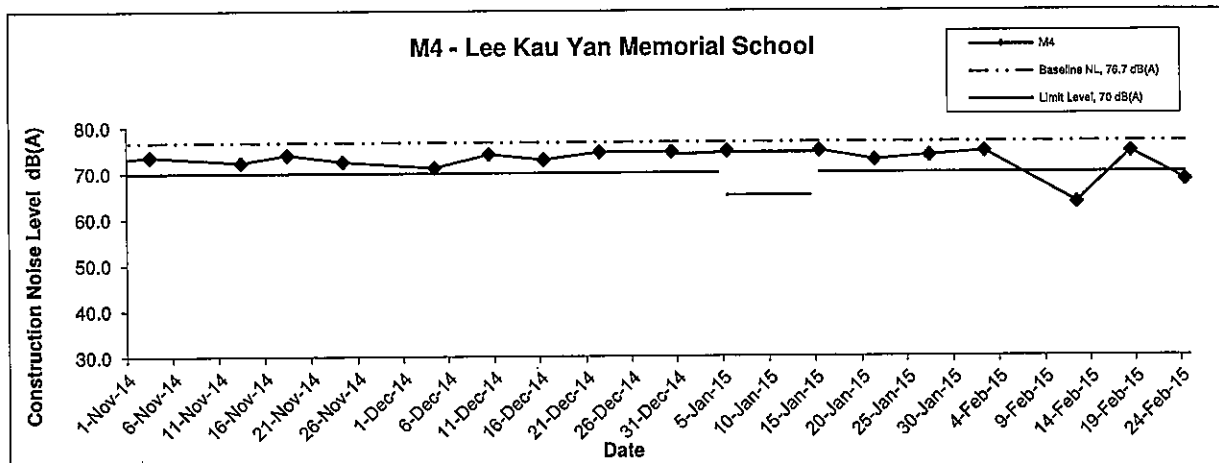
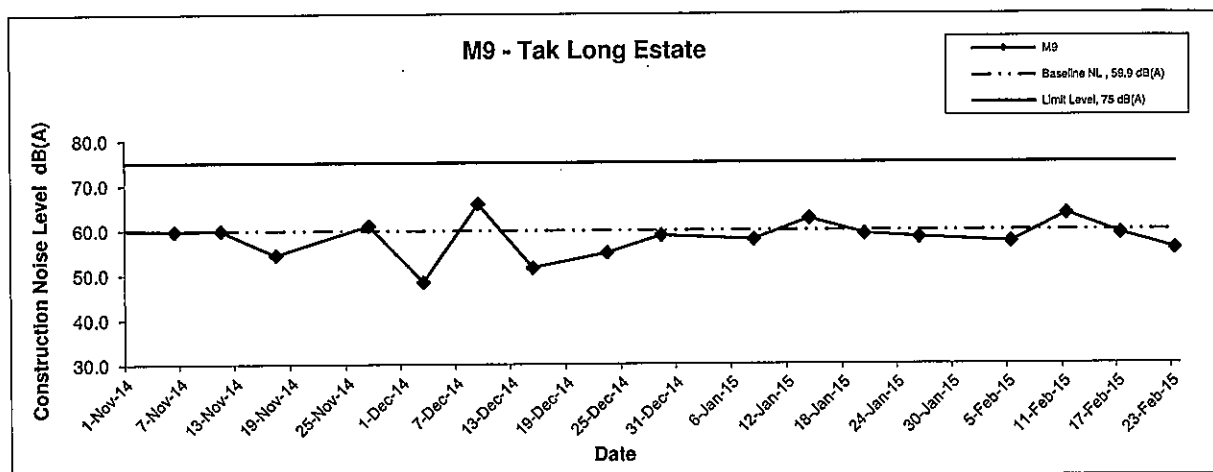
### Noise Levels

Remarks: The construction noise levels in the Tables in Appendix G were adopted for plotting the graphs

Title Contract No. KL/2012/02 Kai Tak Development - Stage 3A Infrastructure at Former North Apron Area Graphical Presentation of Construction Noise Monitoring Results	Scale N.T.S Date Feb 15	Project No. MA13043 Appendix G	
---	----------------------------------	---	--
