EP-344/2009 – New Sewage Pumping Stations Serving KTD and  
EP-337/2009 – New Distributor Roads Serving the Planned KTD

**Contract No. KL/2012/03**  
**Kai Tak Development –Stage 4 Infrastructure at**  
**Former North Apron Area**

Monthly EM&A Report

July 2015

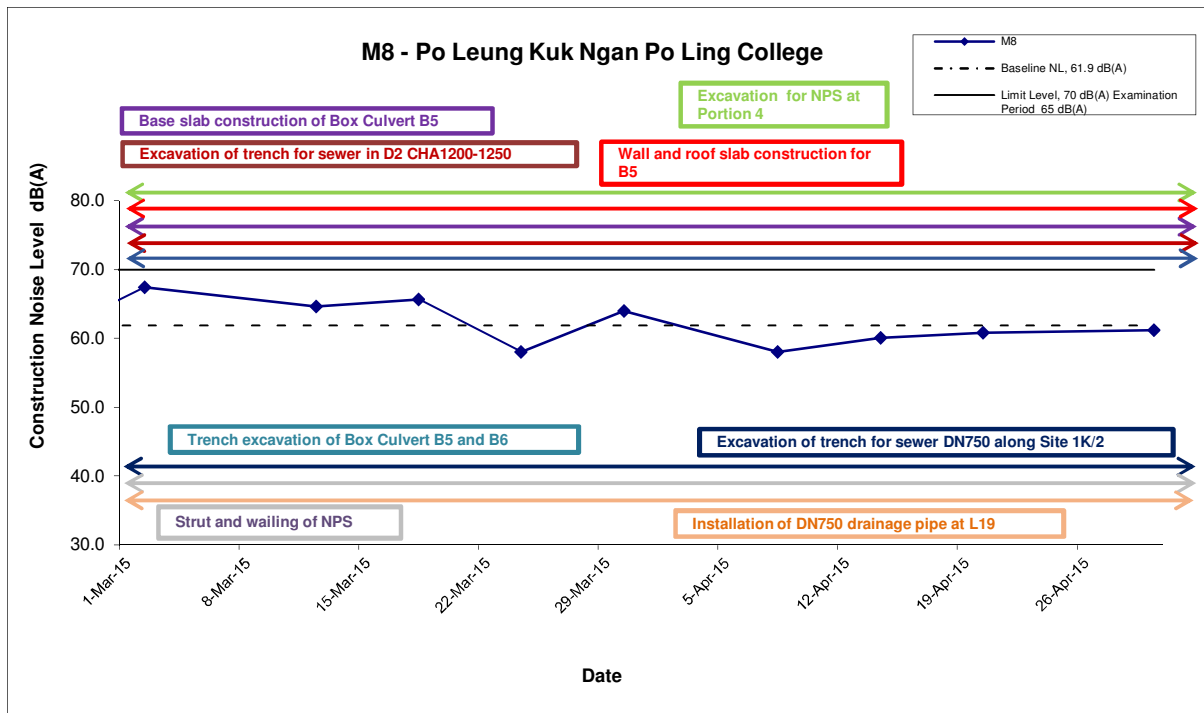
Remarks: The construction noise levels in the Tables in Appendix G were adopted for plotting the graphs

<p>Title</p> <p>Contract No. KL/2012/03</p> <p>Kai Tak Development –Stage 4 Infrastructure at Former North Apron Area</p> <p>Graphical Presentation of Construction Noise Monitoring Results</p>	<p>Scale</p> <p>N.T.S</p> <p>Date</p> <p>Jul 15</p>	<p>Project No.</p> <p>MA13056</p> <p>Appendix</p> <p>G</p>	<p><b>CINOTECH</b></p>
--------------------------------------------------------------------------------------------------------------------------------------------------------------------------------------------------	-----------------------------------------------------	------------------------------------------------------------	------------------------
