EP-344/2009 – New Sewage Pumping Stations Serving KTD and  
EP-337/2009 – New Distributor Roads Serving the Planned KTD

**Contract No. KL/2012/03**  
**Kai Tak Development –Stage 4 Infrastructure at**  
**Former North Apron Area**

Monthly EM&A Report

October 2015

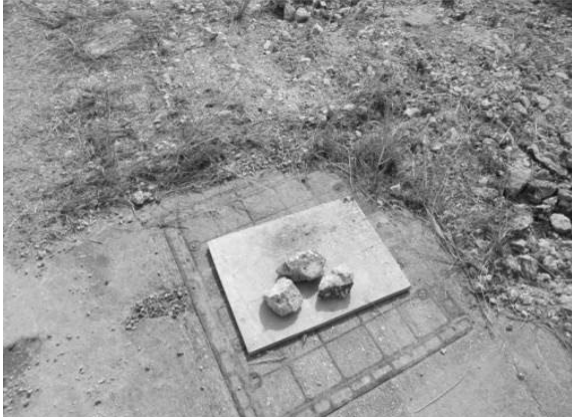
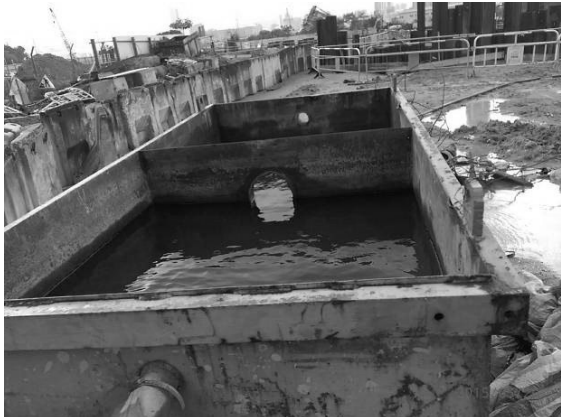
To prevent any surface runoff discharge into any stream course.	Follow-up measure(s) after identification of wastewater discharges from site.

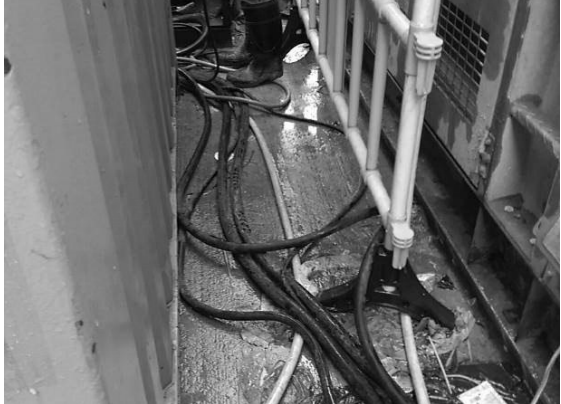
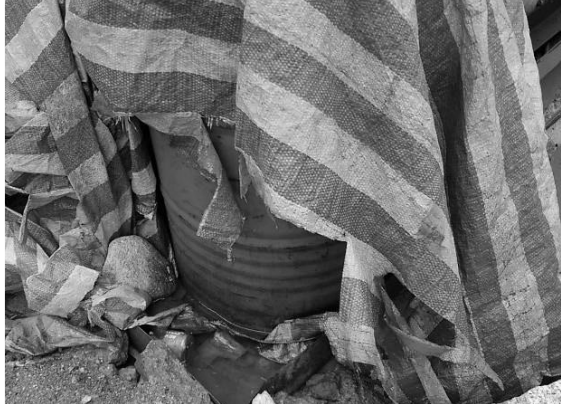
To avoid any discharge or accidental spillage of chemical waste or oil directly from the site	To avoid improper handling or storage of oil drum on site

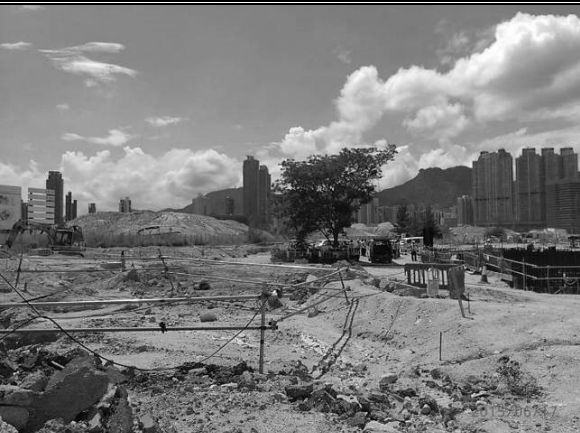
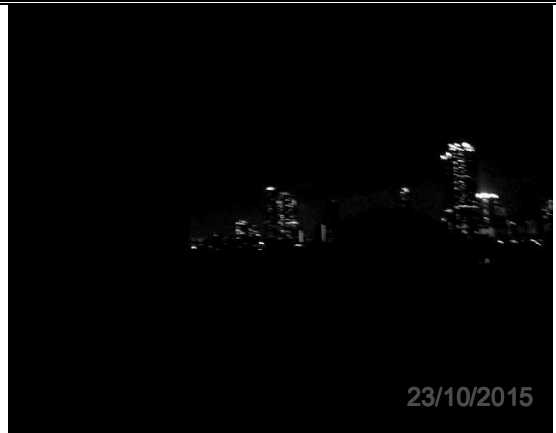
To protect the existing trees to be retained	To control of night-time lighting

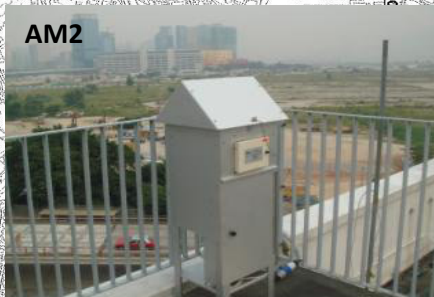
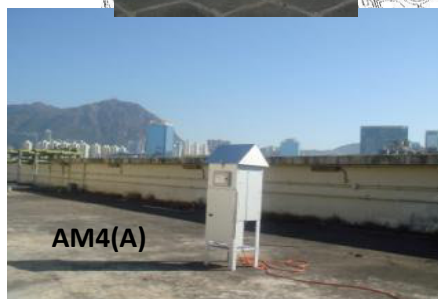
Location		Northing	Easting
AM2	Lee Kau Yan Memorial School	821441.245	838153.917
AM3(A)	Holy Trinity Bradbury Centre	820769.390	837522.115
AM4(A)	EMSD Workshops	820147.495	838155.791
AM5(A)	Po Leung Kuk Ngan Po Ling College	819300.323	837659.613

Title Contract No. KL/2012/03  
 Kai Tak Development –Stage 4 Infrastructure at Former North Apron Area  
 Air Quality Monitoring Stations under this Project
