**EP-344/2009 – New Sewage Pumping Stations
Serving KTD
EP-337/2009 – New Distributor Roads Serving the
Planned KTD**

**Contract No. KL/2012/03
Kai Tak Development –Stage 4 Infrastructure at
Former North Apron Area**

Monthly EM&A Report

April 2017

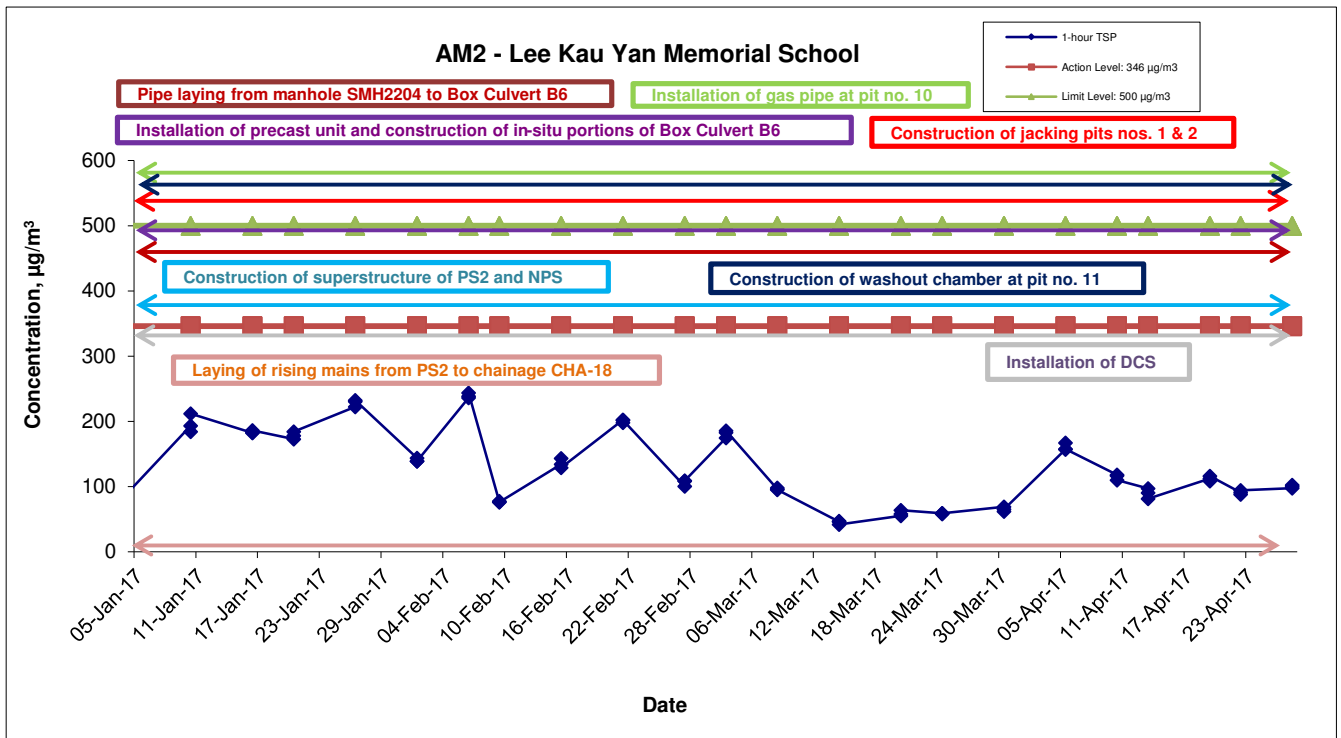
1-hr TSP Concentration Levels

Title Contract No. KL/2012/03 Kai Tak Development –Stage 4 Infrastructure at Former North Apron Area Graphical Presentation of 1-hour TSP Monitoring Results	Scale N.T.S	Project No. MA13056	
		Appendix E	
	Date Apr 17

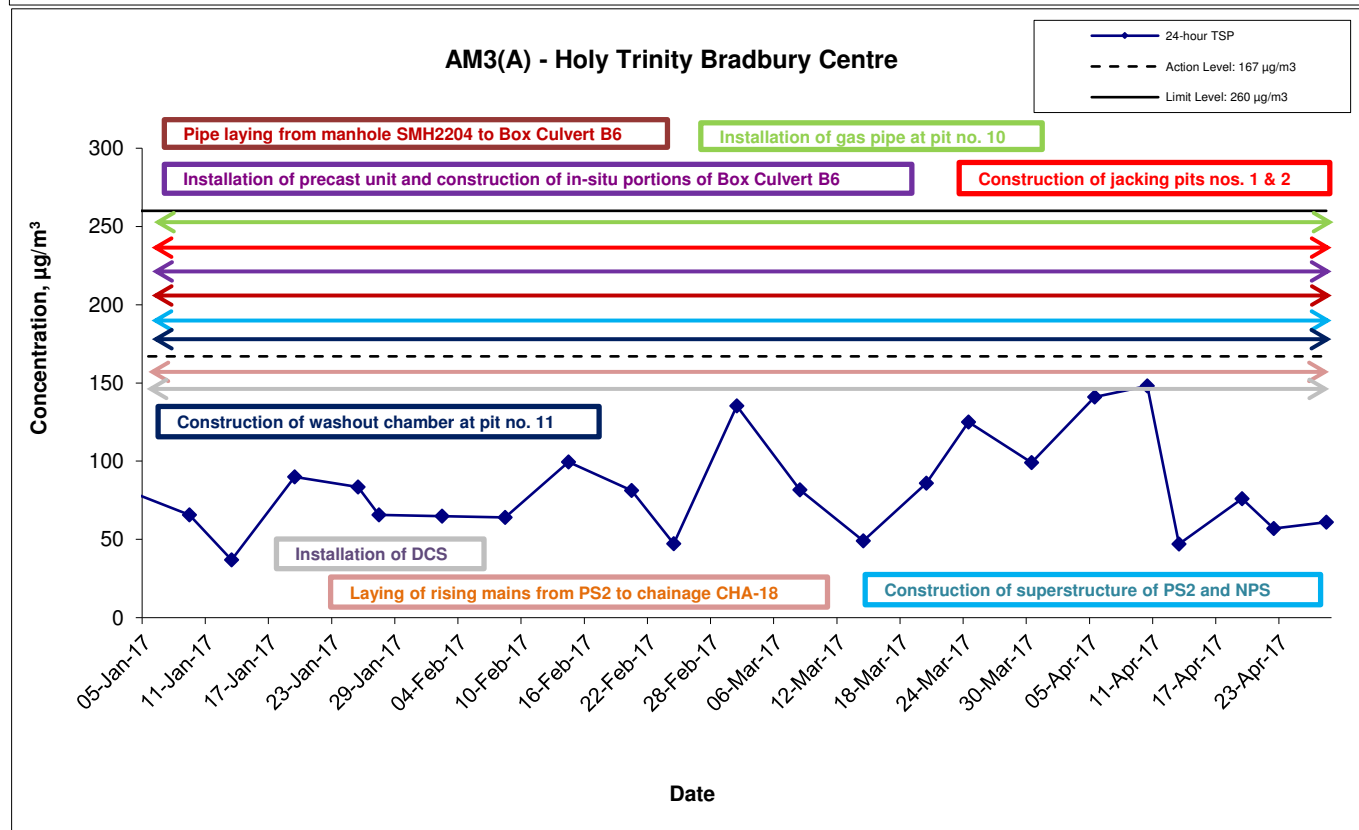
24-hr TSP Concentration Levels

Title	Contract No. KL/2012/03	Scale	Project	CINOTECH
	Kai Tak Development –Stage 4 Infrastructure at Former North Apron Area	N.T.S	No. MA13056	
Graphical Presentation of 24-hour TSP Monitoring Results		Date	Appendix	
		Apr 17	F

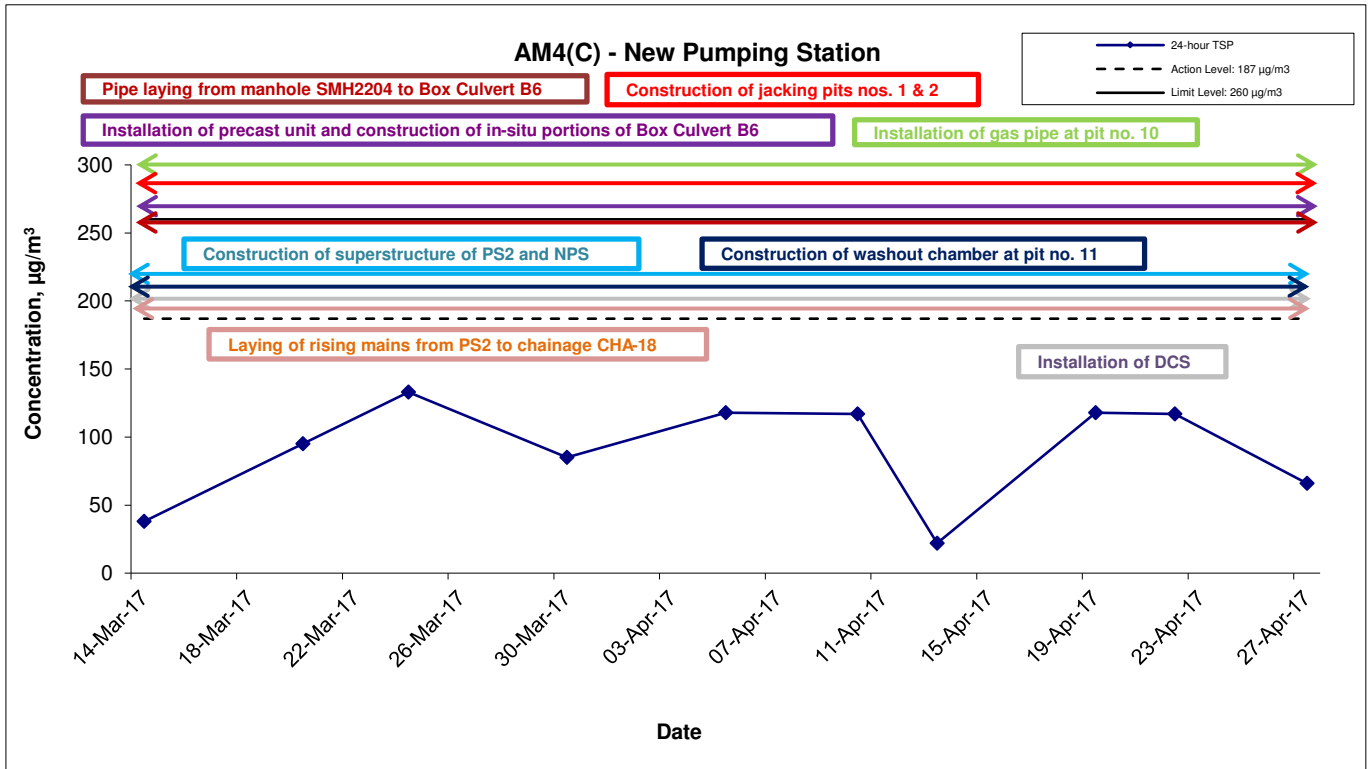
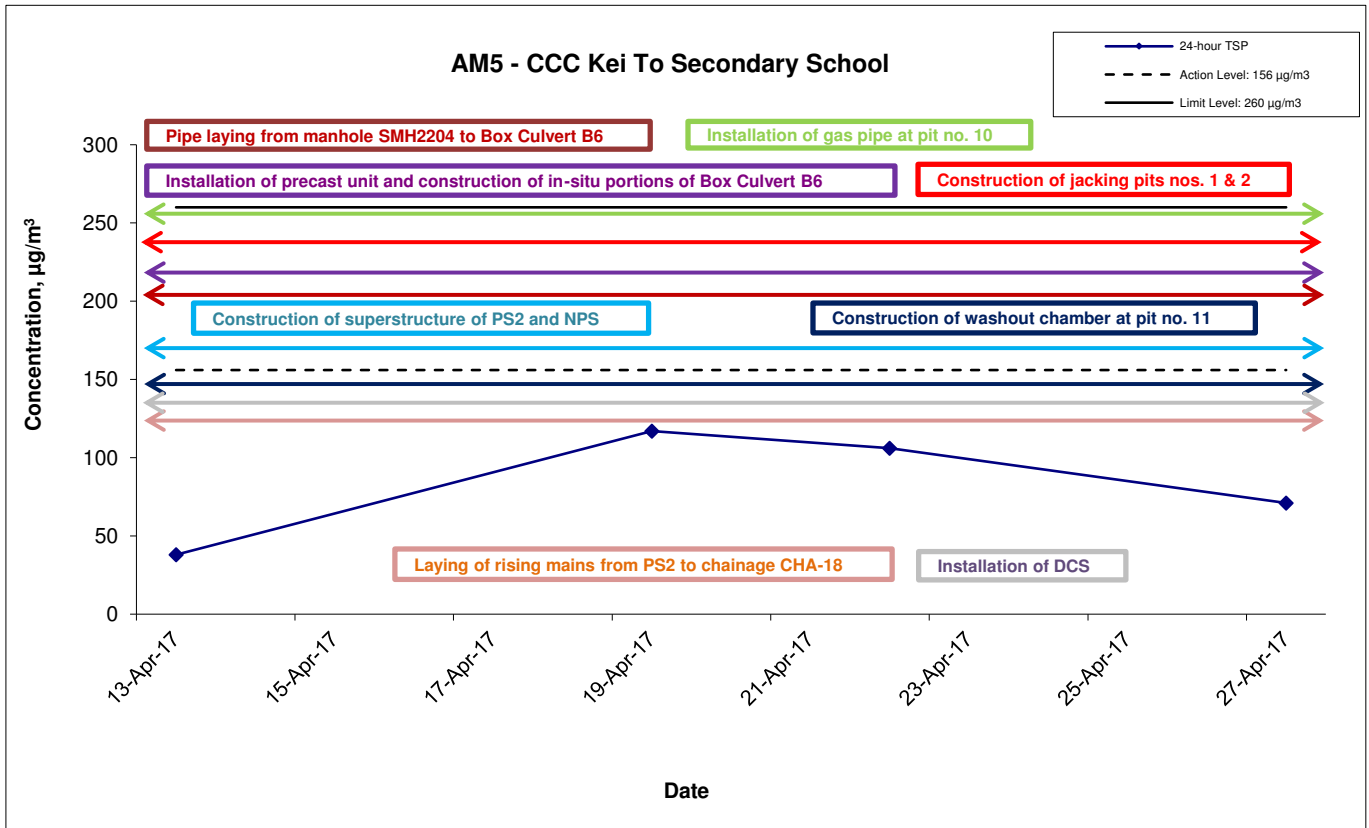
24-hr TSP Concentration Levels

Title	Contract No. KL/2012/03	Scale	Project	CINOTECH
	Kai Tak Development –Stage 4 Infrastructure at Former North Apron Area	N.T.S	No. MA13056	
Graphical Presentation of 24-hour TSP Monitoring Results		Date	Appendix	
		Apr 17	F
