**EP-344/2009 – New Sewage Pumping Stations  
Serving KTD  
EP-337/2009 – New Distributor Roads Serving the  
Planned KTD**

**Contract No. KL/2012/03  
Kai Tak Development –Stage 4 Infrastructure at  
Former North Apron Area**

Monthly EM&A Report

June 2017

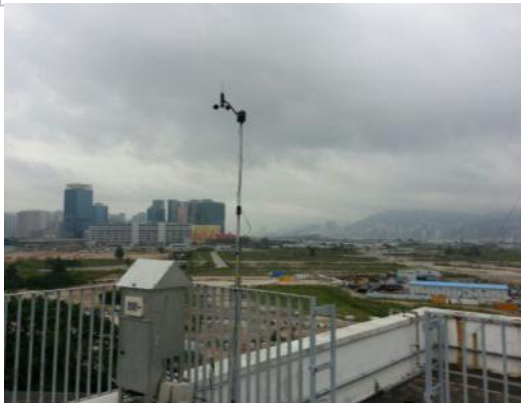
Wind Data Monitoring Equipment set at Lee Kau Yan Memorial School

Wind Monitoring Location	Northing	Easting
Lee Kau Yan Memorial School	821441.245	838153.917

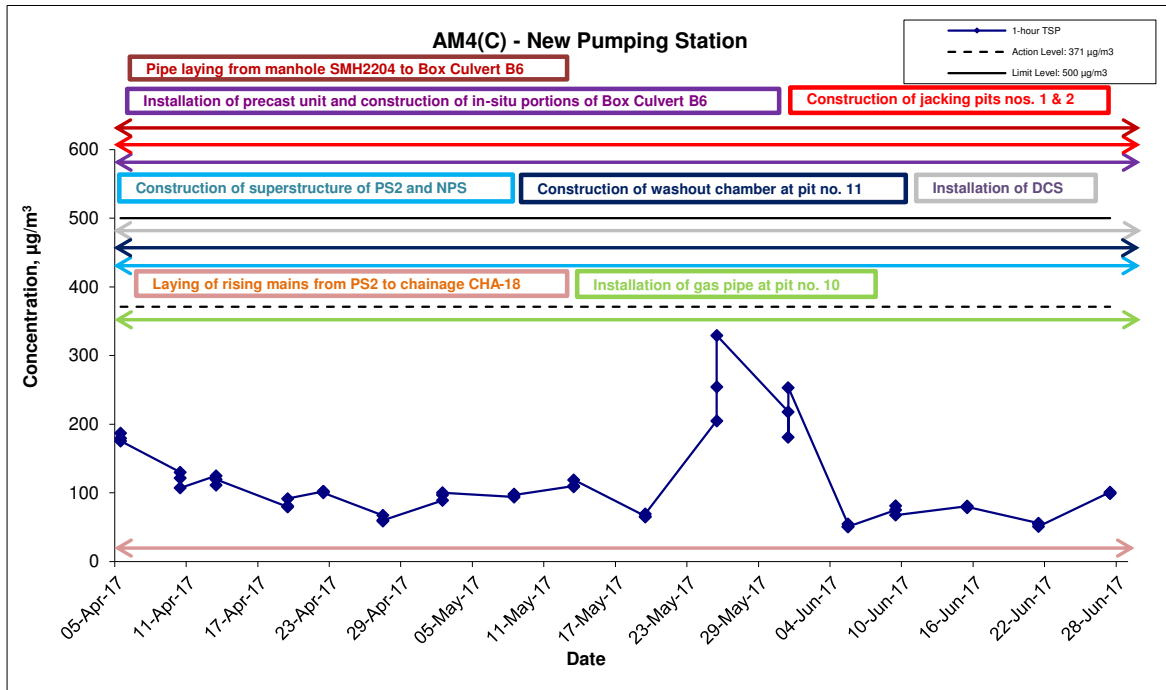
<b>Title</b> Contract No. KL/2012/03 Kai Tak Development –Stage 4 Infrastructure at Former North Apron Area  Graphical Presentation of 1-hour TSP Monitoring Results	<b>Scale</b> N.T.S	<b>Project No.</b> MA13056	<b>CINOTECH</b>
	<b>Date</b> Jun 17	<b>Appendix</b> E

## 1-hr TSP Concentration Levels
