EP-337/2009 – New Distributor Roads Serving the Planned KTD

Contract No. KL/2012/02

Kai Tak Development –Stage 3A Infrastructure at Former  
North Apron Area

Quarterly EM&A Report

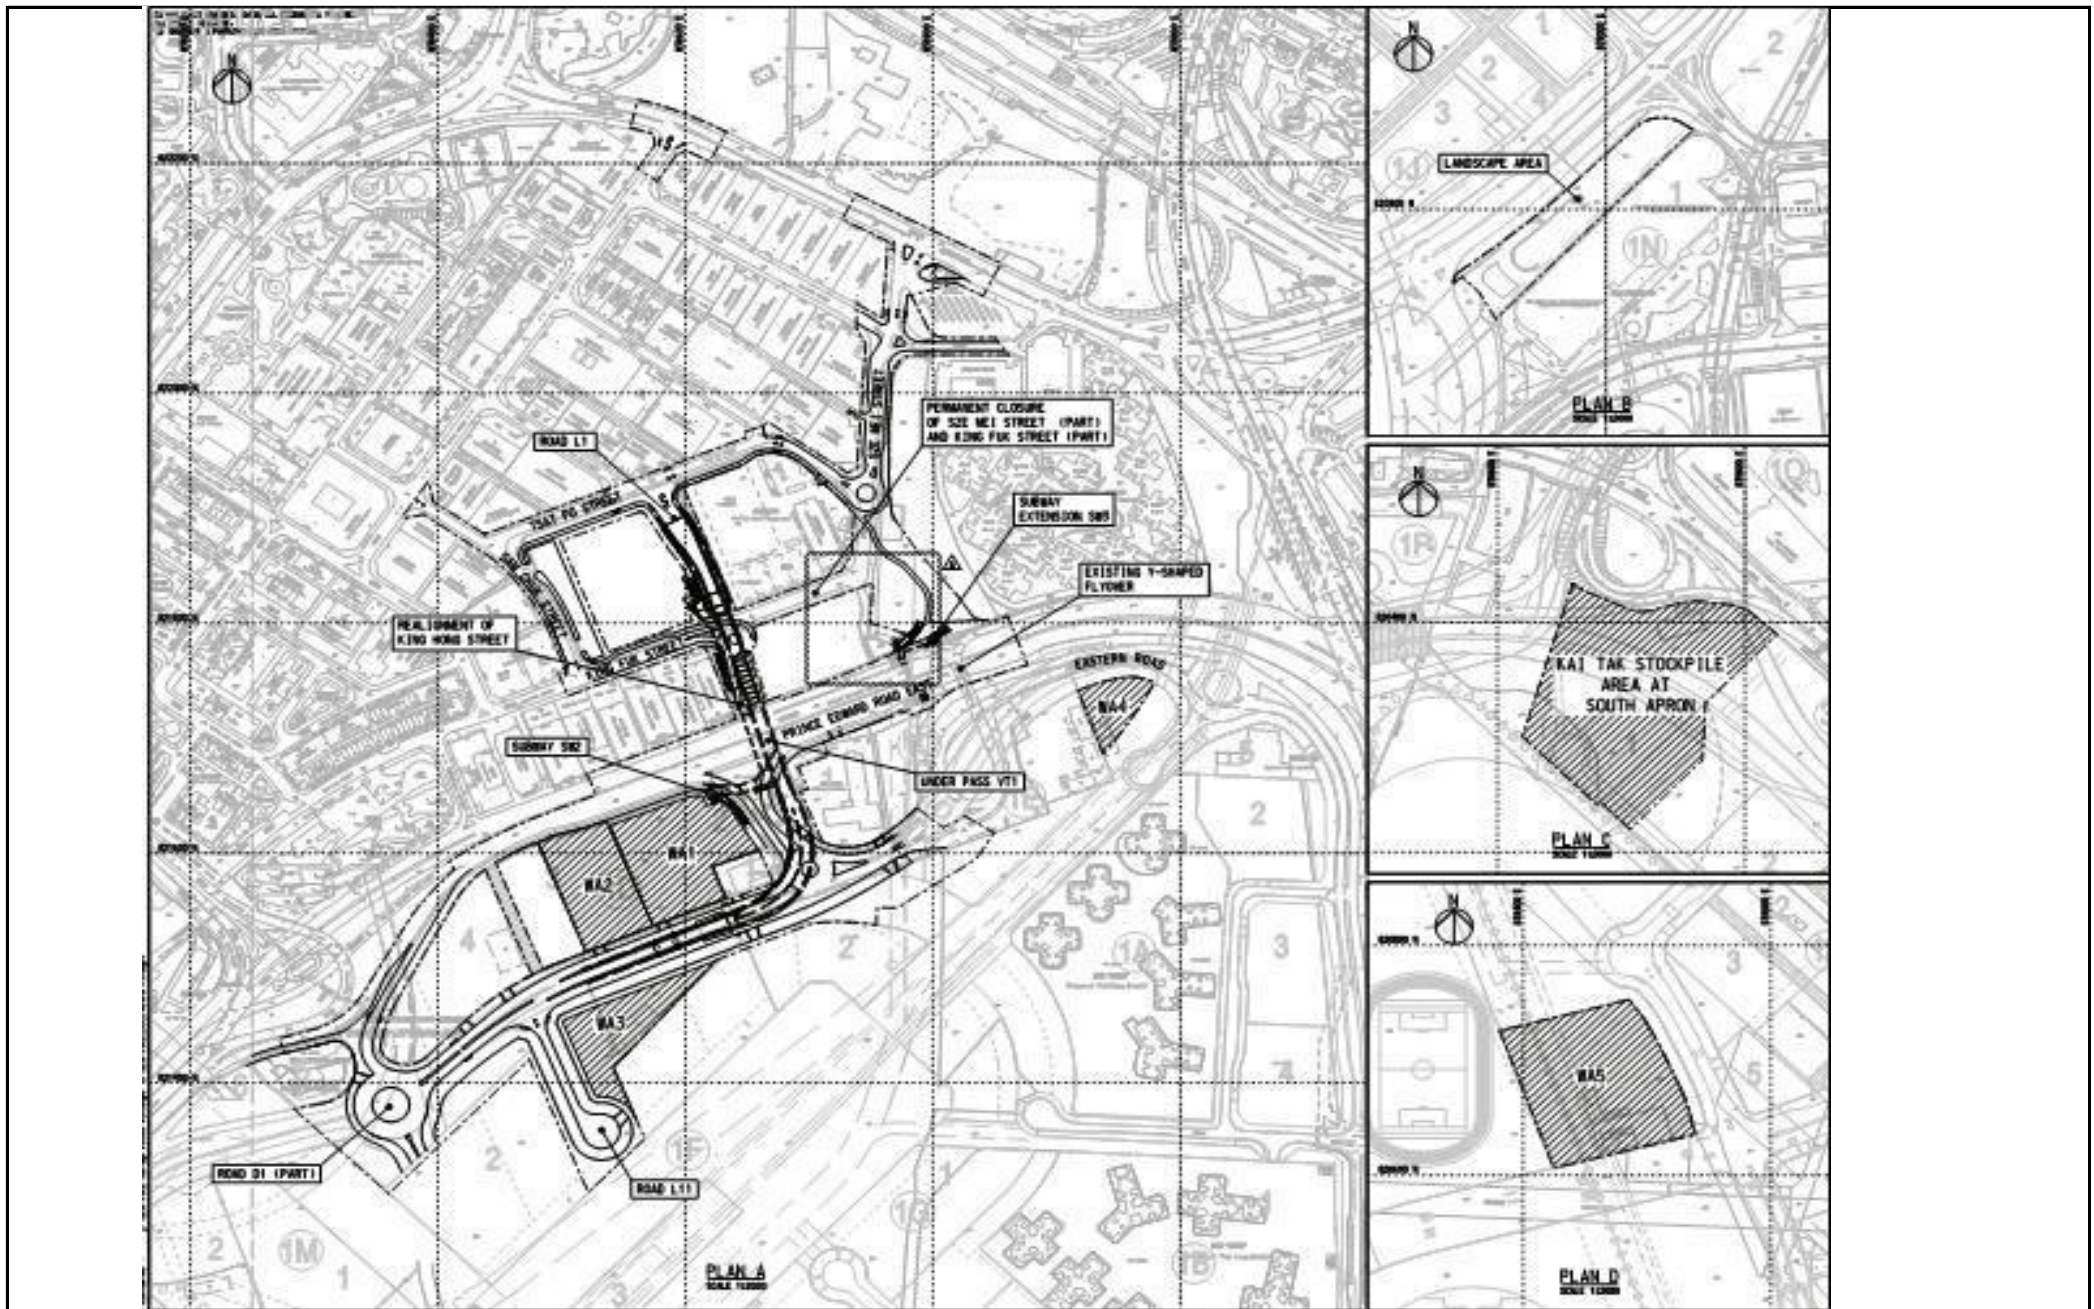
Title	Contract No. KL/2012/02		Scale	Project
	Kai Tak Development –Stage 3A Infrastructure at Former North Apron Area		N.T.S	No. MA13043
Site Layout Plan			Date	Figure
			Aug-13	1

- 1.1 The Kai Tak Development (KTD) is located in the south-eastern part of Kowloon Peninsula, comprising the apron and runway areas of the former Kai Tak Airport and existing waterfront areas at To Kwa Wan, Ma Tau Kok, Kowloon Bay, Kwun Tong and Cha Kwo Ling. It covers a land area of about 328 hectares. Stage 3A Infrastructure at Former North Apron Area is one of the construction stages of KTD. It contains one Schedule 2 DP including new distributor roads serving the planned KTD. The general layout of the Project is shown in **Figure 1**.

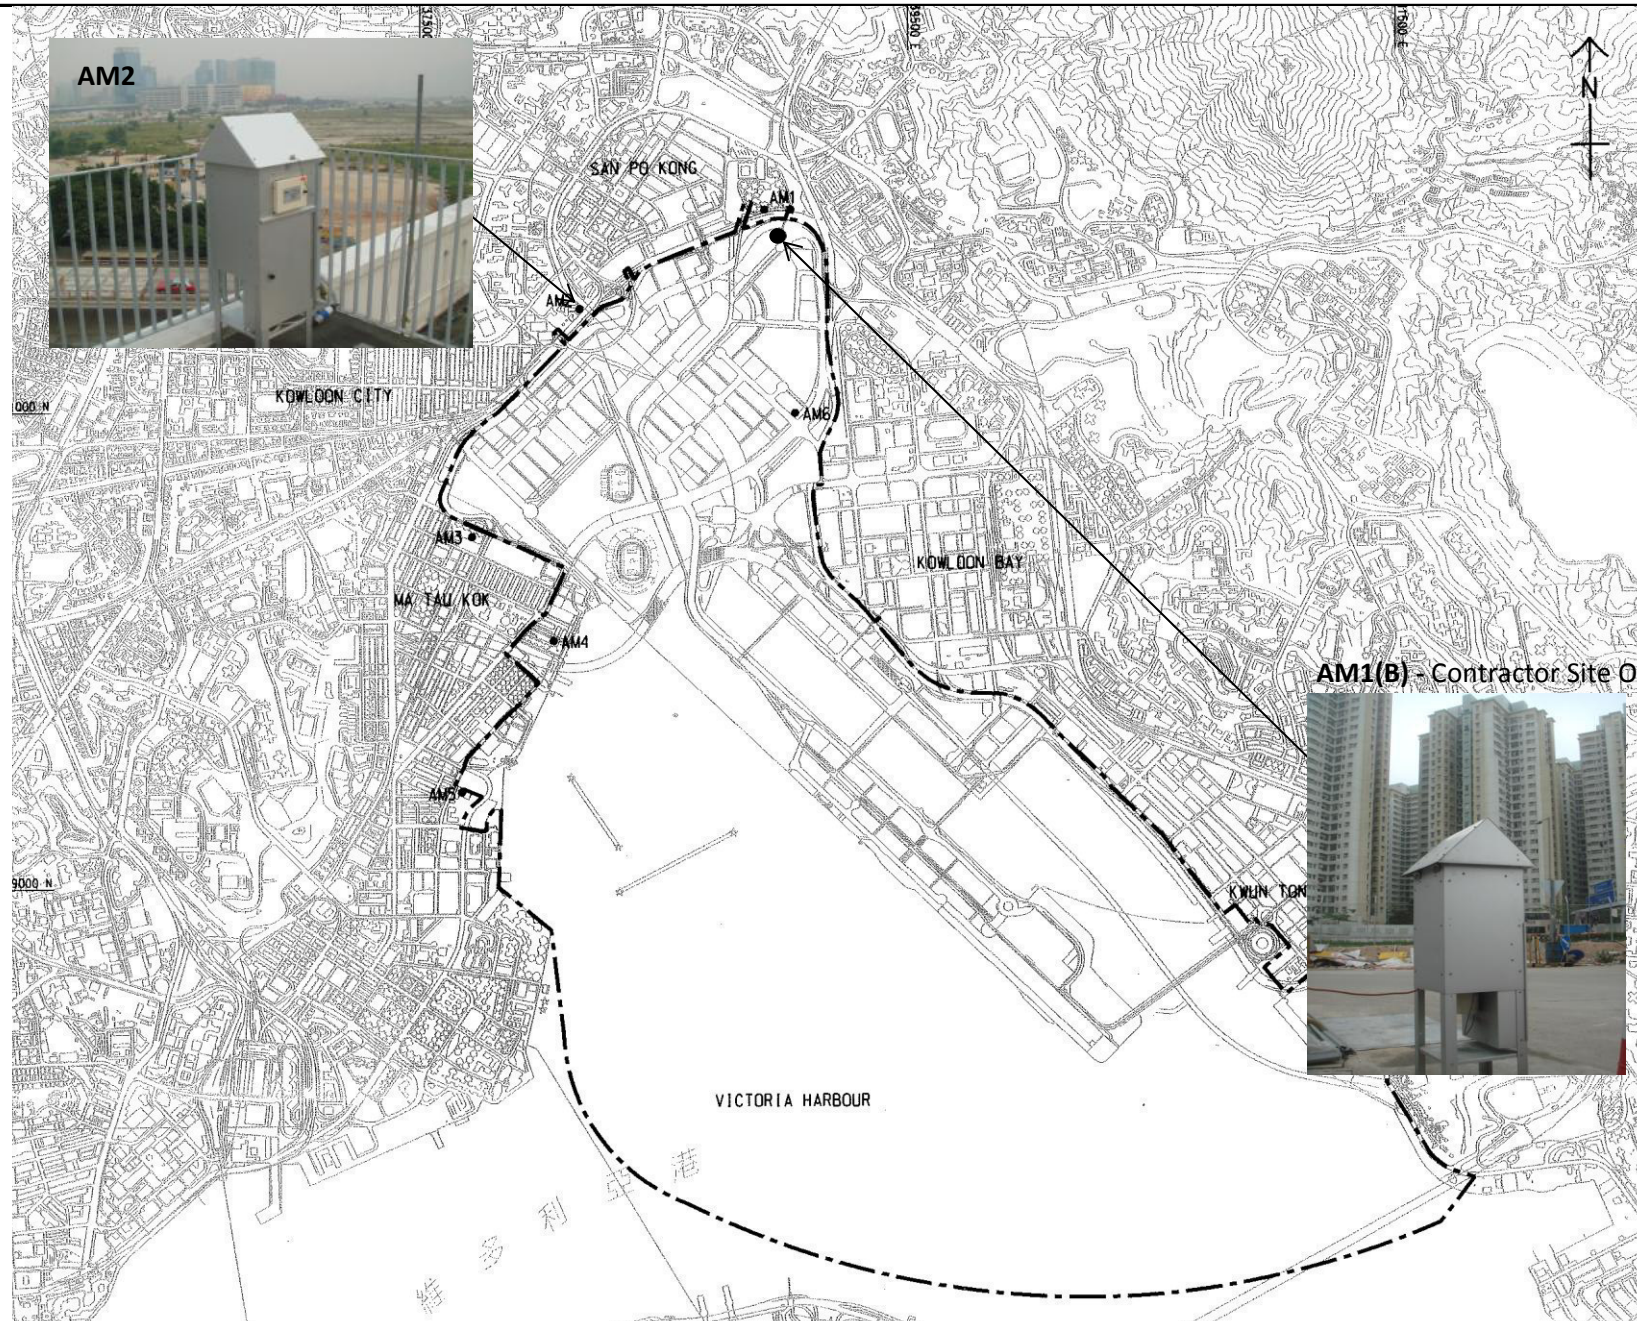
Title	Contract No. KL/2012/02		Scale	Project
	Kai Tak Development –Stage 3A Infrastructure at Former North Apron Area		N.T.S	No. MA13043
Air Quality Monitoring Stations under Contract No.: KLN/2010/04			Date	Figure
		Aug-13	2	CINOTECH

2. With reference to the same principle of EIA report of the Project, air quality monitoring stations within 500m and noise monitoring stations within 300m from the boundary of this Project are considered as relevant monitoring locations. In such regard, the relevant air quality and noise monitoring locations are tabulated in Table I (see **Figure 2** and **3** for their locations).

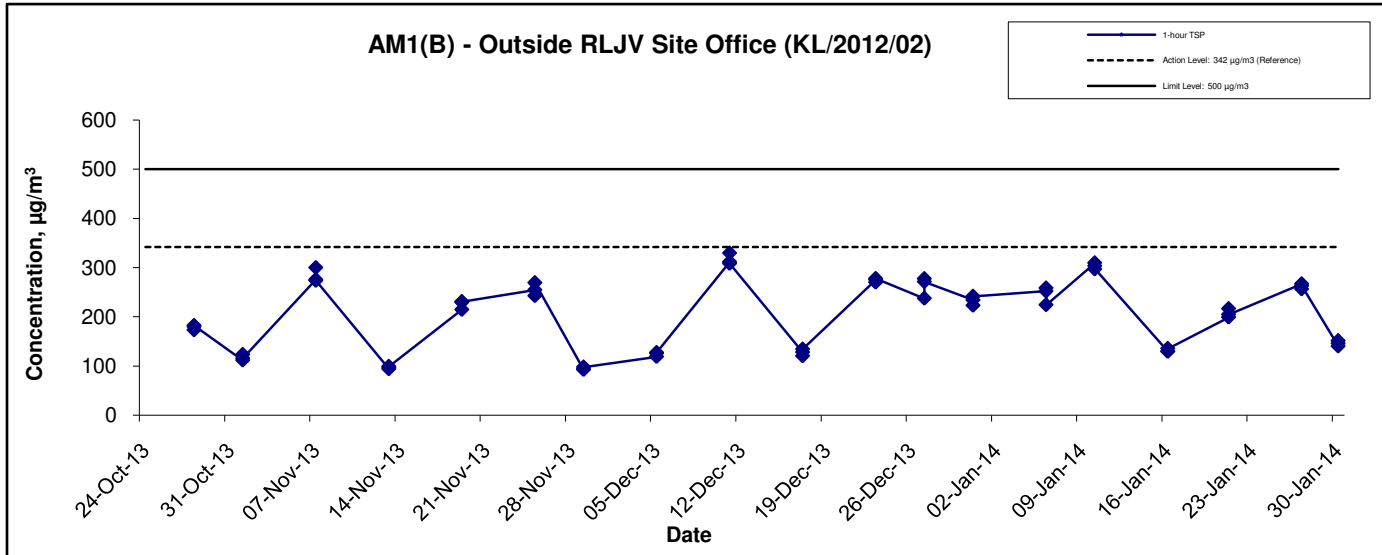
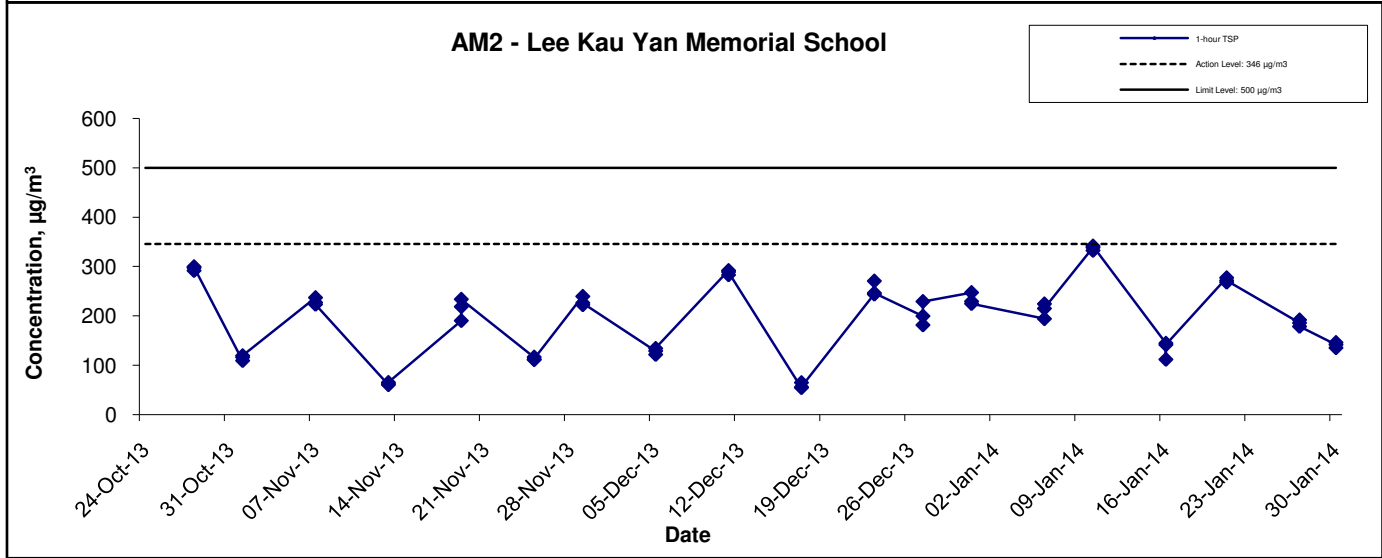
Title Contract No. KL/2012/02  
 Kai Tak Development –Stage 3A Infrastructure at Former  
 North Apron Area  
 Graphical Presentation of 1-hour TSP Monitoring Results

3.3 1-hour TSP monitoring at 2 monitoring stations, AM1(B) – Contractor Site Office and AM2 - Lee Kau Yan Memorial School, was conducted as schedule in the reporting period. No Action/Limit Level exceedance was recorded for 1-hr TSP monitoring in the reporting quarter.

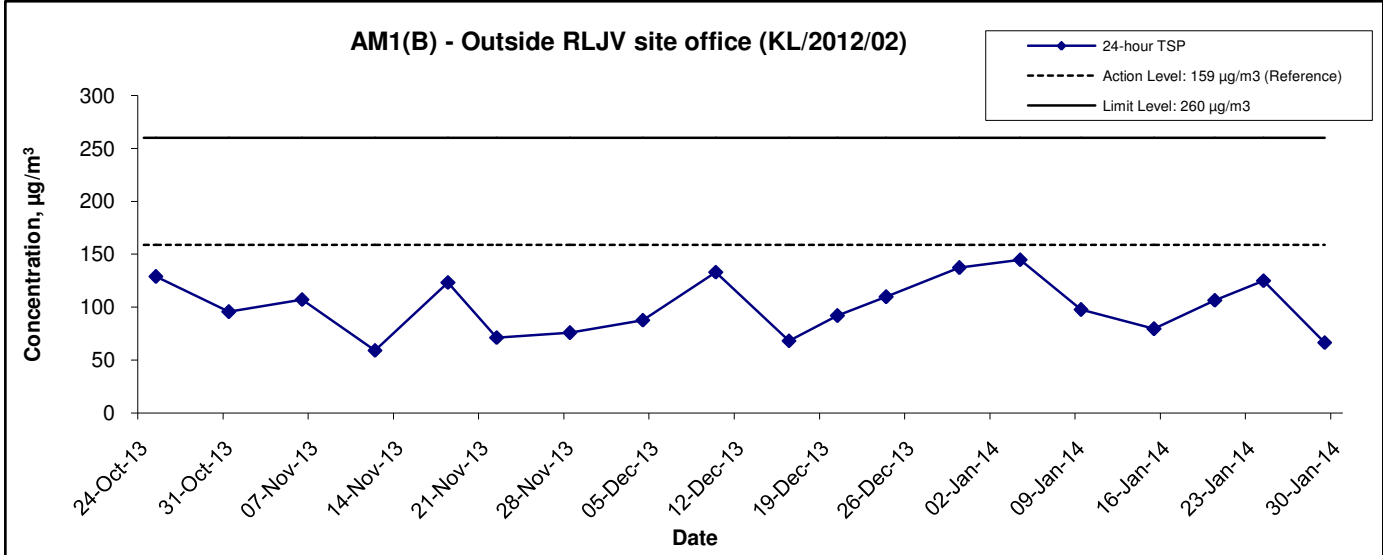
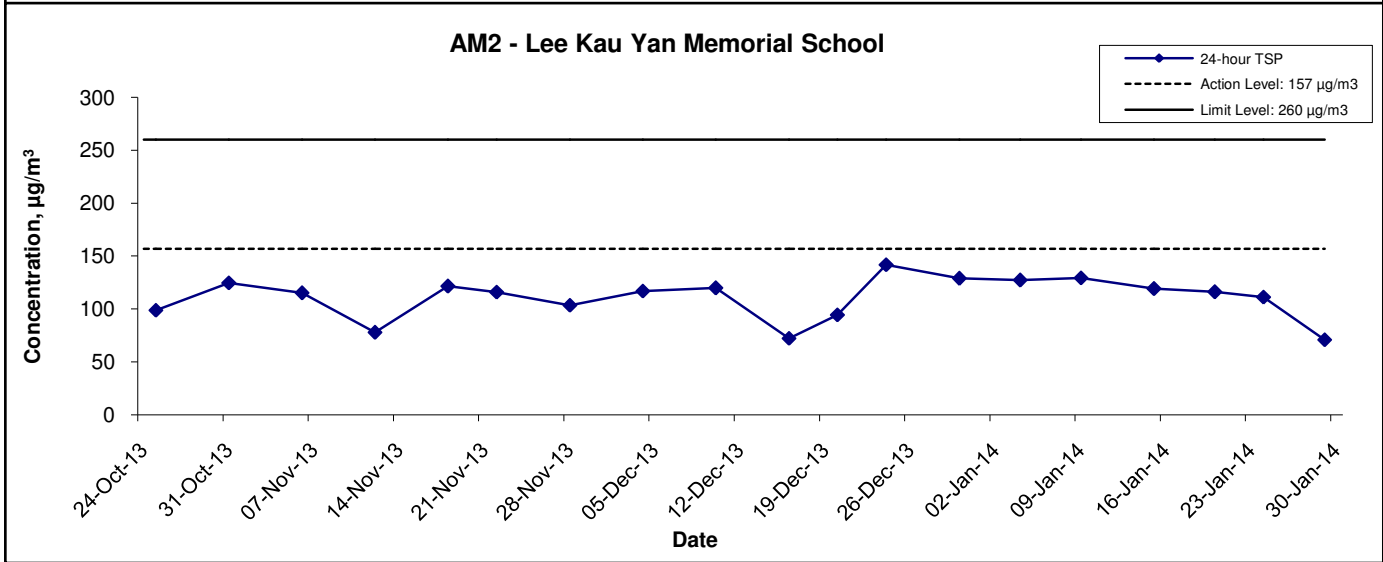
Title Contract No. KL/2012/02 Kai Tak Development –Stage 3A Infrastructure at Former North Apron Area Graphical Presentation of 24-hour TSP Monitoring Results	Scale N.T.S	Project No. MA13043	CINOTECH
	Date Jan 14	Appendix C

3.4 24-hr TSP monitoring at 2 monitoring stations, AM1(B) and AM2, was also conducted as schedule in the reporting period. No Action/Limit Level exceedance was recorded for 24-hr TSP monitoring in the reporting quarter.

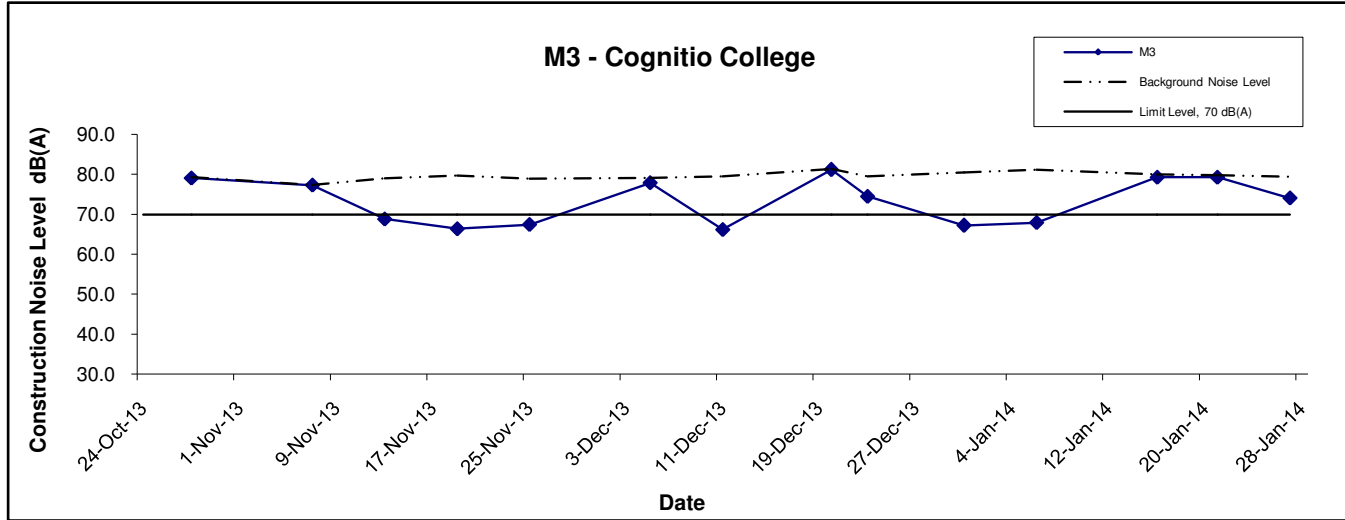
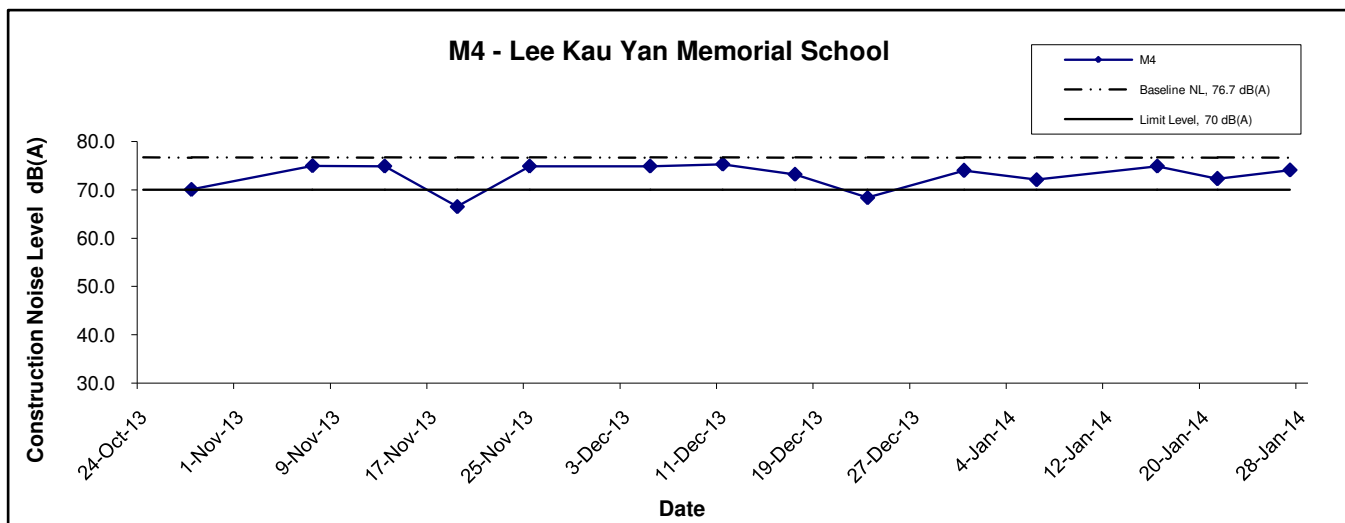
Title Contract No. KL/2012/02 Kai Tak Development –Stage 3A Infrastructure at Former North Apron Area Graphical Presentation of Construction Noise Monitoring Results	Scale	Project No.	CINOTECH
	Date	Appendix	
	N.T.S	MA13043	
	Jan 14	D

3.6 Noise monitoring at 2 monitoring stations, M3 – Cognitio College and M4 – Lee Kau Yan Memorial College, was conducted as schedule in the reporting period. No Action/Limit Level exceedance was recorded for construction noise monitoring in the reporting quarter.

Remarks: The construction noise levels in the Tables in Appendix G were adopted for plotting the graphs
