**Contract HY/2011/09**  
**Hong Kong-Zhuhai-Macao Bridge**  
**Hong Kong Link Road-Section between**  
**HKSAR Boundary and Scenic Hill**

**Quarterly EM&A Report**

**September to November 2015**

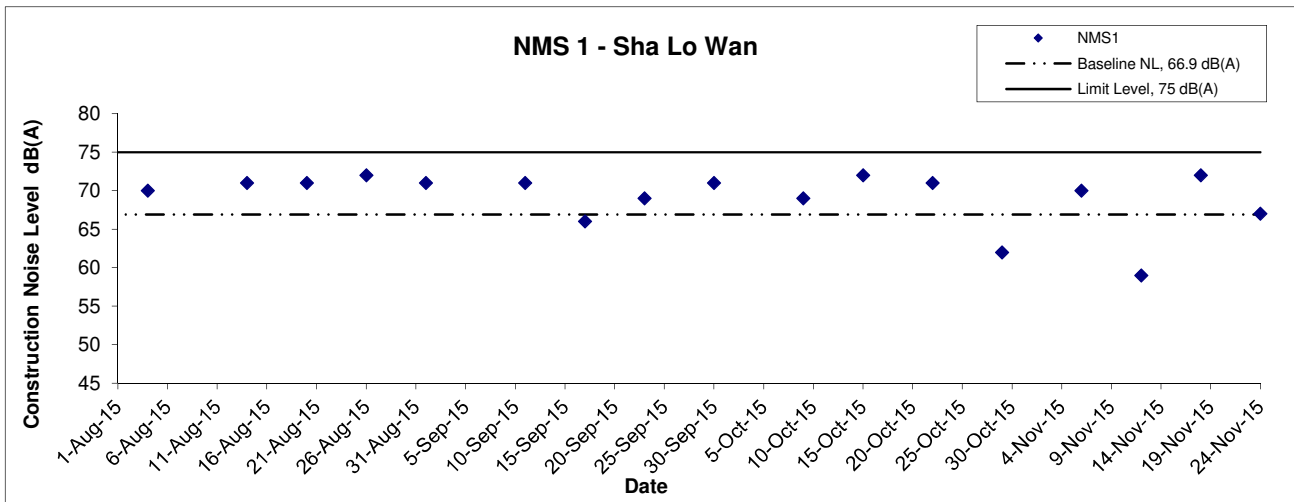
## Noise Levels

Title Contract HY/2011/09 Hong Kong-Zhuhai-Macao Bridge Hong Kong Link Road-Section between HKSAR Boundary and Scenic Hill Graphical Presentation of Construction Noise Monitoring Results	Scale N.T.S	Project No. MA12014	
	Date Nov 15	Appendix D
