**Contract No. HY/2009/11
Central – Wan Chai Bypass
North Point Reclamation**

**Report for
Translocation of Corals from ex-PCWA Basin (Site 13)
& North Point (Site 27) to Junk Bay (Recipient Site)**

April 2010

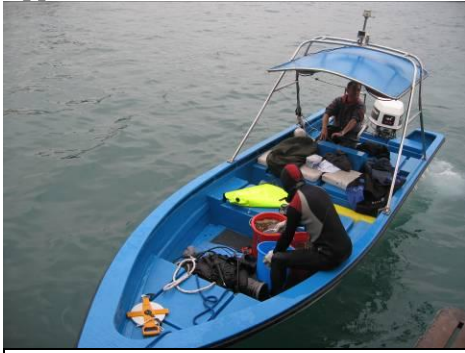
Survey vessel
