Environmental Team Services for Contract No.
CV/2012/02 Construction of Sewage Pumping
Station near Tsz Tin Road and Associated Sewerage
Works in Area 54, Tuen Mun

Quarterly EM&A Report for November 2014 to January 2015
(Rev. A)

Construction of Sewage Pumping Station

Quarterly EM&A Summary Report for November 2014 to January 2015 (Rev. A)

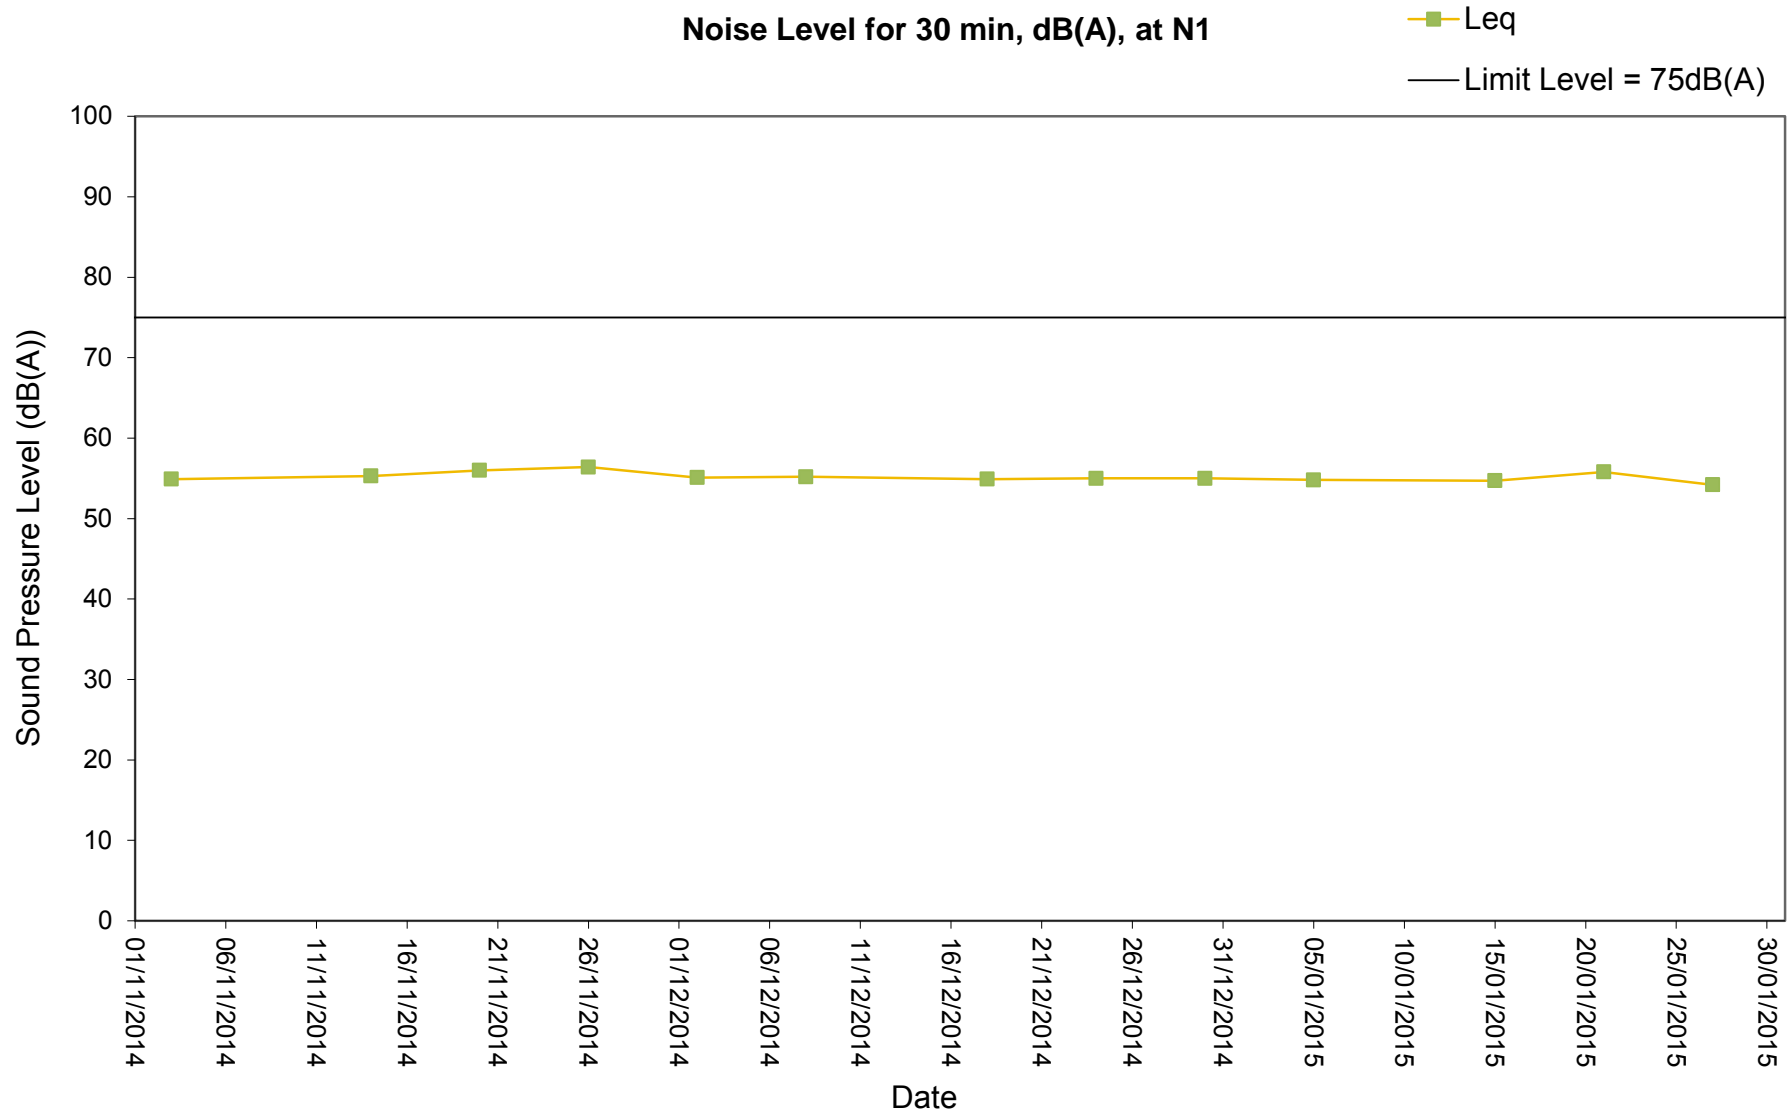
Construction noise monitoring (Station N1)

Monitoring of air quality and noise impact due to the Project was under way. In particular, the 1-hr TSP, 24-hr TSP, noise level (as L_{eq}) under monitoring have been checked against established Action and Limit levels. There was no breach of Action and Limit Levels for 1-hr TSP, 24-hr TSP and noise in the reporting period.

Time Period & Monitoring Locations	Action Level	Limit Level
N1& N2 0700-1900 hours on normal weekdays	When one documented complaint is received from any one of the sensitive receivers	75 dB(A)
